The WW II German Defences Structures around Ploumoguier (Finistère-FR)

Giancarlo T. Tomezzoli

How to cite this paper: Tomezzoli, G. T. (2018). The WW II German Defences Structures around Ploumoguier (Finistère-FR). *Archaeological Discovery*, 6, 62-87. <https://doi.org/10.4236/ad.2018.62005>

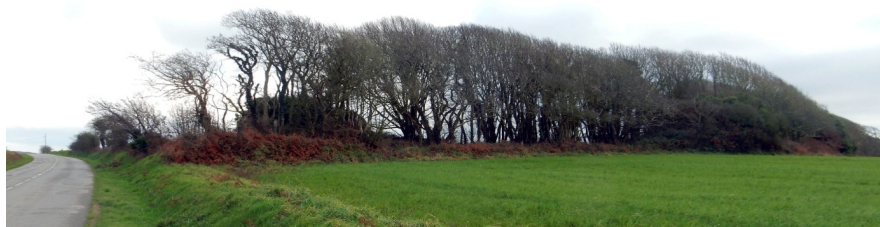
Figure 3. *Stp Re 80*: general view, on the left road to Ploumoguer, through the vegetation *R 669* (1).

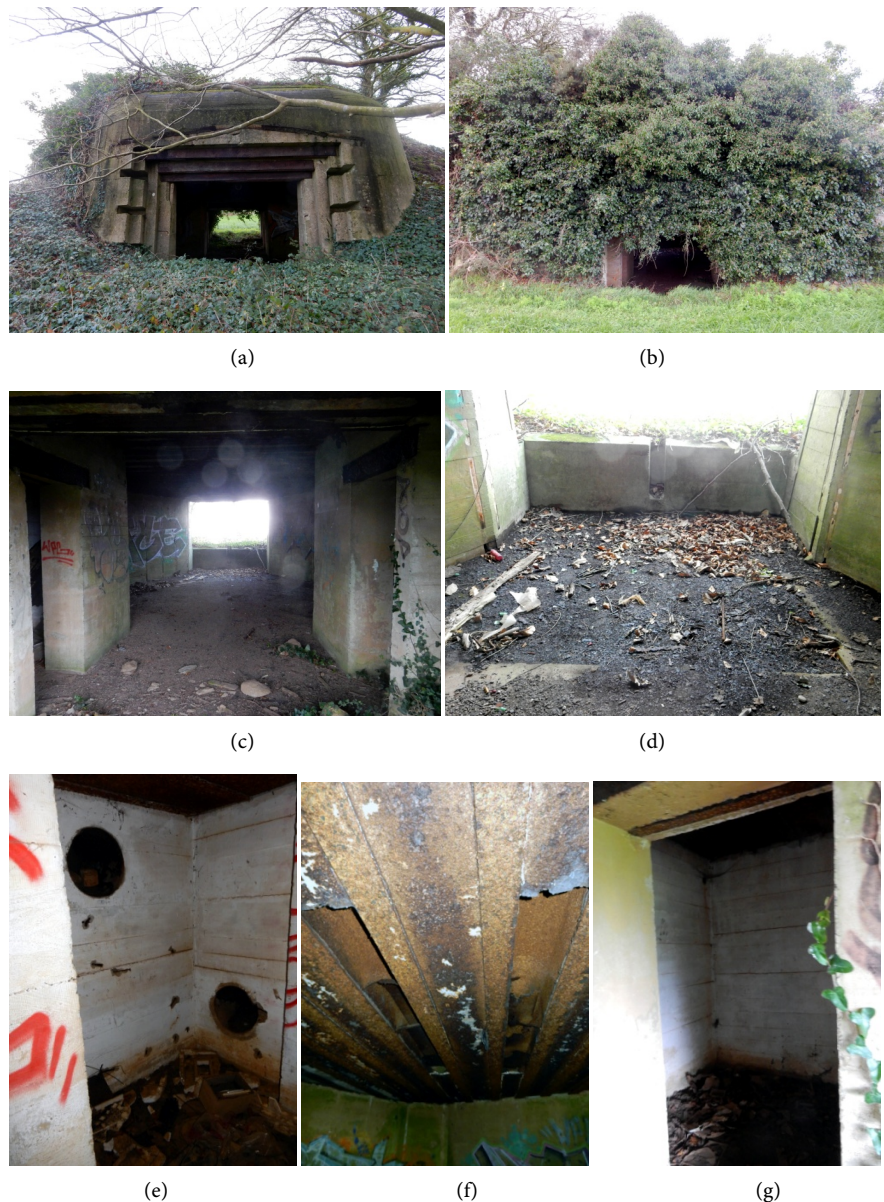
An *R 669*(1) (48°24'5.14"N, 04°41'52.98"W, 97.7 m) (Figure 4) for 100 or 150 mm gun (Rapport Pinczon du Sel, 1947-1948). It presented a well preserved concrete structure partially covered by vegetation, without damages due to bombardments or combats. The rear aperture, partially obstructed by vegetation, introduced into the fire room deprived of its original furniture. On the floor,

the square carriage wheel gun emplacement and the arcuate gun carrier legs emplacement, observed in other *R 669s* (Tomezzoli & Pottier, 2016), although both covered by terrain, were well recognizable. The walls preserved the original white painting and the vertical wood insulation supports embedded in the concrete. On the walls, no traces of a thermal insulation system. The metallic ceiling preserved two gun lifting joints and the gates of the combat gas extraction system, deprived of their original grids. The ammunition room was empty and the combat gas extraction system room preserved some rusted portion of conduits. The exhausted combat gas pipe and a possible niche hosting it (Tomezzoli & Pottier, 2016), on the *R 699* (1) rear side, were covered by vegetation and not visible.

Figure 4. *Stp Re 80-R 669 (1)*: (a) Fire room front side aperture with splinter guards; (b) Fire room rear side aperture partially covered by vegetation; (c) Fire room, on the left side, entrance of the combat gas extraction system room, on the right side entrance of the ammunition room; (d) Fire room front side aperture and square carriage wheel gun emplacement; (e) Combat gas extraction system room; (f) Fire room, metal ceiling with gates of the combat gas extraction system; (g) Ammunition room.

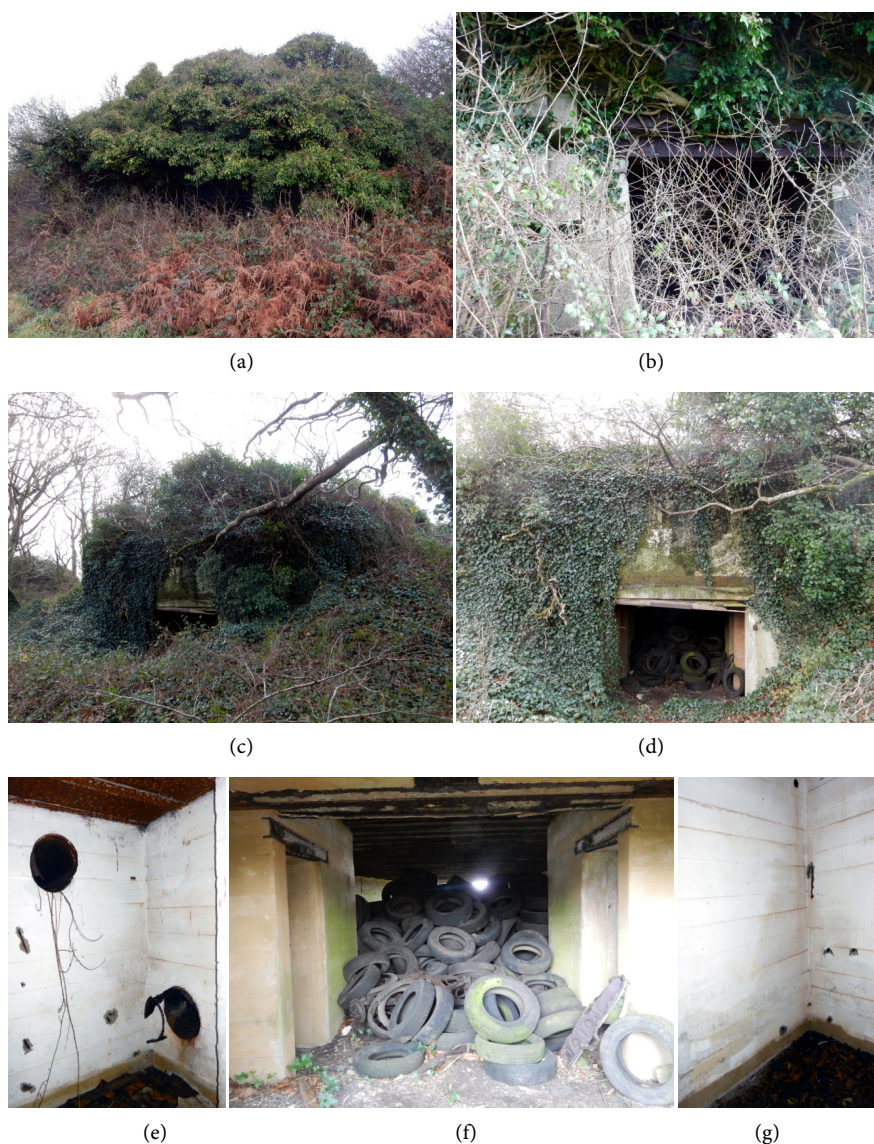
An *R 669* (2) (48°24'3.96"N, 04°41'53.83"W, 97.76 m) (Figure 5) for 100 or 150 mm gun. Its concrete structure was covered by vegetation, but apparently

without damages due to bombardments or combats. The rear aperture introduced into the fire room fully occupied by used tires. The walls preserved the original white painting. The metallic ceiling preserved two joints for the gun lifting and the gates of the combat gas extraction system deprived of their original grids. The ammunition room was empty and the combat gas extraction system room preserved some rusted portion of conduits. The exhausted combat gas pipe and a possible niche hosting it, on the *R 699* (2) rear side, were covered by vegetation and not visible.

Figure 5. *Stp Re 80-R 669 (2)*: (a) Front side covered by vegetation; (b) Fire room front aperture; (c) Rear side covered by vegetation; (d) Fire room rear side aperture; (e) Combat gas extraction system room; (f) Fire room, on the left side entrance of the combat gas extraction system room, on the right entrance of the ammunition room; (g) Ammunition room.

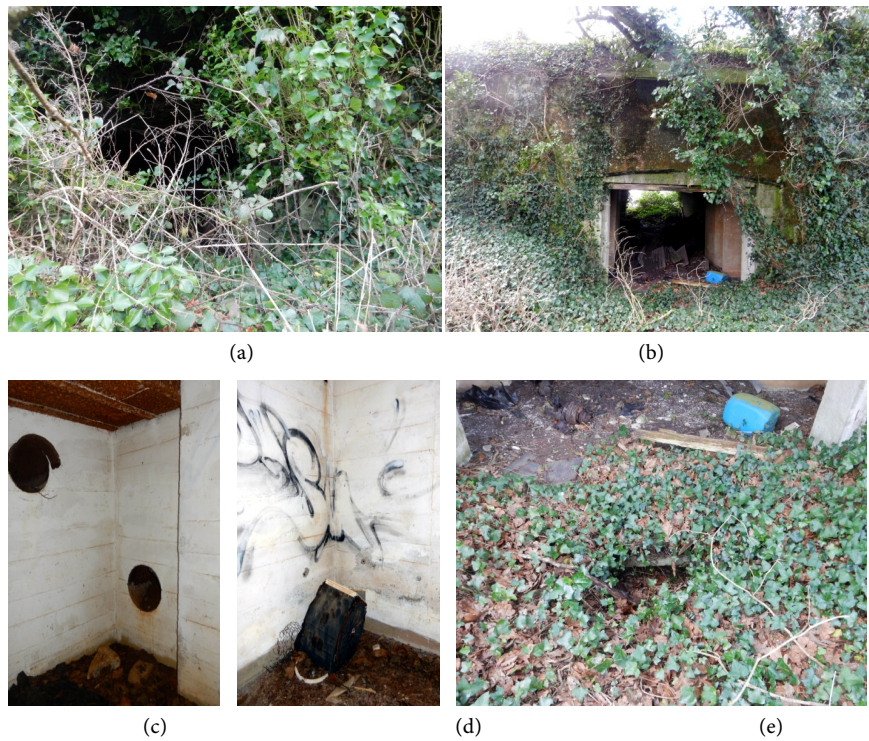
An *R 669* (3) ($48^{\circ}24'3.08''N$, $04^{\circ}41'52.75''W$, 97.13 m) (**Figure 6**) for 100 or 150 mm gun. Its concrete structure was covered by vegetation, but apparently without damages due to bombardments or combats. The rear aperture introduced

into the fire room deprived of its original furniture. The walls preserved the original white painting, somewhere covered by contemporary graffiti, and the vertical wood insulation supports embedded in the concrete. On the walls, no traces of a thermal insulation system. On the floor, the square carriage wheel gun emplacement and the arcuate gun carrier legs emplacement, although both covered by terrain, were well recognizable. The metallic ceiling preserved two gun lifting joints and the gates of the combat gas extraction system, deprived of

their original grids. The walls of the ammunition room were covered by contemporary graffiti. The combat gas extraction system room preserved some rusted portion of conduits. The exhausted combat gas pipe and a possible niche hosting it, on the *R 699 (3)* rear side, were covered by vegetation and not visible.

On the ground, near the *R 699 (3)* rear side, a small bore 30×30 cm, betrayed the existence of the trench drainage system.

Figure 6. *Stp Re 80-Re 669* (3): (a) Fire room front side aperture covered by vegetation; (b) Fire room rear side aperture; (c) Combat gas extraction system room; (d) Ammunition room, on the floor, abandoned, a washing machine drum; (e) Trench floor, bore of the drainage system.

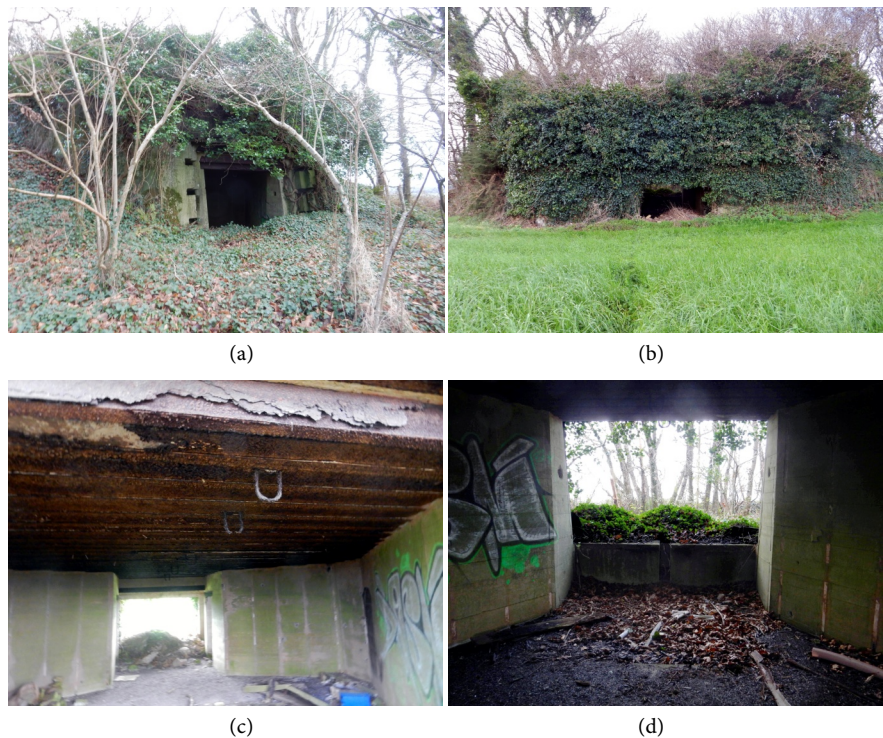
An *R 669 (4)* ($48^{\circ}24'2.26''N$, $04^{\circ}41'53.14''W$, 95.89 m) (**Figure 7**) for 100 or 150 mm gun. Its concrete structure was covered by vegetation, but apparently without damages due to bombardments or combats. The rear aperture introduced into the fire room, deprived of its original furniture. The walls preserved

the original white painting, covered by contemporary graffiti, and the vertical wood insulation supports embedded in the concrete. On the walls, no traces of a

Figure 7. *Stp Re 80-Re 669 (4)*: (a) Fire room front side aperture with splinter guards; (b) Fire room rear side aperture; (c) Fire room, metallic ceiling with two gun lifting joints and vertical wood insulation supports embedded in the wall concrete; (d) Fire room, square carriage wheel gun emplacement, (e) Combat gas extraction system room; (f)-(g) Metallic ceiling with joint for the gun lifting and gates of the combat gas extraction system; (h) Ammunition room; (i) Trench; (j) *R 669* plan: 4 ammunition room, 5 fire room (Rudi, 1998).

thermal insulation system. On the floor, the square carriage wheel gun emplacement and the arcuate gun carrier legs emplacement, although both covered by terrain, were well recognizable. The metallic ceiling preserved two gun lifting joints and the gates of the combat gas extraction system, deprived of their original grids. The ammunition room was empty. The walls of the combat gas extraction system room were covered by contemporary graffiti and preserved some rusted portion of conduits. The exhausted combat gas pipe and a possible niche hosting it, on the *R 699 (4)* rear side, was covered by vegetation and not visible.

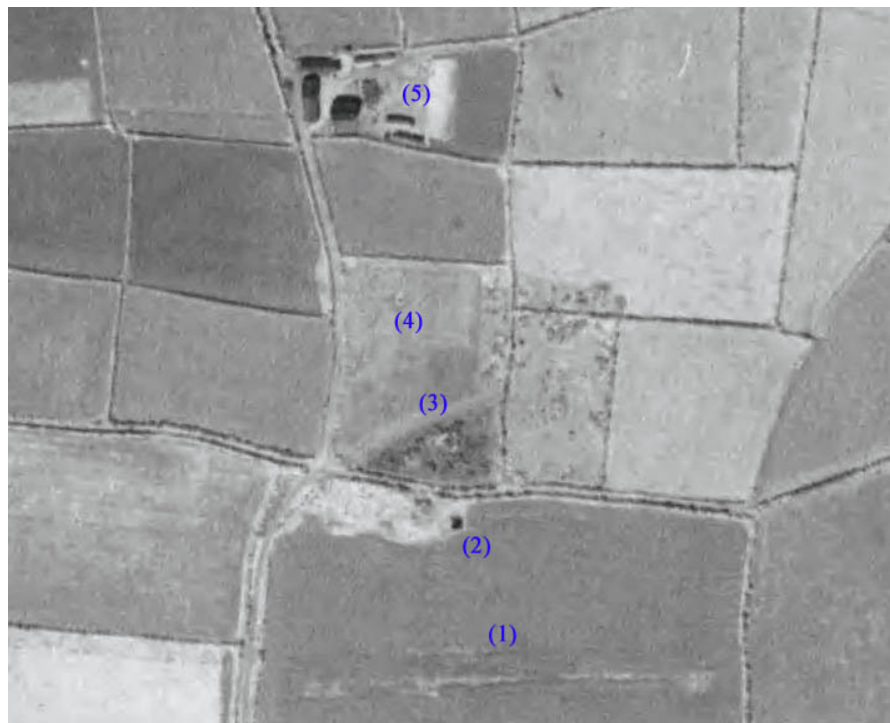
Figure 8. *Stp Re 311-FuMB 445*. (1) possible anti-tank trenches; (2) *V 256*; (3) possible defense constructions; (4) cylindrical water pit of German construction; (5) Kervélédan farm (C0417-0103_1961_F0317-0717_0068, n° 68, Échelle 1/25632, Argentique, 29/06/1961).

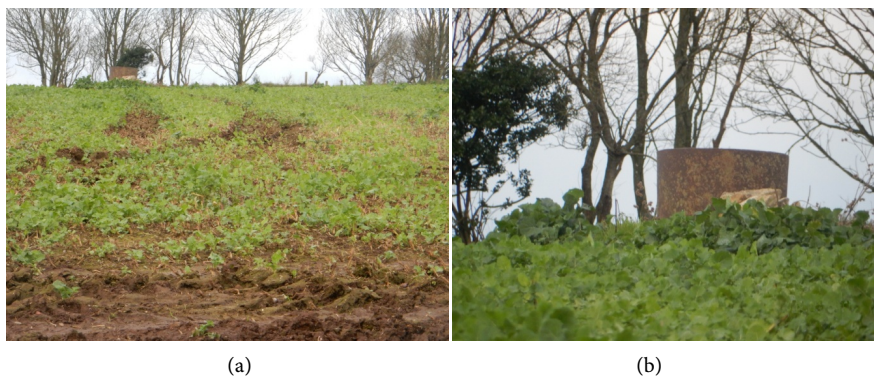
Figure 10. *Stp Re 311-FuMB 445*: (a) Field near *V 256*; on the upper left cylindrical water pit of German construction; (b) Cylindrical water pit.

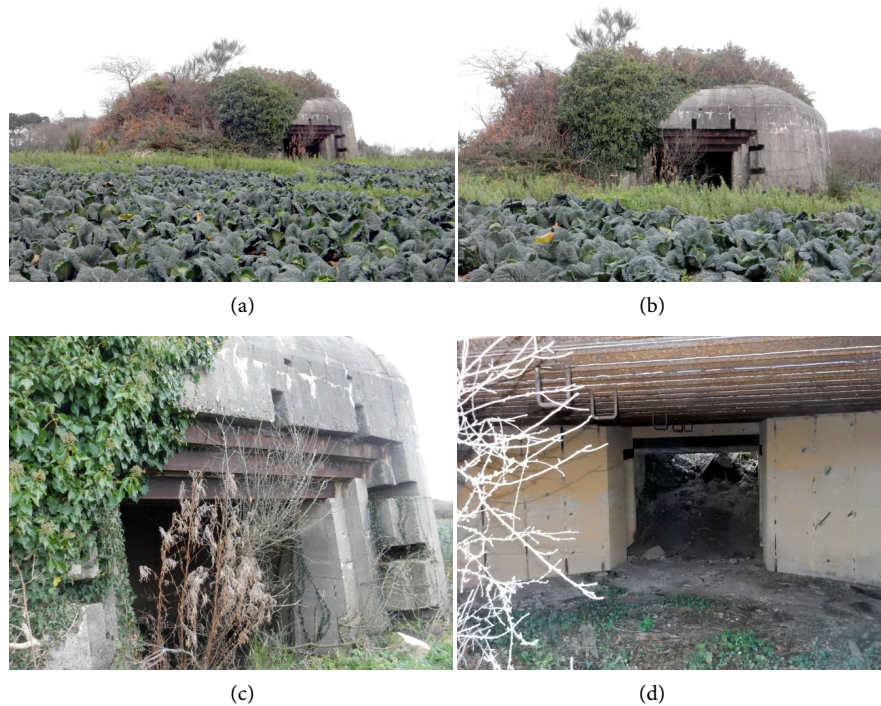
An *R 669* (1) (48°23'46.1"N, 04°43'55.05"W, 48.37 m) (**Figure 12**) for 150 mm gun. Its concrete structure was covered by vegetation, but apparently without damages due to bombardments or combats. The rear aperture introduced into

Figure 12. *Stp Re 77-R 669 (1)*: (a)-(c) Fire room front side aperture with splinter guards; (d) Fire room, on the left side, entrance of the ammunition room, on the right side entrance of the combat gas extraction system room, on the walls the original white painting and the vertical wood insulation supports embedded in the concrete, on the floor, the arculate gun carrier legs emplacement, on the metallic ceiling the five gun lifting joints.

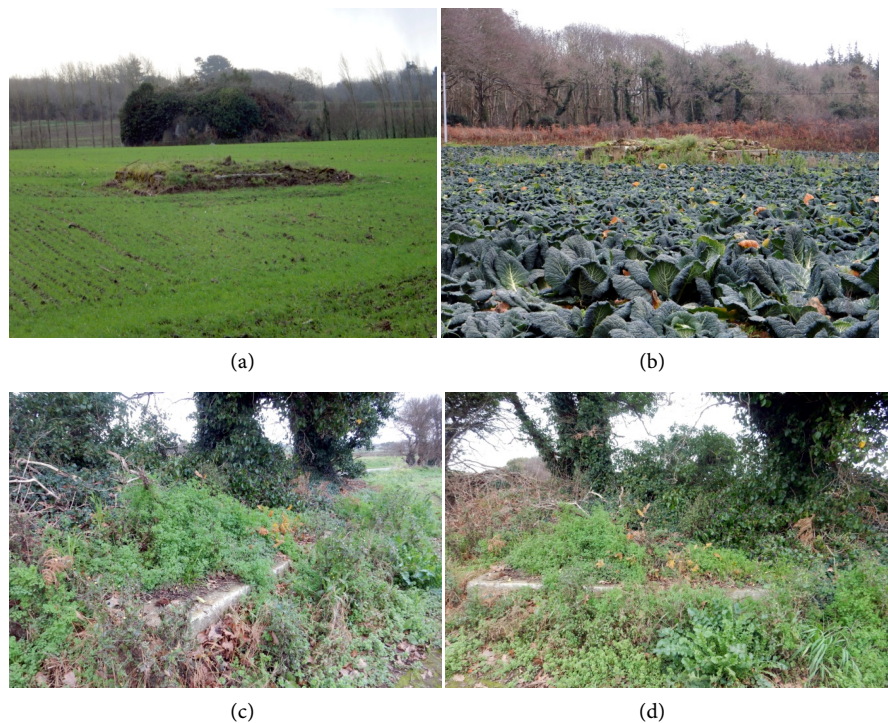
A VF(12) (48°23'46.15"N, 04°43'52.08"W, 49.33 m) (**Figure 13(a)**), about 8 × 4 m, completely buried in the terrain. Only its coverage emerged from the terrain. The entrance was obstructed by the terrain; so that the inspection of the interior was not possible. The apparent absence on its coverage of chimney conduits suggested that it was intended for storing ammunitions and/or

Figure 13. *Stp Re 77*: (a) *Vf(12)*, in the foreground *R 669 (1)*; (b) *Vf(5)*, seen from *R 669 (1)*; (c) *Vf(7)* side view; (d) *Vf(7)* front view.

materials, although the function of guardhouse for a group of soldiers, at the one entrance of the *Stp*, cannot be excluded. The emerging *Vf*(12) concrete structure was in a good preservation state without damages due to bombardments or combats.

A *Vf*(5) (48°23'46.15"N, 04°43'52.08"W, 49.33 m) (**Figure 13(b)**), about 6 × 4.50 m, emerged about one meter from the terrain. It was provided with one entrance not provided with protection walls. The entrance was obstructed by terrain and vegetation; so that the inspection of the interior was not possible. The apparent absence on its coverage of chimney conduits and its position, about 50 m from the *R 669* (1), suggested that it was intended for storing ammunition and/or materials for the *R 669* (1) rather than hosting a group of soldiers. The emerging *Vf* (5) concrete structure was in a good preservation state without damages due to bombardments or combats.

A *Vf*(7) (48°23'50.48" N, 04°43'52.42" W, 50.72 m) (**Figures 13(c)-(d)**), similar to *Vf*(5) was completely buried in the terrain. The entrance was obstructed by the terrain; so that the inspection of the interior was not possible. The apparent absence on its coverage of chimney conduits and its position, about 60 m from the *R 669* (2), suggested that it was intended for storing ammunition and/or materials for the *R 669* (2) rather than hosting a group of soldiers. The emerging *Vf* (7) concrete structure was in a good preservation state without damages due to bombardments or combats.

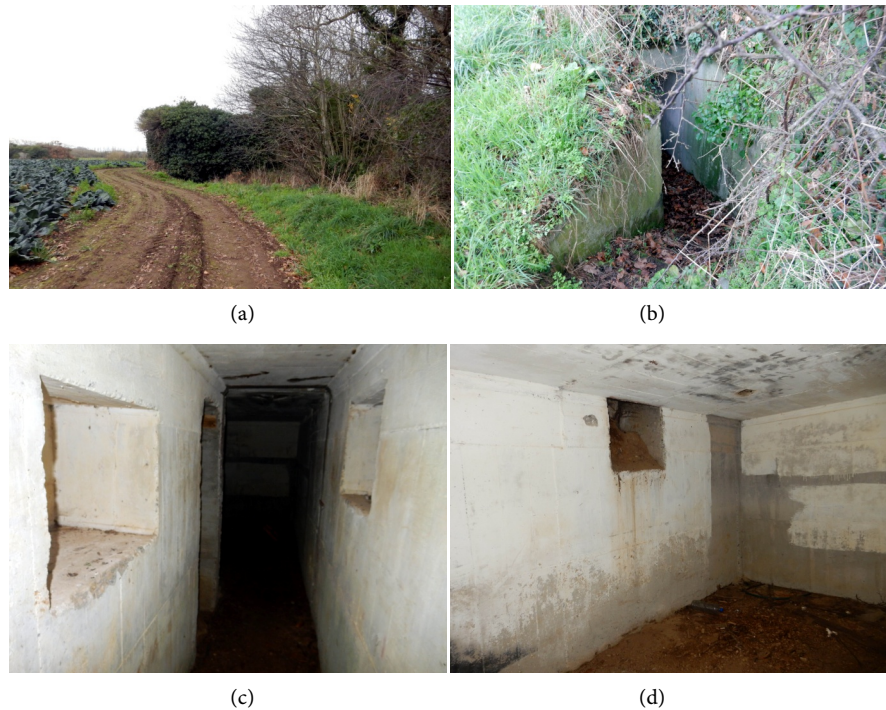
A *Vf*(6) (48°23'49.29"N, 04°43'54.82"W, 49.77 m) (**Figure 14**), about 30 m from *R 669*(2), indicated by the proprietor, was completely buried in the terrain. The labyrinth entrance, free from obstructions, given access to an internal corridor having a rectangular niche about 60 × 50 × 40 cm on each side. The corridor was connected with the entrance of an interior single room about 6 × 6 m large without metallic ceiling. The room preserved on one wall the access to an emergency exit. The corridor and the room preserved their original white painting, although a grey unfinished attempt of painting was visible in the room. The *Vf*(6) concrete structure was in a good preservation state without damages due to bombardments or combats.

Figure 14. *Stp Re 77-Vf(6)*: (a) Access road; (b) Labyrinth entrance, (c) Internal corridor with niches, (d) Internal room with emergency exit.

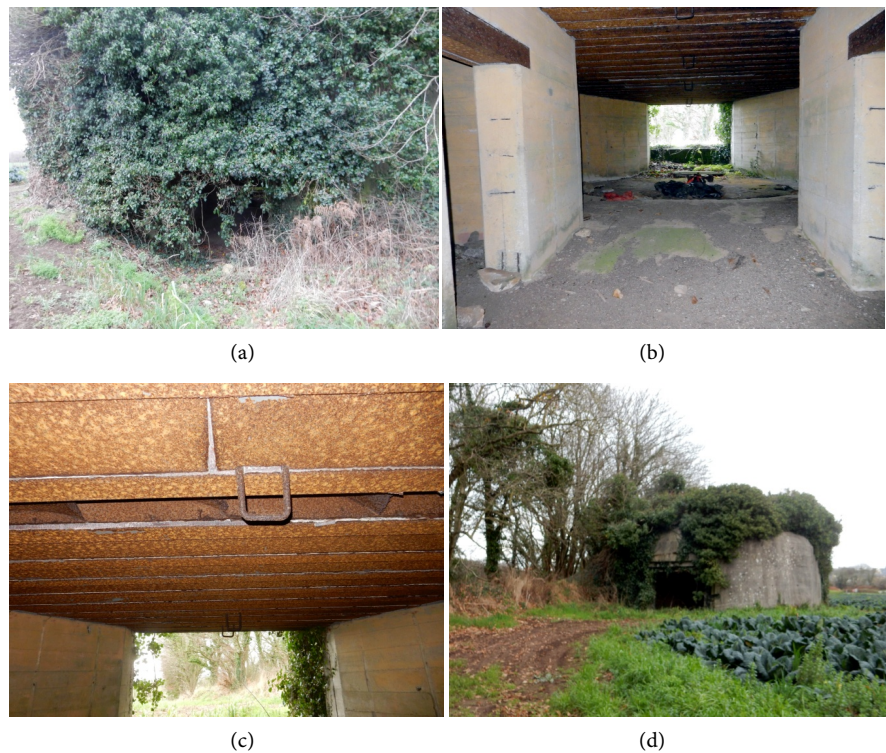
An *R 669* (2) (48°23'48.35"N, 04°43'55.33"W, 50.28 m) (**Figure 15**) for 150 mm gun. Its concrete structure was covered by vegetation, but apparently without damages due to bombardments or combats. The rear aperture introduced into an empty fire room, deprived of its original furniture. The walls preserved the original white painting and the vertical wood insulation supports embedded in the concrete. On the walls, no traces of a thermal insulation system. On the floor, the square carriage wheel gun emplacement and the arcuate gun carrier legs emplacement, although both covered by terrain, were well recognizable. The metallic ceiling preserved two joints for the gun lifting and the gates of the combat gas extraction system, deprived of their original grids. The ammunition room was empty and the combat gas extraction system room preserved some rusted portion of conduits. The exhausted combat gas pipe and a possible niche hosting it, on the *R 669*(2) rear side, were covered by vegetation and not visible.

Figure 15. *Stp Re 77-R 669 (2)*: (a) Fire room rear side aperture covered by vegetation; (b) Fire room, on the left side, entrance of the combat gas extraction system room, on the right side entrance of the of the ammunition room; (c) Fire room, metallic ceiling with two gun lifting joints and gate of the combat gas extraction system; (d) Fire room front side aperture with splinter guards.

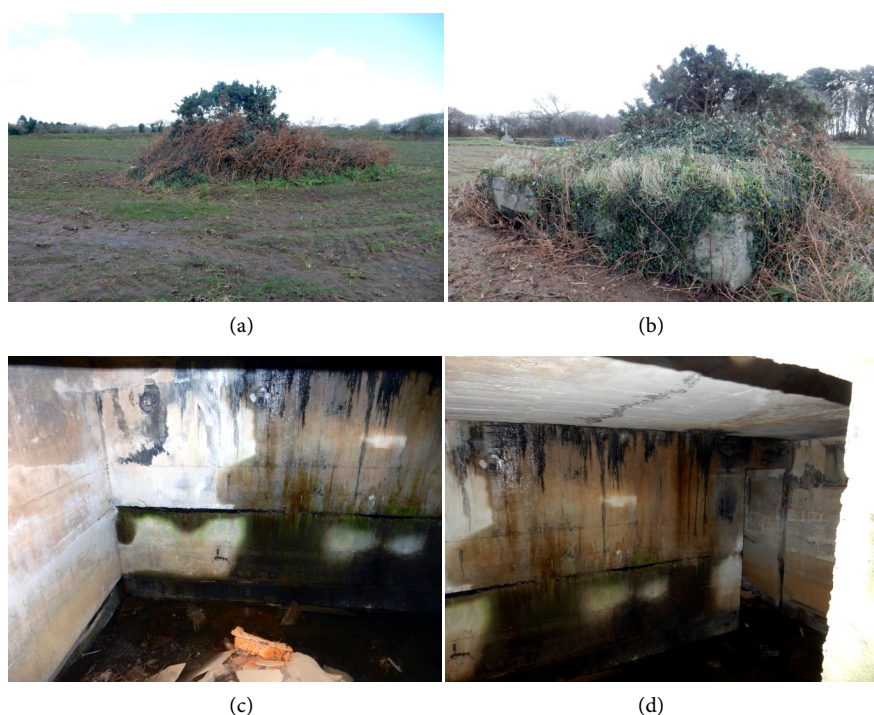
A Vf(16) bunker (**Figure 16**), about 6×6 m, similar to Vf(5) and Vf(7) was completely buried in the terrain. The entrance was not provided with protection walls and emerged partially from the terrain, allowing to see a well preserved, white painted, internal room. On one of its wall an entrance to a nearby room was visible. Although the apparent absence on its coverage of chimney conduits, its position close to the road Plumoguer Blanc Sablons, suggested for this Vf the function of guardhouses for a group of soldiers in charge of the surveillance of said road (**Figure 11**). The emerging Vf(16) concrete structure was in a good preservation state without damages due to bombardments or combats.

Figure 16. *Stp Re 77- Vf (16):* (a) Rear side; (b) Front side with entrance; (c) Internal room; (d) Internal room, on the right entrance to a nearby room.

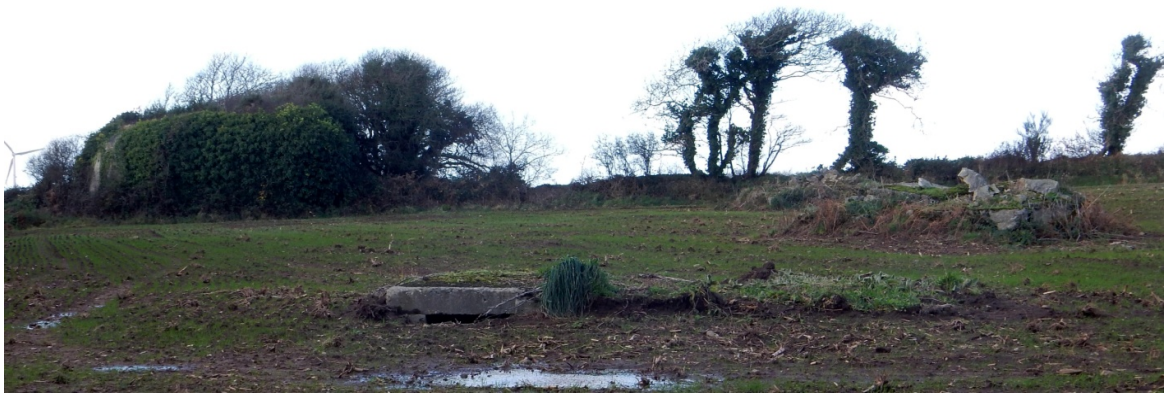
Figure 17. *Stp Re 77*: Vf(10), Vf(8), Vf(9), on the left, in the foreground R 669 (4).

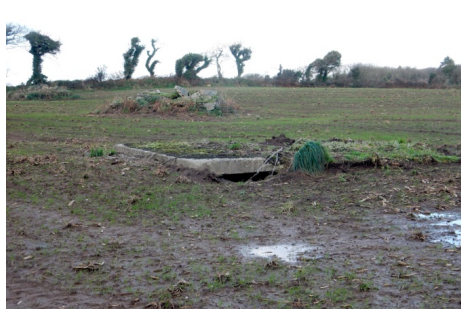
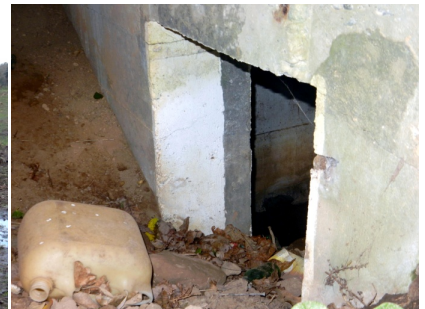
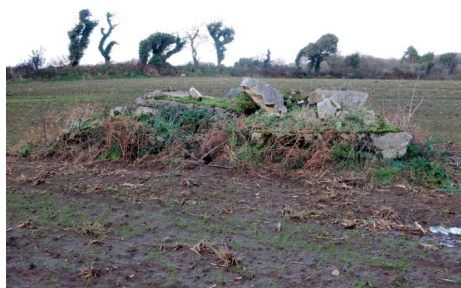
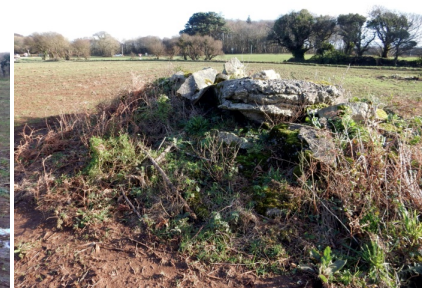
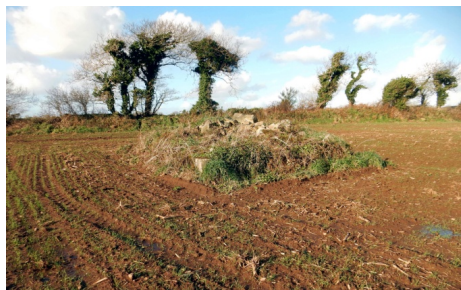
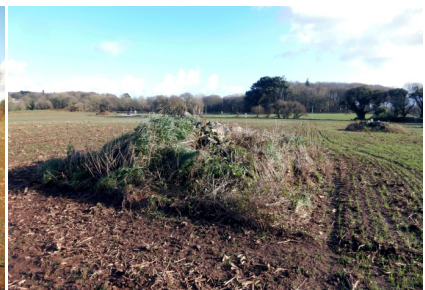
A Vf (10) ($48^{\circ}23'51.05''\text{N}$, $04^{\circ}43'52.42''\text{W}$, 51.18 m) (**Figure 17**, **Figures 18(a)-(b)**), about 5×5 m, similar to Vf(5). It was completely buried in the terrain. The entrance, partially emerging from the terrain, allowing inspecting the interior formed by a short corridor and an internal room both preserving their original white painting. Although the apparent absence on its coverage of chimney conduits, its position close to the road Plumoguer-Blanc Sablons, suggested for this Vf the function of guardhouses for a group of soldiers in charge of the surveillance of said road (**Figure 11**). The emerging Vf(10) concrete structure was in a good preservation state without damages due to bombardments or combats.

A Vf(8) ($48^{\circ}23'51.63''\text{N}$, $04^{\circ}43'54.64''\text{W}$, 51.76 m) (**Figure 18(c)-(d)**), about 5×5 m, similar to Vf(5) completely buried in the terrain. Its position, about 20 m from the R 669 (3), suggested that it was intended for storing ammunition and/or materials for the R 669 (3). The emerging Vf (80) concrete structure

Figure 18. *Stp Re 77*: (a) Vf(10) external structure with partially obstructed entrance; (b) Vf(10) corridor and internal room, (c)-(d) Vf(8) damaged external structure; (e)-(f) Vf(9) damaged external structure.

appeared rather damaged, suggesting that *Vf*(8) was intentionally dynamited or that stones or concrete slabs dispersed in the cultivated fields were collected on its coverage.

A *Vf*(9) (48°23'52.45"N, 04°43'55.7"W, 52.48 m) (**Figures 18(e)-(f)**), about 5 × 5 m, similar to *Vf*(5) and *Vf*(8) completely buried in the terrain. Its position, about 30 m from the *R 669* (4), suggested that it was intended for storing ammunition and/or materials for the *R 669* (4). The emerging *Vf*(9) concrete structure appeared rather damaged, suggesting that the *Vf*(9) was too intentionally dynamited or that stones or concrete slabs dispersed in the cultivated fields were collected on its coverage.

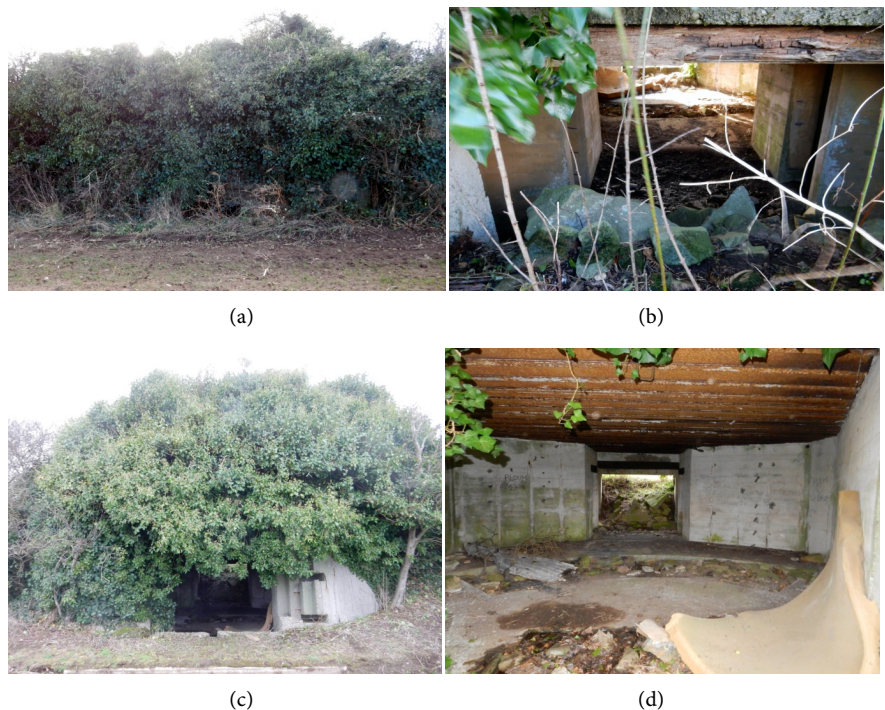
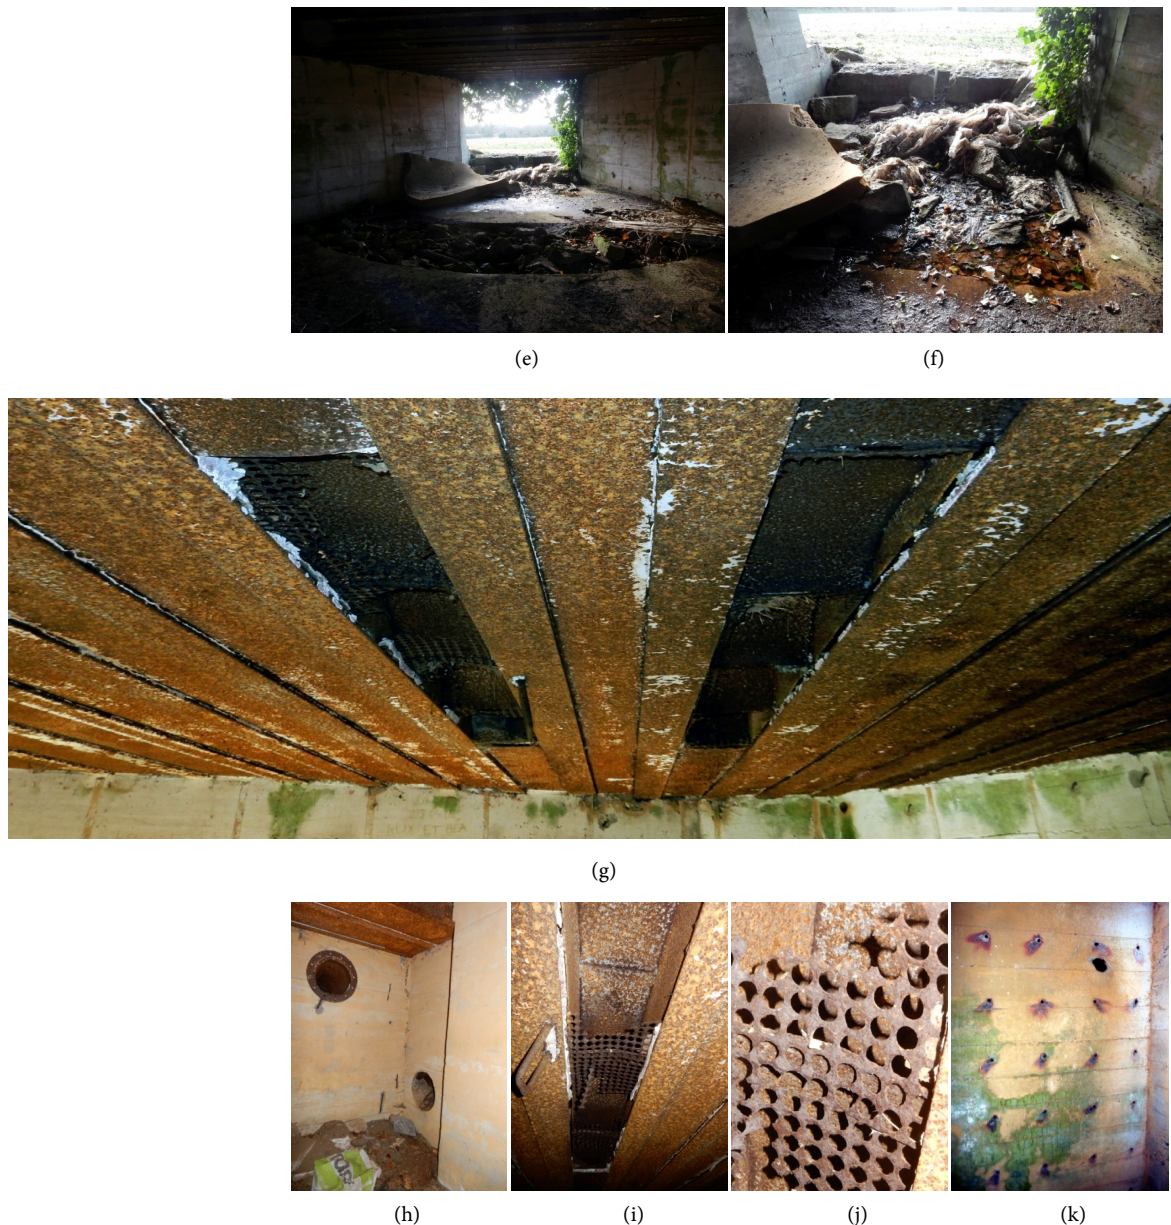
An *R 669* (3) (48°23'50.52"N, 04°43'55.29"W, 50.4 m) (**Figure 19**) for 150 mm gun. Its concrete structure was covered by vegetation, but apparently without damages due to bombardments or combats. The rear aperture introduced into an empty fire room, deprived of its original furniture. The walls preserved the original white painting and the vertical wood insulation supports embedded in the concrete. On the walls, no traces of a thermal insulation. On the floor, the square carriage wheel gun emplacement and the gun carrier legs emplacement were well recognizable. The metallic ceiling preserved two joints for the gun lifting and the gates of the combat gas extraction system, preserving portions of their original grids. The ammunition room was empty and the combat gas extraction system room preserved some rusted portion of conduits. The exhausted combat gas pipe and a possible niche hosting it, on the *R 699* (3) rear side, were covered by vegetation and not visible.

Figure 19. *R 669* (3): (a) Fire room rear side aperture covered by vegetation; (b) Fire room seen from the rear side aperture; (c) Fire room front side aperture with splinter guards covered by vegetation; (d) Fire room, rear side aperture, square carriage wheel gun emplacement and arcuate gun carrier legs emplacement; (e) Square carriage wheel gun emplacement; (f) Square carriage wheel gun emplacement; (g) Fire room, metallic ceiling with gates of the combat gas extraction system; (h) Combat gas extraction system room; (i) Fire room, metallic ceiling with gun lifting joint and gates of the combat gas extraction system; (j) Grid of a gate of the combat gas extraction system; (k) Fire room rear side aperture, holes in the concrete wall.

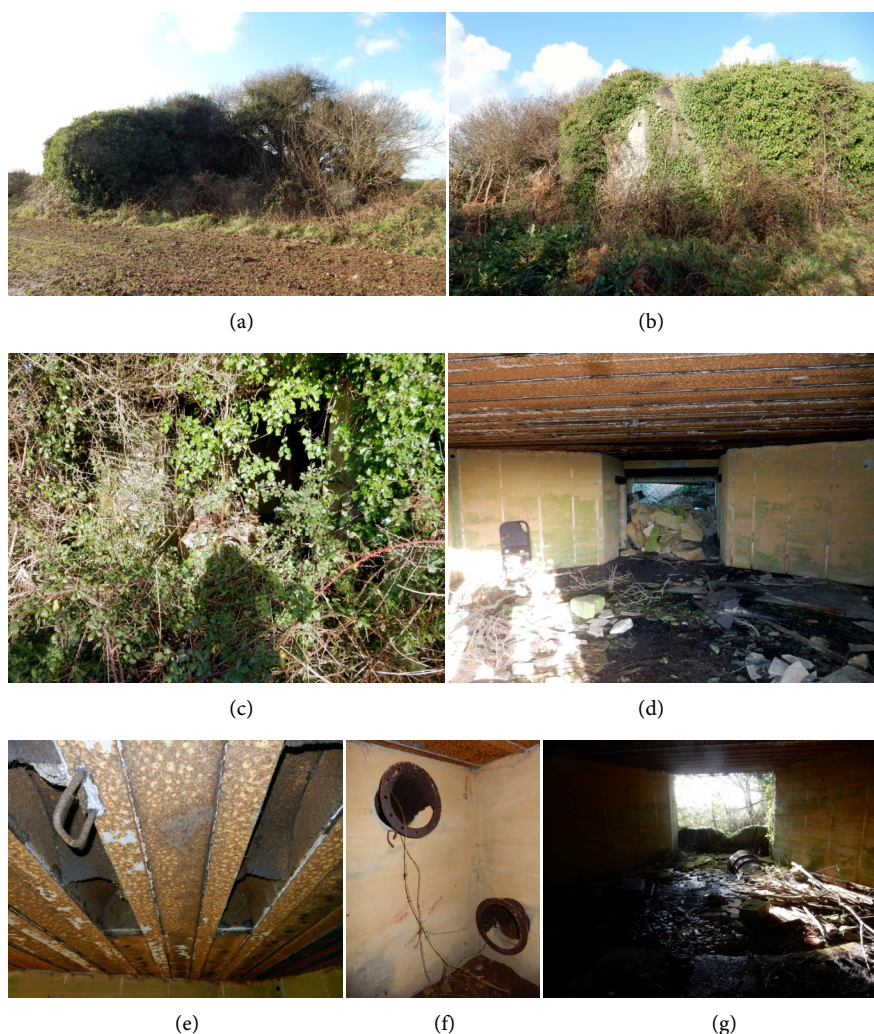
An *R 669* (4) (48°23'51.79"N, 04°43'57.26"W, 51.79 m) (**Figure 20**) for 150 mm gun. Its concrete structure was completely covered by vegetation, but apparently

without damages due to bombardments or combats. The rear aperture introduced into an empty fire room, deprived of its original furniture. The walls preserved the original white painting and the vertical wood insulation supports embedded in the concrete. On the walls, no traces of a thermal insulation system.

Figure 20. *Stp Re 77-R 669 (4)*: (a)-(b) External structure covered by vegetation; (c) Fire room front side aperture covered by vegetation; (d) Fire room, rear side aperture and arcuate gun carrier legs emplacement; (e) Fire room, metallic ceiling with gates of the combat gas extraction system and gun lifting joint; (f) Combat gas extraction system room; (g) Fire room, front side aperture and arcuate gun carrier legs emplacement.

On the floor, the square carriage wheel gun emplacement and the arcuate gun carrier legs emplacement, although both covered by terrain, were well recognizable. The metallic ceiling preserved two joints for the gun lifting and the gates of the combat gas extraction system, deprived of their original grids. The ammunition room was empty and the combat gas extraction system room preserved some rusted portion of conduits. The exhausted combat gas pipe and a possible niche hosting it, on the *R 699 (4)* rear side, were covered by vegetation and not visible.

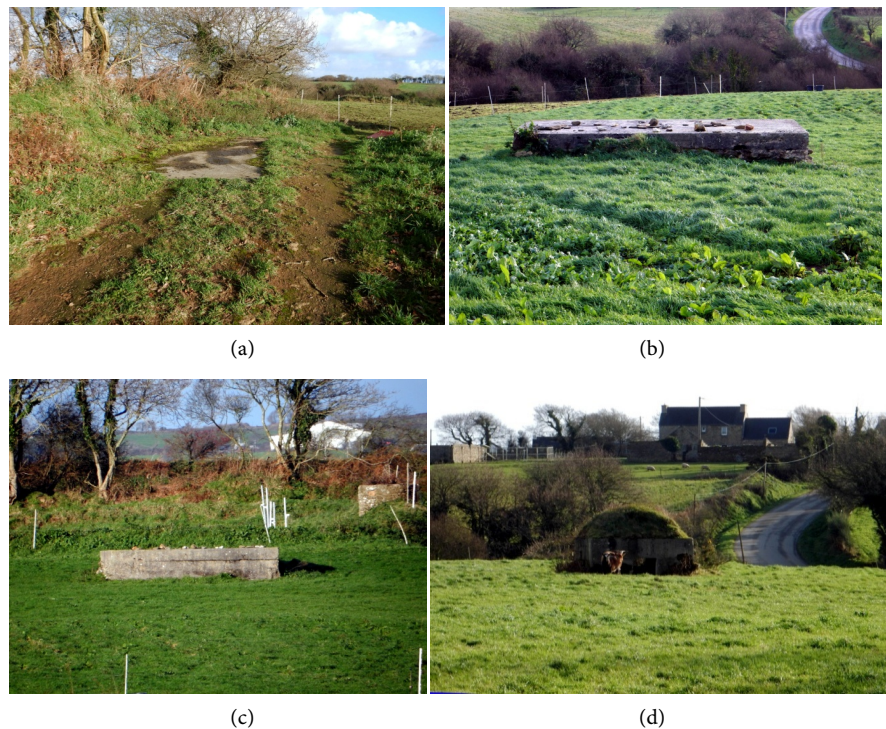
A *Vf*(7) (48°22'43.42"N, 04°42'34.12"W, 55.04 m) (**Figure 22(a)**), about 3 × 5 m completely buried in the terrain, at the entrance of the site. Only a portion of its coverage emerged from the terrain. The entrance was buried in the terrain; so that the inspection of the interior was not possible. The apparent absence on its coverage of chimney conduits suggested that it was intended for storing ammunitions and/or materials, although the function of guardhouse for a group of soldiers, at the one entrance of the *Stp*, cannot be excluded. The emerging portion of *Vf*(7) concrete structure was in a good preservation state without damages due to bombardments or combats.

Figure 22. *Stp Re 79*: (a) *Vf*(7), coverage partially emerged from the terrain; (b) *Vf*(10) front side; (c) *Vf*(10) rear side; (d) *Vf*(11).

A *Vf*(10) ($48^{\circ}22'41.38''\text{N}$, $04^{\circ}42'33.91''\text{W}$, 53.17 m) (**Figures 22(b)-(c)**), about 3×5 m, similar to *Vf*(7) emerged about 0.5 m from the terrain. The apparent absence on its coverage of chimney conduits and its position, about 10 m from the *R 669* (3), suggested that it was intended for storing ammunition and/or materials for the *R 669* (3) rather than hosting a group of soldiers. The emerging *Vf*(10) concrete structure was in a good preservation state without damages due to bombardments or combats.

A *Vf*(11) ($48^{\circ}22'39.13''\text{N}$, $04^{\circ}42'33.02''\text{W}$, 50.48 m) (**Figure 22(d)**), about 4×4 m, similar to *Vf*(7) emerged about 2 m from the terrain. The interior appeared formed by a single square room with one North side entrance aligned with a South side entrance. A monticule of terrain protected its coverage. Its position, near the site South border and the protected coverage suggested that it was intended for hosting a group of soldiers in charge of the surveillance of the South side of the site. The emerging *Vf*(11) concrete structure was in a good preservation state without damages due to bombardments or combats.

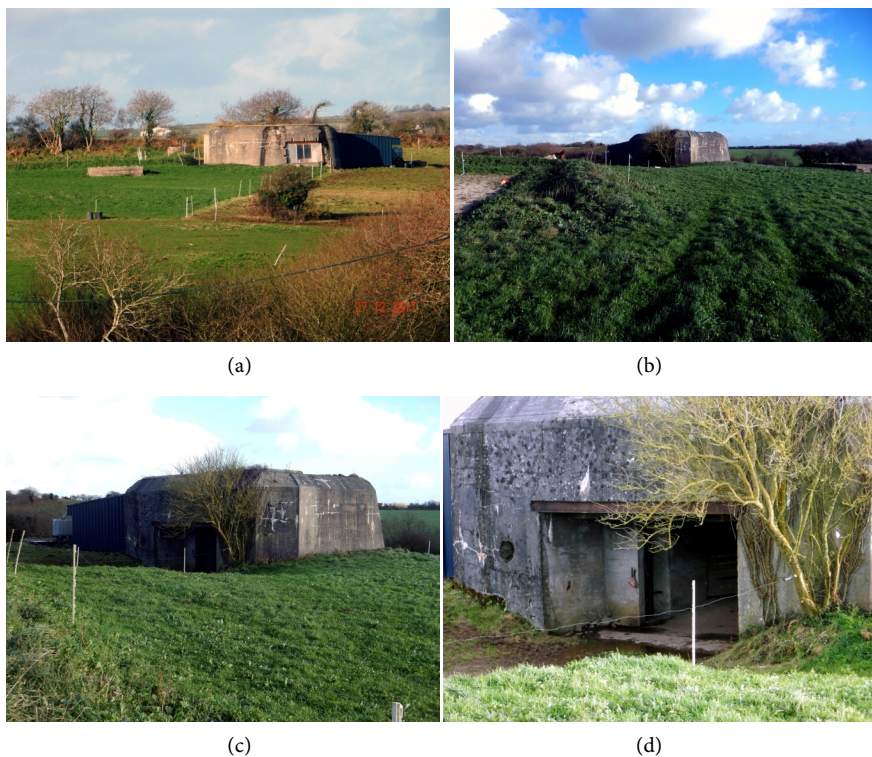
A *R 669* (3) (48°22'41.80"N, 04°42'33.24"W, 53.06 m) (**Figure 23**) for 150 mm gun. Its concrete structure appeared in a good preservation state without damages due to bombardments or combats. A modern agricultural shed was added to one side of the *R 669* (3). The fire room front aperture was closed by a modern white door provided with two rectangular windows. The fire room rear aperture was open allowing seeing a portion of the fire room interior and the entrance of the combat gas extraction system room. The walls appeared to preserve the original white painting. The exhausted combat gas pipe, without hosting niche, was visible on the *R 699* (3) rear side.

Figure 23. *Stp Re 79*: (a) *R 669* (3) front side, on the left *Vf*(1); (b) *R 669* (3) rear side; (c) *R 669* (3) rear side, on the left modern agricultural shed; (d) *R 669* (3), fire room rear aperture with entrance of the combat gas extraction system room, on the left exhausted combat gas pipe.
