Evaluation of Deterioration and Proposed Restoration of the Limestone, White Monastery—Sohag, Egypt

Abd-Elkareem E. Ahmed^{1*}, Ahmed O. Mashaly², Basel N. Shalaby², Mohamed A. Rashwan²

How to cite this paper: Ahmed, A.-E.E., Mashaly, A.O., Shalaby, B.N. and Rashwan, M.A. (2017) Evaluation of Deterioration and Proposed Restoration of the Limestone, White Monastery—Sohag, Egypt. *Open Journal of Geology*, 7, 1287-1302.

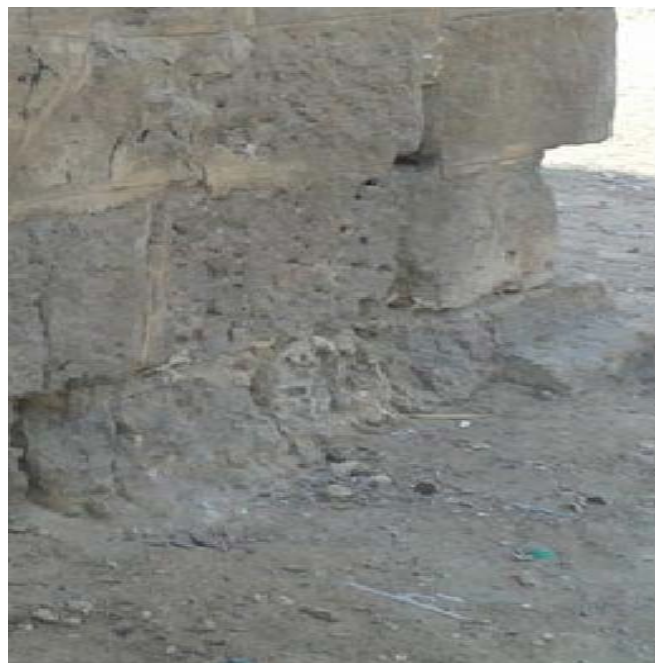
1) Stone material fatigue: occurs as a result of temperature changes between day-night, as well as seasons, leading to volume changes expressed as expansion and shrinking, the continuous temperature change causes cracks and fractures on stones as a result of the material fatigue [11] (**Figure 2**).

Figure 2. Stone material fatigue in.

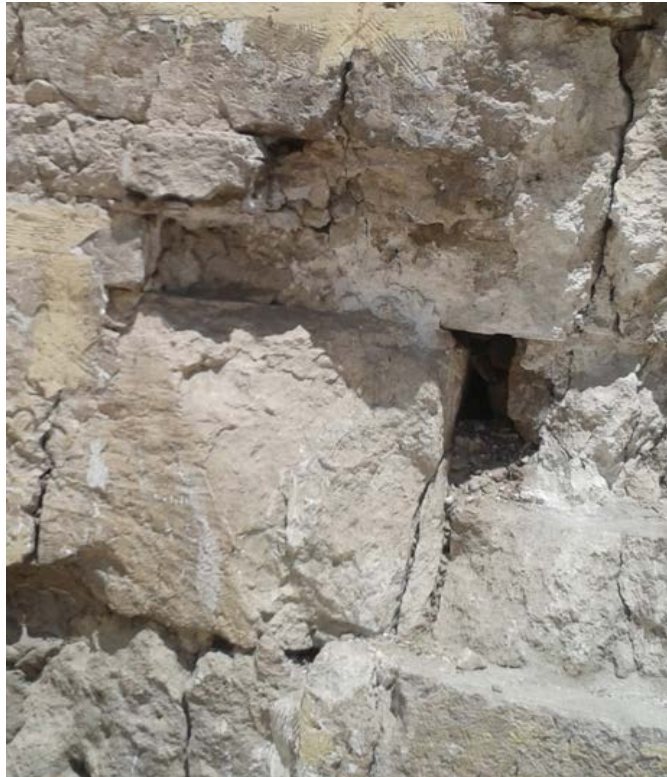
2) Internal disintegration: expressed as powdering of the stone behind the skin (surface crust), as a result of breaking down of the internal structure of the rock. This may be due to retention of fluids which are not allowed to escape by normal evaporation due to the impermeable nature of the skin. Some sets of cracks are noticed developed parallel to the exposed stone surface, and the internal structure is effectively shattered (**Figure 3**).

Figure 3. Internal disintegration.

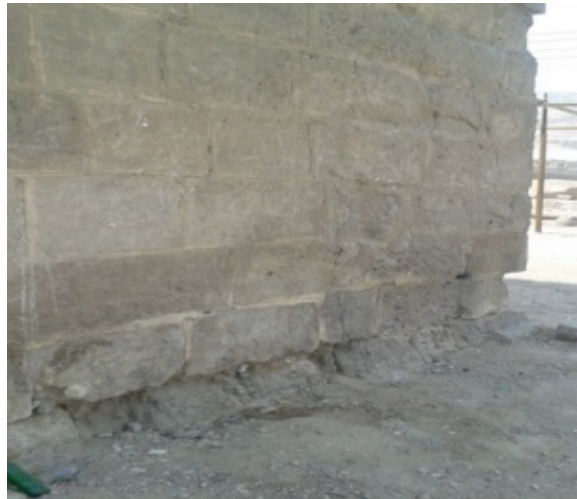
3) Efflorescence: soluble salts are considered to be the main cause of stone decomposition. Salts are usually cause stone damage in several ways. The most common is the growth of salt crystals in the stone pores, resulting in stresses that may overcome the stone’s tensile strength [12] [13] [14] [15]. The efflorescence action may proceed as long as the soluble salts remain in the stone, by time, the

soluble salts dissolved in the fluids are concentrated, and on crystallization, the crystallized salts initiate the disintegration.. The soluble salts may, also crystallize on the stone surface forming unsightly deposits, known as “efflorescence”. The effect of salt deterioration is expressed on the limestone of the walls as shown in **Figures 4-6**.

Figure 4. Continuous deterioration action resulted from efflorescence and salt crystallization.

In cases where soluble salts are the major factor for stone deterioration, it is worthy to remove these salts. Desalination is usually recovered through various types of poultices, consist mainly of a different types of materials (e.g. clays, sands, as well as paper pulps) [23].

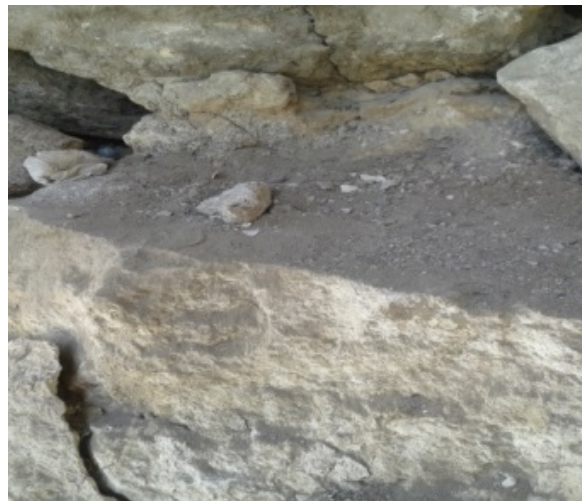
Figure 5. Foundations affected by ground water.

From the table it is shown that the water absorption of the limestone samples (average 9.26%) is reduced after the treatment with penetrating sealer to 1.22% which will protect the limestone from the action of the ground water and reduce the possibility of efflorescence formation.

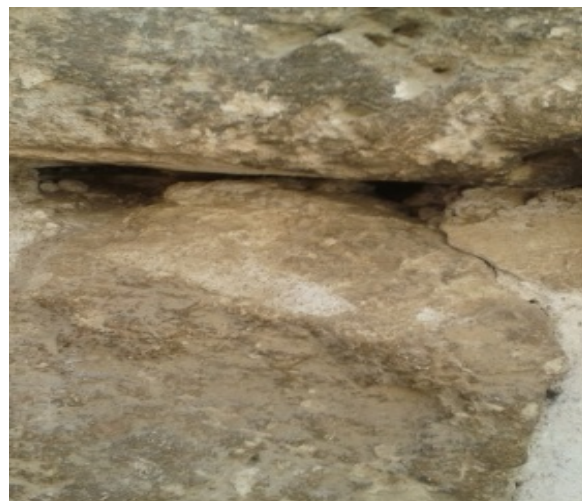
Figure 6. Detachment and salt crust on limestone surface.

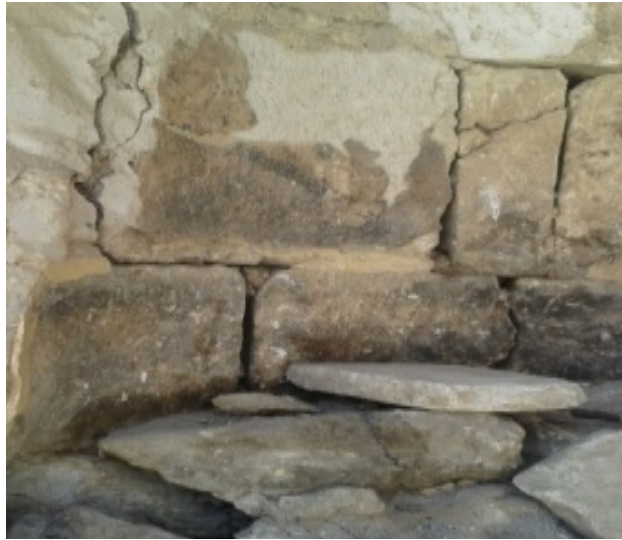
4) Crust removal: the temperature change produces stresses resulted from the differential expansion, such stresses tend to cause delamination of the surface. When the wet stone surface warms by long exposure to the sun, as well as warm atmosphere, the surface expands and, contemporaneously, evaporation-precipitation processes takes place. Calcium sulphate crystals may be deposited in the fine cracks developed during the expansion phase. The repetition of these processes may produce an observed expansion and/or blistering of the crust (surface layers) (**Figure 7**).

Figure 7. Loosening of stone crust.

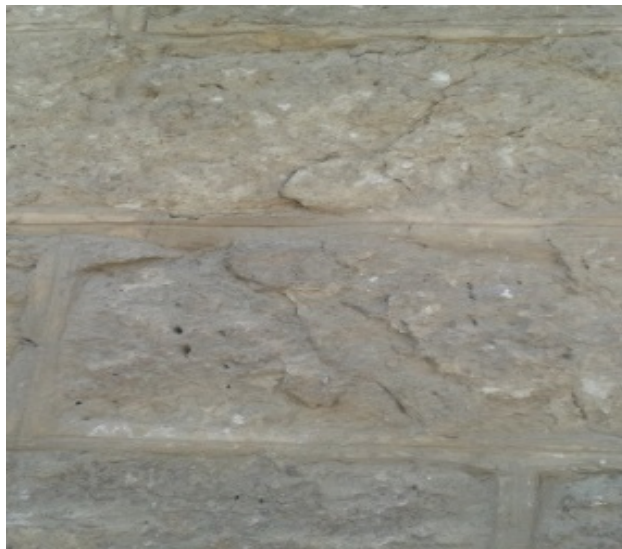
5) Biodeterioration: the biologic activities of bacteria and algae, negatively, affect the stone mechanically and chemically, Mechanical damage is caused by penetration of the hyphae into the stone and by the expansion and contraction of the thallus (the vegetative part of the fungus) under changes of humidity. Chemical damage [16], however, is more important and may arise in three ways: by the secretion of oxalic acid, by the generation of carbonic acid, and by the generation of other acids capable of chelating ions such as calcium [17]. The limestone of the walls shows borrowings and detachments due to biodeteriorations (**Figure 8**).

Figure 8. Effect of borrowing on limestone.

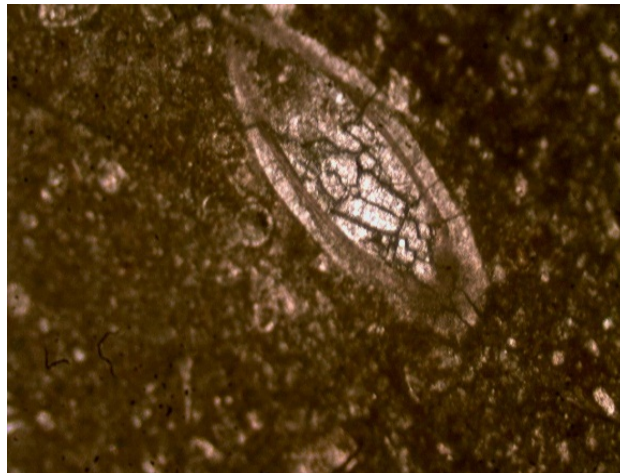
The studied limestones are Nummuliticbiomicrites and represented by a varying amount of fossils and fossil fragments embedded in a micritic matrix (**Figure 9** and **Figure 10**). Allochems consists mainly of different types of foraminifera (Nummulites is the most dominant type). Nummulites content ranges between 20% - 30% by volume, the other bioclastics form about 10% and represented, mainly, by randomly oriented algal remnants and fossil fragments (**Figure 11**). Most of fossils were, partially, replaced by sparry calcite, while lesser amounts of fossils were partially recrystallized and others were subjected to partial dissolution, in their cores. The inner cores of Nummulites are filled with micritic and/or sparritic calcite (**Figure 12**). The allochems embedded in the matrix are composed mainly of micrite. The micritic matrix shows slight neomorphism into microsparite. Terrigenous material (mainly fine detrital quartz) occurs scattered in the micritic matrix.

Figure 9. Fossil embedded in micrite.

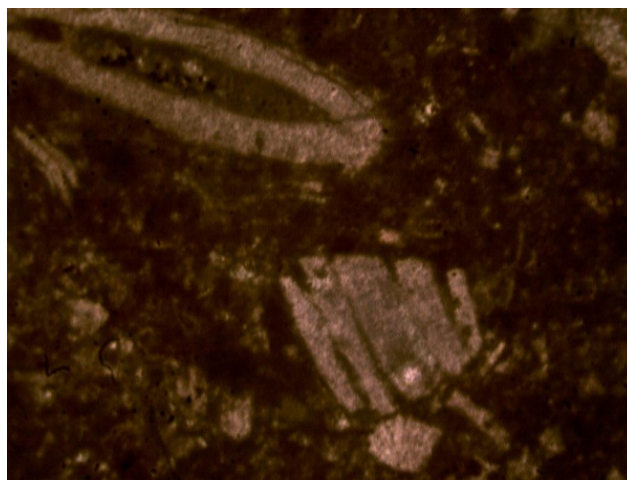
Figure 10. Fossils and fossil fragments.

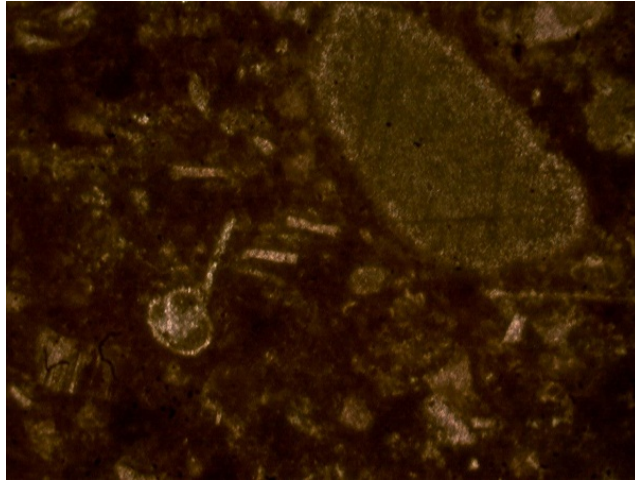
Figure 11. Fossils and algae.

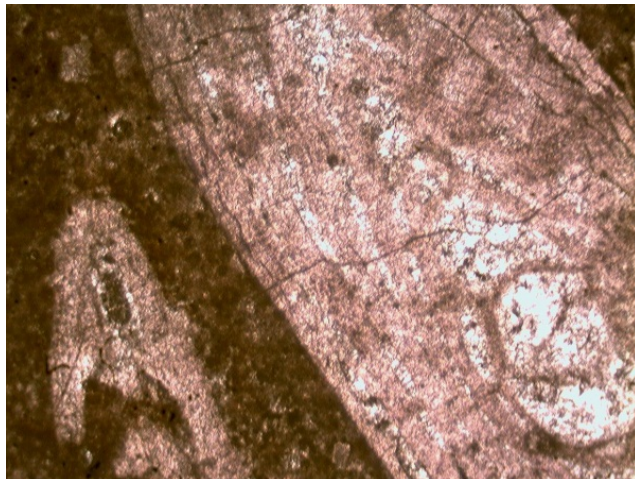
Figure 12. Fossil filled with sparry calcite.

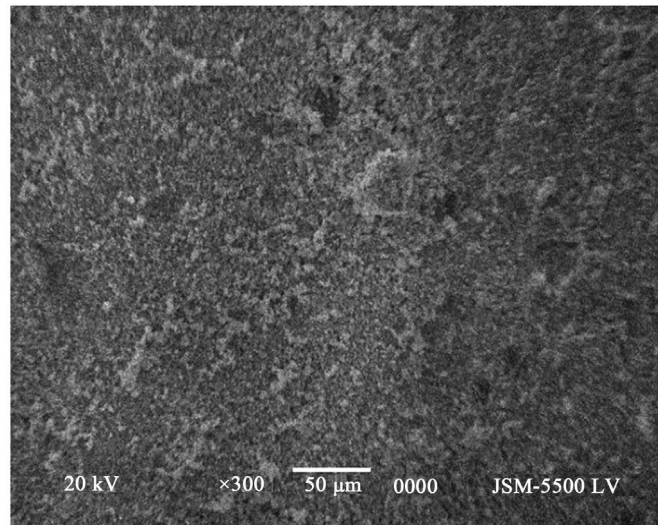
The study of the limestone samples with the scanning microscope show the presence of micropores and microcracks (**Figure 13** and **Figure 14**). The surface of the calcite crystals show dissolution features (**Figure 15**). Crystalline salts and gypsum crystals are also observed (**Figure 16**).

Figure 13. Some micro pores in limestone.

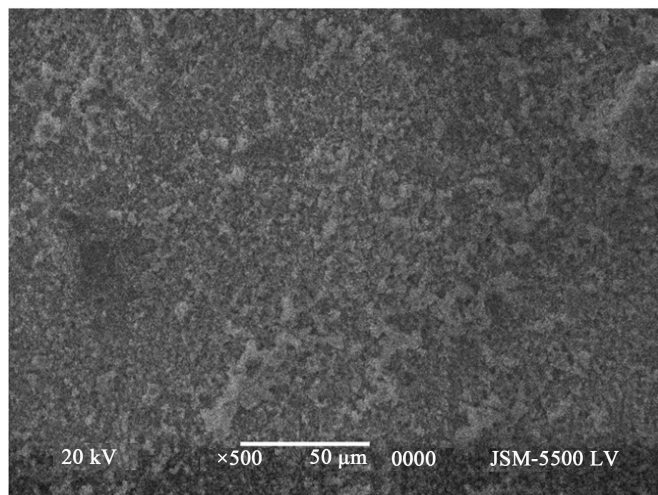
Figure 14. Some fractures result of dissolution.

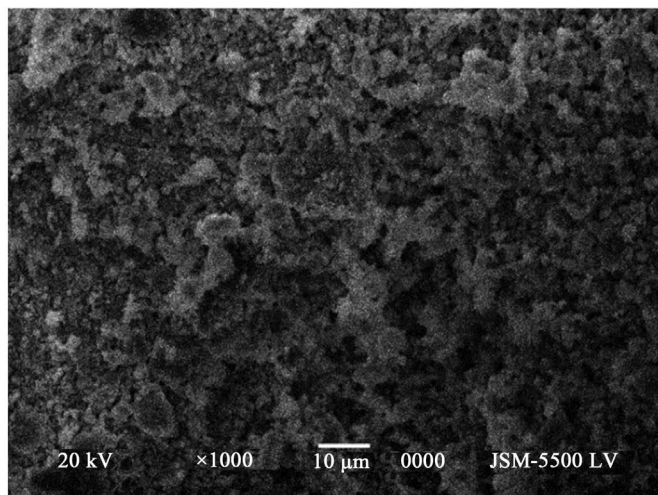
Figure 15. Damage surface of calcite crystals result of dissolution and salts.

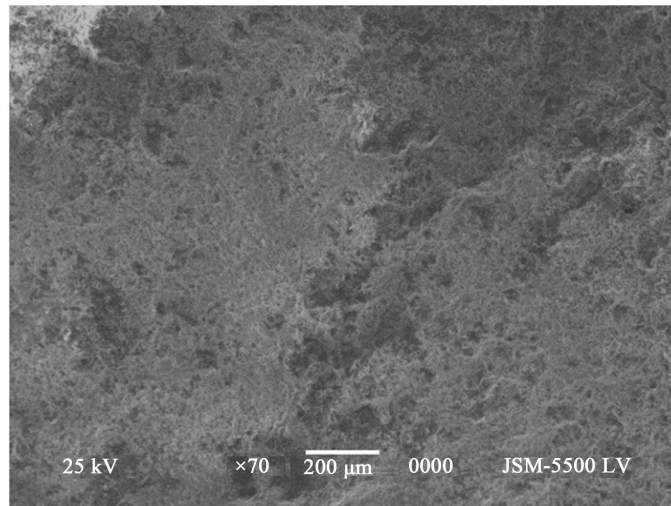
Figure 16. Gypsum and micro cracks in stone.

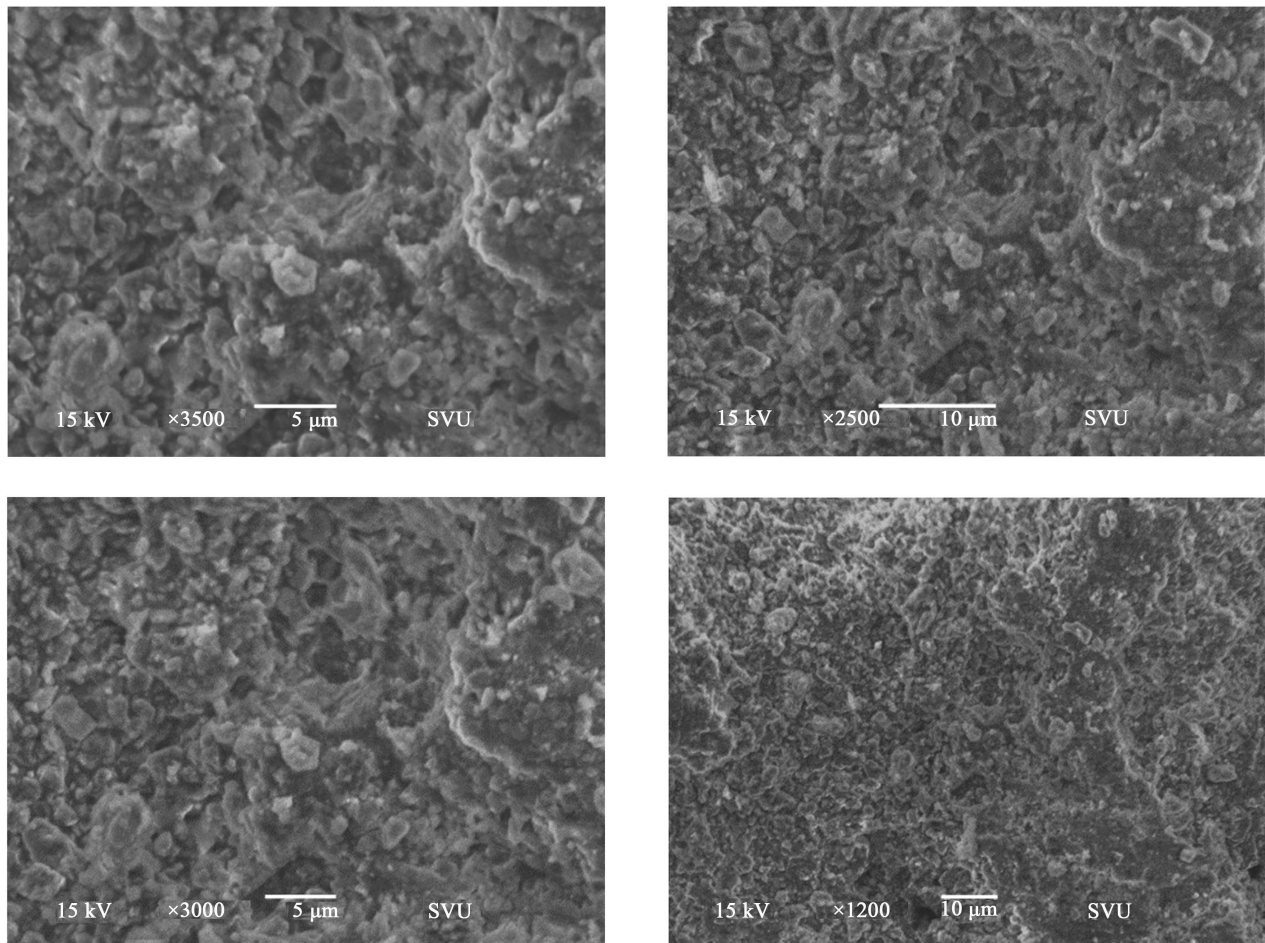
Images of the scanning electronic microscope show the extent of the penetration of the material between the granules, and their ability to encapsulate the limestone granules on a regular basis, and the absence of calcification or inappropriate gatherings (**Figure 18**).

Figure 18. SEM of limestone samples after treatment.

The stone samples were treated with penetrating sealer of (Aqua Mix). The results of the treatment are shown in **Table 3**.
