Use of Multi-Method Approach for a Gravity Irrigation Network Diagnosis: Case of Karfiguela Paddy Field in Burkina Faso

How to cite this paper: Compaore, H.M.M., Sauret, É.S.G., Kissou, O.J., Kinglo, M.A.A., Bazongo, P., Yameogo, P.L., Koita, M. and Serme, I. (2022) Use of Multi-Method Approach for a Gravity Irrigation Network Diagnosis: Case of Karfiguela Paddy Field in Burkina Faso. *Agricultural Sciences*, 13, 1396-1420.

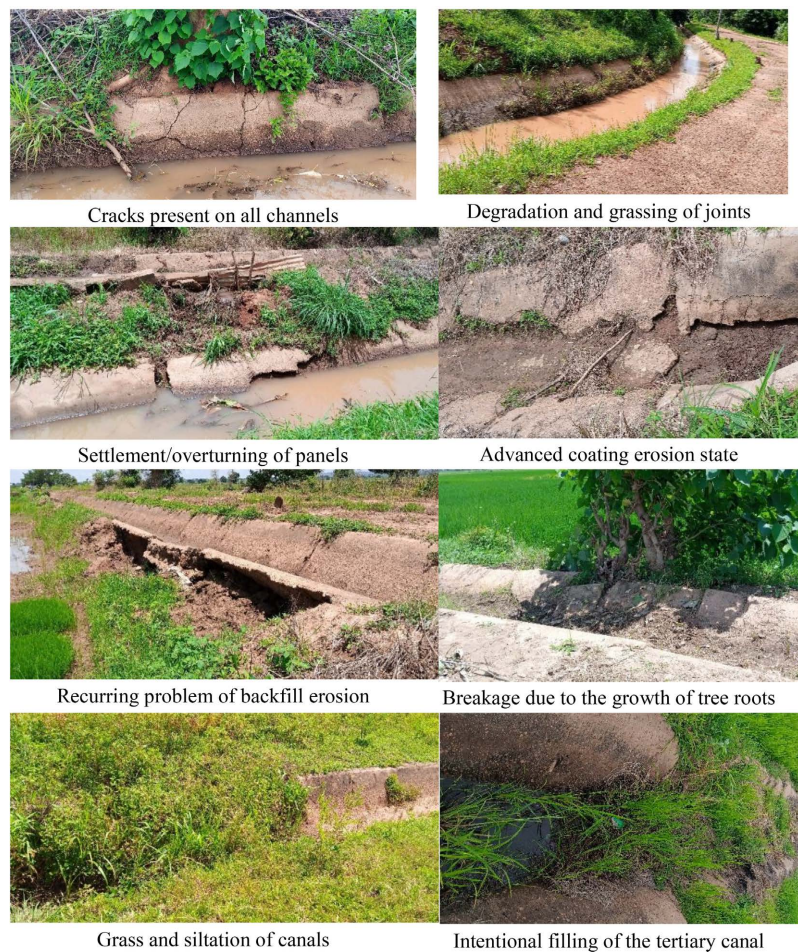
Figure 5. Some of the most recurring degradations on the irrigation network of the perimeter.

In general, the feeder and the primary channel suffer from some minor slight pathologies ranging from grass cover to cracks in the panels, including silting up. As for the secondary and tertiary canals, the damage is greater (Figure 4). The eight (8) main impairments observed on the different channels can be summarized as follows (Figure 5): 1) transverse, vertical, oblique or any other cracking of the majority of the panels; 2) complete degradation of the panels joints on all the channels and grassing of these joints; 3) settlements and overturning of certain canals; 4) advanced erosion of the canals lining, especially in the tertiary canals; 5) erosion of the backfill of canals and weirs (intake infrastructure) certainly due to overflows caused by improper handling of valves; 6) presence of shrubs and large trees in close proximity of the canals leading to serious cracks and even overturning of the concrete modules over a length of several meters for the secondary and tertiary canals; 7) significant siltation and grassing of the various canals and 8) intentional filling of the last sections of certain tertiary canals with a view to redirecting all the water towards the plots upstream. The state of deterioration of the channels can be explained by the old age of the network, built more than 45 years ago.

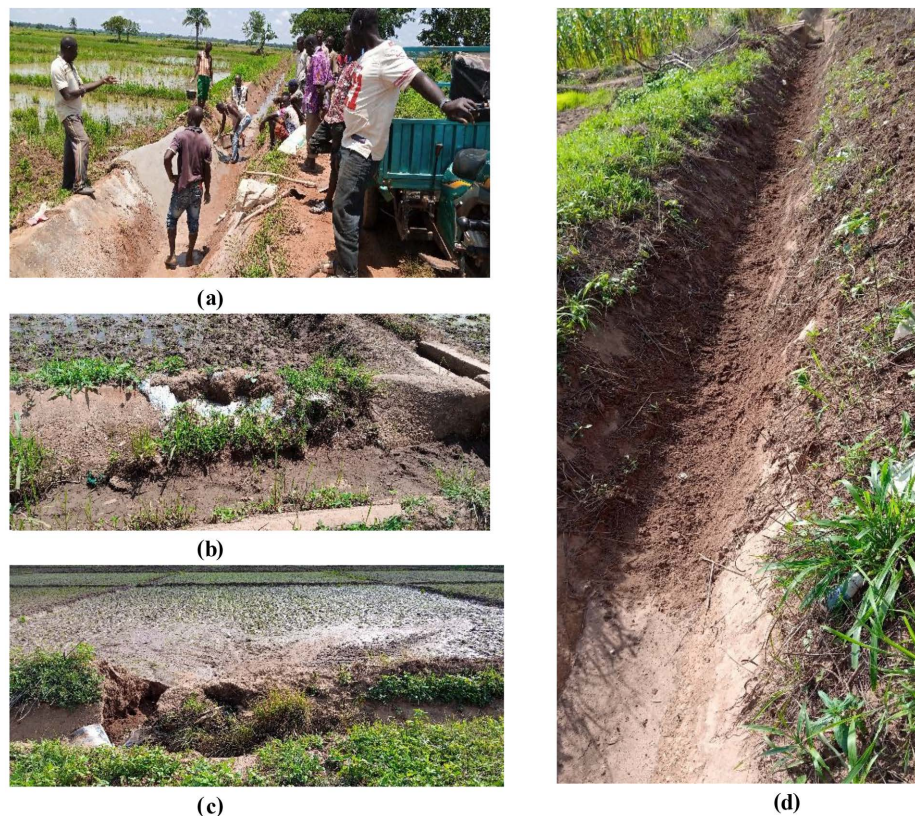
Figure 10. upkeep and maintenance operations of the canals: (a) rehabilitation of S3 by cooperative III; (b) rehabilitation of a tertiary canal by an operator; (c) rehabilitated tertiary channel which has failed; (d) tertiary canal weeded and cured.

The maintenance and upkeep of hydraulic infrastructure remain a central component in the management of irrigated areas [13]. These operations allow better management of water distribution while strengthening the sustainability and efficiency of the infrastructure. On the perimeter, channel maintenance operations generally consist of weeding and cleaning (Figure 10(d)). For a synergy

and staggering of maintenance tasks, the roles are distributed as follows: the feeder and the primary channel are maintained by all the cooperatives, the portion of the canal which directly feeds its block and the secondary canals are maintained by each cooperative, the tertiary canals are maintained by the irrigators concerned and finally, the quaternary canals are traced at each campaign. The weeding and cleaning works are carried out with archaic materials such as hoes and manual shovels.

Rehabilitation such as the rebuilding of degraded, cracked or overturned canals (a) and b), are often carried out by farmers on the irrigation canals. These maintenance or rehabilitation works are made possible through water charges (10 Euros/ha) paid at the end of each season by the operators. The rehabilitation is controlled by the office of the cooperative concerned with the repairs. Unfortunately, it's clear that this work is often botched and the rehabilitated infrastructure fails quite frequently (**Figure 10(c)**). As for the drainage network, it is not frequently rehabilitated and the malfunctions only accumulate.
