Dynamics and Vulnerability of Hydrogeomorphological Units to the Degradation of Climatic Conditions in the Watershed of the Birnin Lokoyo Pond (Iullemeden Basin, Southwestern Niger)

How to cite this paper: Hantchi, K.D., Hassane, B., Ousmane, H., Balla, F.I.S., Konaté, M. and Garba, Z. (2022) Dynamics and Vulnerability of Hydrogeomorphological Units to the Degradation of Climatic Conditions in the Watershed of the Birnin Lokoyo Pond (Iullemeden Basin, Southwestern Niger). *Journal of Environmental Protection*, 13, 233-260.

Abstract

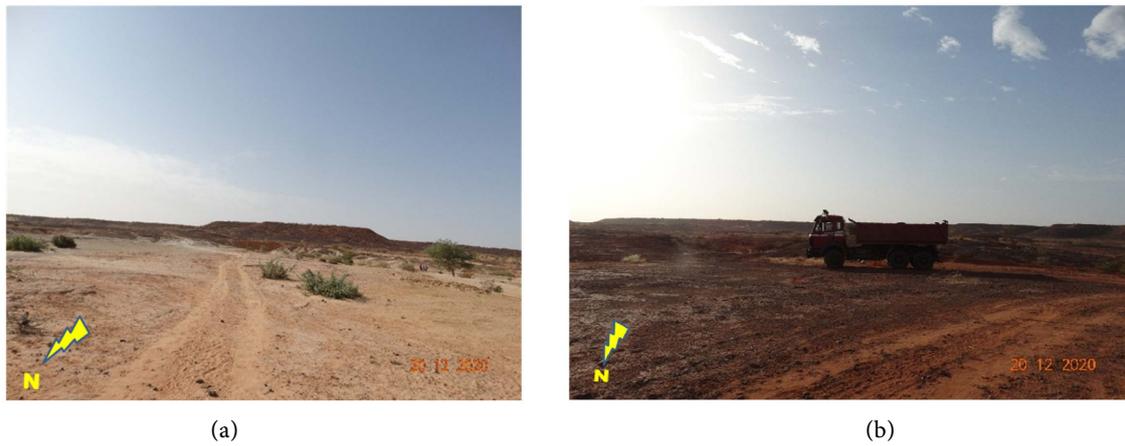
Figure 10. Human activities on the southern shores of the watershed. (a) Upstream, southwest of Barébari. (b) Downstream between Natchira and Matankari.

The populations of the surrounding villages dig on the banks to find mud and gravel (**Figure 10**). This extraction of local materials on the banks partly clears the beds of torrents and accelerates the phenomenon of water erosion, in addition to promoting wind deflation in the dry season. Each year, field work as well as human traffic promotes the destruction and weakening of soils, as well as the disruption of the hydrological regime in the southern part of the watershed (**Figure 11**).

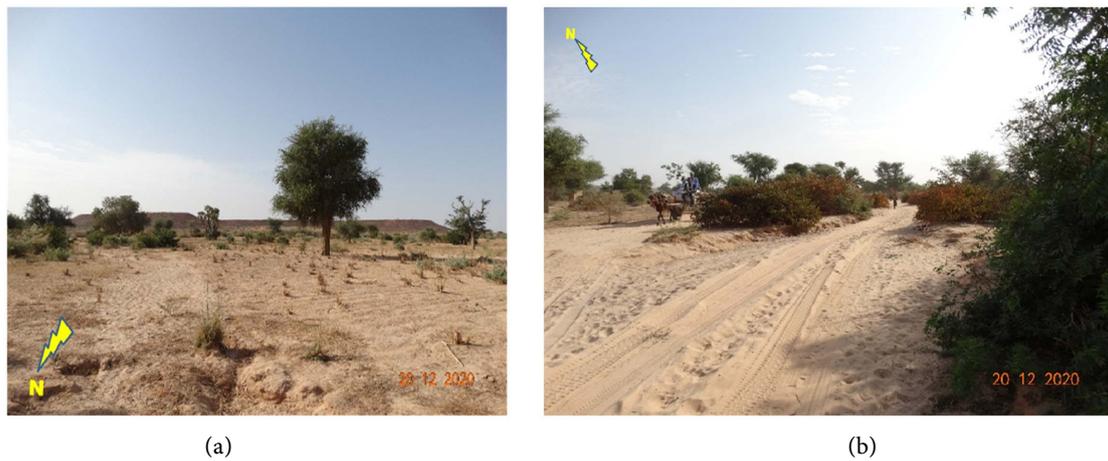
Figure 11. Illustrations of the cases of impacts of human activity on the southern banks of the major bed of the basin (between Natchira and Barébari). (a) A bare field. (b) A path transformed into a ravine.

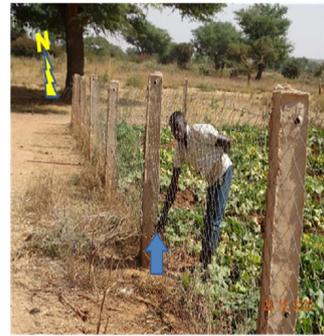
Figure 16. Type of fencing found in the western component of the watershed (gardens in Matankari). (a) Wire mesh fence. The market gardener indicates the level reached by water in 2018-2019. (b) Fence in branches of thorns around a garden (case of new extensions to the Colonel Nouhou Bako site). (c) Organic manure and (d) compost.

Under the confession of an operator of the Matankari perimeter, it is already remarkable that the last two years are the least flooded (**Figure 16(a)**). In this context, it is therefore to be feared that the loss of water from the pond will have a higher vertical component than the intense overflow of water at the level of the threshold of the protection dike to the west. The infiltration of water through the dike and in the downstream areas is justified by the intensity of the connection of the NE-SW and NW-SE fractures, and therefore their fortuitous and respective topographic position (**Figure 9** and **Figure 15(a)**). These observations join those of [20], who showed that most of these linear structures evolve to become permanent or temporary watercourses from which groundwater recharge takes place in the southwestern part of the Niger and the Iullemeden basin.

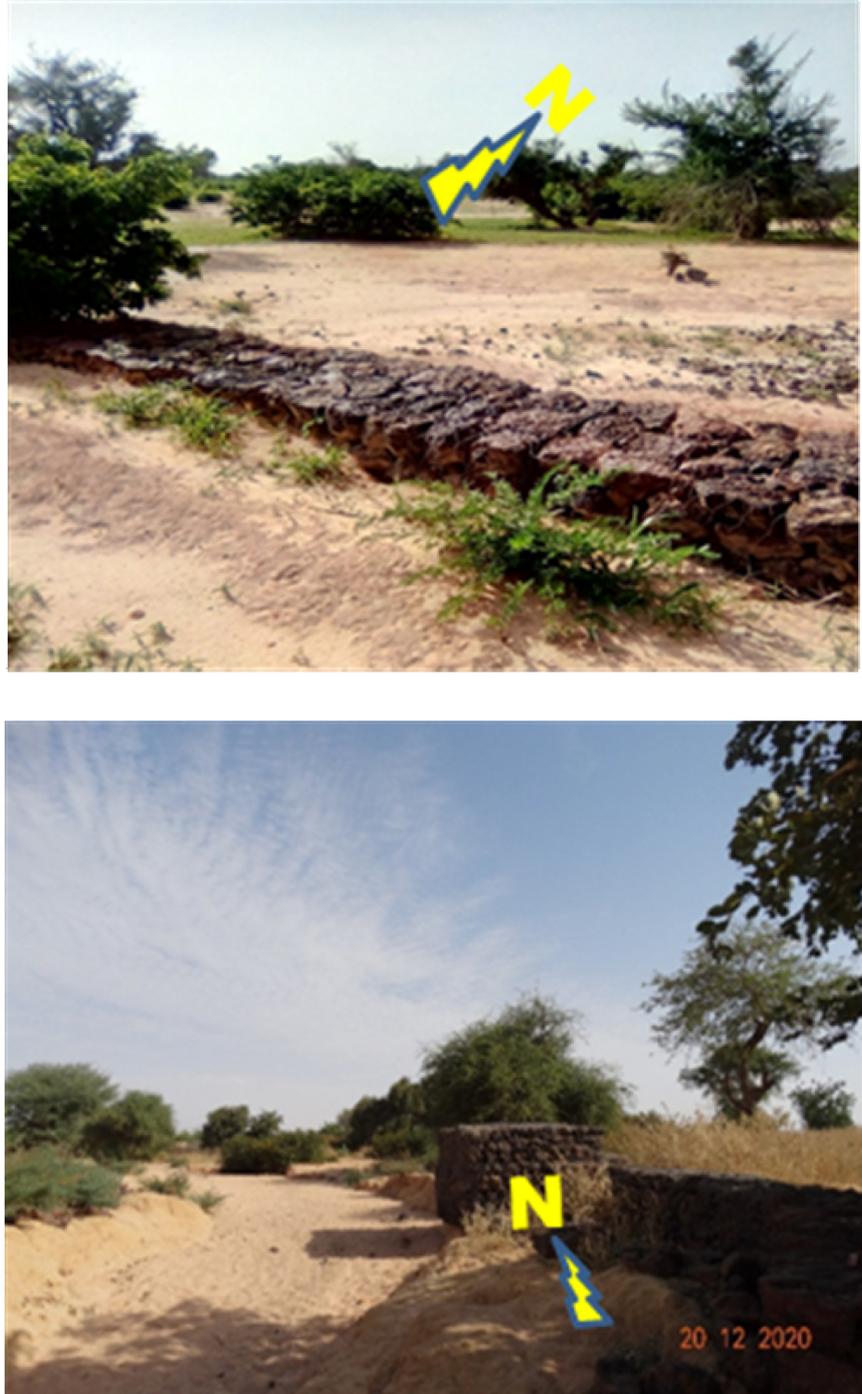
Figure 18. Paving in the western Barébari.

Under these conditions of water runoff from the pond and its advance towards Matankari, silting is gaining ground upstream and becomes a daily and permanent concern for the populations of the eastern component upstream of the basin. Among the other consequences of the reduction in the duration of the flow of the pond, one can point out that the dike protecting against the advance of water and certain works to fight against water erosion, such as lifting, does not prevent the appearance of gullies (**Figure 18**).

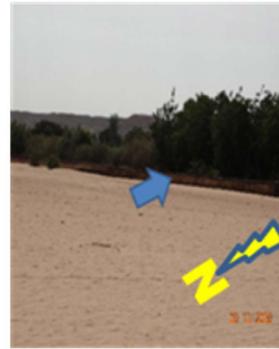
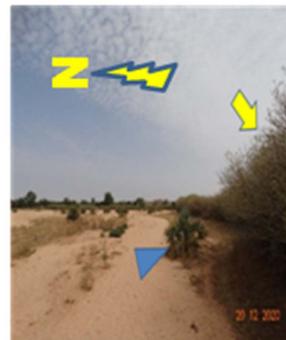
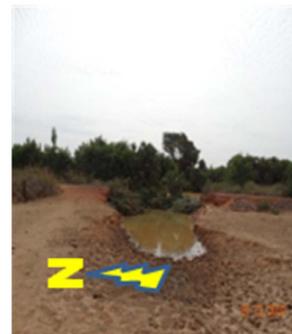
Figure 19. Northern borders of Barébari (cf. **Figure 15**). (a)-D1: Ancient dike on the south bank of the minor bed. (b)-NP1: Living hedge of protection in Barébari. (c)-D2: Forced water-forced breach of the protective dike at the northern entrance to Barébari. (d)-D3: Flood protection dike at the northern entrance to Barébari.

The reality on the ground shows that the gullies are widening, damaging more and more the displays and threatening the houses and the mosque, the road and paths, schools and fields (**Figure 19**).

According to the population, some houses in Birnin Lokoyo fell by the runoff of water from tributaries of the pond so that landowners could be moved. To stop the sand advancing from the banks towards the pond, upstream in the minor bed of the main kori and the northern banks (towards Birnin Lokoyo), the species *Sida rhombifolia* was planted by making a curtain of living hedge (**Figure 20**). Wherever there is this species (*i.e.* *Sida rhombifolia*), alone or in association with *Hyphaene thebaica* (**Figure 20(c)**-NP2 and **Figure 19(b)**-NP1), it is more difficult for the sand to pass through it.

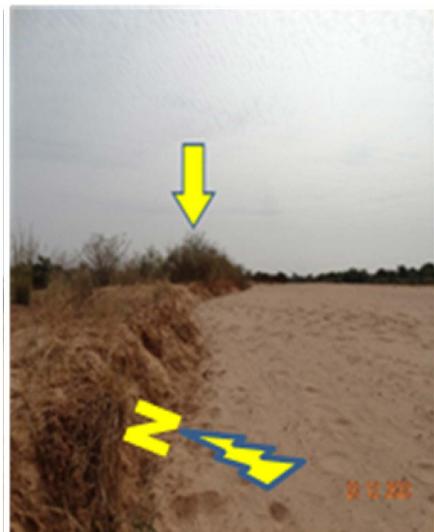
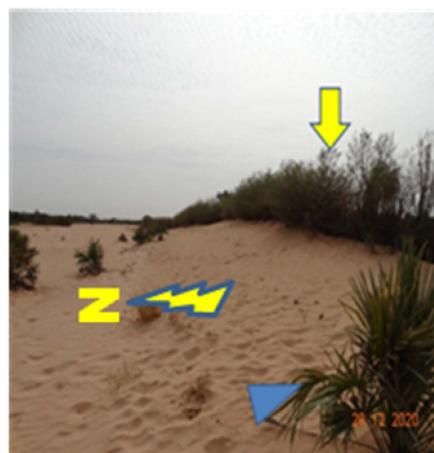
Figure 20. Planting of *Sida rhombifolia* against the ensaliation of the pond and the ravine (a) in Birnin Lokoyo (southern exit, leaving towards Barébari); (b) upstream in the middle of the minor bed and (c) upstream on the southern slope of the pond at the entrance to Barébari. There are in (c) plants of *Hyphaene thebaica* in the foreground and left. Note that photos (c)-NP2 and (b)-NP3 correspond to sites NP3 and NP2 in **Figure 15**, respectively.

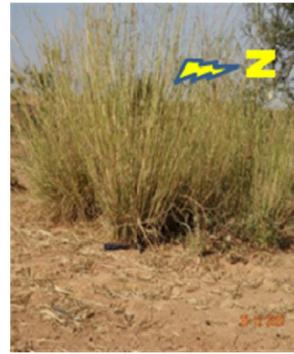
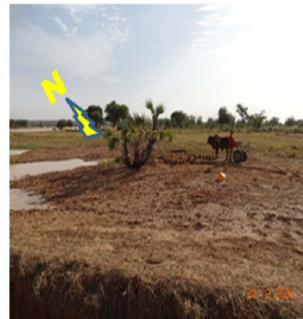
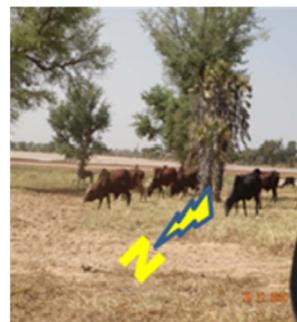
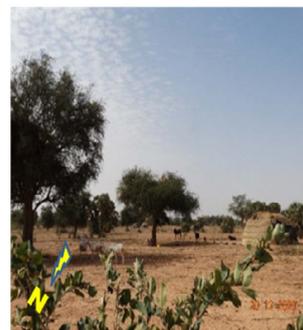
Figure 22. The species *Vetiveria nigriflora* against silting up and its potentialities. (a) On the western shores of the pond above the discharge dike towards Matankari. (b) Brick-making activities on the western shores of the pond (in the south, towards Natchira). (c) Cattle in the minor bed, upstream at the eastern limit of the pond. (d) Ubiquitous installations of some breeders on the northern banks, towards Birnin Lokoyo.

In the minor bed of the pond, the species *Vetiveria nigriflora*, naturally present, also retains the sand (**Figure 22**). By its roots, it fixes the water, which allows the clay to remain. This species is very important to humans and animals. Thus, the local populations use it to make the clay bricks compact, while it constitutes a place of pasture for animals. Moreover, there are Fulani Peulh herders who have settled there in the confines of the pond to feed their cattle (**Figure 22(c)** and **Figure 22(d)**).
