# Using Anonymous Connected Vehicle Data to Evaluate Impact of Speed Feedback Displays, Speed Limit Signs and Roadway Features on Interstate Work Zones Speeds

Jijo K. Mathew, Jairaj Desai, Howell Li, Darcy M. Bullock

Purdue University, West Lafayette, USA

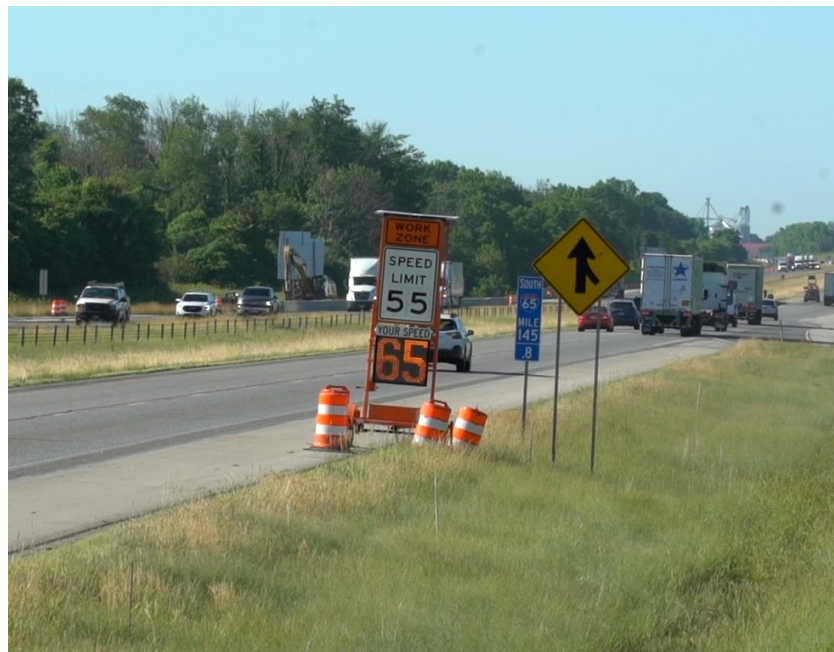
**Figure 1.** Radar-based speed limit sign with motorist speed feedback.

The main objective of this study is to use connected vehicle data to evaluate the speed compliance of different post-mounted speed limit signs and a radar-based speed limit sign with motorist speed feedback display in a work zone (Figure 1). A secondary objective is to identify locations in the work zone with major speed drops and understand the factors that affect the driver behavior at these locations.

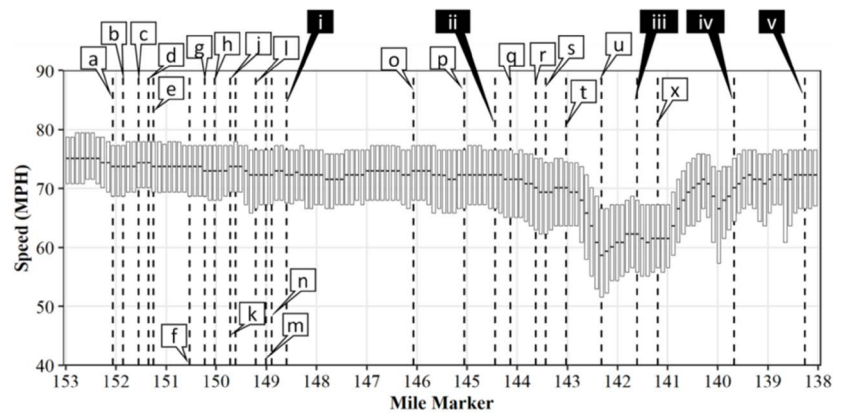
Figure 3 shows an interquartile range plot or boxplot of the speeds at every

**Figure 3.** Boxplot of speeds every 0.1-mi with location of road signs.

0.1-mi increment along the work zone for a 1-week period (May 25-31, 2021). The x-axis highlights the southbound mile markers in the direction of travel and y-axis highlights the interquartile range of the speeds, with the bottom end representing the 25<sup>th</sup> percentile speeds, midpoint representing median speed and top end representing the 75<sup>th</sup> percentile speed. This plot is overlaid with dotted lines illustrating the location of warning and posted speed limit signs placed throughout the work zone. **Table 1** shows a list of all the signs and their corresponding miler marker location.

**Table 1.** Road signs from **Figure 3**.

Figure 3 Callout	Mile Marker	Road Sign
i	148.6	Speed Limit 55 MPH
ii	144.4	Variable Speed Limit 45 MPH
iii	141.6	Speed Limit 55 MPH
iv	139.6	Speed Limit When Flashing 45 MPH; Speed Limit 70 MPH
v	138.2	Speed Limit 70 MPH
a	152.0	Road Work Ahead (Variable Message Sign)
b	151.8	Speeding Fine
c	151.5	Road Construction 2 Miles
d	151.3	Speeding Fine
e	151.2	Road Work 2 Miles
f	150.5	Road Construction 1 Mile
g	150.2	Road Work 1 Mile
h	150.0	Road Construction 0.5 Miles
j	149.7	Road Work 0.5 Miles
k	149.6	Road Construction Ahead
l	149.2	Road Work Ahead
m	149.0	Road Work Ahead (Variable Message Sign)
n	148.9	Speed Limit 55 MPH Ahead
o	146.0	Speed Limit 55 MPH
p	145.0	Speed Limit 55 MPH
q	144.1	Lane Shift Ahead
r	143.6	Speeding Fine
s	143.4	Road Construction Ahead
t	143.0	Lane Shift Ahead
u	142.3	Speed Limit When Flashing 45 MPH
x	141.2	Lane Shift Ahead

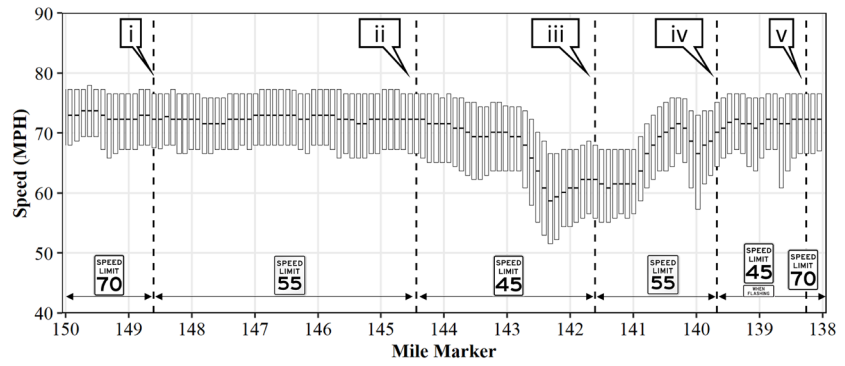
**Figure 4(a)** shows the same boxplot of speeds from **Figure 3**, with just the location of posted speed limit signs. Callouts i, ii, iii, iv and v denotes the location of different speed limit signs posted along the work zone. Callouts i and ii are reduced speed limits from 70 mph to 55 mph and 55 mph to 45 mph, respectively. Callouts iii and v are increased speed limits from 45 mph to 55 mph and 45 mph to 70 mph, respectively. Callout iv shows the sign 45 mph when flashing or 70 mph otherwise. As seen, the speed limit signs have little to no impact near the boundary conditions, except when speed limit increases. It is interesting also to note that median speeds were mostly above 70 mph except between callouts ii and iv, where geometric constraints such as lane shifts (callout q and x from **Figure 3**) resulted in lower speeds. Additionally, the lowest 25<sup>th</sup> percentile of speeds for any 0.1-mi section was above 50 mph, even though posted speed limits were below 45 mph for more than 3 miles.

To evaluate the impact of posted speed limit signs at boundary locations, further spatial analysis within a 0.2-mi (~1000 ft) upstream and downstream of the sign is conducted. **Figure 4(b)** shows the boundary condition at callout i from **Figure 4(a)**, where the posted speed limit reduces from 70 mph to 55 mph. Speed records on a 0.2-mi section before (MM 148.8 - 148.6) and after (MM 148.6 - 148.4) the speed limit sign (MM 148.6) are compared.

**Figure 4.** Spatial analysis of posted speed limit signs. (a) Boxplot of speeds with location of posted speed limit signs; (b) Spatial analysis adjacent to MM 148.6 over a 0.2-mi (~1000 ft) before and after section from the speed limit sign at callout i.

v from **Figure 4(a)**) in the work zone. Overall, none of the reduced speed limit signs (callout i and ii) had any significant impact on reducing speeds.

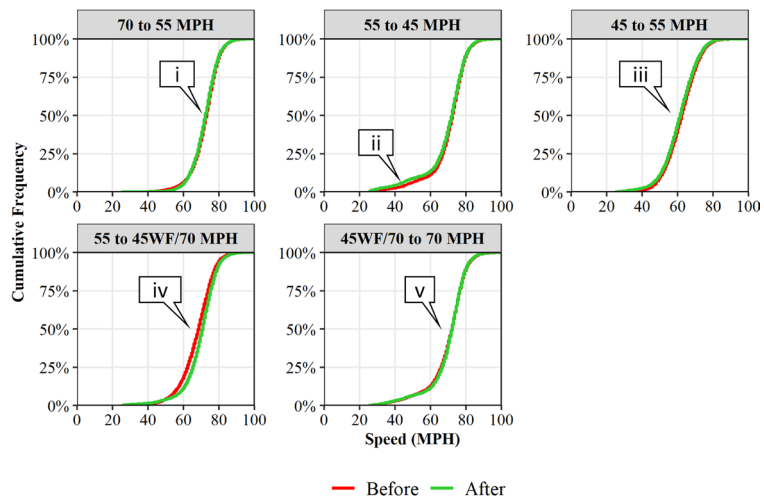
**Figure 5** illustrates cumulative frequency diagrams (CFDs) comparing the speeds in the before and after section for the five speed-limit transitions (callout i -

**Figure 5.** CFDs illustrating distribution of speeds on the 0.2-mi section before and after posted speed limit sign.

Median speeds remained around 72 mph after the posted speed limit dropped from 70 mph to 55 mph (callout i). In the second location, where speed limit reduced from 55 mph to 45 mph, the observed median speeds also remained around 72 mph. Less than 7% of the speeds were below 45 mph in the after section (callout ii)—an increase of 2% from the before section. The third location, where speed limit rose from 45 mph to 55 mph, also had similar distributions in the before and after section. In contrast to the previous two locations, median speeds for both the sections in this location dropped to 62 mph (callout iii). As seen earlier, this is due to the geometric constraints in this section of the work zone. In location 4, where speed limit increased from 55 to 70 mph (or 45 mph when flashing), the observed speeds in the after section also increased, as ex-

pected. The median speeds in the after section increased to 70 mph, an increase of more than 2 mph compared to the before section (callout iv). The speed distributions for before and after speeds in the final location also did not vary much, possibly because of similar speed limits. However, median speeds for both sections rose to 72 mph (callout v).

Spatial analysis over a 0.2-mi segment before and after the posted speed limit signs over a one-week period showed that the signs had no impact on reducing speeds (**Figure 5**).

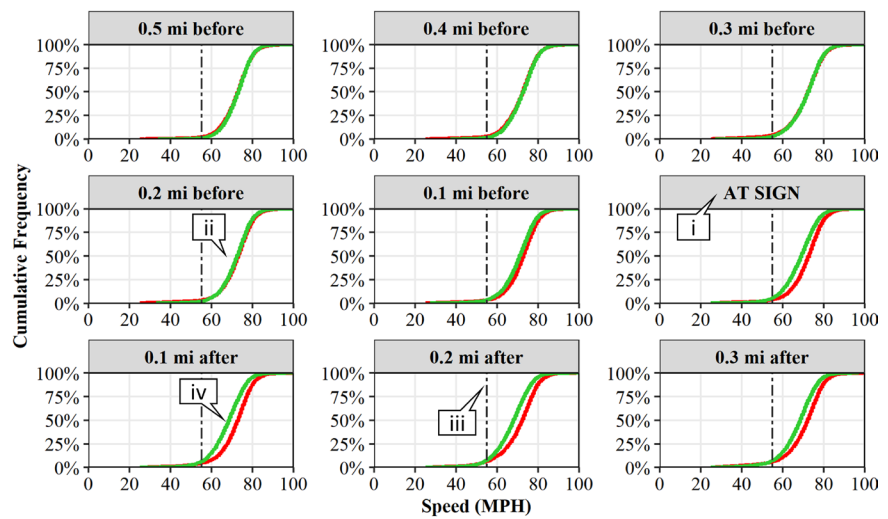
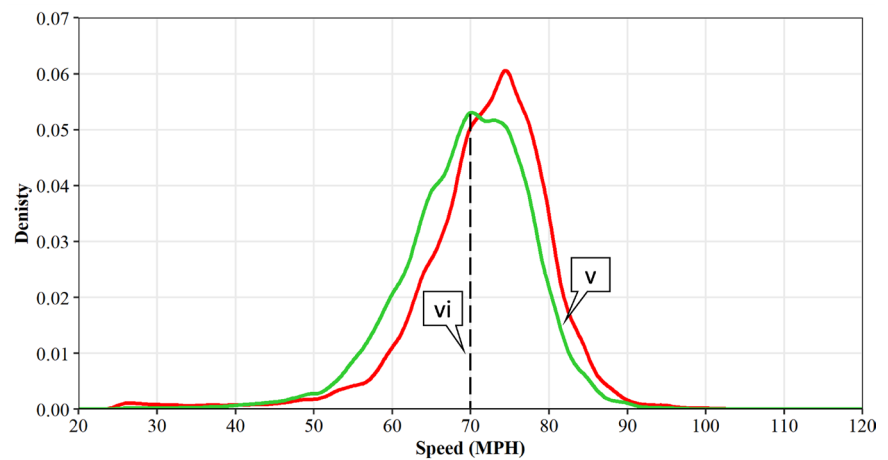
To further evaluate the spatial impact, CFDs of speeds are plotted for sections before and after the speed feedback display sign, as shown in **Figure 7(a)**. Each panel represents a 0.1-mi section. Callout i shows the CFD for the section between MM 145.8 and MM 145.7, where the speed feedback display sign was deployed. As seen, there is no considerable difference in distributions for the panels between MM 146.3 (0.5 mi before the sign) and MM 146.1 (0.3 mi before). The reduction in speeds begins around MM 146, approximately 0.2-mi (~1000 ft) upstream of the sign (callout ii), as shown by the “After” curve that begins to shift slightly towards the left indicating the drop in speeds. This is

**Figure 7.** Distribution of speeds before and after the deployment of speed feedback display sign. (a) Spatial distribution of speeds every 0.1-mi upstream and downstream of the sign; (b) Density plot comparing speeds on a 0.2-mi (~1000 ft) section before and after the sign.

intuitive as motorists possibly react as soon as they see the signs. Speeds continue to decrease downstream of the sign, as shown by the “After” curve shifting further left. Although the speed limit in this region was 55 mph (callout iii), the observed median speeds on both before and after sections were still around 70 mph. The highest reduction in median speed was observed between a 0.1 to 0.2-mi section downstream (callout iv) of the sign, with a 5-mph reduction between the before and after deployment.

To understand where the shift in speeds occur, a density plot of speeds for a 0.2-mi before and after section near the sign is plotted. The kernel density plots, which are smooth curves estimating the probability density function of the continuous variable, help compare the distributions in an effective way. The area under each curve always adds up to 1. Figure 7(b) compares the density plot for before and after deployments. The “After Deployment” distribution is slightly flatter and shifted to the left of the “Before Deployment” distribution, indicating a dip in speeds. The shift in the right tail also shows that the upper speeds dropped in the after period (callout v). Analyzing the area under the curve, this translates to a proportion of around 10% - 15% reduction in sample speeds greater than 70 mph (callout vi).

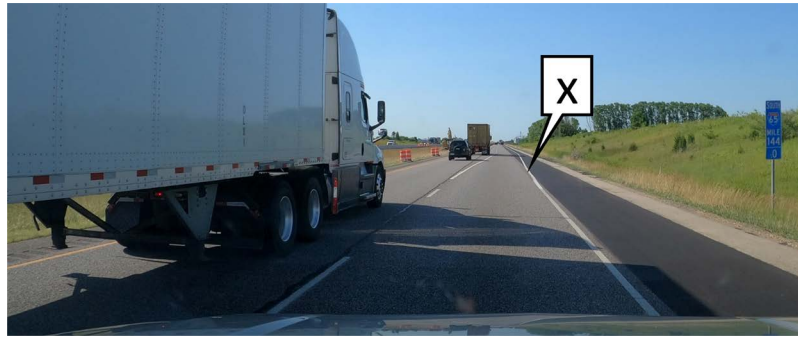
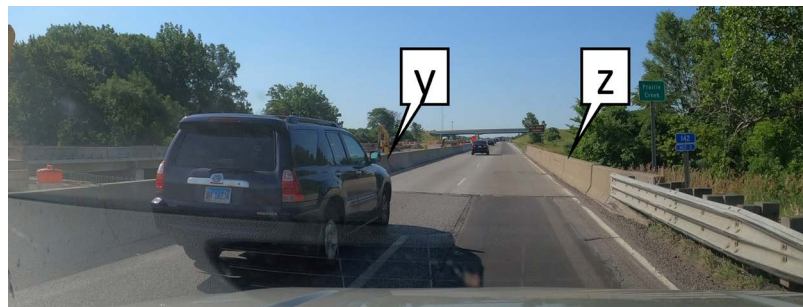
ii), where the left shoulder is closed due to construction (callout y on **Figure 9(b)**). The largest speed drop around MM 142.4 (callout iii) is due to a narrow lane without both shoulders (callout y and z on **Figure 9(c)**) on the Prairie Creek bridge. It is interesting to note that the larger speed reductions are not due to speed limit regulations, but due to geometry changes that require additional driver workloads, especially during shoulder drops and lane shifts.

**Figure 9.** Images corresponding to callouts in **Figure 9** with speed drops. (Callout x shows the lane shift; callout y shows the left shoulder closed; callout z shows right shoulder closed). (a) Lane shift (callout i on **Figure 9**); (b) Left shoulder closed (callout ii on **Figure 9**); (c) Narrow lane bridge with no shoulders (callout iii on **Figure 9**).

The analysis also revealed that the larger speed drops inside the work zone were due to geometric constraints that required additional driver workloads, especially during shoulder drops and lane shifts (**Figure 8**). Speeds were found to be the lowest when there were no shoulders on both sides (**Figure 9(c)**).
