Contribution to the Knowledge of Biodeteriogenic Flora on Three Historical Calabrian (Southern Italy) Churches

Biodeterioration, Churches, Flora, Hazard Index, Italy

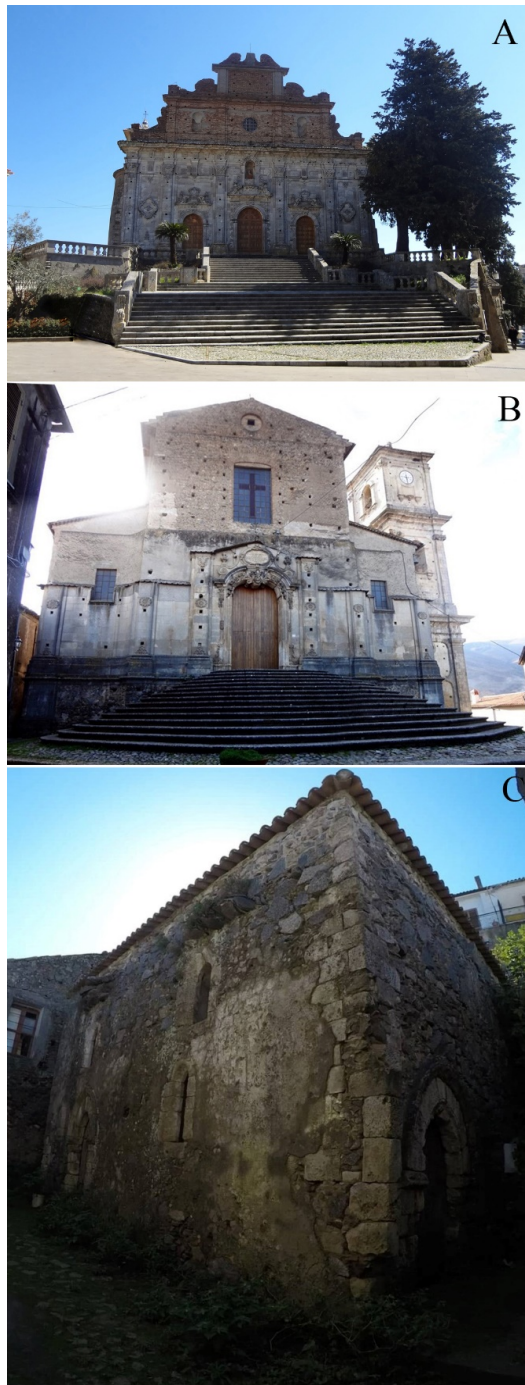
Figure 2. Historical churches: A—Santa Maria della Serra, B—Santissima Annunziata, C—Santa Maria della Pietà.

The Church of Santa Maria della Serra in Montalto Uffugo (SMS) (**Figure 2(A)**), dates back to 1227 and stands on a hill in a peripheral position from the center of the village of Montalto Uffugo. Over the centuries, it has undergone numerous restorations due to the disastrous earthquakes that damaged it over time. The restoration work continued for about thirty years but left the upper part of the main facade incomplete, therefore it is made up of exposed bricks. The Church, originally in Romanesque style and initially composed of a Greek cross plan with three naves, later assumed a planimetric layout with Latin cross plants and architectural solutions in Baroque style [21].

The Mother Church of the Santissima Annunziata in San Fili (SA) (**Figure 2(B)**) dominates the town and strongly characterizes the urban layout of the whole village of San Fili. The church has been documented since the seventeenth century and was enlarged at the end of the 18th century. The principal facade, unfinished in the upper part, is connected to the churchyard by a wide staircase leading to the portal. Today the church is divided into three naves; the main entrance consists of a round arch cleverly carved with floral motifs and acanthus leaves [21] [22].

Lastly, the Church of Santa Maria della Pietà in Squillace (SMP) (**Figure 2(C)**), so-called “Gothic church”, is protected from urban and anthropic pollution and is not exposed to winds because it is sheltered by surrounding houses that shield it from the sun. It is one of the rare Gothic architectural artifacts in Calabria, dating back to the 13th century. It consists of an almost square plan. On the

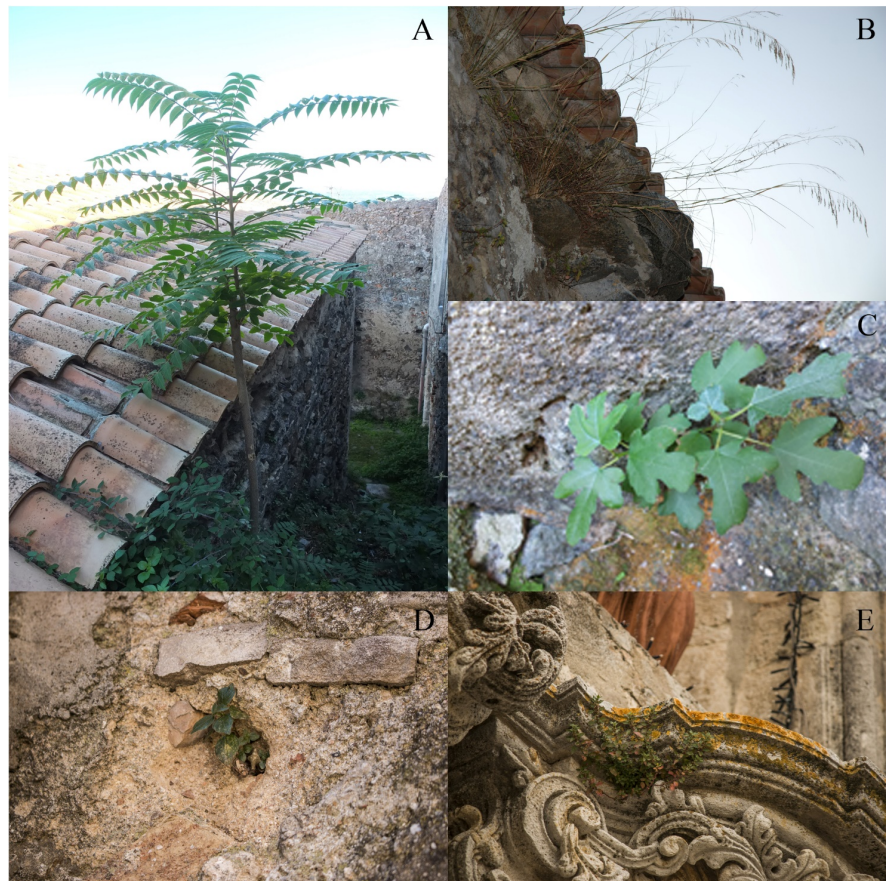
Figure 3. Biodeteriogen species colonising the architectural elements of churches. A—*Ailanthus altissima*; B—*Hordeum murinum*; C—*Ficus carica*; D—*Parietaria judaica*; E—*Micromeria graeca*.

The 27 plant species detected were subdivided into two microhabitats, according to their position compared to buildings: on the walls (16 taxa), on the perimeter of the walls (11 taxa), and (**Figure 3**).

Most species are spontaneously present on the walls and include trees (*Ailanthus altissima*, *Ficus carica*), shrubs (*Dittrichia viscosa*, *Micromeria graeca*, *Rubus ulmifolius*, *Trachelium caeruleum*) annual herbaceous plants (*Crepis neglecta*, *Hordeum murinum*,) and perennial herbaceous plants (*Mentha pulegium*, *Mirabilis jalapa*, *Parietaria judaica*, *Phytolacca americana*, *Plantago lanceolata*, *Picris hieracioides*, *Sanguisorba minor*, *Sorghum halepense*). Among these there are the most dangerous species with a high HI value (8 - 10) such as *Ailanthus altissima*, *Ficus carica*, *Rubus ulmifolius* and *Sambucus nigra*, which are characterized by imposing and robust roots creeping in the junction points between the bricks of construction, using cracks and pre-existing fractures, causing the disintegration of mortars and plasters up to the foundations of the buildings. On the perimeter of the walls of the buildings are dominant annual and perennial herbaceous species (e.g. *Anthemis arvensis*, *Erigeron canadensis*) which have a medium-low average HI, such as *Parietaria judaica* or *Plantago lanceolata*, HI 5 and 6, respectively. They are almost all specimens with a generally not very developed root system, therefore they do not represent a big risk for the stability and the mechanical resistance of the walls.

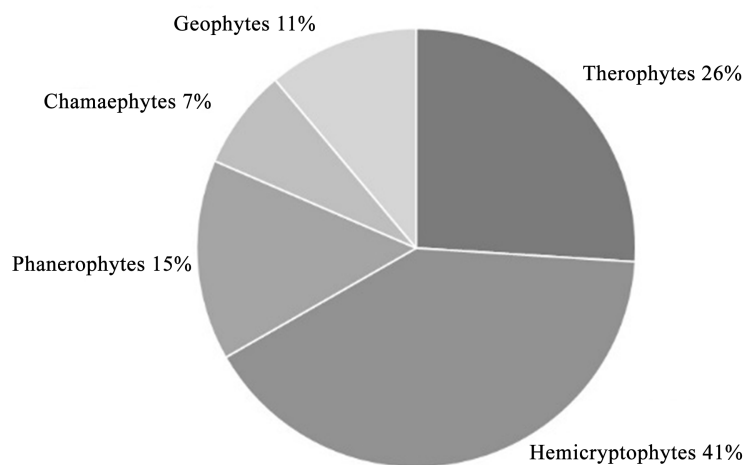
Figure 4. Plant life form spectrum.

The analysis of biological life forms showed five different shapes, with the predominance of Hemicryptophytes (11 species, 40.7%) in all tree churches. Also Therophytes (7 species, 26%) were common in all sites, whereas Chamaephytes (2 species, 7.4%) were present only in SMS and Phanerophytes (4 species, 14.8%) and Geophytes (3 species, 11.1%) only in SMP (**Figure 4**, **Table 1**). Sixteen out of 27 species grow on vertical surfaces, all Geophytes and Chamaephytes were on horizontal surfaces, while Therophytes grow rather on vertical surfaces.

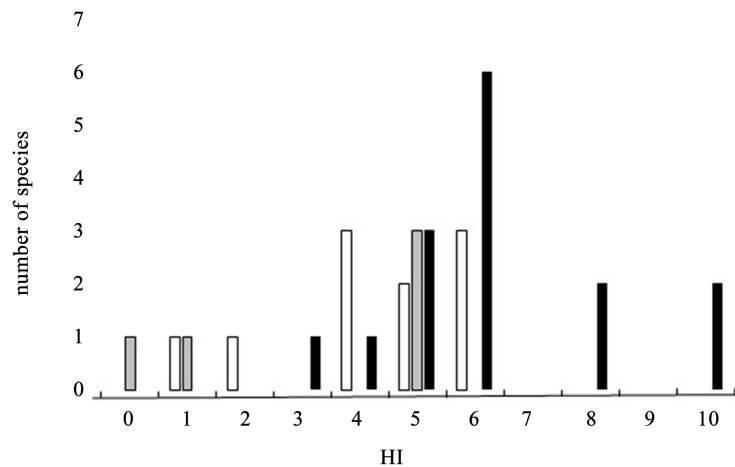
Figure 5. Hazard Index at the three study sites with relative number of species. Church of Santa Maria della Serra in Montalto Uffugo (SMS, white bars), Church of the Santissima Annunziata in San Fili (SA, gray bars) and Church of Santa Maria della Pietà in Squillace (SMP, black bars).

A significant difference was found in the HI values in the three sites examined (Figure 5, Table 1). Indeed, only the church of SMP showed a high average value of Hazard Index (HI 6.3), due to the presence of 4 species with high values, *Ailanthus altissima* and *Ficus carica* (HI 10), *Rubus ulmifolius* and *Sambucus nigra* (HI 8). The other 2 churches, SMS and SA, showed much lower average values, 3.9 and 3.2, respectively: in these two sites 65% - 75% of the species found had an intermediate HI value between 4 and 6.
