Studies on Chemical Resistance of PET-Mortar Composites: Microstructure and Phase Composition Changes

Ahmed Soufiane Benosman^{1,2,3*}, Mohamed Mouli², Hamed Taibi¹, Mohamed Belbachir¹,
Yassine Senhadji², Ilies Bahlouli¹, David Houivet⁴

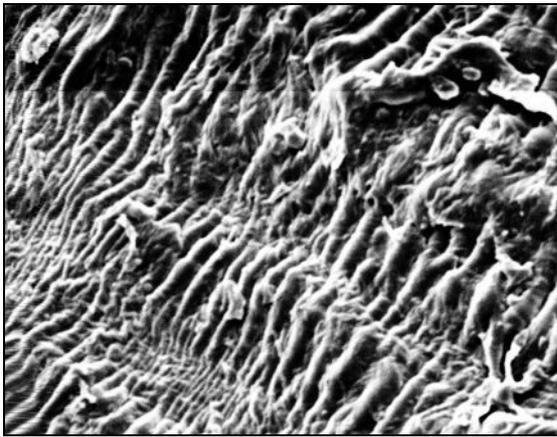
Figure 1. Scanning electron micrographs of PET particles, (magnification, $\times 1200$).

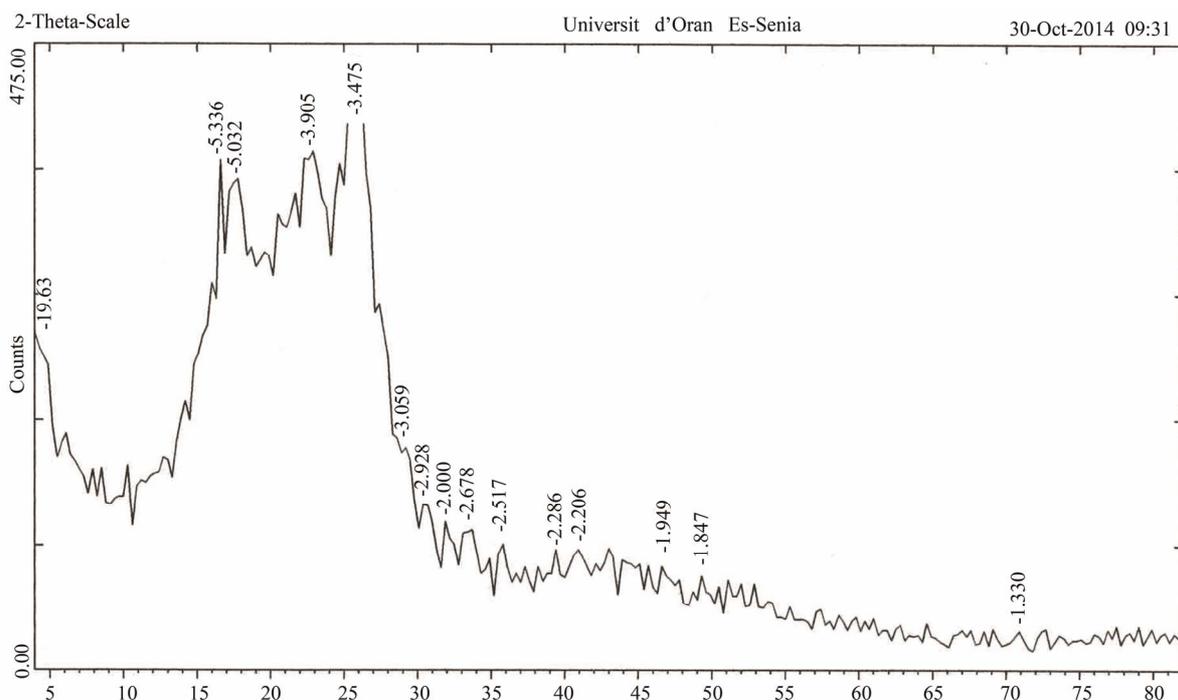
Figure 2. X-ray diffraction pattern of the PET particles.

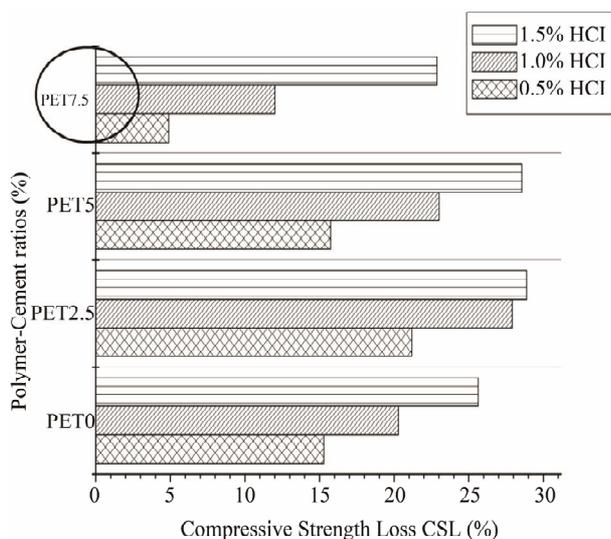
Hence, **Figure 4** presents the results of compressive strength loss *CSL%* of the mixes at 56 days in different hydrochloric acid concentration (0.5%, 1% and 1.5%) solutions. The results indicate that the resistance of acidic attack of the composites (PET7.5) was increased with an increase in PET content. At day-56, the *CSL%* of PET7.5 was reduced by 68%, 41%, 10.7% for the 0.5%, 1% and 1.5% of HCl acid solutions, respectively, when compared to that of PET0.

Figure 4. Compressive strength loss of specimens under HCl acid solutions exposure.

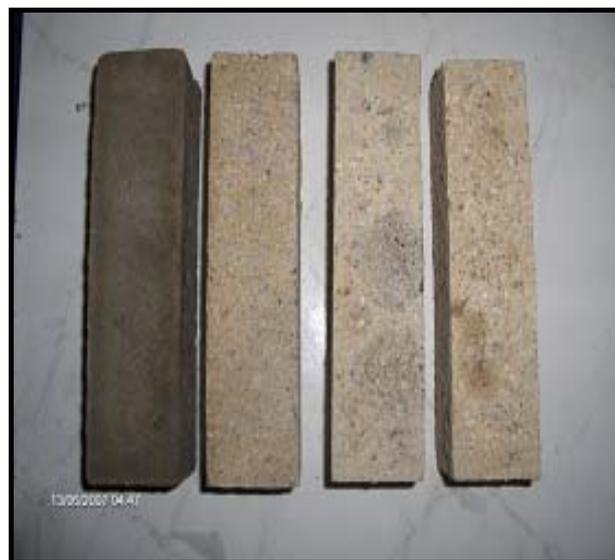
aggressive solutions as depicted in **Figure 5**. These mortars kept their rectangular forms more or less, but their dimensions decreased considerably from 0.5%, 1% to 1.5%. Hydrochloric acid attack is a typical acidic corrosion which can be characterized by the formation of layer structure [47]; its can be divided to three main zones: undamaged zone, hydroxide mixture zone or brown ring, and attacked zone. By hydroxide mixture zone, there is a layer formed by undissolved salts seen as a dark brown ring.

Figure 5. Deterioration of specimens after 56 days of immersion; (1) Tap water, (2) 0.5%, (3) 1%, (4) 1.5% HCl acids (From the left to right, respectively).

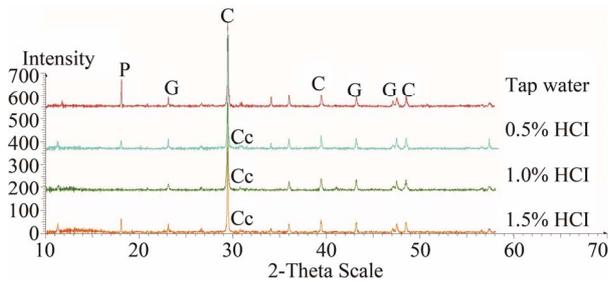
Figure 6 presents the XRD analysis of composite PET0, as an example, before and after attack by different hydrochloric acid concentration (0.5%, 1% and 1.5%) solu

Figure 6. X-ray diffraction pattern of the specimens under HCl acids exposure. P: portlandite $\text{Ca}(\text{OH})_2$, C: calcite, G: gypsum, Cc: $\text{CaCl}_2 \cdot 2\text{H}_2\text{O}$ (hydrated calcium chloride).

tions. The stacking of the various spectra (initial state, after 0.5% attack, after 1% attack and after 1.5% attack) confirms the appearance of a trace of calcium chloride (CaCl_2) on the specimens exposed to hydrochloric acid. The low quantity of calcium chloride found is due to its high solubility in water (46.08g/100ml of H_2O). Washing of each specimen after the immersion period leaves its surface nearly free from this salt. Additionally, the portlandite $\text{Ca}(\text{OH})_2$ was decomposed by different acids concentration following the chemical reaction (Equation (3)).

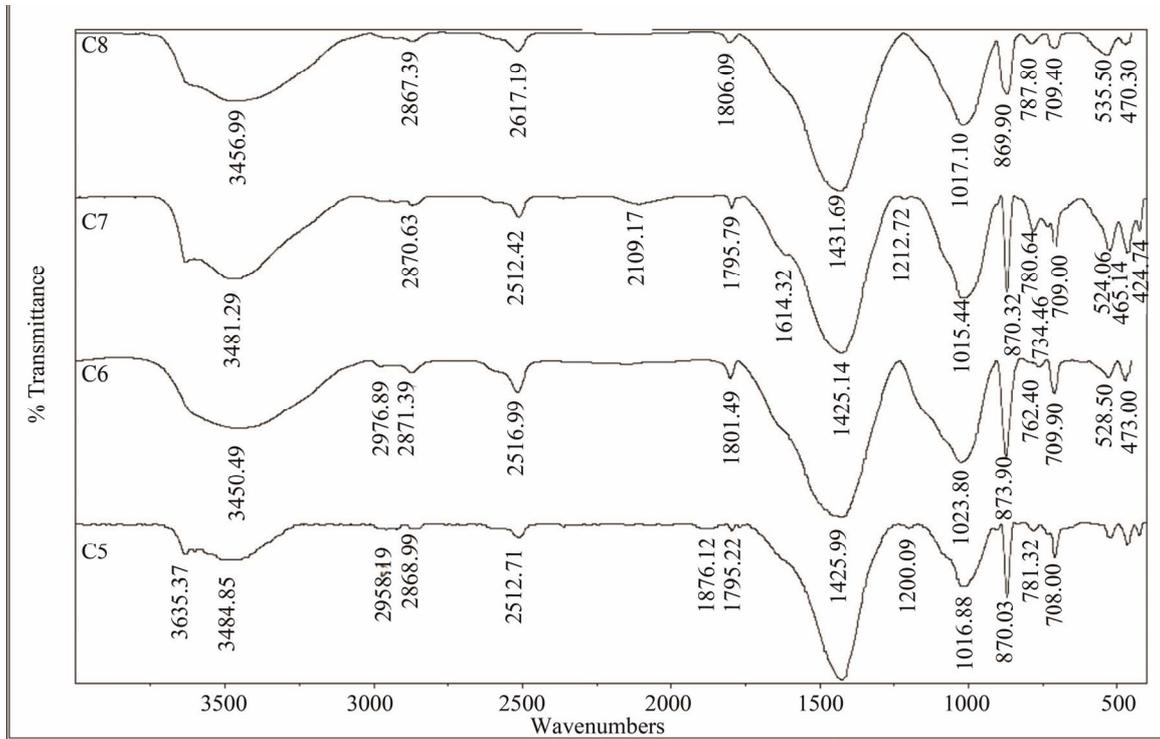
As the same for the X-ray diffraction, the FT-IR analysis of composite after attack by different acids (**Table 5**, **Figure 7**) confirms the appearance of a trace of calcium chloride (CaCl_2) on the specimens exposed to various HCl acids. The low quantity of calcium chloride found is due to its high solubility in water.

Figure 7. FT-IR spectra of the specimens under HCl acid exposure, (C5: Tap water, C6: 0.5%, C7: 1%, C8: 1.5%).

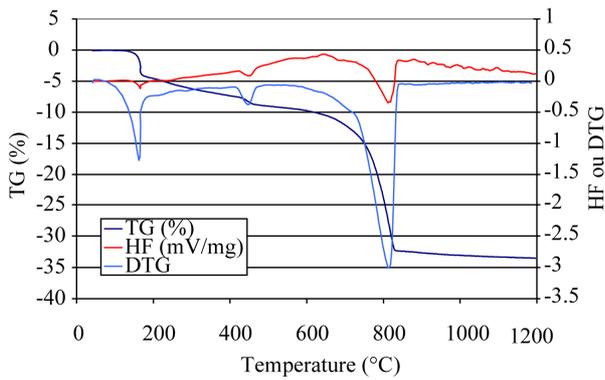
Figure 8. DTA/TG curves at 20 K/min of composite PET0 in tap water exposure.

Figure 8 shows the DTA/TG curves of mortar without polymer PET0 in the tap water. It can be seen that DTA-TG/dTG curves for this mortar consist of four zones:

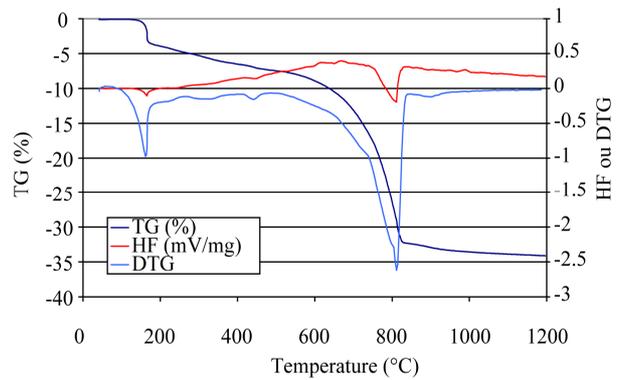
Figure 10. DTA/TG curves at 20 K/min of composite PET0 under 1.0% hydrochloric acid exposure.

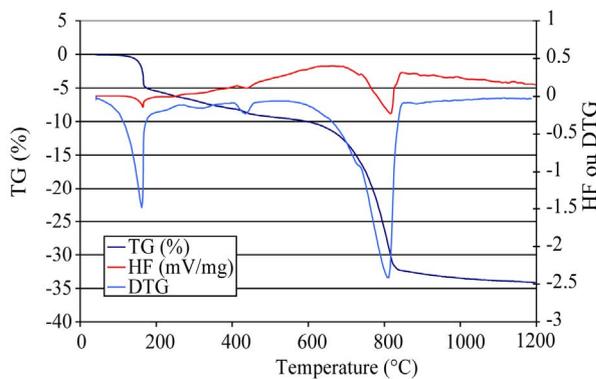
Figure 9. DTA/TG curves at 20 K/min of composite PET0 under 0.5% hydrochloric acid exposure.

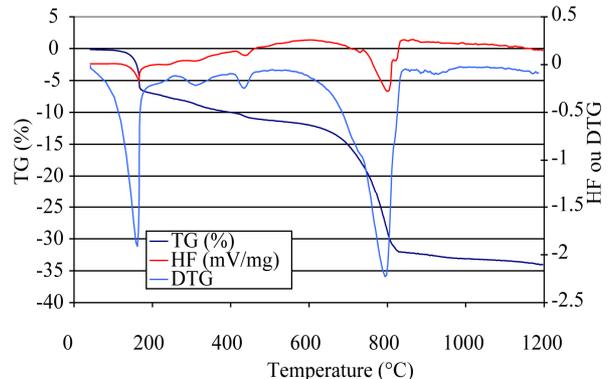
Figure 11. DTA/TG curves at 20 K/min of composite PET0 under 1.5% hydrochloric acid exposure.

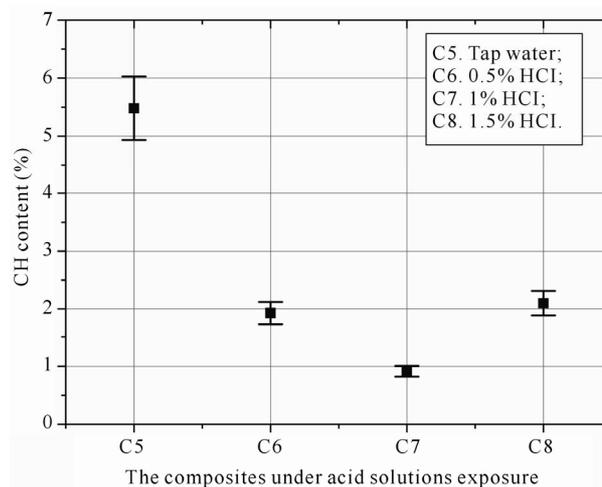
Figure 12. Effect of HCl acids concentration on the calcium hydroxide content (CH).

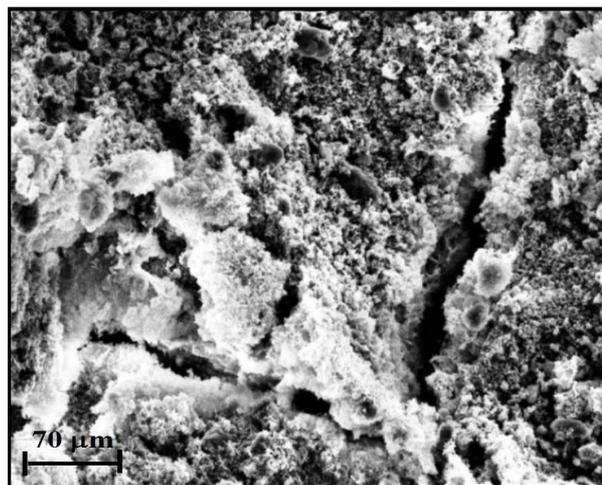
In case of HCl attack, the damaged of PET0 composite was selected as an example to observe the microstructure of deterioration and the SEM images are shown in **Figure 13**. No portlandite crystal exists in the acid attacked composite. It is clear that exposure to solution of hydrochloric acid generates pores and micro-cracks in the mortar specimens. So, The SEM and ATD-TG/dTG analyses corroborate some of the results discussed above.

Figure 13. SEM images obtained for the external porous texture of PET0 sample after being attacked by the 1% hydrochloric acid solution ($\times 600$).

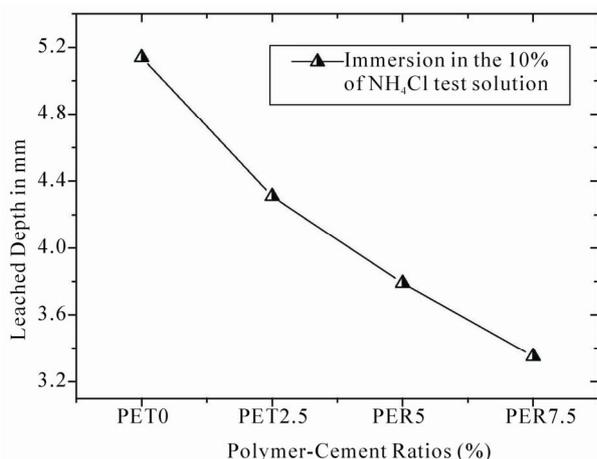
Figures 14 and 15 show the evolution of the degraded thickness of composite immersed in a solution of ammonium chloride 10%, represented as a function of the polymer-cement ratios. Loss of mass followed the same trend. At 480 days, significant differences were obtained: compared to PET0, the depth of attack was 16.2%, 26.2% and 34.8% lower for PET2.5, PET5 and PET7.5, respectively.

Figure 14. Depth of attack due to the leaching of composite immersed in 10% ammonium chloride.

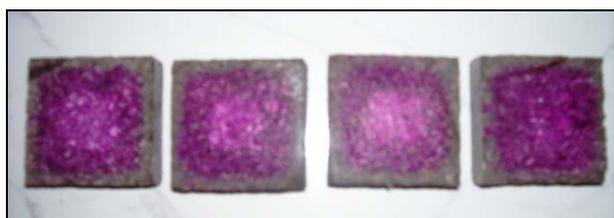
Figure 15. Depth of reduced lixiviation of the composites PET0, PET2.5, PET5 and PET7.5 (from the left to right) indicated by the phenolphthalein solution.

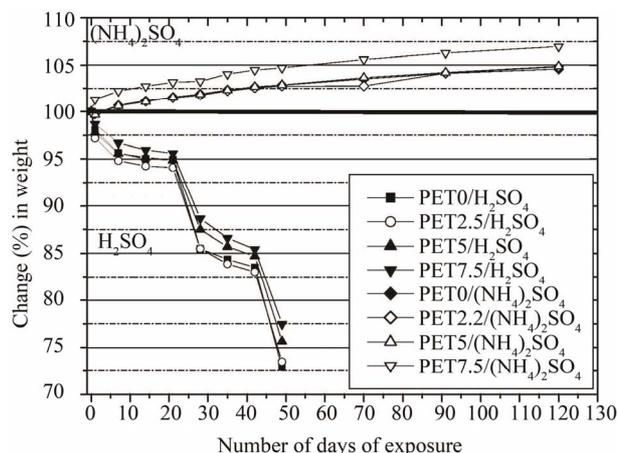
Figure 16 shows the percentage change with respect to time in the weight of cubes immersed in sulfuric acid and

Figure 16. Change (%) in weight with time under H₂SO₄ acid and (NH₄)₂SO₄ solutions.

ammonium-sulfate. It can be seen in the same figure that there is an increase in weight of cubes immersed in ammonium sulfate for the period of experimentation. The augmentation in weight after 120 days of immersion was 4.5%, 4.8%, 4.86% and 6.9% for PET0, PET2.5, PET5 and PET7.5 respectively. However, in the cubes immersed in sulfuric acid it can be noted that the reduction in weight has occurred. So, the rate of reduction in weight was less in PET5 and PET7.5. The mass loss for PET7.5 is lower than the corresponding PET0 mortar by 5% (Figure 16).

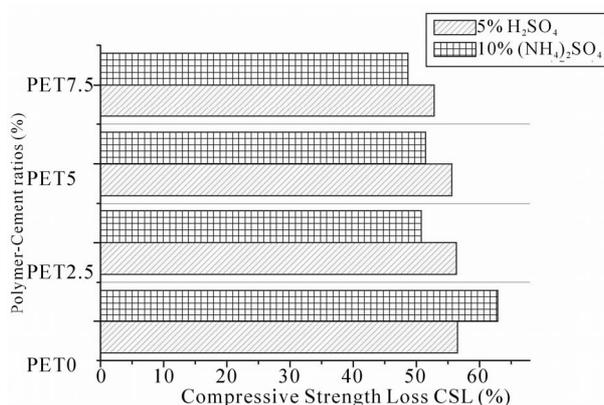
Compressive strength losses CSL% of PET-composites samples after curing in water for 28 days and exposed in 10% of ammonium-sulfate solution for 860 days and in 5% of sulfuric acid for 56 days are presented in Figure 17. It can be seen that the modified mortar samples containing polyethylene terephthalate have better behaviour in ammonium-sulfate solution. The results indicate that the resistance to (NH₄)₂SO₄ solution of the composites was increased with an increase in PET content. At day-860, the CSL% of PET2.5, PET5 and

Figure 17. Compressive strength loss of specimens under H₂SO₄ acid and (NH₄)₂SO₄ solutions exposure.

PET7.5 were reduced by 19.2%, 18.2% and 22.6%, respectively, when compared to that of PET0. In addition, at 56 days, there is a CSL% diminution around 7% for PET7.5 compared to an unmodified one in sulfuric acid solution (Figure 17).

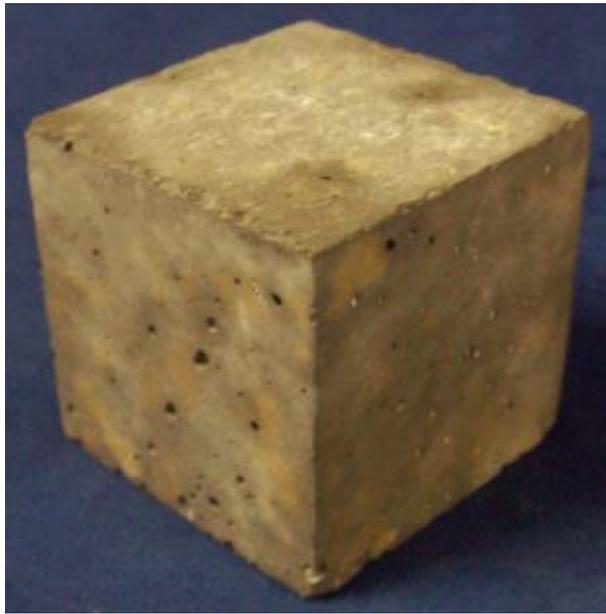
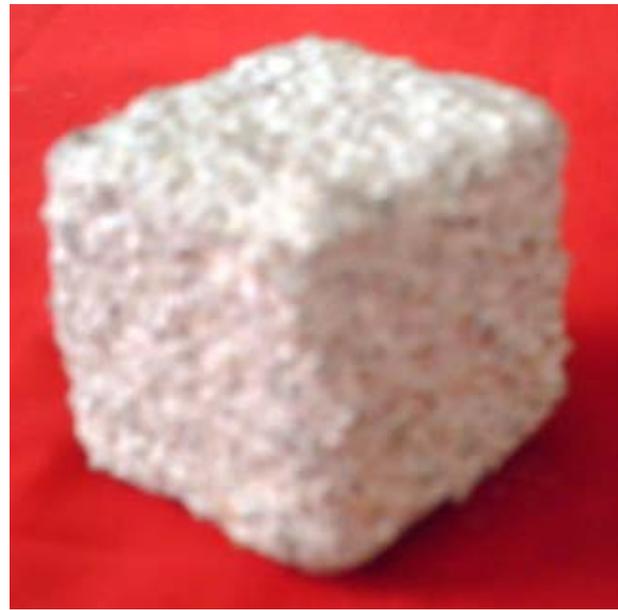
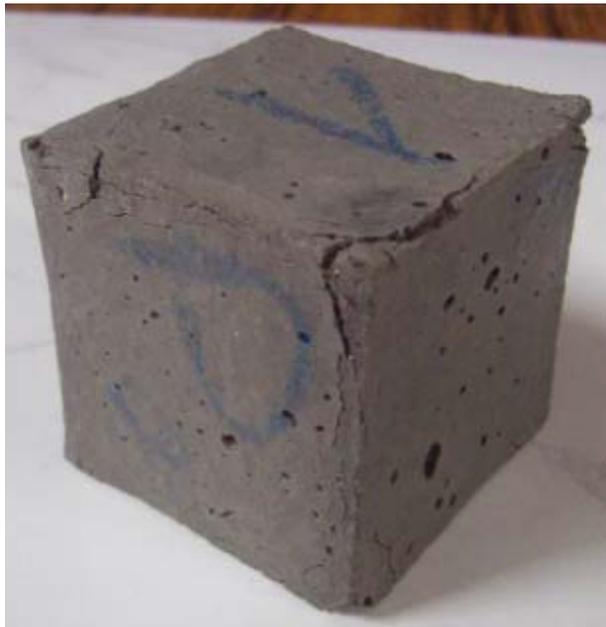
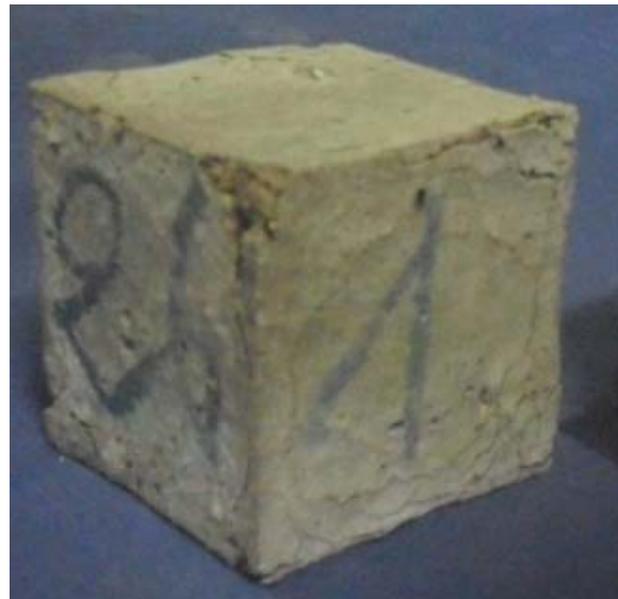
Photos of specimens stored in the ammonium sulfate solution for 120 and 860 days are presented in Figure 18. The samples stored for 120 days under ammonium sulfate exposure showed the first signs of deterioration, while the specimens stored in tap water did not show any

Figure 18. Specimens cubes (50 mL) exposed to: (a) Tap water, (b) H_2SO_4 (56 days), (c) $(\text{NH}_4)_2\text{SO}_4$ (120 days), (d) $(\text{NH}_4)_2\text{SO}_4$ (860 days).

clear evidence of attack. The discussion below concerns the samples stored in $(\text{NH}_4)_2\text{SO}_4$ solution. In all cases, the first sign of attack was the deterioration of the corners, followed by cracking along the edges. Progressively, expansion and spalling took place on the surface of the specimens.

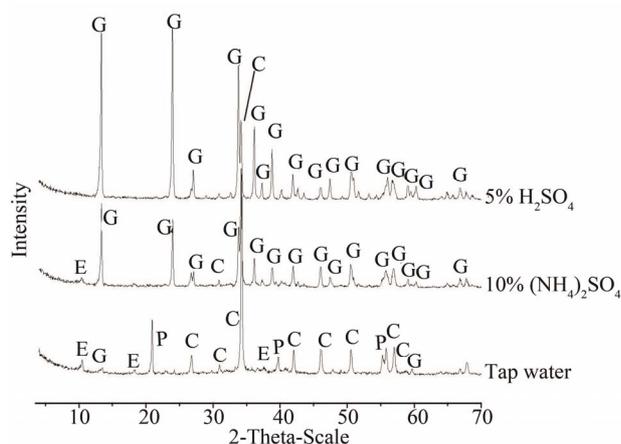
Figure 19. X-ray diffraction pattern of the specimens under H_2SO_4 acid and $(\text{NH}_4)_2\text{SO}_4$ solutions exposure. P: portlandite Ca(OH)_2 ; E: ettringite; C: calcite; G: gypsum.

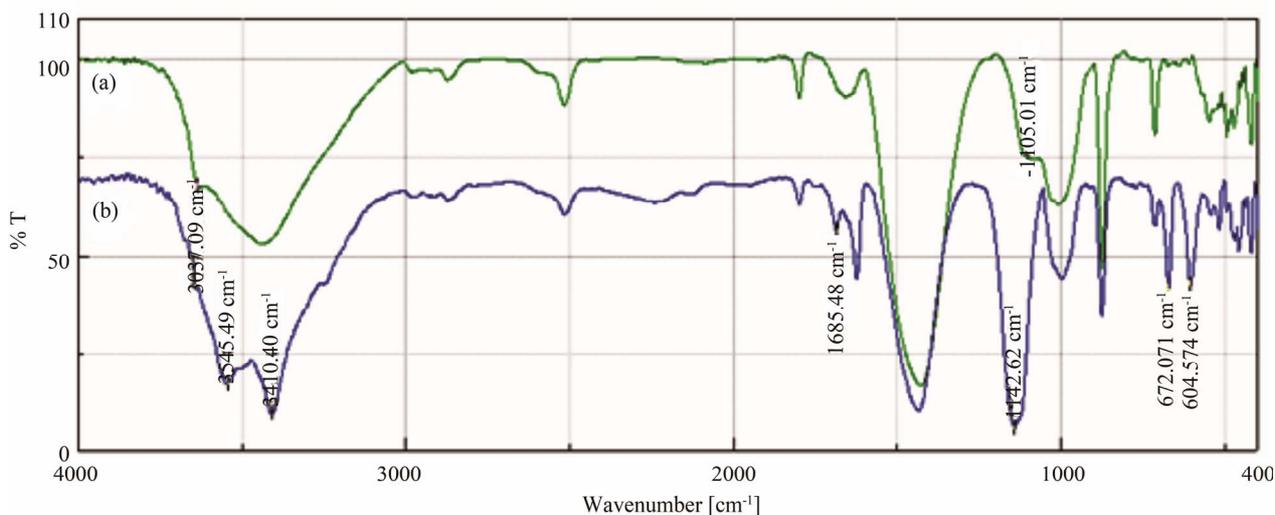
Table 6 illustrates the positions and intensities of infrared absorption bands and **Figures 20** and **21** show the FT-IR patterns of specimens exposed to: Tap water, H_2SO_4 , and $(\text{NH}_4)_2\text{SO}_4$. The FT-IR spectra of the composite hydrated up to 28 days and cured in water are presented in **Figure 20** and **Table 6**. The major changes of

Figure 20. FT-IR spectra of the specimens under (a) Tap water and (b) (NH₄)₂SO₄ solution exposure.

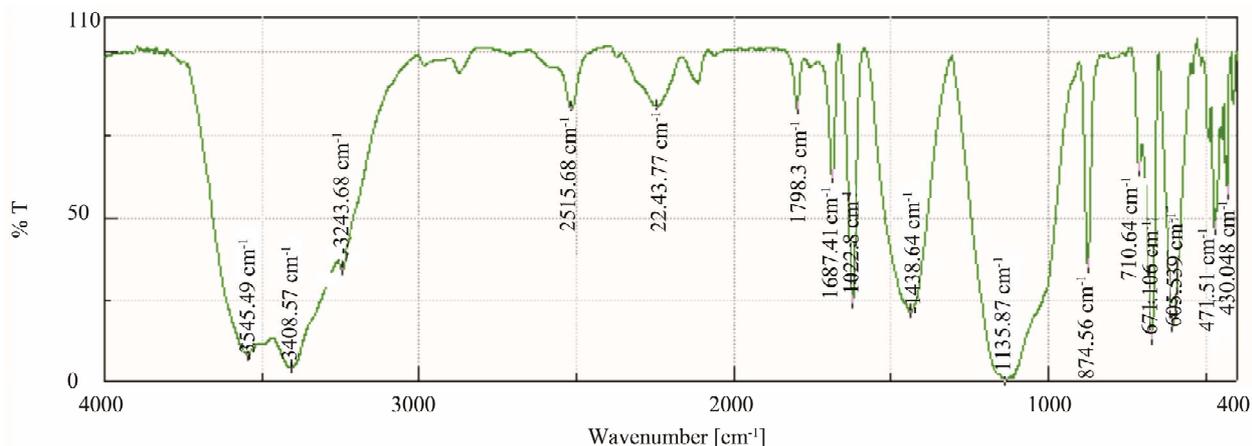
Figure 21. FT-IR spectra of the specimens under sulfuric acid exposure.

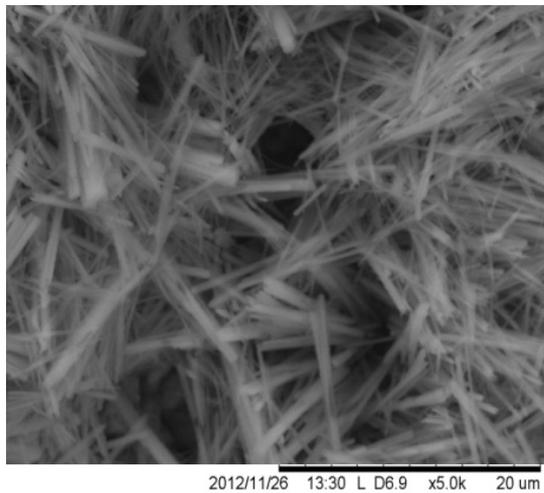
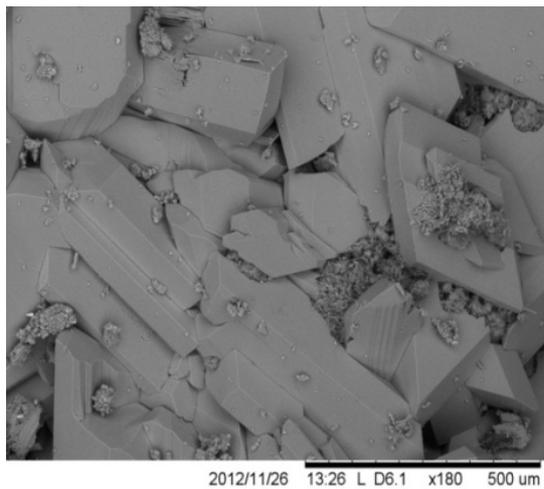
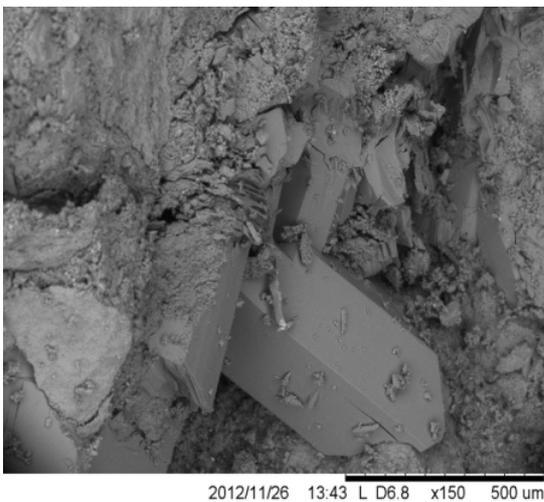
The composite of PET0 exposed to $(\text{NH}_4)_2\text{SO}_4$ solutions was selected as an example to observe the microstructure of deterioration products, and the SEM images are shown in **Figure 22**. No portlandite Ca(OH)_2 crystal existed in the sulfate-attacked unmodified mortar, and many club-shaped or needle-like crystals were embedded irregularly in the pulpy material with a very open microstructure. **Figure 22(a)** shows a large number of needle-like ettringite crystals, smaller than $2\mu\text{m}$ in diameter and $10\text{ - }11\mu\text{m}$ in length, and the existence of different morphologies of the C-S-H gel in the specimen covering the mortar surface before sulfation. In the pores or surface cracks, there were many club-shaped gypsum crystals, which had much larger sizes (smaller than $100\text{ - }200\mu\text{m}$ in diameter and $300\text{ - }500\mu\text{m}$ in length) than the ettringite, as shown in **Figure 22(b)**. The formation of both ettringite and gypsum led to the cracking, spalling, and decomposition of the unmodified mortar exposed to a sulfate environment (**Figure 22(c)**). The combination of XRD, FT-IR and SEM led to the positive identification of the deterioration products' formation.

Figure 22. SEM photos of the PET0 composite after exposure to 10% $(\text{NH}_4)_2\text{SO}_4$ solution for 860 days; (a) Needle-like ettringite crystals, (b) Club-shaped gypsum crystals and (c) deteriorate mortar.

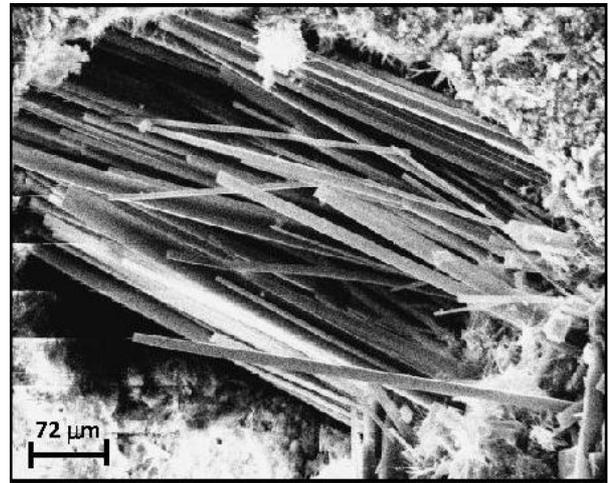
sulfuric acid solutions and the results are exhibited in **Figure 23**. In addition, **Figure 23** taken around a crack on the surface of the core sample shows deposition of a large number of needle-like crystals (gypsum), smaller than 36 - 40 μm in diameter and 300 - 500 μm in length, covering the mortar surface. In the pores or surface cracks, there are many club-shaped gypsum crystals as shown in **Figure 23**. The formation of gypsum leads to the cracking, spalling, and decomposition of mortar exposed to sulfuric acid environment. The SEM images obtained by SEM corroborate some of the results discussed above.

Figure 23. SEM photos of the PET0 composite after exposure to 5% H_2SO_4 solution ($\times 600$) for 56 days; needle-like crystals (gypsum) in the pore.

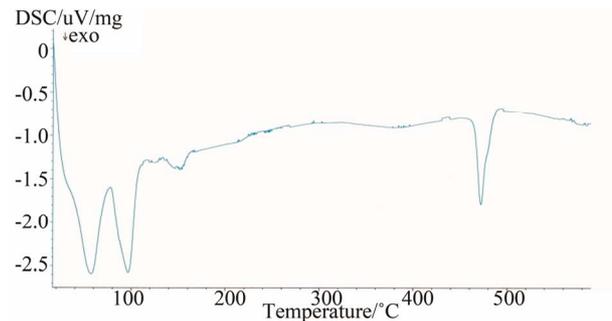
Figure 24. DSC curves at 10 K/min of composite PET0 in tap water exposure.

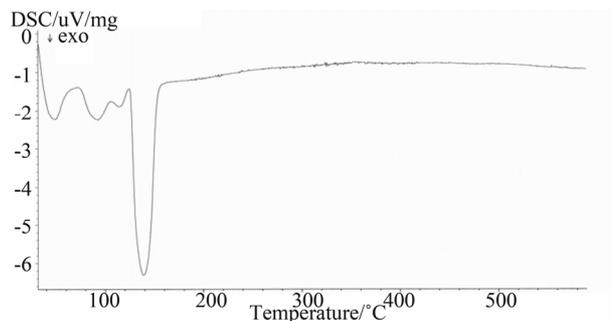
Figure 25. DSC curves at 10 K/min of composite PET0 in $(\text{NH}_4)_2\text{SO}_4$ solution exposure.

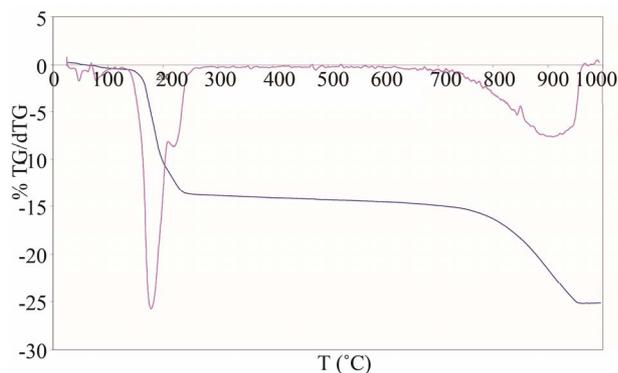
Figure 26. TG/dTG curves at 10 K/min of composite PET0 in H_2SO_4 acid exposure.
