Channel Evolution of Sandy Reservoir Sediments Following Low-Head Dam Removal, Ottawa River, Northwestern Ohio, U.S.A.

Nathan Harris^{1,2}, James E. Evans^{1*}

¹Department of Geology, Bowling Green State University, Bowling Green, USA

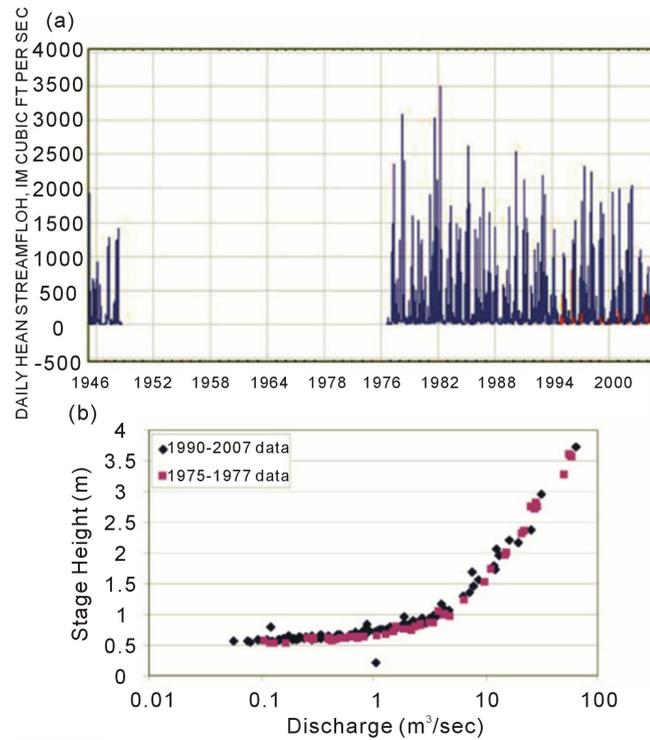
Figure 2. Hydrologic data for the Ottawa River. (a) annual hydrograph data from USGS Gage Station 04177000. (b) stage-discharge relationship for the Ottawa River from two data sets.

Hydrologic data about the Ottawa River is available from a U.S. Geological Survey gage station at river kilometer 17.3 (RK 17.3). There are continuous stage-discharge records from 1945-1948 and from 1977-present (Figure 2). The mean daily flow for this interval is 5.3 m³·sec⁻¹ and discharge for 10, 25, 50, and 100-year flows

have been calculated as 91, 127, 170, and 219 $\text{m}^3\cdot\text{s}^{-1}$, respectively [21]. The Ottawa River is characterized by “flashy” discharges (low base flows, high peak flows, and a short lag-to-peak) which are often characteristic of agricultural and urbanized drainages in the region [21]-[23].

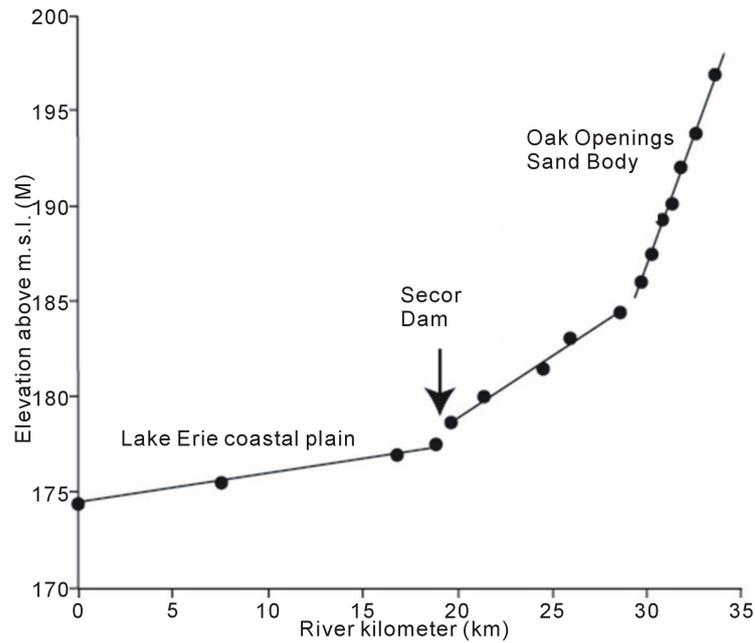
Figure 3. Longitudinal profile for the Ottawa River showing segmented components related to the geologic setting of portions of the drainage basin.

The longitudinal profile of the Ottawa River is segmented (**Figure 3**) reflecting changes in geologic setting. Between Lake Erie and approximately RK 8 the Ottawa River is essentially an extension of Lake Erie, with slopes approximately zero, and dominated by mud deposition. Between RK 8 and RK 26, the gradient is about 0.7 m/km and the channel substrate is moderately sorted fine- to medium-grained sand that is armored by fine gravel (mostly bivalve shells and anthropogenic materials) and abundant woody debris. In the head-waters above RK 26, where the Ottawa River flows through the Pleistocene Oak Openings sand body, the gradient varies from 1 - 6 m/km, and the channel substrates are dominantly sand.

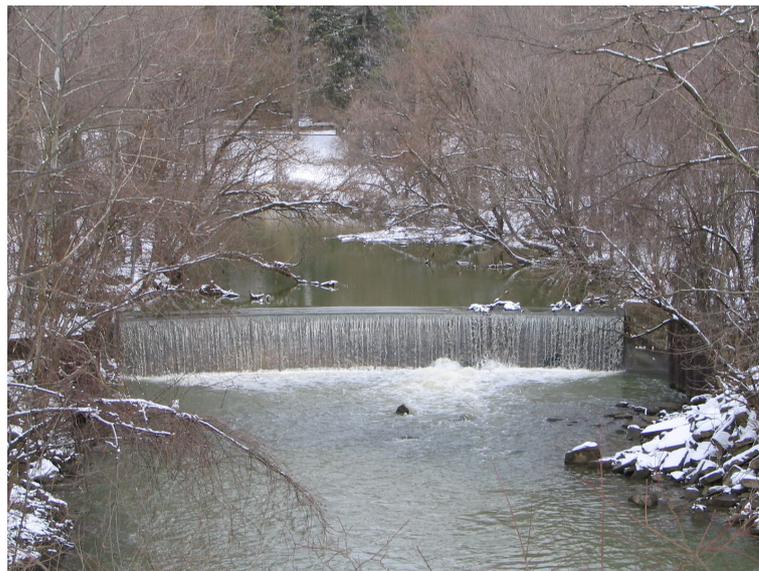
Figure 4. Field photograph of the Secor Dam prior to its removal in 2007.

The Secor Dam was located at RK 18. It was a run-of-river dam or weir 2.5 m tall and 17 m wide (**Figure 4**). The dam was built in 1928 for recreational purposes and was removed in 2007 because of liability concerns and for ecosystem restoration.

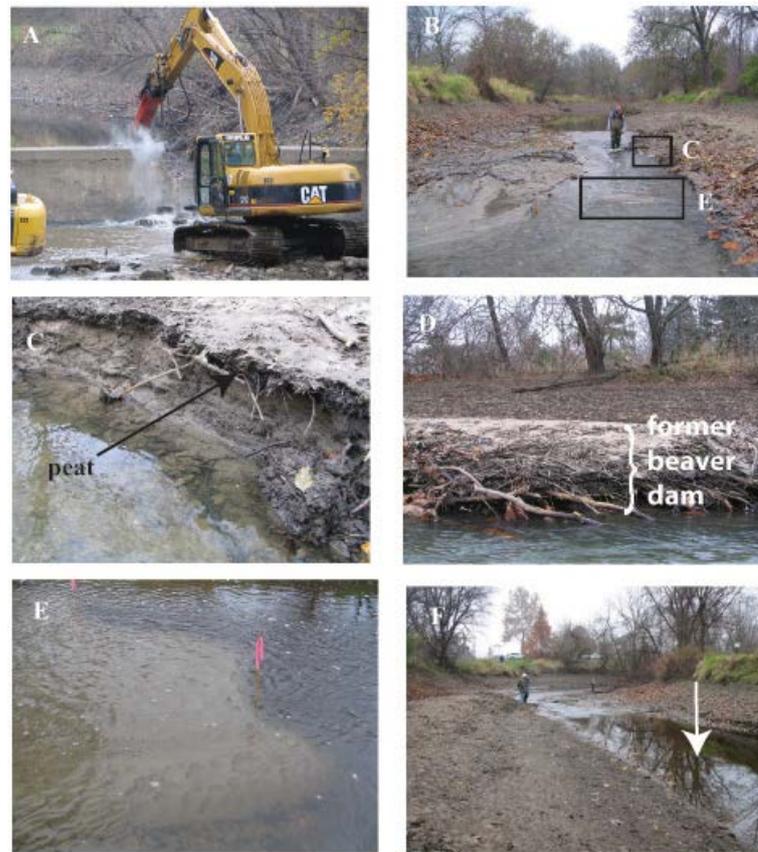
Figure 5. Field photographs of removal of the Secor Dam and immediate responses. (A) Photograph of breaching the dam. (B) Initial incision into flat floor of the former reservoir indicating the locations of other images. (C) Photograph of exposed peat layer (pre-settlement paleosol) that slowed subsequent channel incision. (D) Photograph of mat of log debris interpreted as exhumed beaver dam. (E) Photograph of sandwave migrating downstream (see text for details). (F) Photograph of newly incised channel after approximately 48 hours.

The Secor Dam was removed over a three-day interval from November 19-22, 2007 (**Figure 5(A)**). The removal was coordinated with low-flow conditions in the river. A significant amount of reservoir drawdown had been accomplished prior to the removal of the dam.

The immediate (within 24-hours) response was the upstream migration of a diffuse erosional step called a “nickzone” (**Figure 5(B)**). The nickzone was the width of the channel and approximately 10 m in length. After migrating approximately 85 m upstream within the first day after dam breaching, the nickzone stabilized at a location about 70 m upstream of the former dam. Subsequent coring and trenching revealed that the cause for stalling of the nickzone was because channel incision had intersected a peat horizon (**Figure 5(C)**). This peat horizon added cohesive strength to the channel substrate and significantly slowed channel incision and continued upstream migration of the nickzone. Subsequent studies indicates the peat horizon is the pre-settlement paleosol that was drained and buried within the past ca. 200 years due to human land clearance and settlement [5].

The second response, again starting within the first 24-hours and overlapping with nickzone migration, was the formation and downstream migration of a sandwave (**Figure 5(E)**) through the newly incised channel (**Figure 5(F)**). The sandwave translated toward the former dam as a bedload sheet. The sandwave initially consisted of three lobes as it entered the downstream meander bed. These lobes merged or reformed at different times over the 48-hour period (**Figure 6**). Eventually the sandwave dissipated in the pool of the re-formed meander.

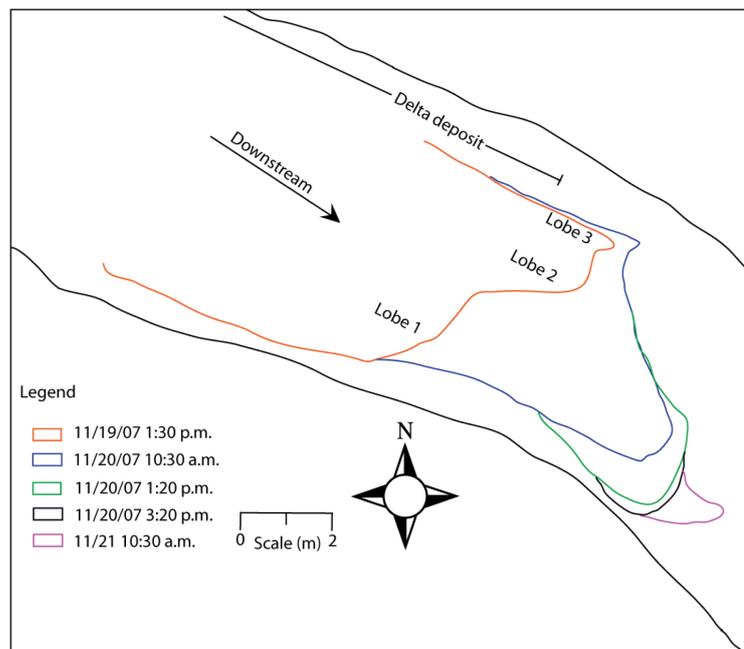
Figure 6. GPS survey of the position of sandwave at sequential times during the first 48-hours after breaching the dam. The sandwave stalled out in the pool of the re-formed meander upstream of the former dam.

The sandwave was continually tracked for the first two days using a GPS unit. The rate of downstream movement translation changed from 0.5 m/hr during the first 12-hours after dam breaching to 0.2 m/hr during the following 36-hours.

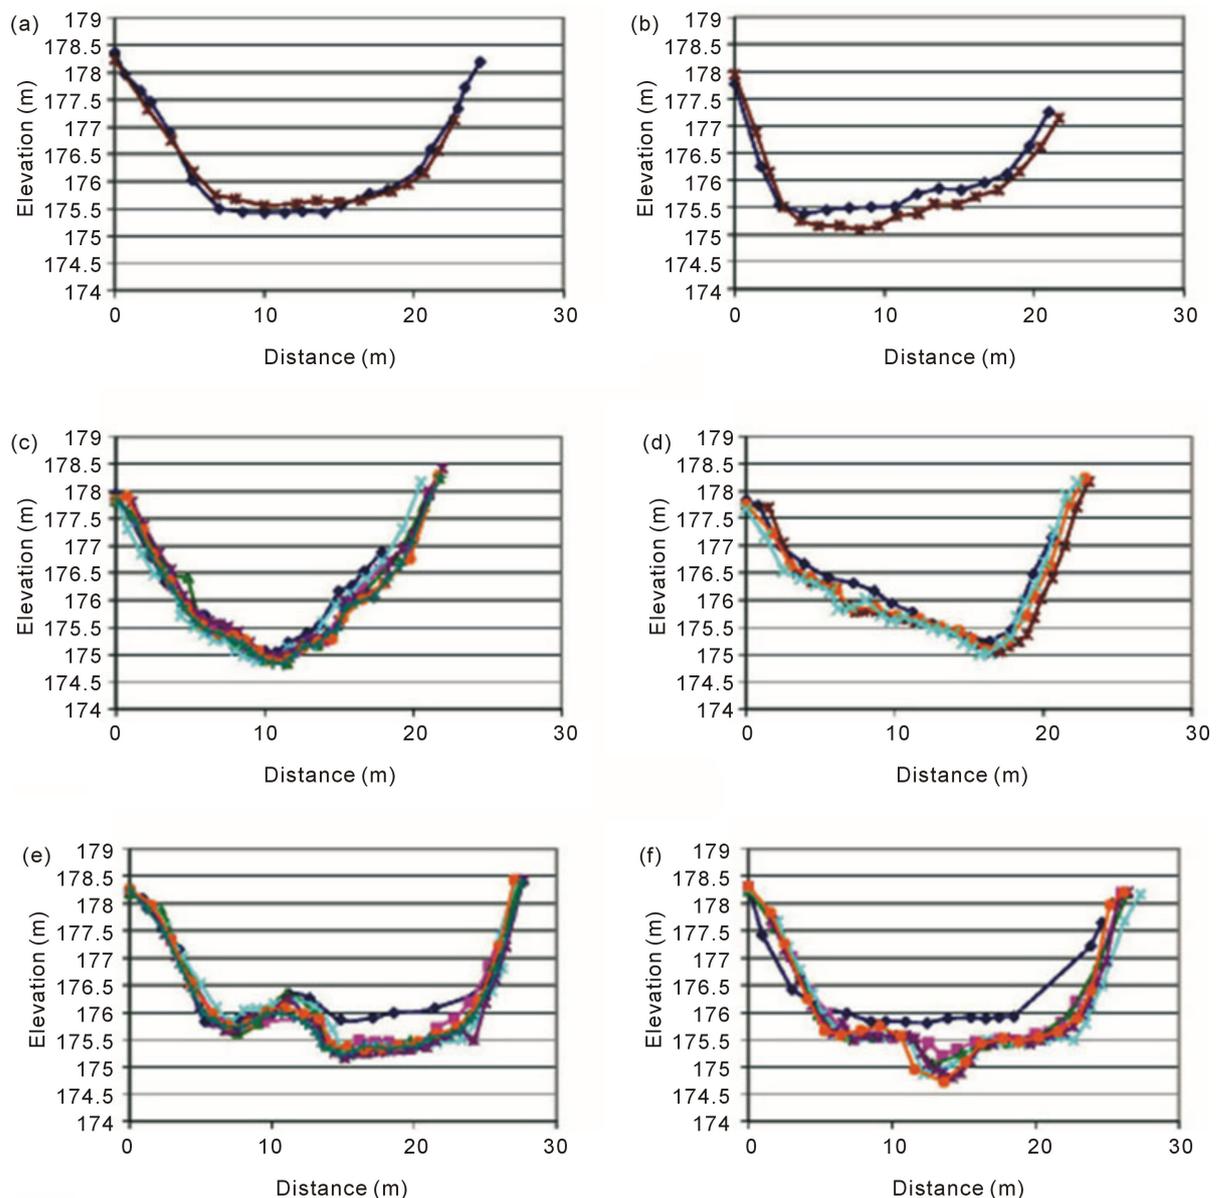
Figure 7. Sequential changes in channel cross sections (see key in Figure 9). (A) Cross section 1. (B) Cross section 2. (C) Cross section 3. (D) Cross section 4. (E) Cross section 5. (F) Cross section 6. See Figure 1 for cross section locations. Elevations are with respect to mean sea level (MSL). Note minimal pre-dam removal and post-dam removal profile changes in cross sections 1 and 2 (located about 330 m and 165 m upstream of the former dam). The maximum incision observed, in cross sections 5 and 6, was 1.3 meters.

Channel cross-sections were re-surveyed 14 days after the dam removal (3 December 2007). The results are shown on [Figure 7](#), [Figure 8](#), [Figure 9](#). All of the upstream cross sections showed significant incision (to a maximum of >0.7 m) but very little channel widening. Channel widening was localized and controlled by substrate heterogeneities such as the exhumed peat horizon. Downstream of the former dam as much as 0.5 m of aggradation was recorded, boulders in the foot-of-dam plunge pool were partly buried, and there was construction

Channel cross-sections were again resurveyed 31 days after the dam removal (20 December 2007). Relatively minor changes had occurred (Figure 7, Figure 8, Figure 9), but generally localized scours had been removed and the channel shape was more uniform. In places there were channel bed outcroppings of the underlying glacial-lacustrine sediment, which are highly consolidated clays that limited further incision at these places.

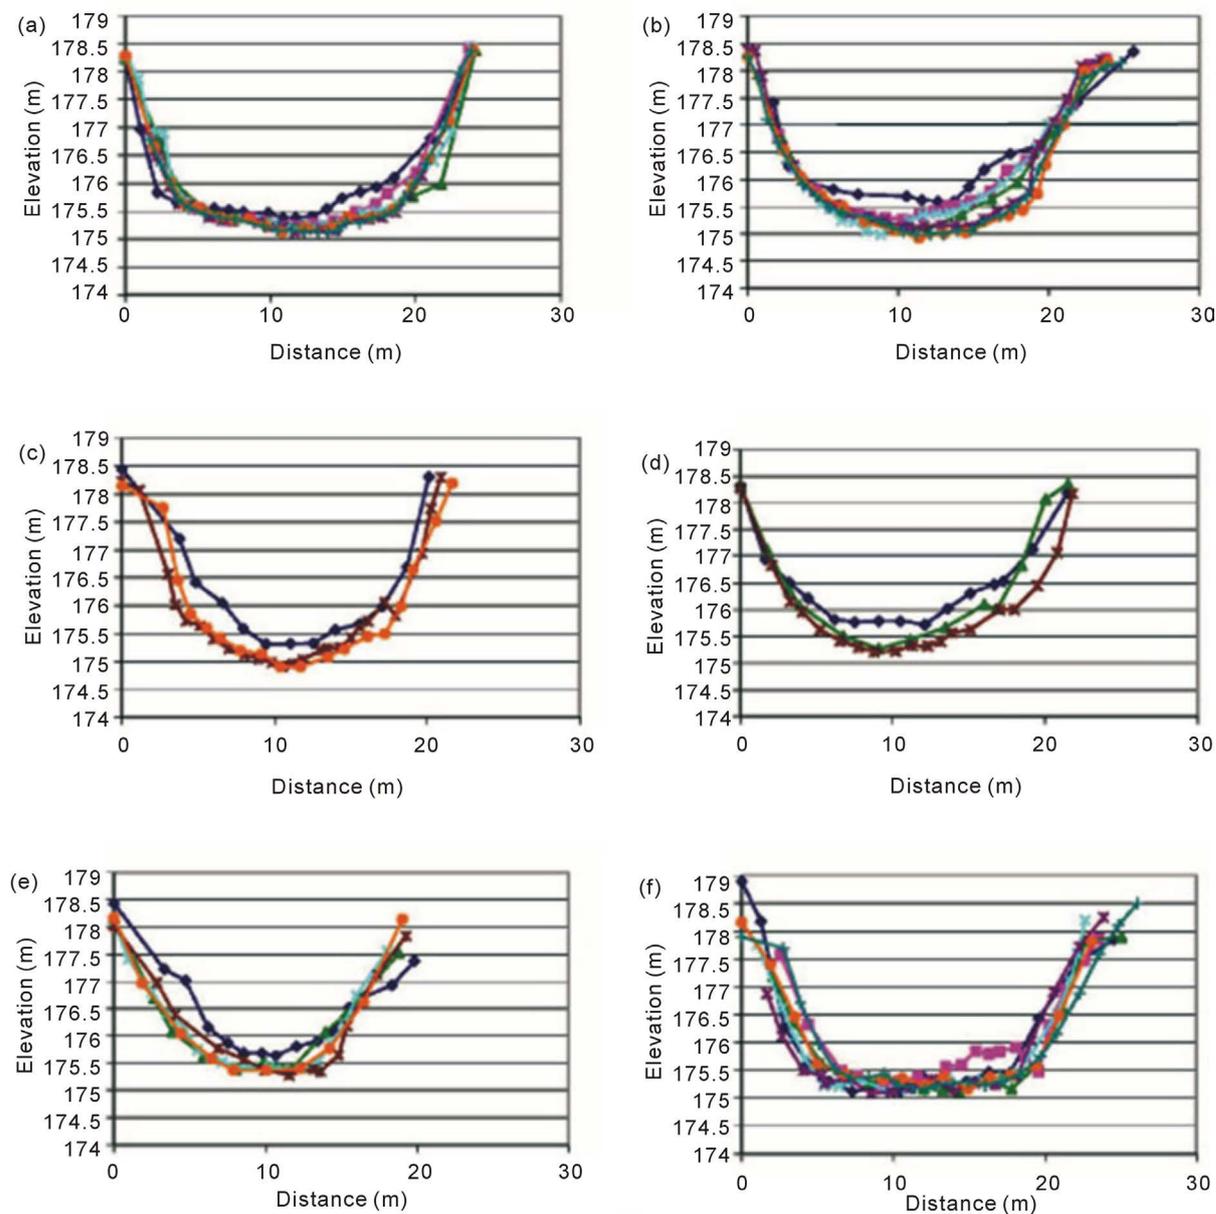
Figure 8. Sequential changes in channel cross sections (see key in Fig. 9). (A) Cross section 7. (B) Cross section 8. (C) Cross section 9. (D) Cross section 10. (E) Cross section 11. (F) Cross section 12. See Fig. 1 for cross section locations. Note shift from erosion above the former dam (cross sections 7-11) and deposition below the former dam (cross section 12).

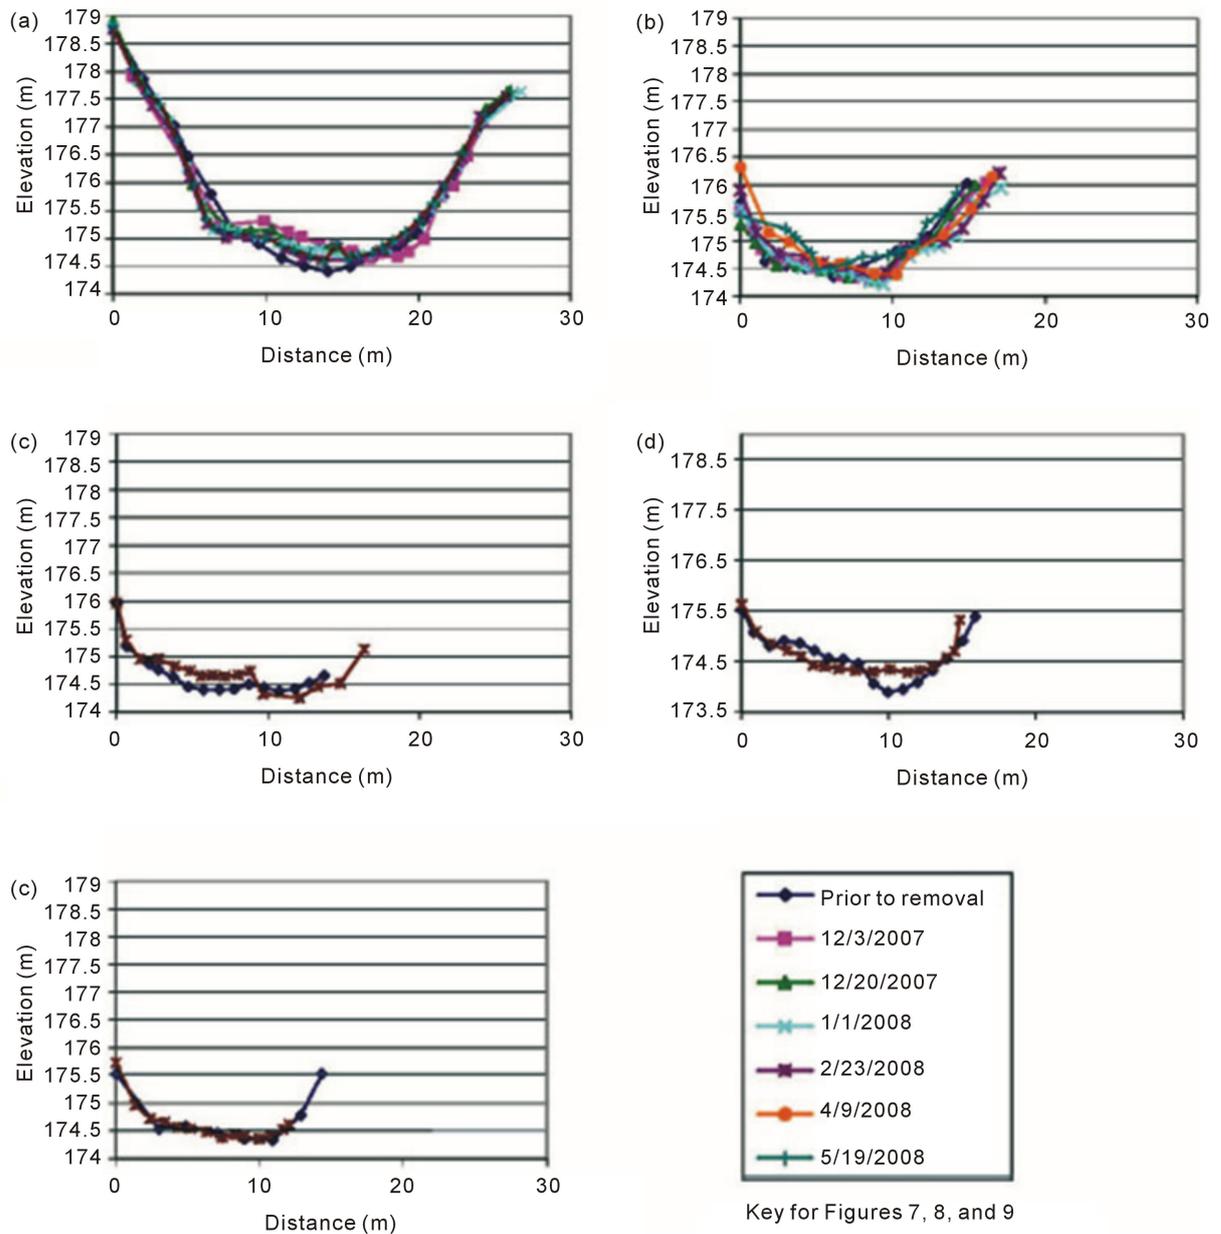
Figure 9. Sequential changes in channel cross sections. (A) Cross section 13. (B) Cross section 14. (C) Cross section 15. (D) Cross section 16. (E) Cross section 17. See Fig. 1 for cross section locations. Note the shift from deposition downstream of the dam after dam removal to essentially no change in cross section 17.

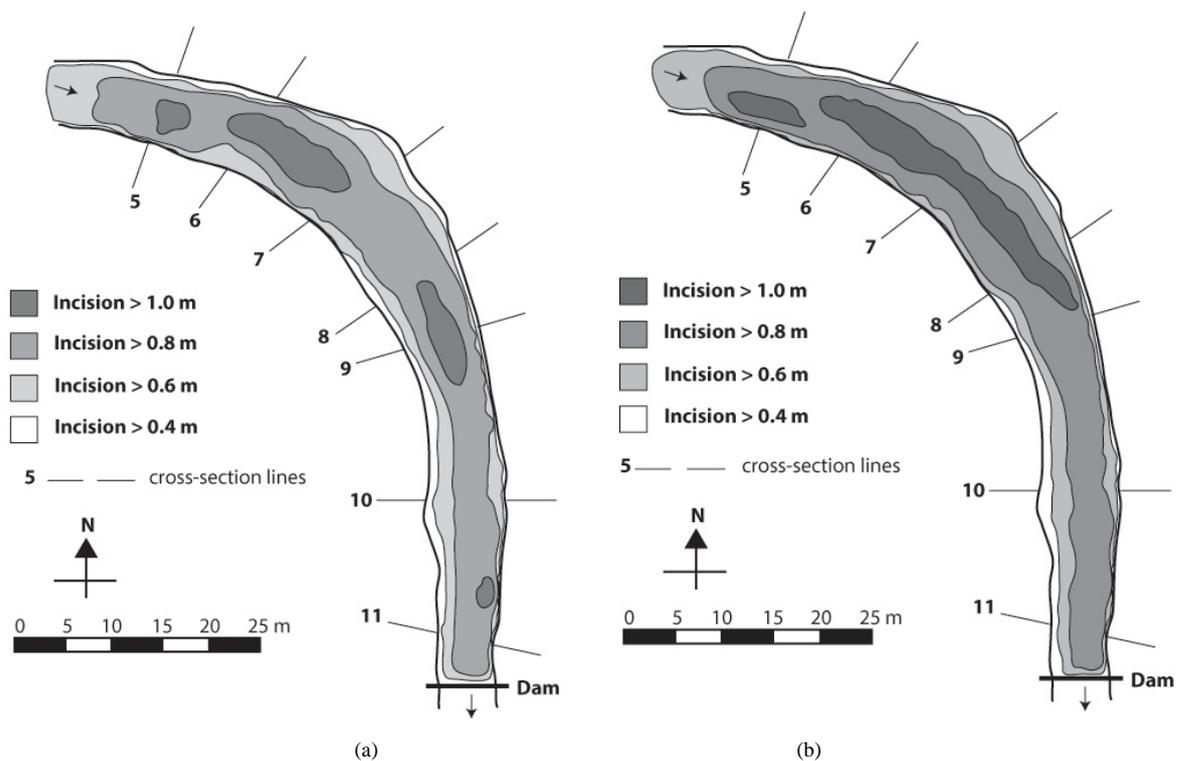
Figure 10. Channel bed elevation changes in the former reservoir during (top) the first 96 days (from 19/11/2007 to 23/02/2008) and during (bottom) the first 182 days (from 19/11/2007 to 19/05/2008). See text for discussion.

540 m³ of mostly sand. **Figure 10(a)** demonstrates that most of the reservoir incision was mid-channel. There was relatively minor change in channel cross-sections downstream.

On day 181 (19 May 2008) approximately 6 months after the dam was removed, channel re-surveys again documented localized erosion at cutbanks and growth of pools at outer bends. There had also been significant erosion of the point bar that had formed upstream of the former dam. This is interpreted as instability in meander wavelength following removal of the dam and the initial phases in channel readjustments in meander geometry [5]. A second set of DEMs and a difference DEM was calculated (**Figure 10(b)**) showing that the region of

maximum reservoir incision has shifted to be more asymmetrical than previous. It was calculated that 285 - 315 m³ of mostly sandy sediment had been removed since the three month calculation, or in other words about 814 m³ (between 772 - 855 m³) of sandy sediment had been eroded from the reservoir in the 6 months following the dam removal.
