# 3D Finite Elements Technique for Collapse Causes of the Pylons in Egyptian Temples: A Study of the Great Pylon of Ramesseum Temple, Luxor, Egypt

Essam H. Mohamed

Archaeological Conservation Department, Faculty of Archaeology, South Valley University, Qena, Egypt

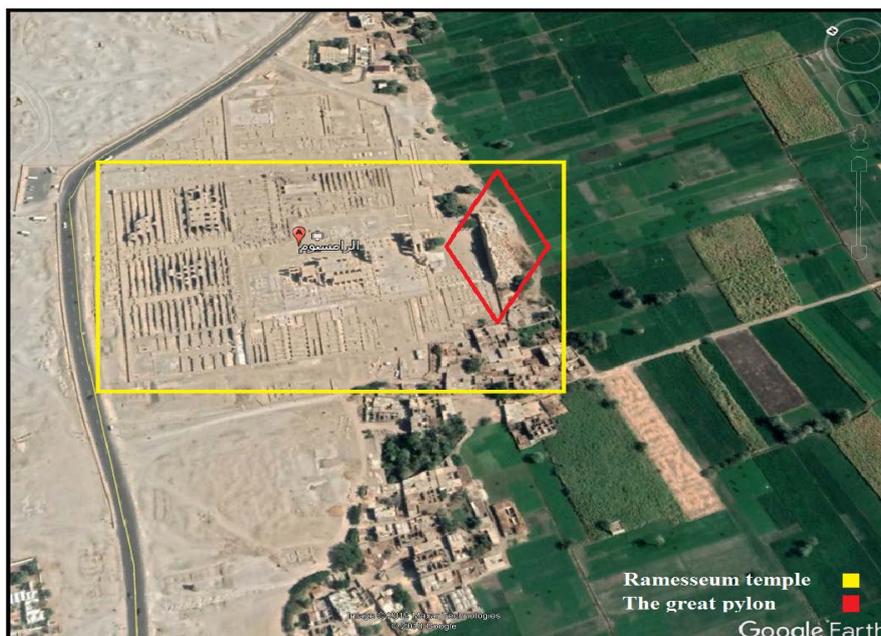
**Figure 1.** The site of Ramessium temple and the farmland in the eastern side of the great pylon.

All the structures in front of the pylon have disappeared today and are now being covered over by the farmland. We can imagine there was a forecourt with a monumental entrance and a dromos between the quay and the pylon. The pylon, whose eastern side is now totally ruined, most certainly had two flag masts on each of its piers; it marked the temple entrance and the first courtyard.

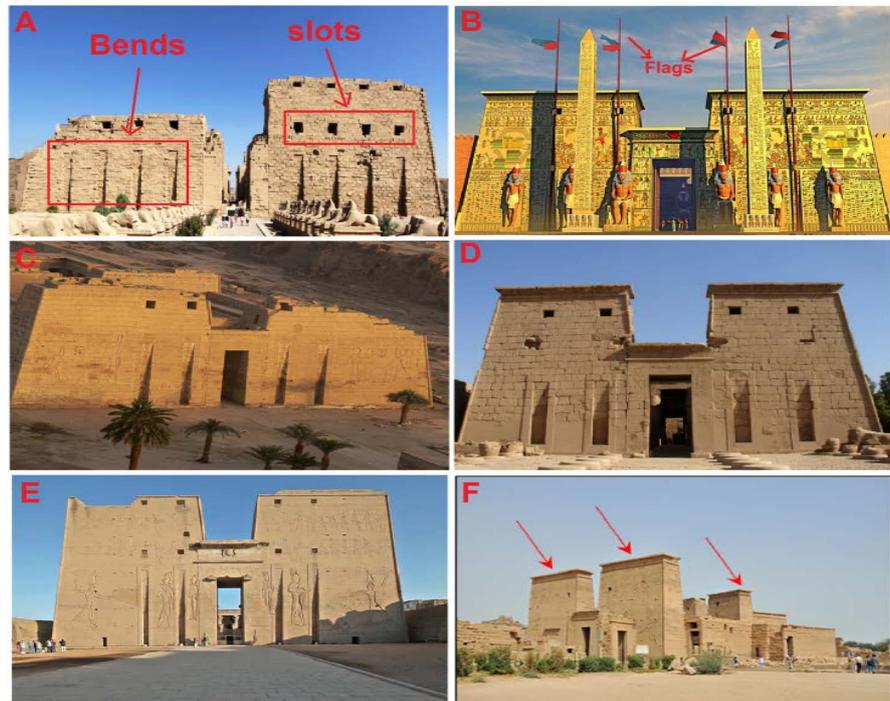
**Figure 2.** Different shapes of the temples pylons (A) Shows the slots and the bends in the pylon which use to put the flags (Karnak temple). (B) Imagine shape to the external facade of the first pylon of Luxor Temple. (C) The first Pylon of Rameses III temple (Habu city). (D) the pylon of Khonsu temple. (E) The first Pylon of Edfu temple. (F) The pylons of Philae temple.

The pylon is considered a huge build consist of two towers in which symmetrical shape, between them a door connecting to the open courtyards and roofed columns. The pylon facade is ample from the undermost, and narrows whenever it rose, it is interspersed with a number of Entries ranging from two to eight and has been dedicated to the installation of temple flags, the façades of pylons were ornamented with huge wooden flagstaffs (reaching 30 m in height) capped with colorful cloth flags, The flagpoles were carved from individual wooden beams that brought from the forests of modern-day Lebanon or northern Syria from, these flagstaffs were often tipped with invaluable metals that reflected the rays of the sun [11] [12] (Figure 2).

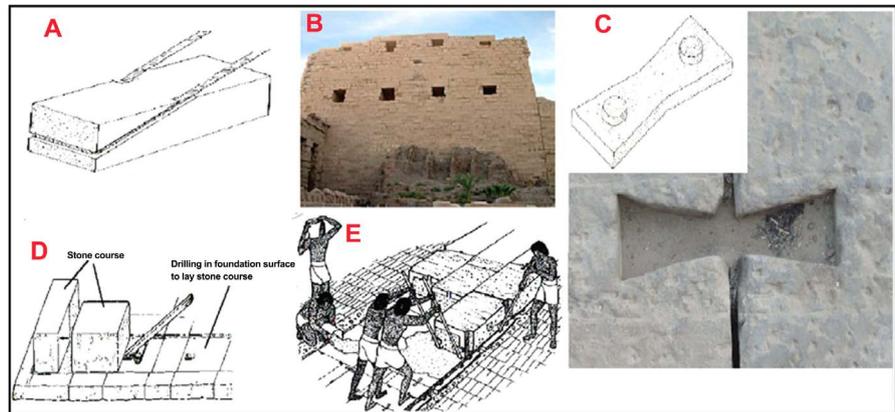
**Figure 3.** Methods of construction of the wall courses. (A) Using the ropes to pull the stone. (B) Mud brick ramps. (C) The stone dowels which use for connecting the blocks together. (D) Using a crow-bar to moving the blocks. (E) Using the mortar in installation of the blocks.

developed, where they used the bricks in as retaining walls of the trench of the foundation to avoid the soil collapse, in the Ptolemaic period, the construction techniques were developed, more substantial blocks were used to support the superstructures, this is clearly demonstrated in the temples of Dandara, Edfu and Kom Ombo. After the quarried stone arrived at the building site, the bobbins, ropes and a crow-bar were used to moving the blocks towards their place in course of the wall (Figure 3(A), Figure 3(D)). It would be given dressing on any side that would later come into link with other stones. The stones of one course would be then placed together in a row and each individually cut along their sides, sometimes with irregular or deflector angles, and combined together by stone dowels in course of the wall (Figure 3(C)) [15], after the wall grow verti-

cally the workers reaching the top of the wall via mud brick ramps to dress the upper face of the blocks (**Figure 3(B)**), usually they used liquid mortar to joint the blocks together (**Figure 3(E)**).

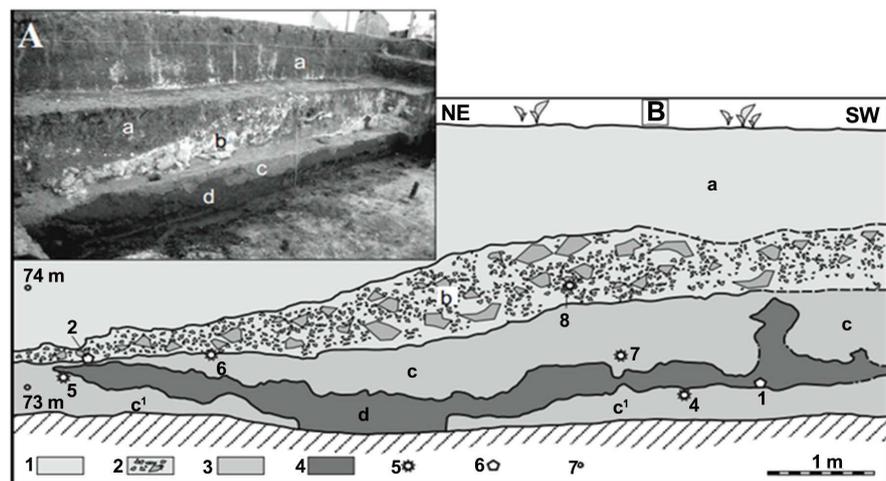
**Figure 4.** Shows a Trench at the second pylon of Amenhotep III temple, (A) Photo of the trench and (B) trench log. 1—soil rich in silt and organics brought by seasonal floods of the Nile (layer a), 2—destruction layer (b), 3—dense clay above (layer c) and below ( $c'$ ) the dike, 4—sand dike (layer d), 5—14C sampling locations, 6—ceramics sampling locations, 7—elevation mark of 74 m above sea level (after: Karakhanyan *et al.* 2010).

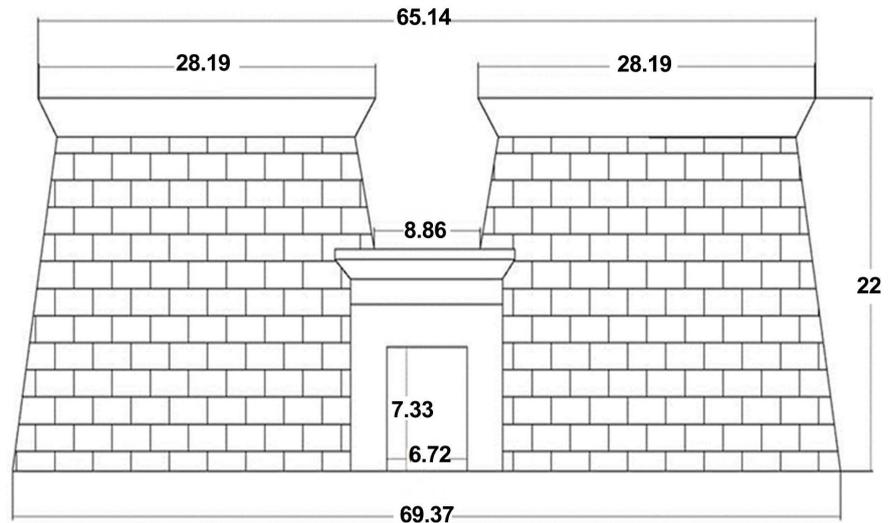
**Figure 5.** Shows the elevation façade of the first pylon of Ramessium temple.

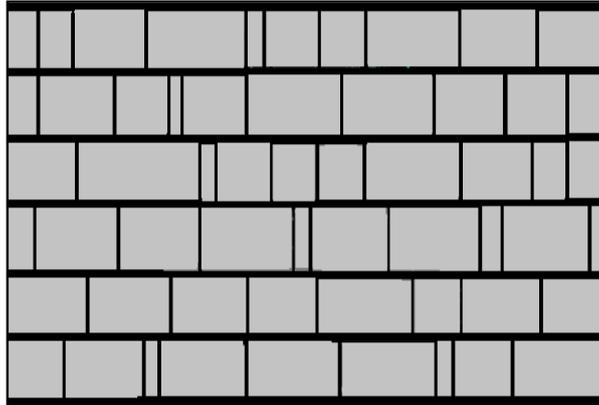
**Figure 6.** Shows construction style of courses used in the construction of the walls of Ramessium temple, where the arrows indicate the vertical joints between stone blocks.

3) The construction system: a) the stones of one course were placed together in a row and each individually cut along their sides and combined together by stone dowels. b) Channels were carved in all surfaces of courses of the wall; these diggings were filled with a bonding mortar to ensure that the blocks cohesion to each other. c) The field study showed that the construction courses of the first pylon are almost equal (**Figure 6**); the joints between the blocks were filled by fractures of small stones from the remains of the quarrying process.

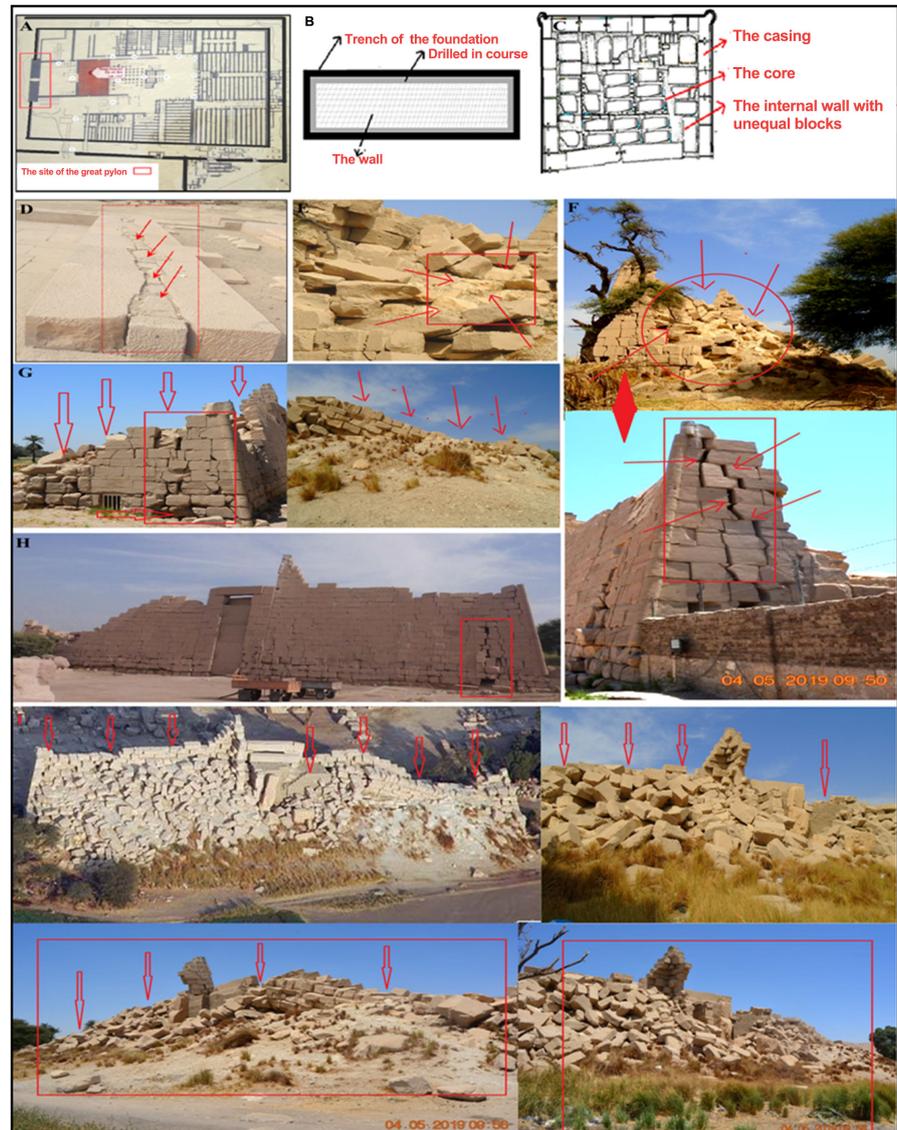
5) The eastern side of the pylon is totally ruined now, and the western side is suffering from different sizes, shapes of cracks, and partially loose of the wall. The northern side was destroyed more than the southern side of the pylon.

6) We are observed different weathering forms in the pylon's stones, such as loss of stone material, missing parts, erosion of stone surfaces, exfoliation, efflorescence of salt, Pitting, peeling, and granular disintegration.

**Figure 7.** Shows different deterioration symptoms of the first pylon of the Ramessium Temple (A) Shows site of the first pylon of the Temple (Horizontal Design). (B) Cross section of foundation of the pylon. (C) Longitude section of the first pylon. (D) (E) Shows building technique of the pylon, where show rubble and reused stones which used as a core for the pylon. (F) The southern side of the Pylon, where shows wide cracks in the wall and partial loss of the wall and separate of the blocks. (G) The northern side of the Pylon shows partial loss and more destroyed of this side. (H) The western façade of the Pylon shows different cracks, settlement in the southern side and partial loss in the upper parts of the façade. (I) The eastern façade of the pylon shows totally ruined.

The first Pylon of the Ramessium temple was founded on alluvial soil that is vulnerable to water, due to that the ancient builder didn't realize effect of the soil type on the foundations, in addition to using shallow trenches in foundation process. These the trenches were filled with loose rubble, chips of dressed stones and reused material because of may be technical or economical reasons (**Figure 7**).

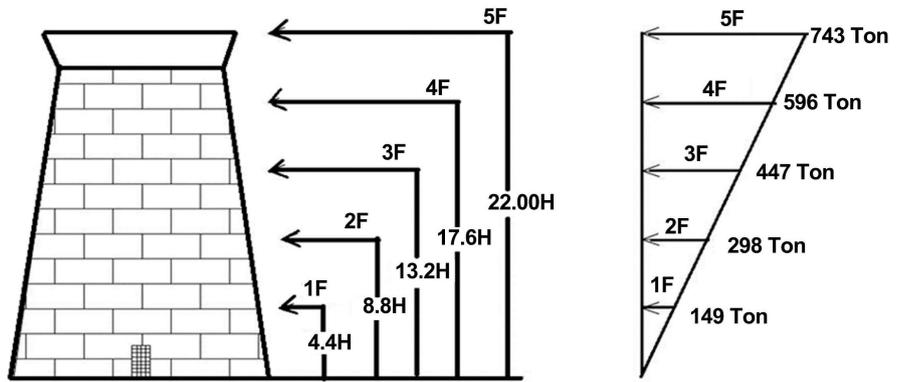
**Figure 8.** Shows the values of the equivalent horizontal forces affecting on the front façade of the pylon.

According to the previous Equation (1) and curve response spectrum, the values of the equivalent horizontal forces affecting on the front facade of the pylon are shown in **Figure 8**.

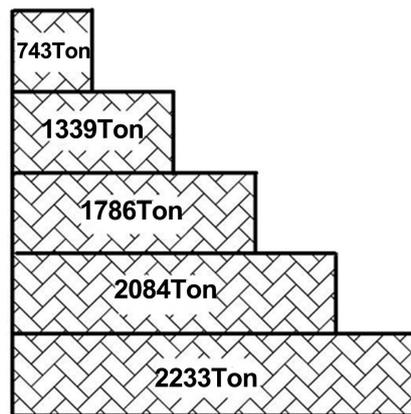
**Figure 9.** Shear force daigramme affecting on the front façade of the pylon.

When the pylon is exposed to horizontal earthquakes loads, the horizontal forces attempt to overturn the building, the pylon weight works to balance of the building against these forces, the shear force affecting on the pylon shows in, where we observe that value of the shear force increase in the lower parts of the pylon, which amounted to 2233 tons (**Figure 9** and **Figure 10**).

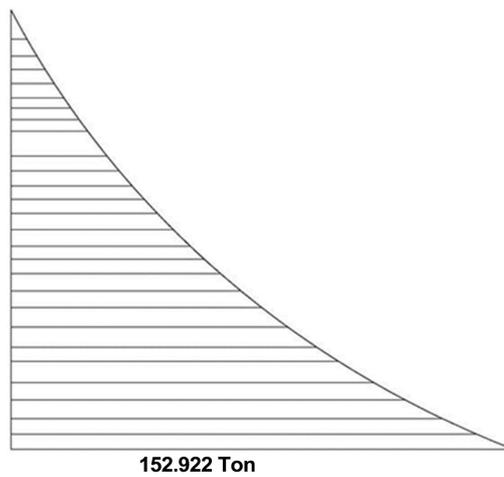
**Figure 10.** The moment curve affecting on the pylon, due to earthquakes loadings.

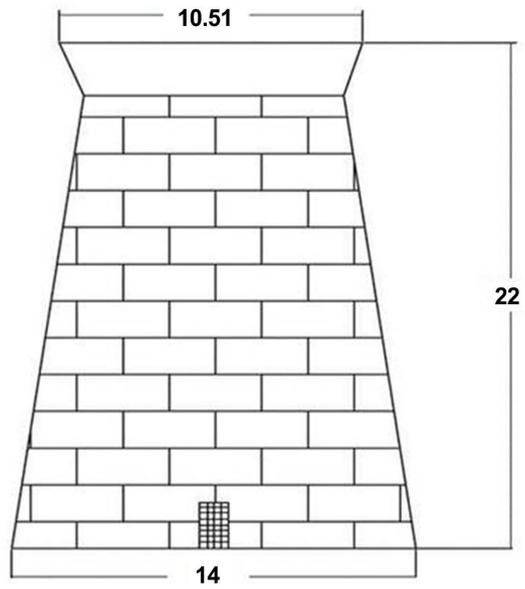
Figure 11. The side façade of the pylon.

- Side facade area =  $0.5 \times (14 + 10.5) \times 22 = 269.5 \text{ m}^2$  (**Figure 11**).

- The volume of the left part of the pylon ( $V$ ) = Side area  $\times$  Part length.  
 $= (269.5) \times (31.9) = 8490 \text{ m}^3$ .

The weight ( $W$ ) = Density ( $D$ )  $\times$  Volume ( $V$ ).  
 $= 1.9 \times 8490 = 16131 \text{ Ton}$ .

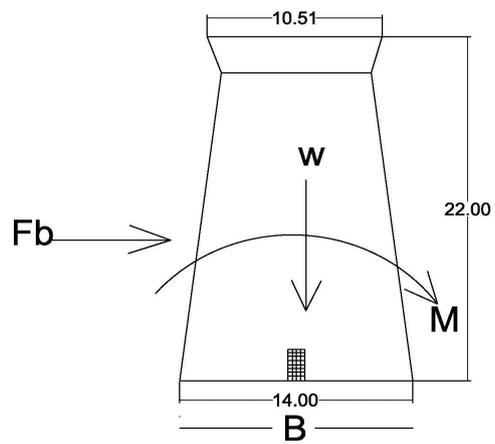
Figure 12. Visualize to check overturning.

$$\begin{aligned} M \text{ stability}/M \text{ overturning} &\geq 1.5 \\ 225.83/152.922 &= 1.47 < 1.5 (\text{Unsafe}) \end{aligned} \quad (2)$$

According to the Egyptian Code of Earthquake Loads,  $M$  stability/ $M$  overturning should not be less than 1.5 (**Figure 12**), so the pylon was not safe to withstand the earthquake forces, where the value of Equation (2) was less than the safety limit, as a result, the pylon collapsed.

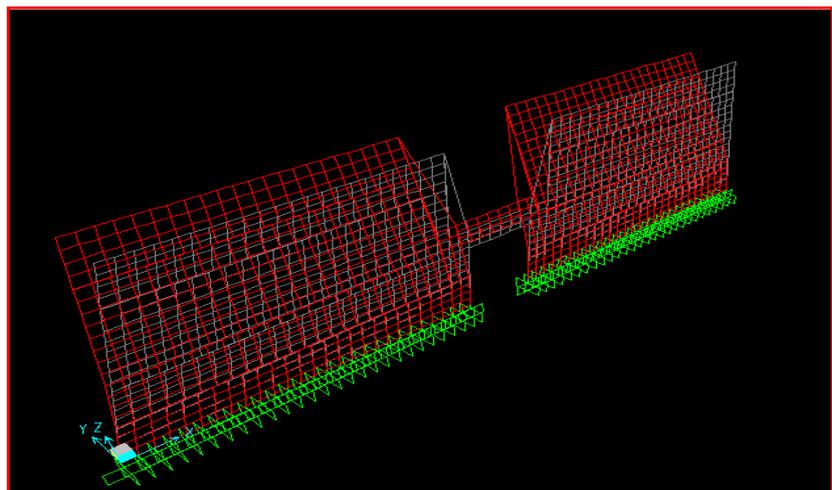
Figure 13. Horizontal displacement diagram in the direction of the axis (x-x).

3D finite elements used to understand the structural behaviour of the pylon under seismic loads. The resultant deformations are shown in **Figure 13**. Which represents the displacement values of the structure in the direction of the axis

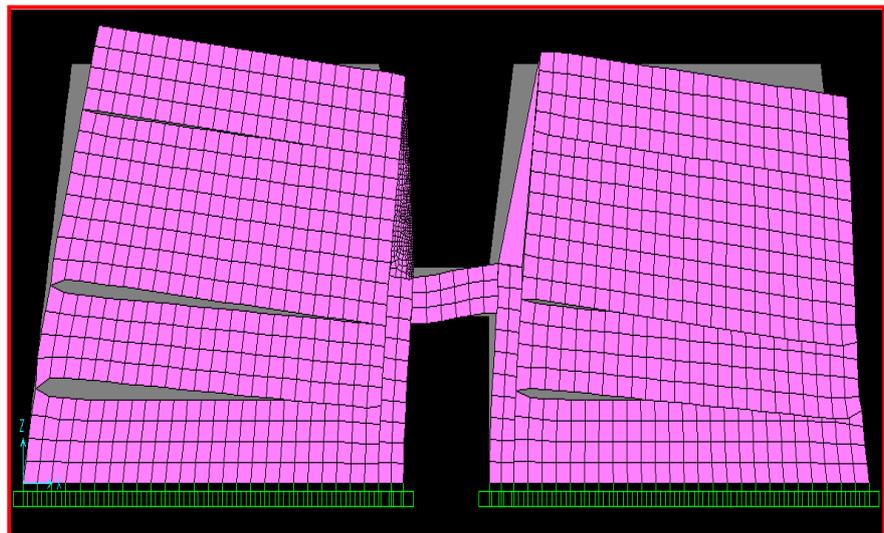
**Figure 14.** The horizontal displacement diagram in the direction of the axis (y-y).

After the structural analysis of the SAP program we set limits for the moment by the value of (*Mr*) that was taken out of Prokon program, where the largest values of (*Mr*) represent the areas subject to cracks and collapse as shown in **Figure 14**. The resultant deformations indicated that corners of the pylon are most of the places that have been exposed to the stresses more than the limit permissible (**Figure 15**).

After finishing the analysis of the pylon, the resultant deformations are shown in **Figures 14-16**, where **Figure 14** and **Figure 15** represent the structural analysis under seismic loads, and **Figure 16** represents the structural analysis under dead loads. The results indicated that the pylon subjected to horizontal displacement resulting from earthquakes stresses and vertical displacement of dead loads of the building.

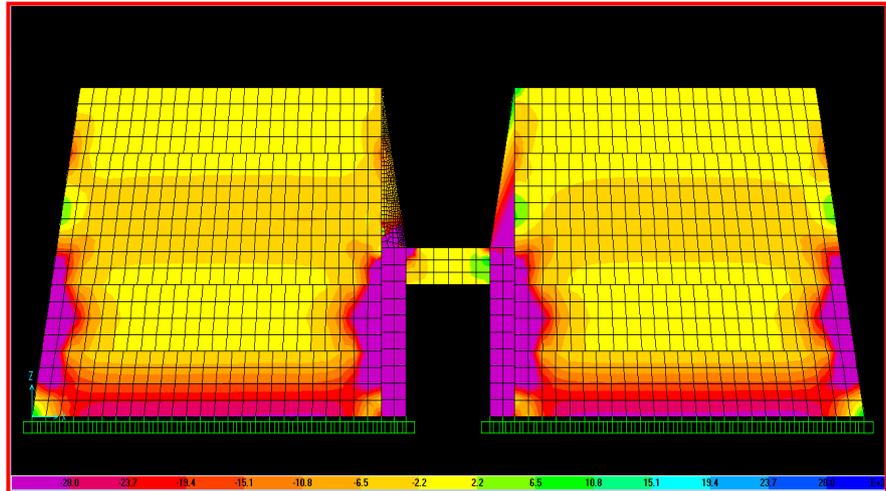
**Figure 15.** Resultant deformations of the great pylon of Ramesseum temple under seismic loads.

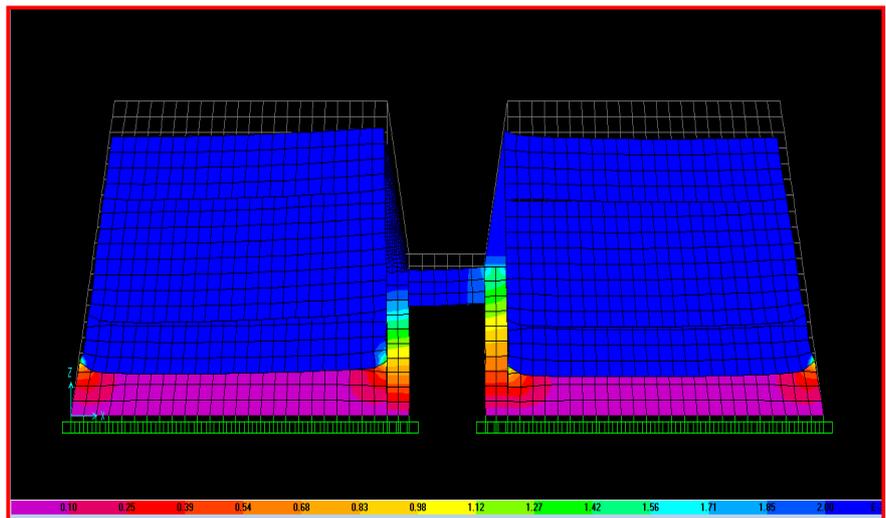
**Figure 16.** Resultant deformations of the great pylon of Ramesseum temple under dead loads.

3D finite elements used to understand the structural behaviour of the pylon under dead loads, the maximum vertical displacements diagram of the pylon under dead load is shown in **Figure 16**, it can be seen from resultant deformations that the vertical displacement have an increasing trend from sides and middle of the building.
