Double J Stent Mislocation—Case Report

Andreas P. Christodoulides, Theocharis KaraolidEs, Ziad Milad Ibrahim

Nicosia General Hospital, Nicosia, Cyprus Email: andreaschristodoulides1986@gmail.com, charikara@gmail.com

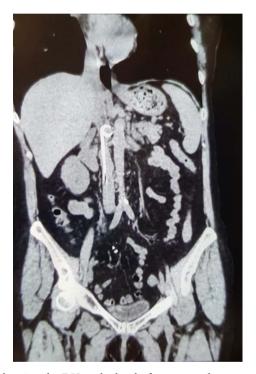
The dislocation was identified by a non-contrast CT scan that was performed two months later in order to organize further management. The proximal end of the stent appeared to be coiled in the supra-renal vena cava and the distal tip was in normal position in the urinary bladder [Figure 2]. The scan did not show hematomas.

Figure 2. CT scan showing the DJS at the level of supra-renal vena cava. Proximal curl is noted.

During cystoscopy, the integrity of the bladder wall was confirmed before retrieving the DJS. The coiled stent was encountered in the bladder and was successfully withdrawn without obvious complications. Retrograde pyelogram was performed which revealed integrity of the urinary tract wall, without extravasation of contrast. After the procedure, the patient was clinically well but presented tachycardia a few hours later, with normal blood pressure and no other symptoms. CT angiography revealed limited contrast leakage at the perforation site and no signs of internal bleeding. The heart rate normalized spontaneously. The
