Scientific Investigation of the Paintings from the Agarbiciu (Cluj County) Wooden Church

How to cite this paper: Măruțoiu, C., Bratu, I., Nemeș, O.F., Nemeș, D., Neamțu, C., Moldovan, Z., Tia, T., Udrea, I. and Tigae, C. (2020) Scientific Investigation of the Paintings from the Agarbiciu (Cluj County) Wooden Church. *Journal of Minerals and Materials Characterization and Engineering*, 8, 177-196.

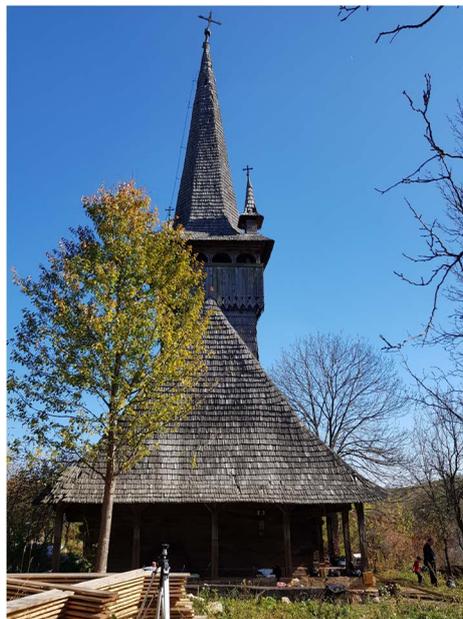
Figure 1. The Agarbiciu village wooden church.

The Agarbiciu village wooden church (**Figure 1**) is situated in Capusu Mare parish, Cluj county and has The Holy Trinity and Saint Michael and Gabriel Archangels as titular saints, who are the spiritual protectors of Romanians from Ardeal region. The church is situated in the old village cemetery, on the left flank of Agarbiciu valley. The church is built on top of a stone foundation extracted from a local quarry. The walls are built from oak beams horizontally disposed in a Blockbau system, fastened with swallow tail style eyelets. It is a large, well-proportioned edifice with 10 m × 6.5 m dimensions and positioned on a West-East axis ending with an unhooked altar apse.

The southern and western flanks of the church are rounded by an open porch. The shingle covered roof is guarded by a bell tower which rises high above the narthex and its crest is flanked by four small turrets. The painting was made by Dimitrie Ispas from Gilau village in two stages: the altar and the nave in 1801 and the narthex and southern facade in 1818. This arises from the two inscriptions above the vestibule separating the nave and narthex. In the first inscription you can find the year of painting, the names of the painter, archpriest, priest (bishop name missing) and the ruling emperor name accompanied with various felicitations and wishing and the fact that the expenses were covered by the villagers (**Figure 2**).

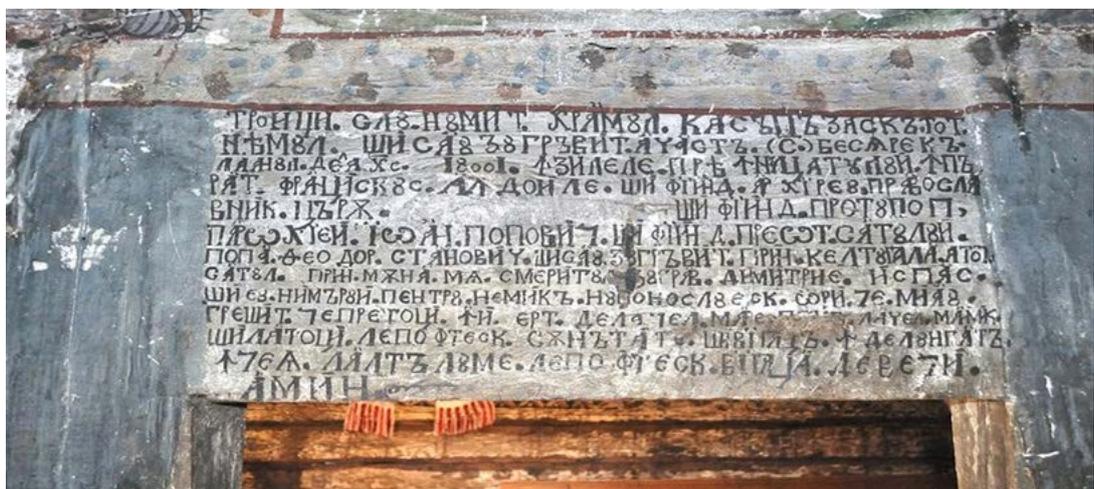
Figure 2. The first inscription above the vestibule separating the nave and narthex.

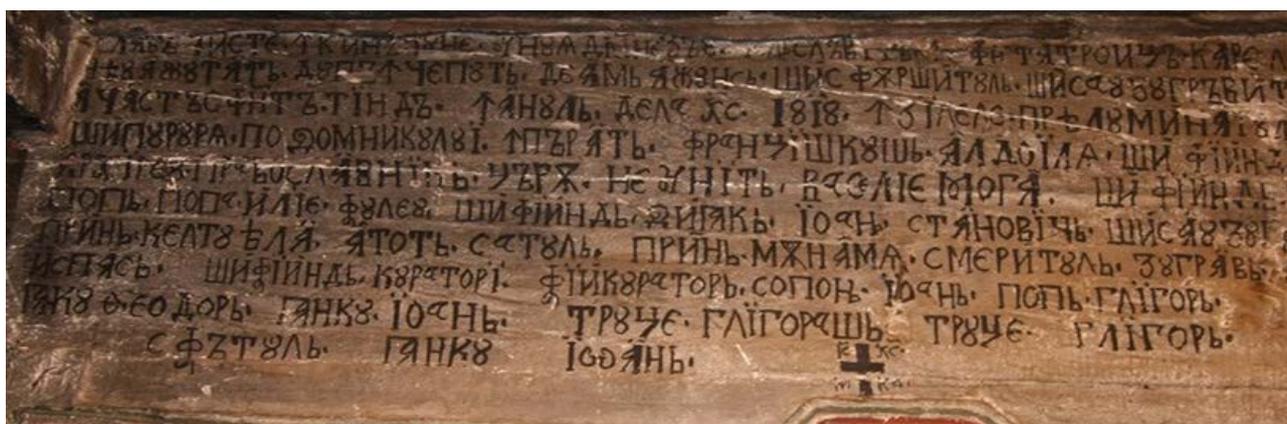
Figure 3. The second inscription above the vestibule separating the nave and narthex.

In the second inscription, you can find the year of the painting, the names of the painter, archbishop, archpriest, priest, curators, the name of the ruling

emperor and again the fact that the expenses were covered by the villagers (**Figure 3**) [1]-[6].

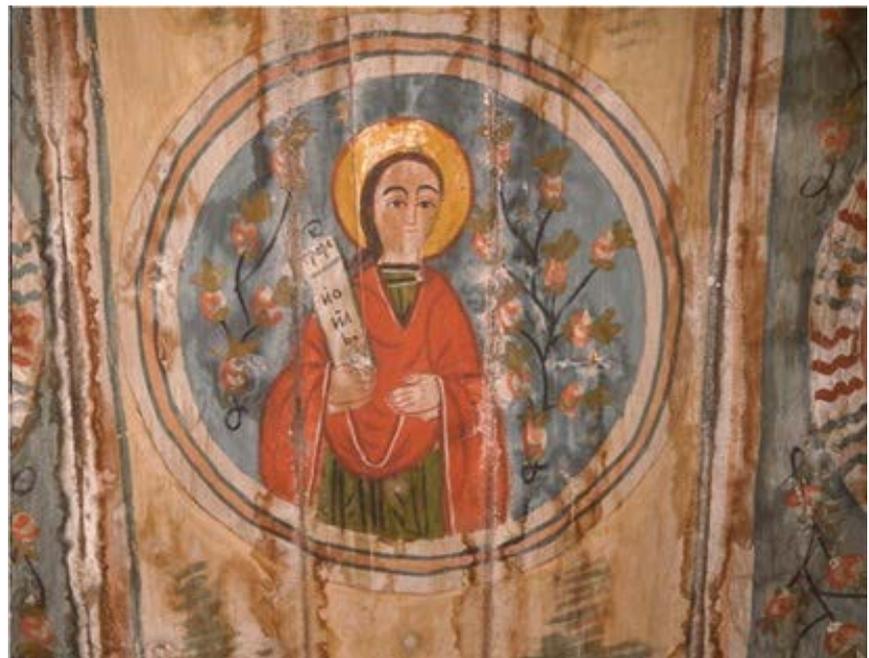
Figure 6. The painting from narthex roof of the wooden church.

Nondestructive analyses were performed using portable devices by approaching them to the paintings (**Figure 4**—image from altarpiece; **Figure 5**—image from nave dome; **Figure 6**—image from narthex roof).

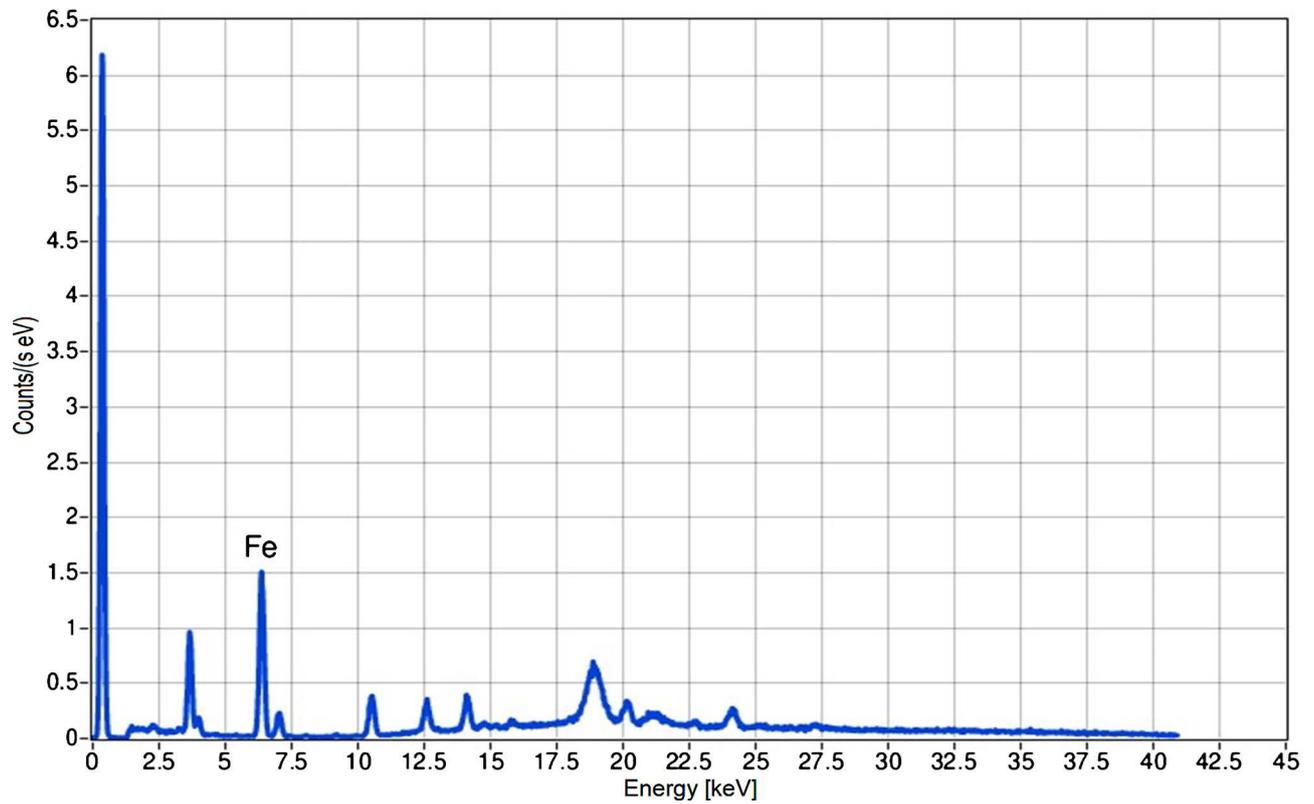
Figure 7. XRF spectrum for red colour from nave. The iron demonstrates de presence of iron oxide.

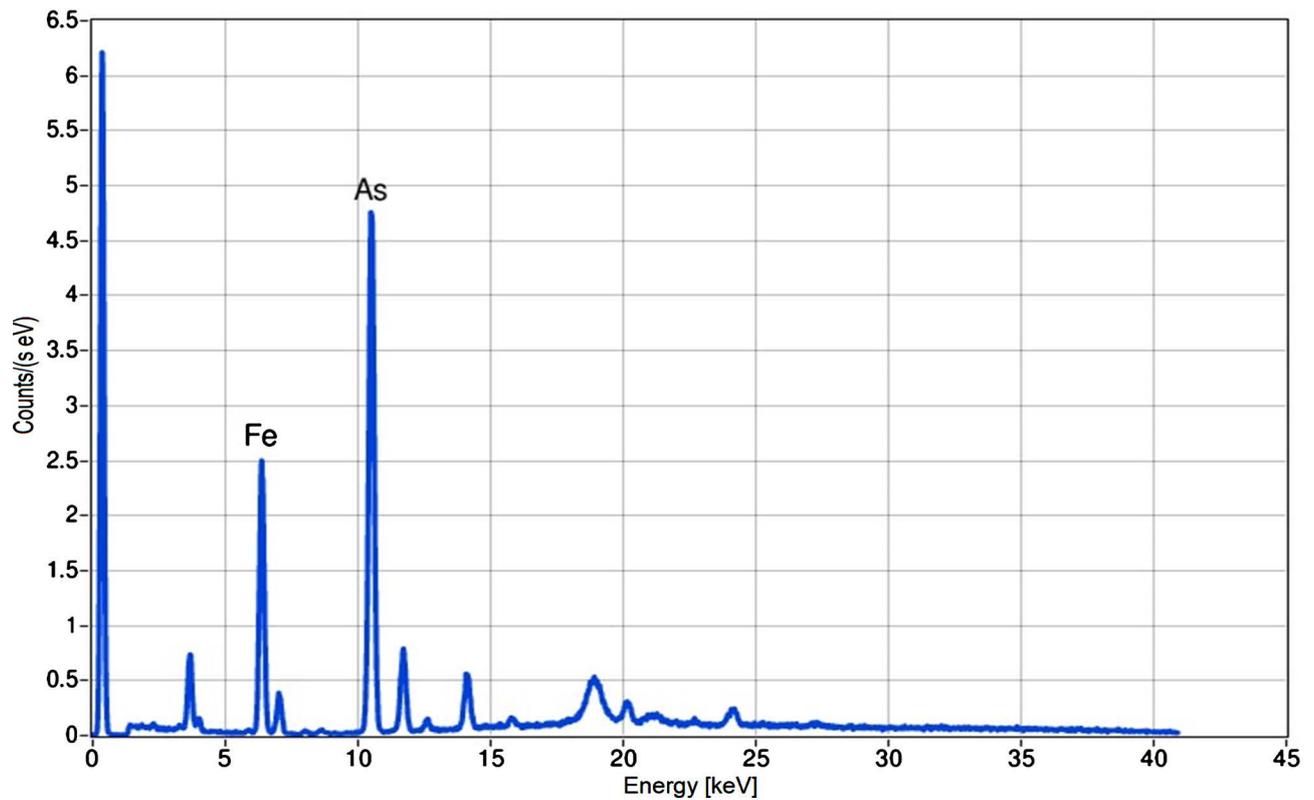
Figure 8. XRF spectrum for red colour from nave (Iron red + Arsenic red mixture). The presence of As red and iron oxides demonstrates the composition of red pigment.

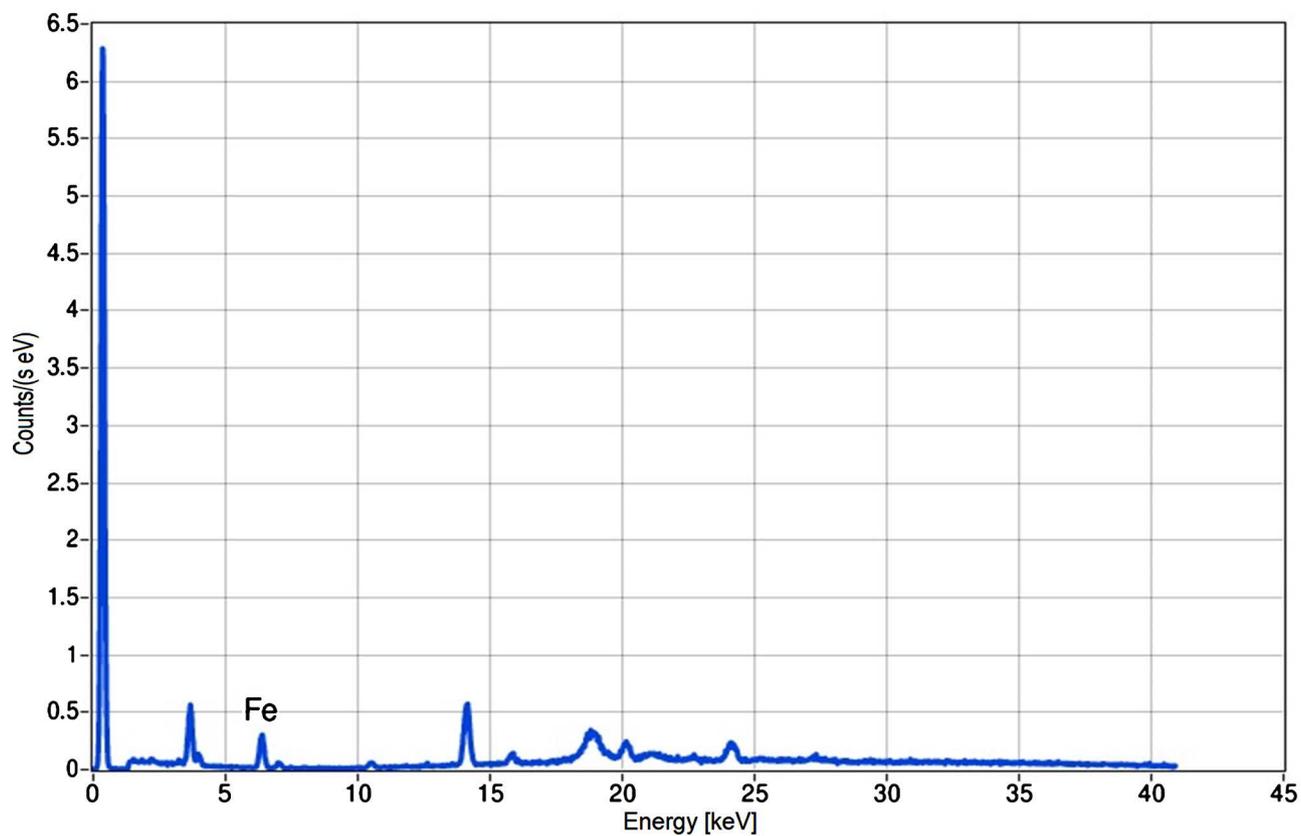
Figure 9. XRF spectrum for black colour from nave. The black pigment contained carbon and iron oxide.

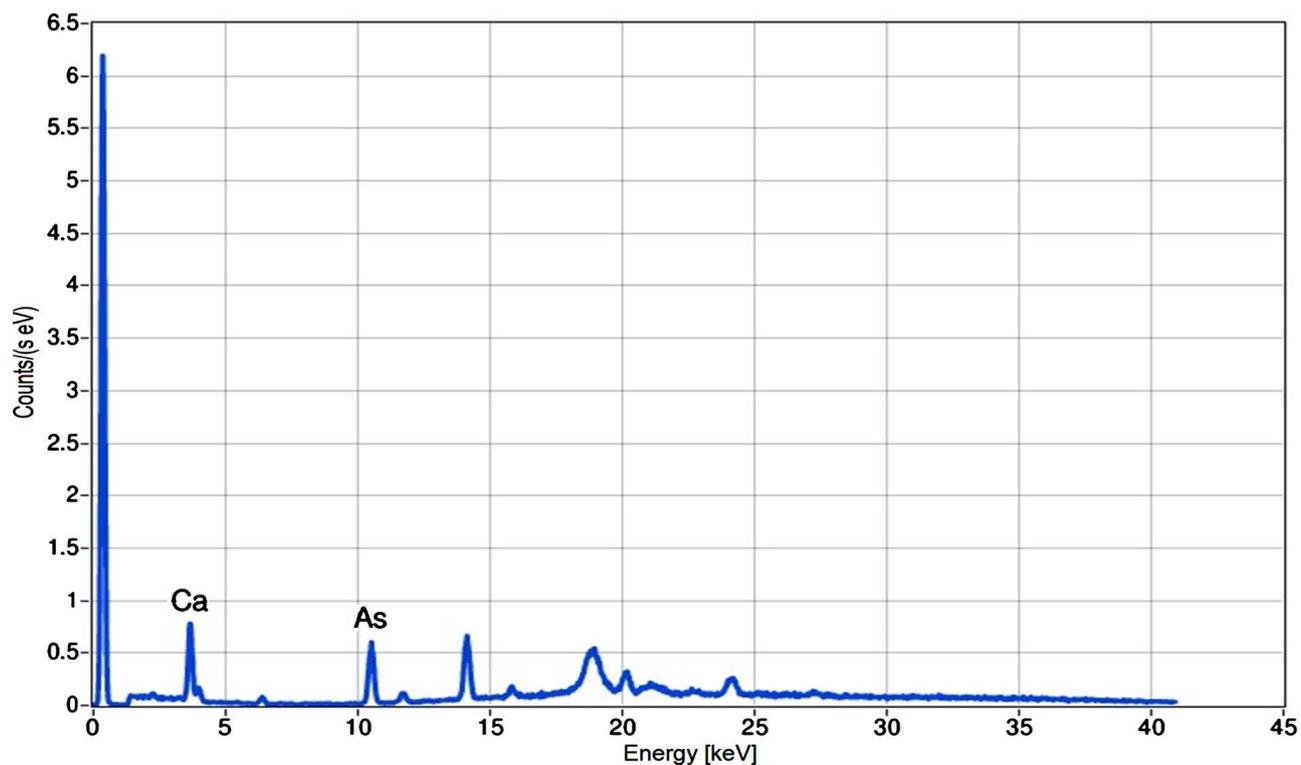
Figure 10. XRF spectrum for yellow colour from aura (nave). The yellow color was done by the presence of orpiment (As_2S_3), the presence of Ca was due to the white calcite.

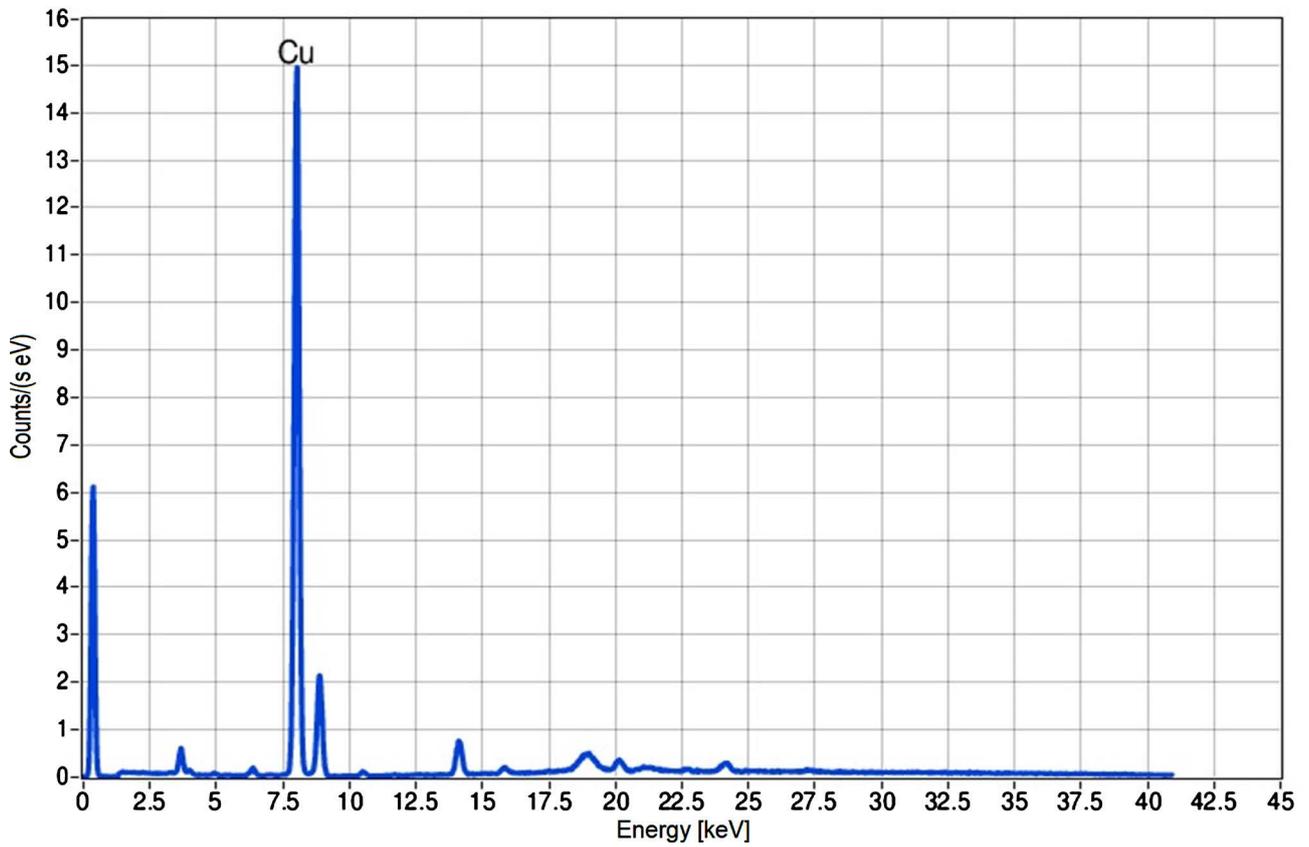
Figure 11. XRF spectrum for green colour from nave. The copper demonstrates the presence of malachite as green pigment.

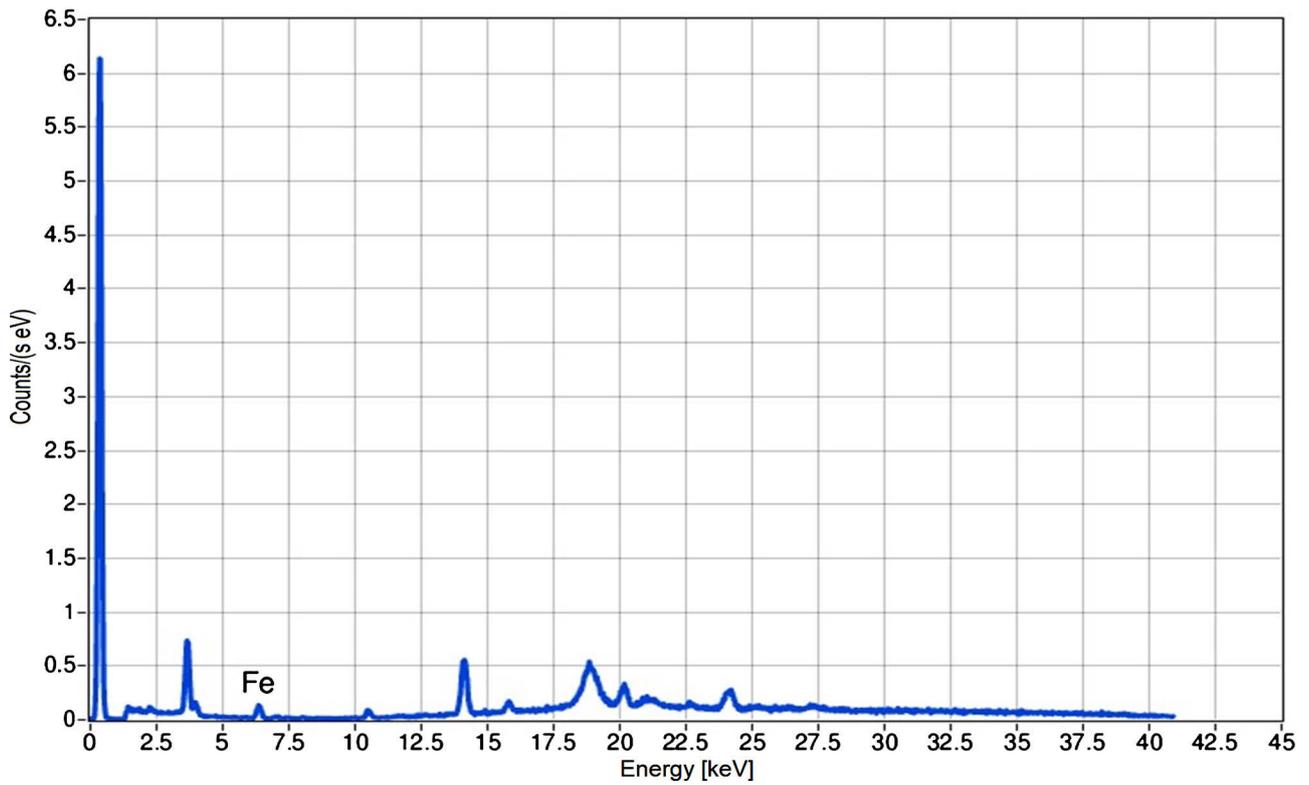
Figure 12. XRF spectrum for blue colour from nave. The iron demonstrates the traces of Prussian blue pigment.

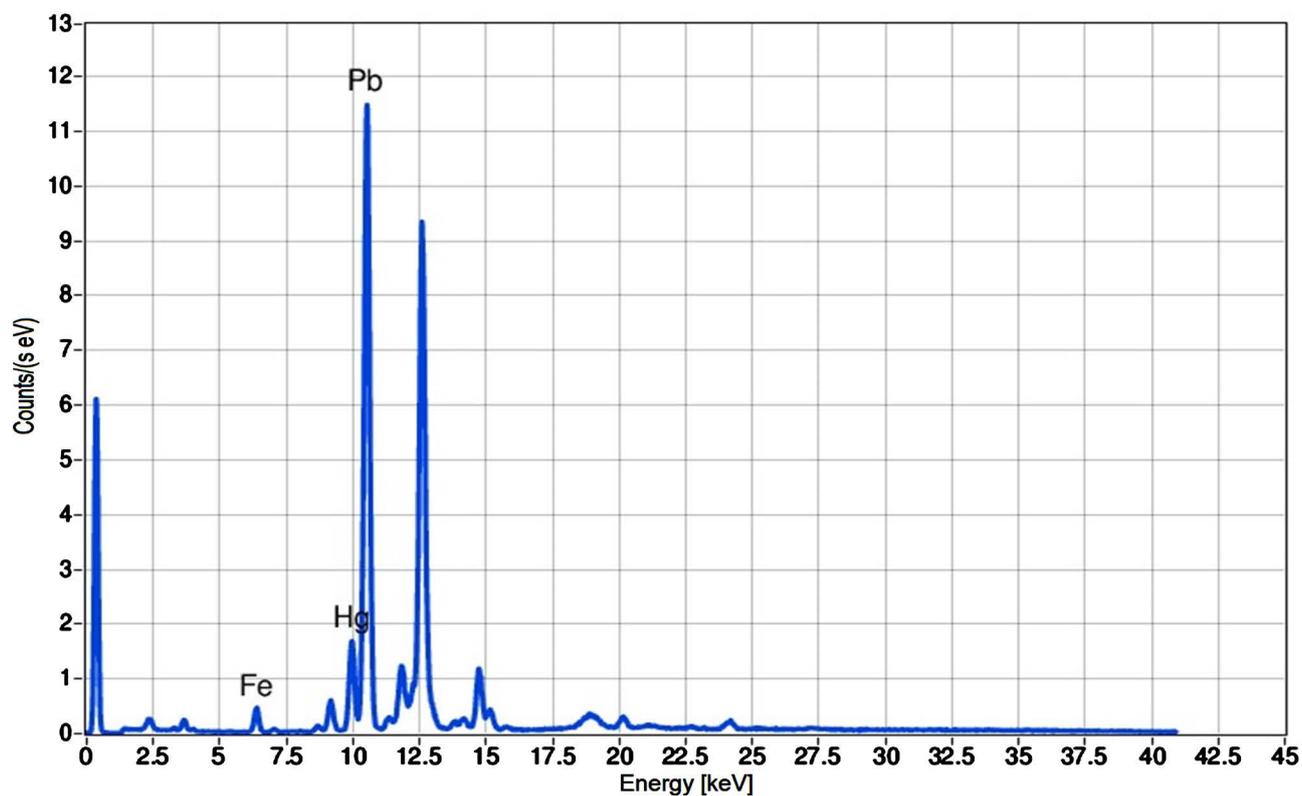
Figure 13. XRF spectrum for red colour from narthex (mixture of Fe, Pb and Hg red). The red pigment contained a mixture of iron and lead oxides and mercury sulphide.

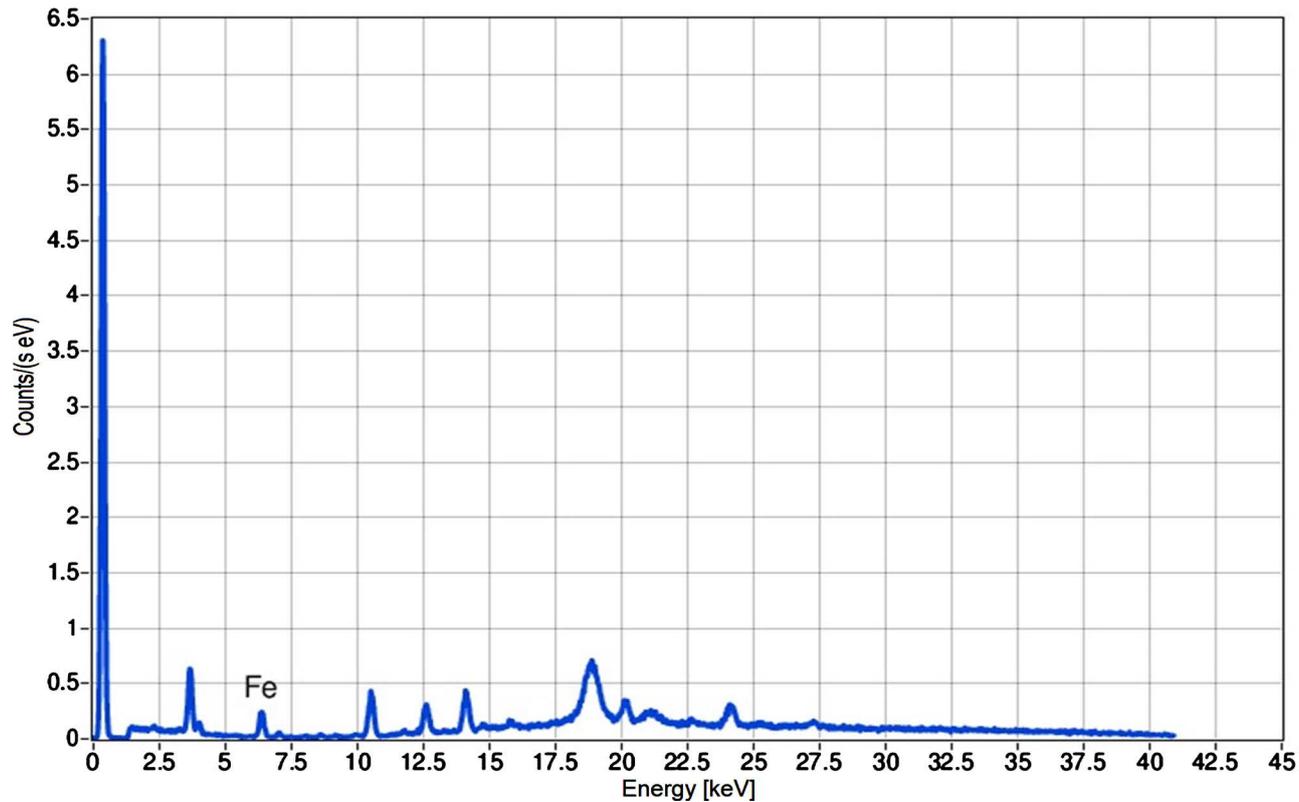
Figure 14. XRF spectrum for black colour from narthex. The black pigment contained carbon and iron oxide.

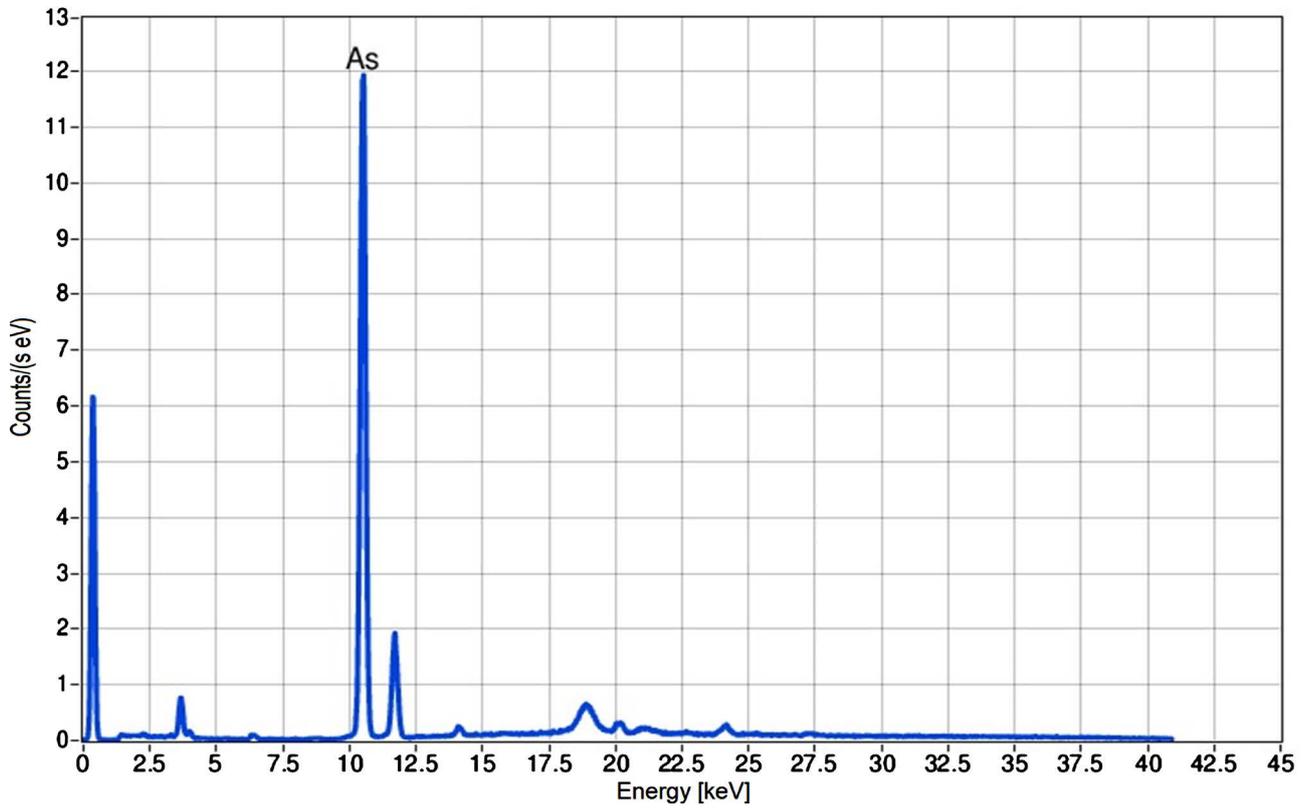
Figure 15. XRF spectrum for yellow colour from aura (narthex). The yellow pigments are based on orpiment (As_2S_3).

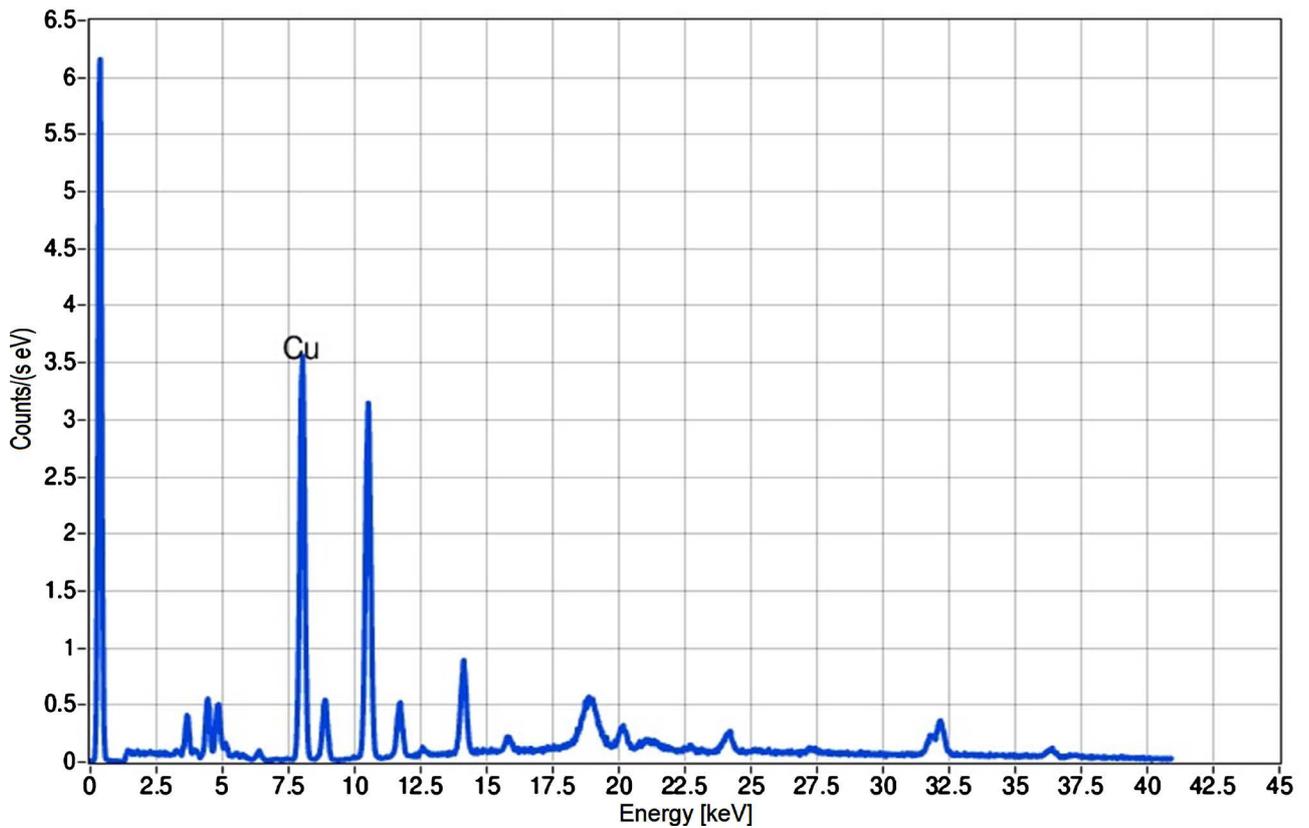
Figure 16. XRF spectrum for green colour from narthex. The presence of malachite is also demonstrated.

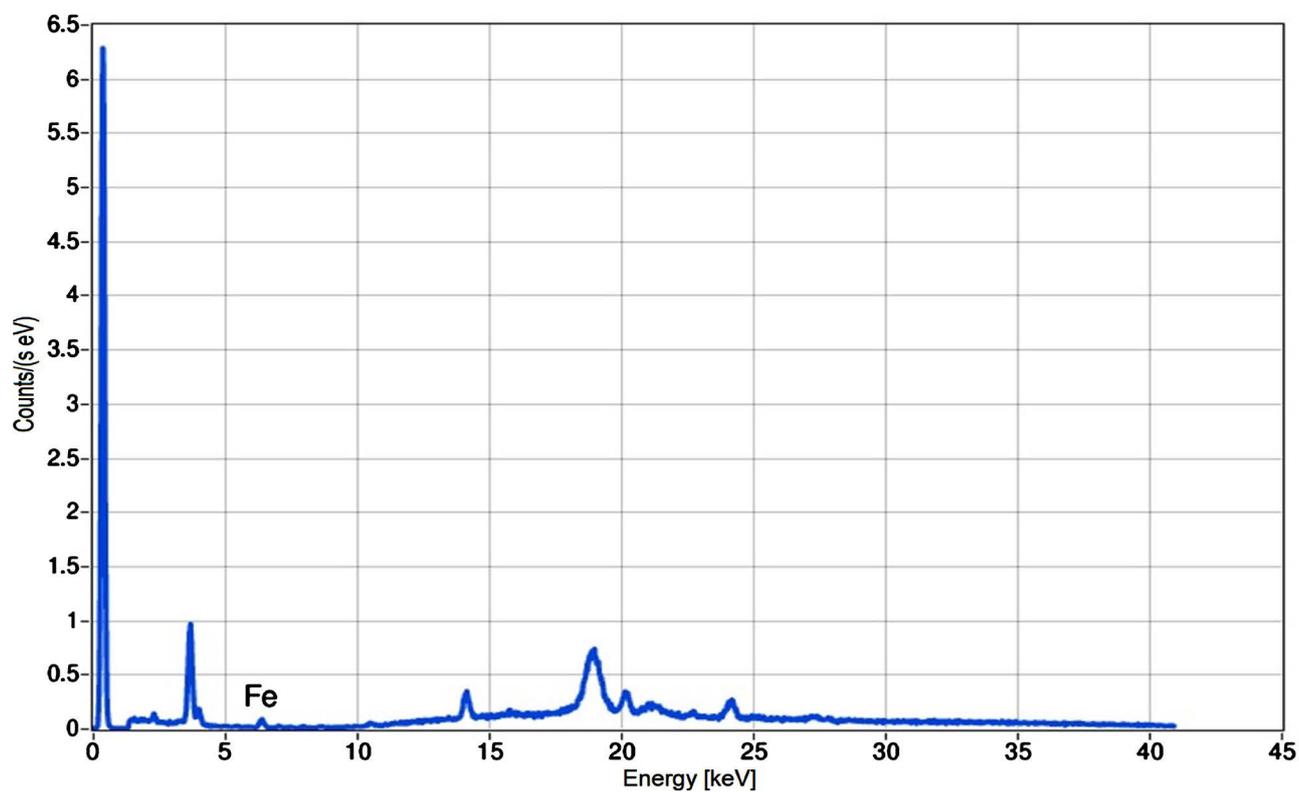
Figure 17. XRF spectrum for blue colour from narthex. The Prussian blue pigment is demonstrated by the iron presence in the XRF diagram.

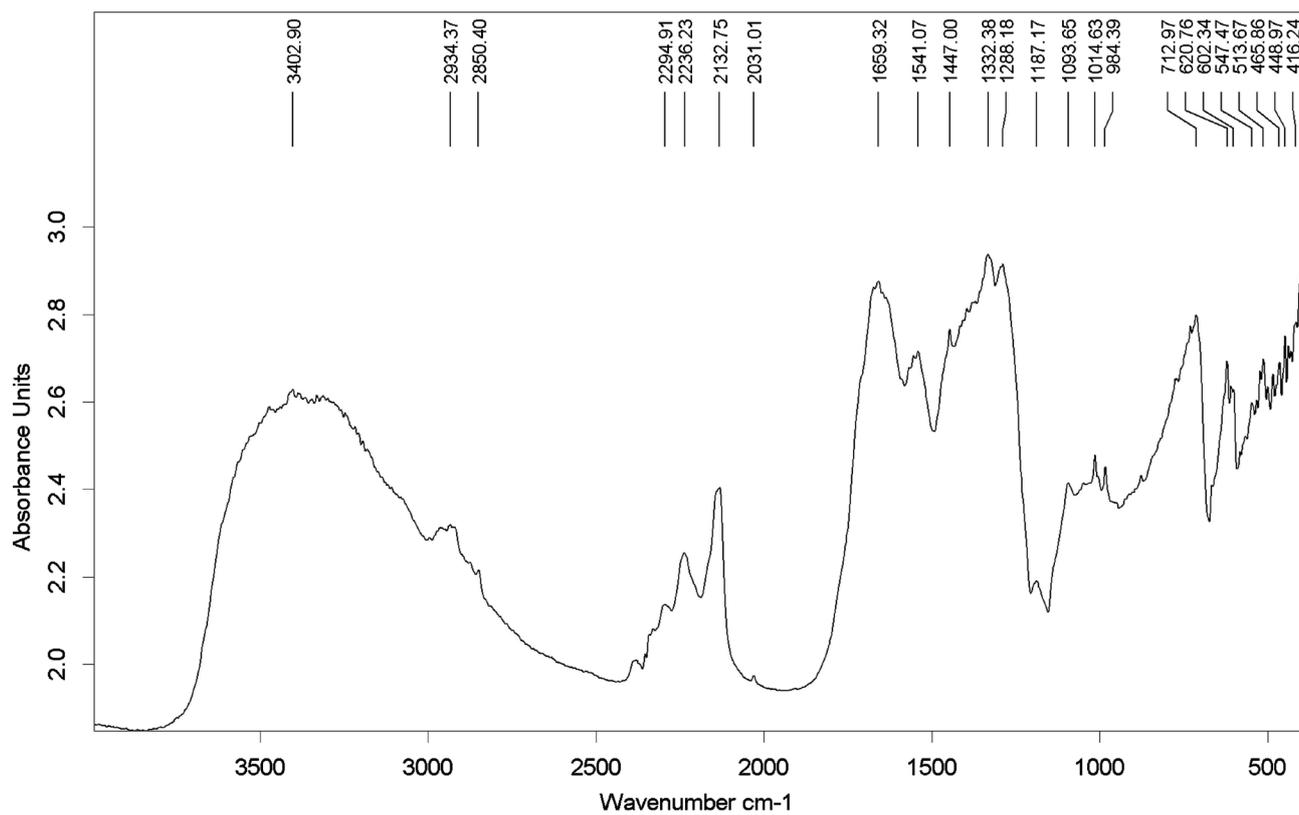
From the reflectance spectrum (**Figure 18**)—one can identify the presence of Prussian blue (2132.75 cm^{-1}), calcium carbonate (1447 cm^{-1}), collagen (1288.18 cm^{-1} and 712.97 cm^{-1}), egg yolk protein (1541.07 cm^{-1}), gypsum 3403 cm^{-1} , 621 cm^{-1} , spectral domain 4000 - 400 cm^{-1} .

Figure 18. FTIR Spectrum (non-destructive) for blue pigment.

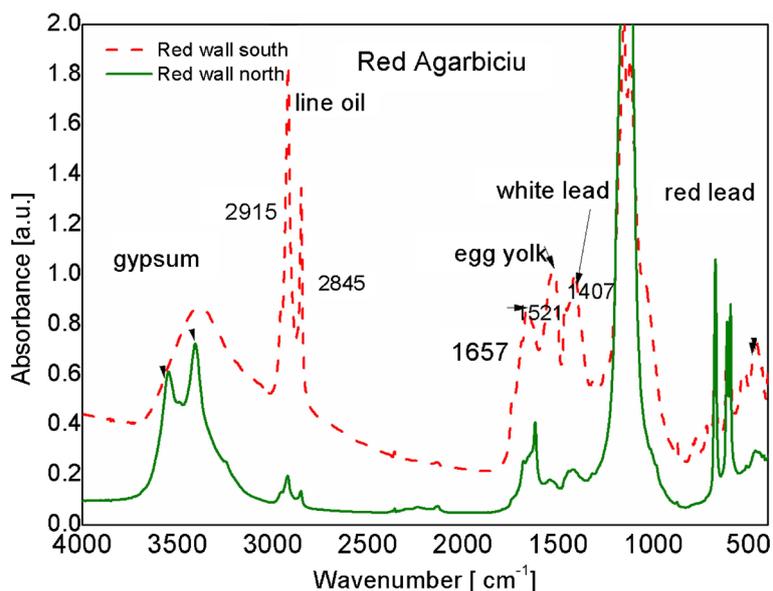
the southern and northern wooden walls of the church are presented in **Figure 19**.

Figure 19. FTIR absorption spectra of red painting material.

From both destructive and non-destructive FTIR analyses the following materials were identified: ground-gypsum, white chalk, Prussian blue; binder-egg yolk, linseed oil (tempera), animal glue.

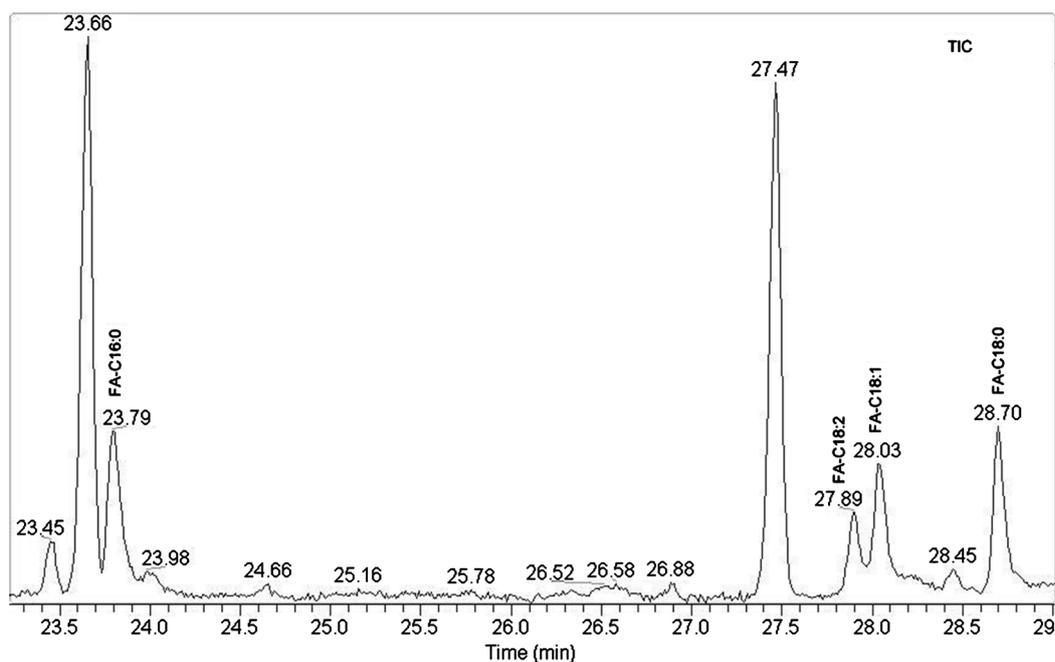
We used a simple GC/MS method for the identification of specific molecular biomarkers of drying oils and lipids used in old art works. Common molecular biomarkers are individual fatty acids. The relative concentration of fatty acids is a very useful indicator for identification of glycerolipids [14] [15] [16]. The procedure was applied for the characterization of two old paint microsamples. The GC/MS chromatogram (TIC) of ethylated palmitic, linoleic, oleic and stearic fatty acids are shown in **Figure 20** and their relative concentrations are presented in **Table 1**.

Figure 20. GC/MS Chromatogram (TIC) of: the Palmitic acid ethyl ester (C16:0), the Linoleic acid ethyl ester (C18:2), the Oleic acid ethyl ester (C18:1) and the Stearic acid ethyl ester (C18:0).

From **Table 1**, it results in that the ratio P/S is 1.02 for Sample 1 and 1.06 for Sample 2. According to the P/S value, it was suggested that linseed oil was used as

a binder. The presence of traces of cholesterol leads to conclusion that small quantity of egg can be also present in the binder material. Our results agree with the results reported earlier.

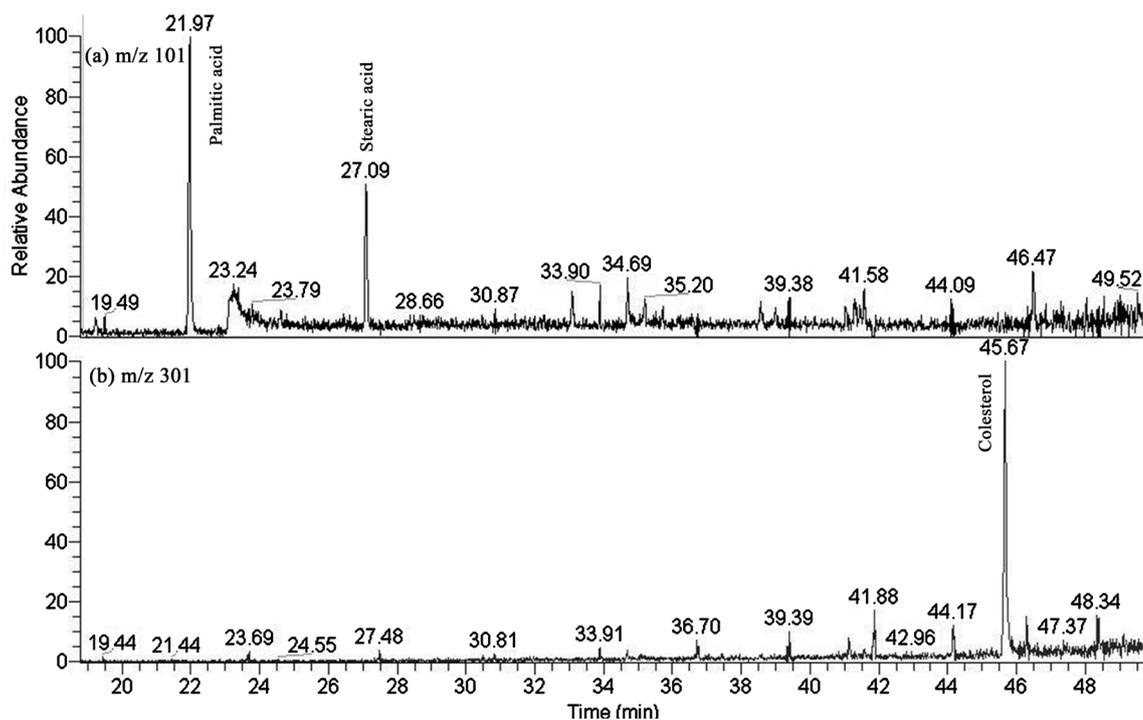
The compounds detection from the “Agarbiciu green and binder” sample, based on selected ions (Figure 21): (a) m/z 101, palmitic and stearic acids; (b) m/z 301, cholesterol. The detected compounds are specific to vegetable oils and egg yolk.

Figure 21. GC/MS chromatogram on selected ions: m/z 101 (palmitic and stearic acid) and m/z 301 (cholesterol).

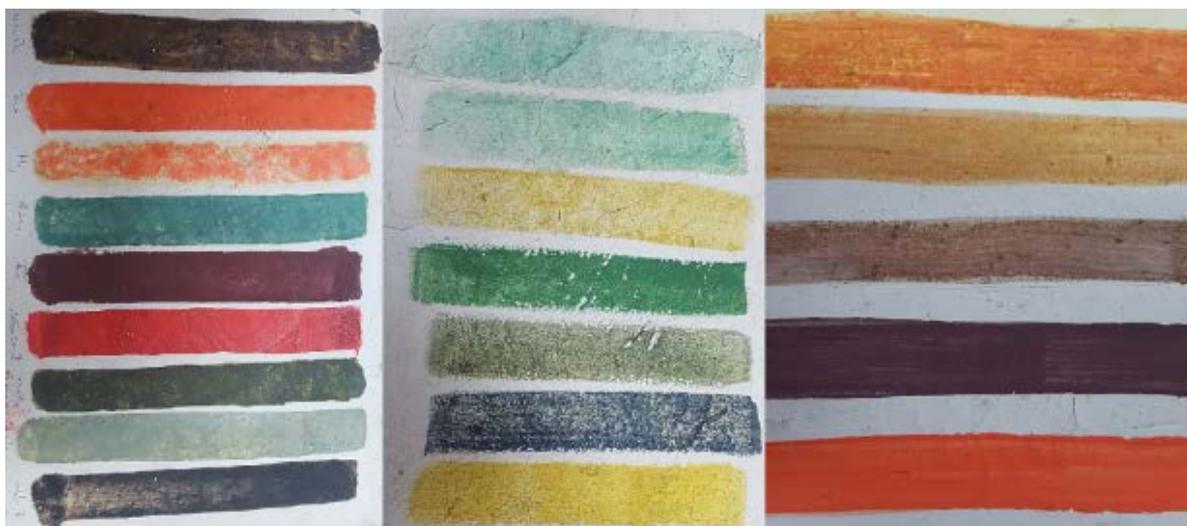
Figure 22. Pigments obtained on the basis of the physico-chemical analyses.

Following the physicochemical analyzes described in the previous chapter, the pigments used for the church interior painting can be obtained in the laboratory (Figure 22) digitized and preserved digitally.

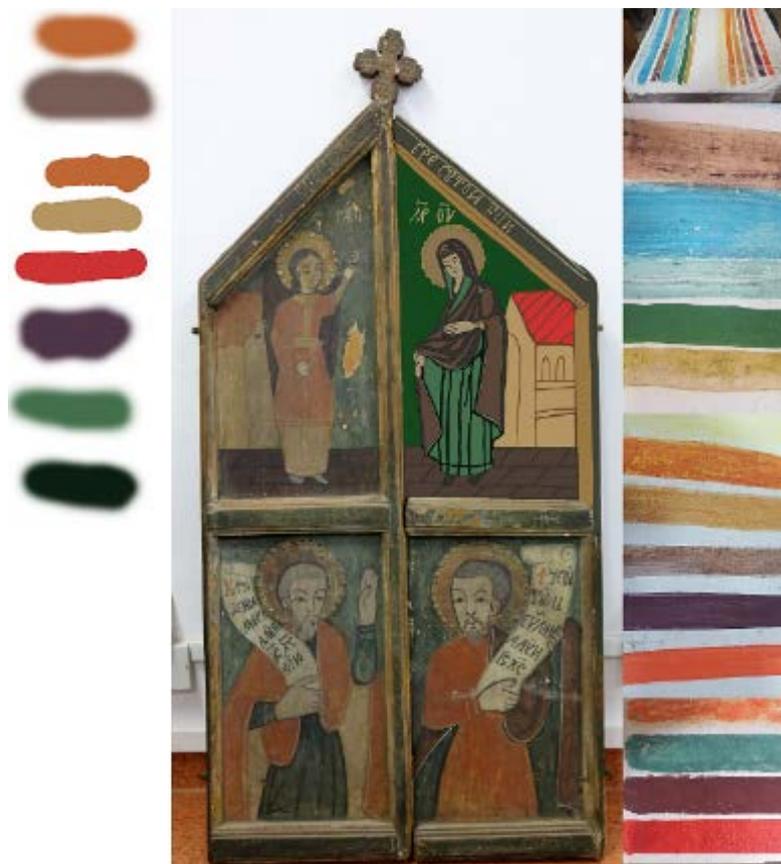
Figure 23. The digital repainting.

The pigments can be used in the process of digital repainting to eliminate the effect of time and other factors that degraded the painting layer (**Figure 23**).

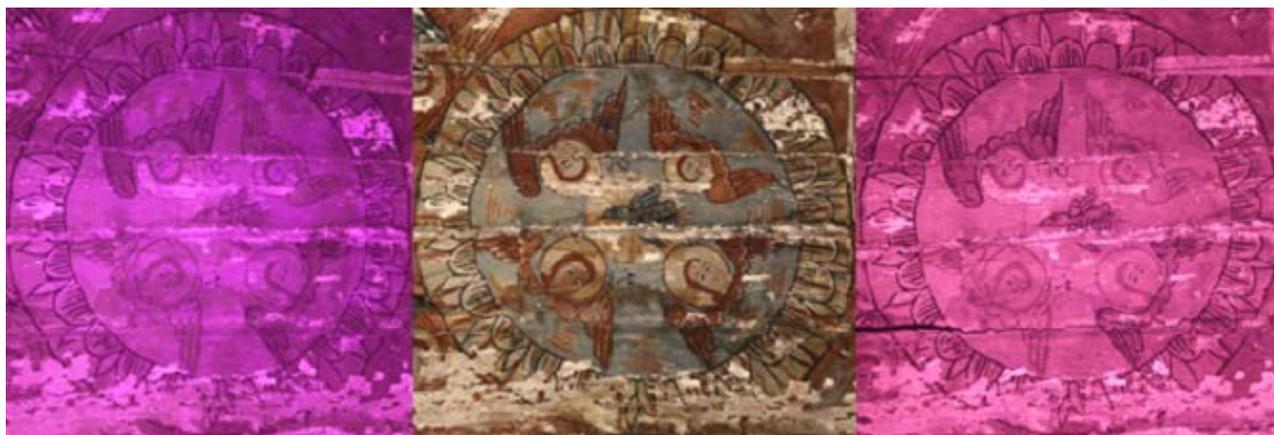
The documentation of the current preservation status of the painting layer has been made digitally using detailed photography within the visible spectrum, IR and UV (**Figure 24**).

Figure 24. Detailed photography documentation within the visible spectrum, IR and UV.

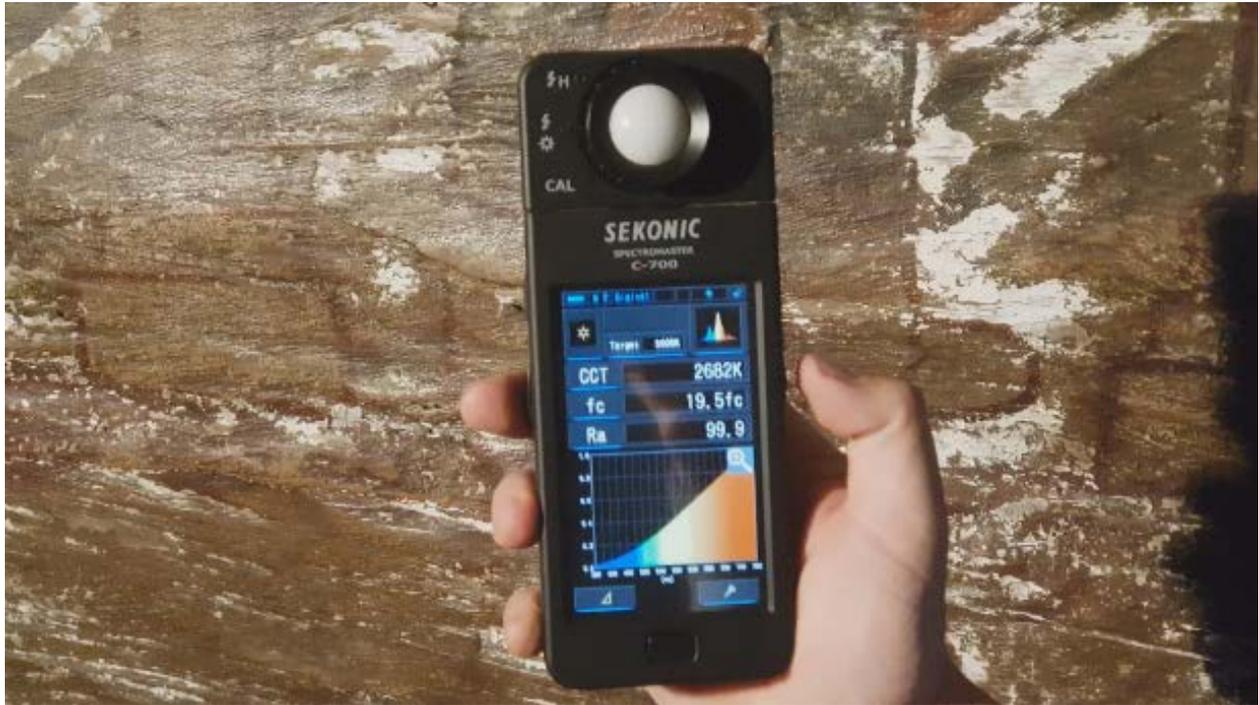
The photographic documentation was done using professional equipment (Canon 5DSLR, 50 Mpx), the light was measured and recorded every 10 minutes using a spectrometer (Sekonic C7000) (**Figure 25**), the acquired data will be archived together with the pictures in RAW file format.

Figure 25. Parameter measurement during the photographic documentation inside the Wooden Church.

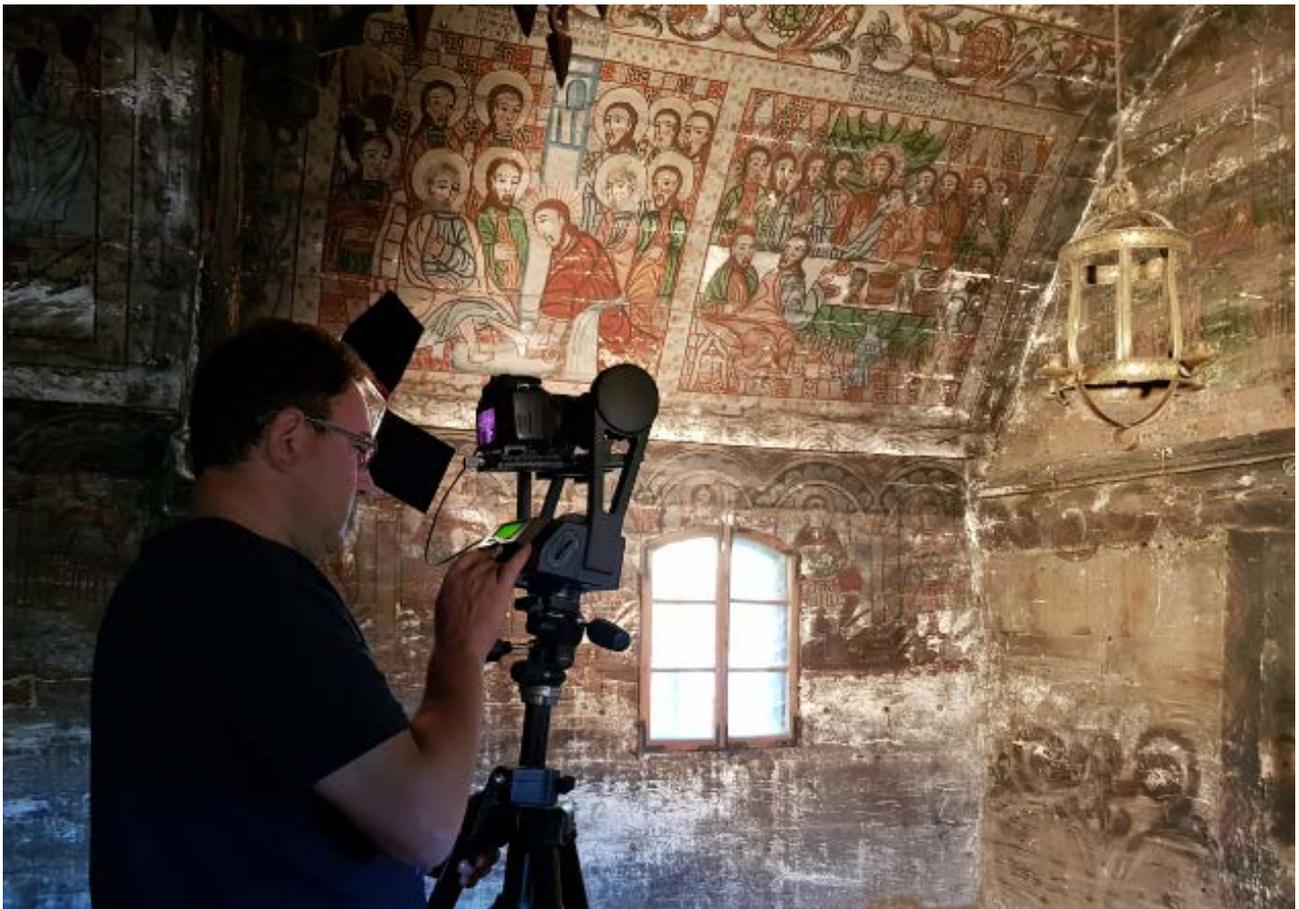
The interior has been photographed in 360° using an automatic photography system (Giga Pan—**Figure 26**), the shooting systems enables high resolution photography by combining multiple images of 50 Mpx each with an overlap of 10% - 15%.

Figure 26. 360° photography of the church's interior.

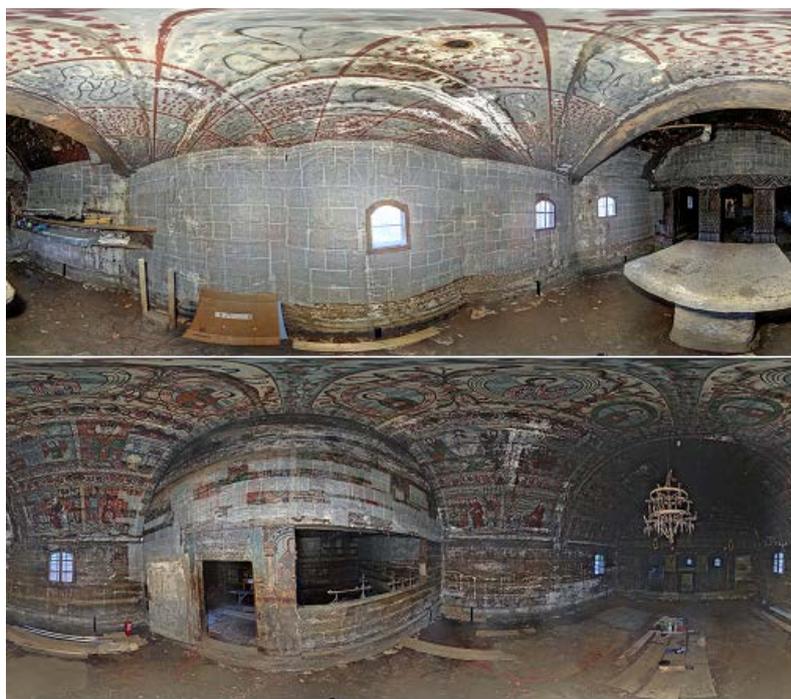
A set of HDR image (**Figure 27**) was obtained using the Z + F 5010X terrestrial laser scanner. This set enables the compositing and tone-mapping of images to extend the dynamic range capability.

Figure 27. HDR images with the interior of the wooden church.
