Scientific Investigation of the Paintings from the Agarbiciu (Cluj County) Wooden Church

How to cite this paper: Măruțoiu, C., Bratu, I., Nemeș, O.F., Nemeș, D., Neamțu, C., Moldovan, Z., Tia, T., Udrea, I. and Tigae, C. (2020) Scientific Investigation of the Paintings from the Agarbiciu (Cluj County) Wooden Church. *Journal of Minerals and Materials Characterization and Engineering*, 8, 177-196.

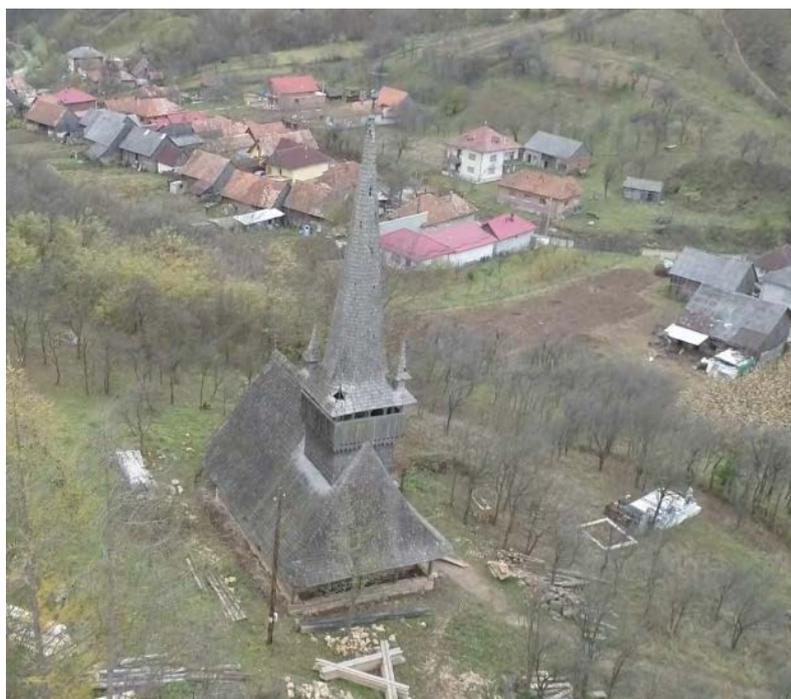
To record the exterior conservation status of the wooden church, a UAV was used to inspect the tower and roof structure. Based on the architecture of the wooden churches the exterior of the church tower is hard to inspect with traditional equipment. The church exterior has been recorded with a 4 k camera (**Figure 28**) to enable the generation of the 3D model.

Figure 28. Using UAV in the digital documentation of the conservation status.

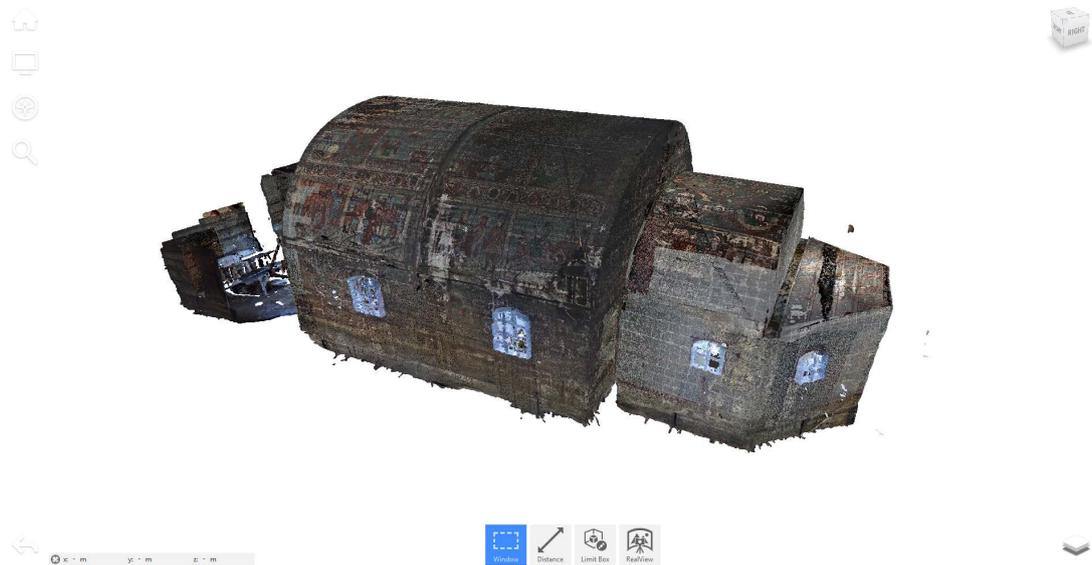
Figure 29. Using UAV in the digital documentation of the conservation status.

The interior has been 3D scanned using the Z + F Imager 5010× terrestrial scanner, the model obtained has a resolution of 1 mm, the texture has also been acquired and mapped to the 3D scanned model (Figure 29).
