Field Investigation on Anthropogenic Impacted Lowland Riparian Zones

ABSTRACT

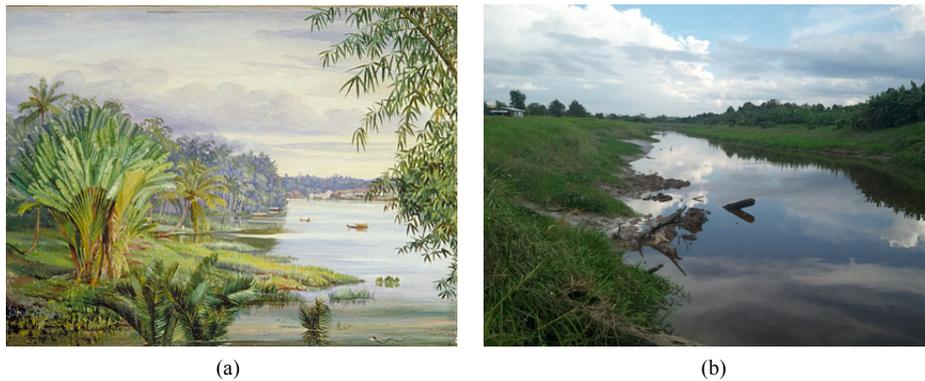
Figure 2. Riparian Zones, (a) view of Sarawak River (1880s)^a and (b) view of Maong River (2012).

The remnants of riparian zones along Maong River are taking over by secondary growth extending 50 - 100 m from the river banks (see **Figure 2(b)**). For comparison, the 100-year old painting in **Figure 2(a)** is showing the primary growth of tall nipah palms. Apparently, in the late 1880s where human settlement of colonial era was significant, grasses appeared in the painting after human clearing of lands.

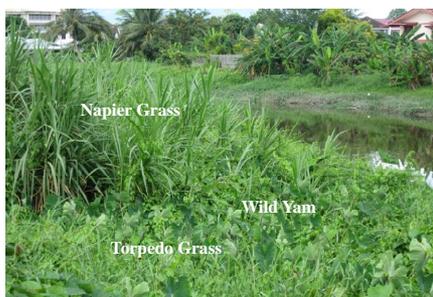
100 m in dimension for field investigation and sampling purposes (see **Figure 3**). There are a total of 27 polygons selected for representation of its situations in the riparian system under study. All polygons should touch the water edge as much as possible. The composition in each polygon varies with two distinct characteristics of vegetation cover and human activities.

Figure 4. Grasses along Maong River.

Stretches of Maong River beside the Wee and Wee Garden is chosen, for its upper and lower boundaries are easily identifiable and findable for repeat assessments. Areas of concern are designated into polygons of 100 ×

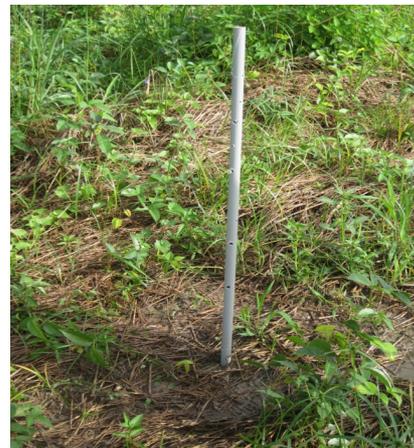
From the aspect of hydrology, groundwater level is one important factor as riparian vegetation relies much on the groundwater table [20,21]. On-site tests have been carried out. The apparatus involved perforated pipe with adequate diameter, post hole digger, hammer and measuring tape. The pipe is inserted into the soil at a distance 2.5 - 3.0 m away from the water edge allowing the shallow groundwater to flow into the pipe, then lifted up to notice the level of water line from the ground surface (see **Figure 7**). Average reading for each polygon is plotted (see **Figure 8**). Comparing to PFC data set, it is observed that when the groundwater level from ground surface is 20 cm or higher, the system in place is no longer functioning. About 60% of the polygons are functioning with groundwater level around 15 cm from the ground surface.

Figure 7. Shallow groundwater test.
