# Using of GIS Technology for Conservation of the Ottoman Bathroom and Its Urban Surrounding in Qena—Egypt

Archaeological Conservation Department, Faculty of Archaeology, South Valley University, Qena, Egypt

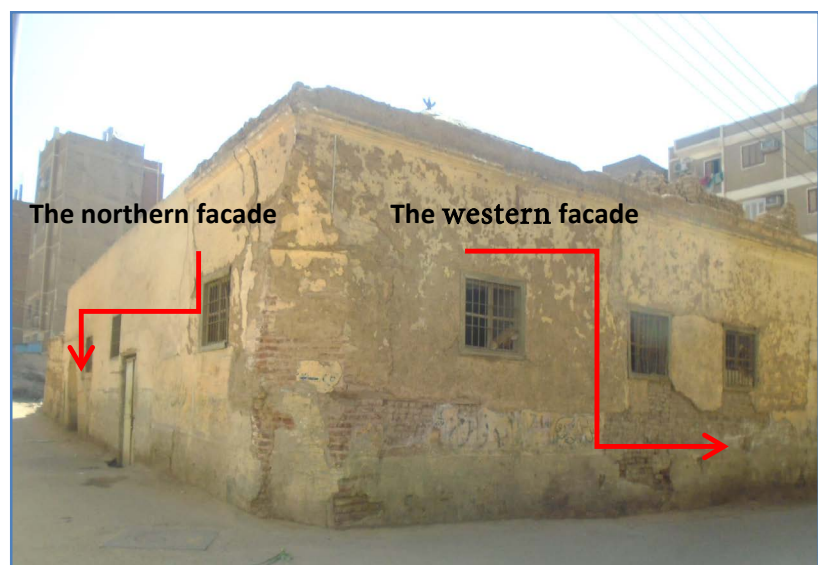
**Figure 5.** The northern, western facades of the Ottoman Bathroom.

The façades of the build are characterized by simplicity; the main facade is located in the northern side of the Bathroom where there is the main entrance in the eastern side, this face has two windows. The western façade has three windows similar to those on the northern façade. The southern façade has another entrance is located in the western side, its width less than the main entrance; this façade extends to a space where the furnace was located (Figures 4-7).

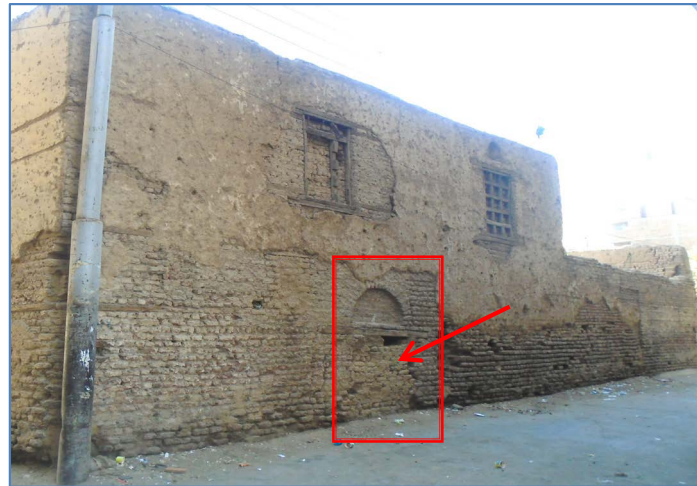
**Figure 6.** The southern façade of the Ottoman Bathroom.

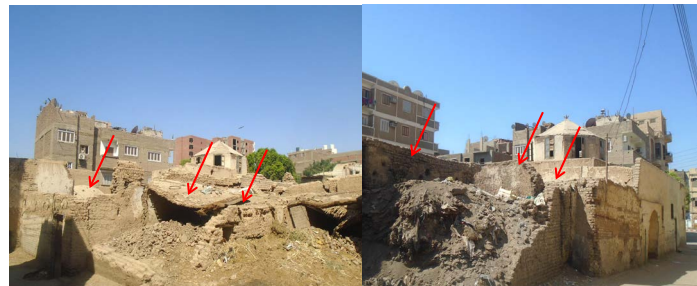
**Figure 7.** The eastern side of the Ottoman Bathroom.

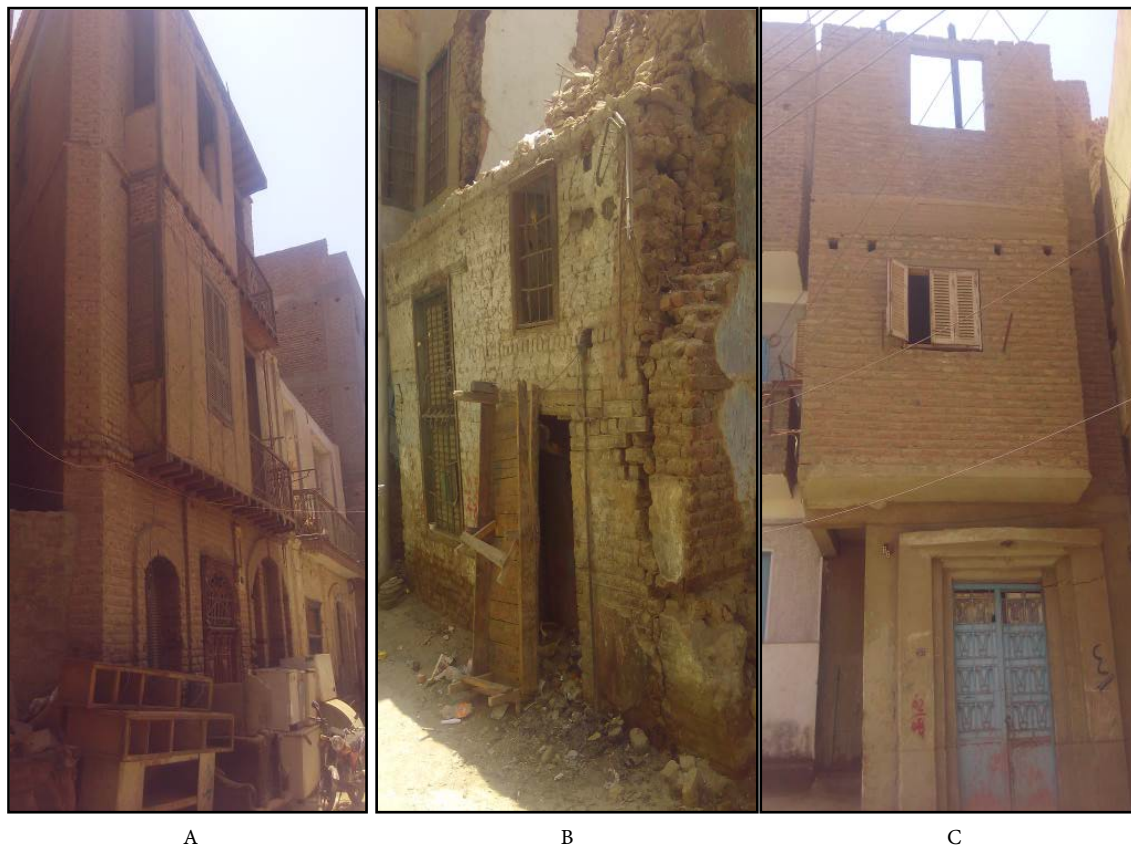
**Figure 13.** A. Shows the buildings were built by walls and concert roofs. B. Shows the buildings were built by mud bricks. C. Shows the buildings were built by walls and wooden roofs.

- From the assessment of structural style of buildings, show that 27.77% were built of walls and concert roofs, 27.77% were built of mud bricks, 20.37% were built of walls and wooden roofs, and 5.55% were built of concrete buildings (**Table 2**, **Table 3** & **Figure 13** & **Figure 14**).

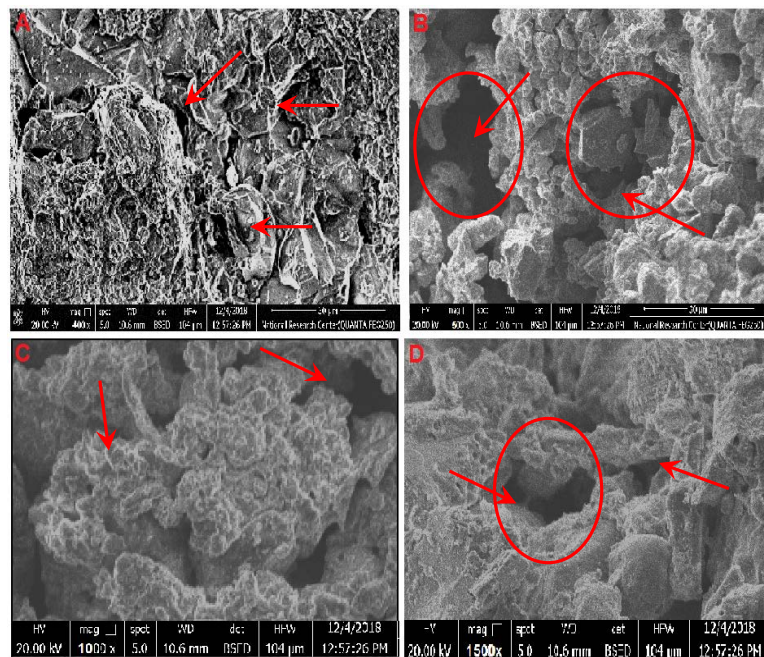
**Figure 15.** SEM Photographs of red bricks. A. Showing corrosion of quartz and presence voids in bricks structure. B. Showing loss of binding materials and presence of crystallized salt. C. Showing dense of crystallized salt between pores of bricks. D. Presence of voids and salts in bricks structure.

SEM image of red bricks samples are presented the deterioration places in the Ottoman Bathroom. The examination is shown weakness and cracks in bricks fiber and also shows no cohesion and interdependence with the presence of crystallized salt in the internal structure of the bricks. Deterioration, corrosion, voids and loss of binding materials observed in bricks structure. From the investigation, we observed intensive of sodium chloride between pores of bricks (**Figure 15**).

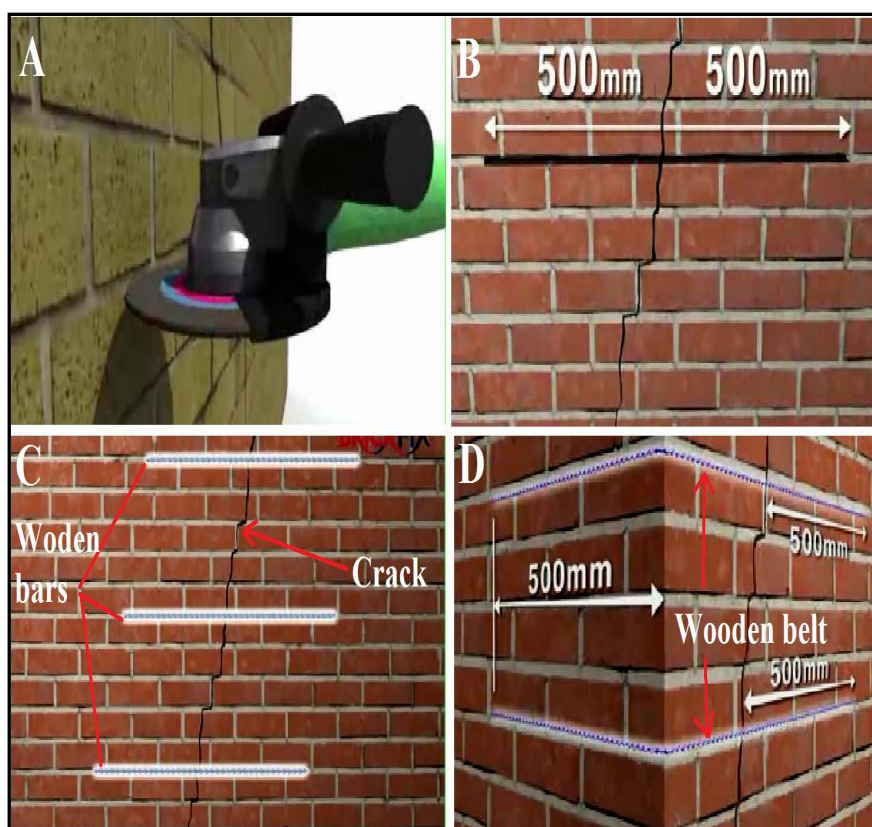
**Figure 17.** Showing stages of cracks Stitching. (A) Cutting in bricks course. (B) Cleaning the cutting in the course. (C) Install wood bars in the cutting on sides of the cracks. (D) Install wooden belt in corners of the build.

- **Procedures of restoration of the Ottoman Bathroom were summarized in the following.** From observation of various deterioration forms of the exterior facades of the Bathroom; the restoration steps can be defined as follows: 1) Restoration of cracks will be carried out with wooden bars method; in this method Cutting is done in bricks course with 50 cm length on both sides of the crack. It is possible to make a full belt around the building (**Figure 17**). The application of this technique is in accordance with the principles and rules of international restoration, especially the provisions of Article (10) of the Venice Charter in 1964, and Article (11) of the Lahore Charter in 1980. 2) A mortar made of lime, sand and kaolin is used to fill cracks after laying of wooden bars. 3) Replacement of damaged bricks with red bricks having the same chemical and physical properties. 4) Compensation the missing plaster layer of the facades. 5) Repair of the skylight of Ottoman Bathroom.
