# The Heer Küste Artillerie Abteilung 1161

Giancarlo T. Tomezzoli

**How to cite this paper:** Tomezzoli, G. T. (2022). The Heer Küste Artillerie Abteilung 1161. *Archaeological Discovery*, 10, 193-214. <https://doi.org/10.4236/ad.2022.104007>

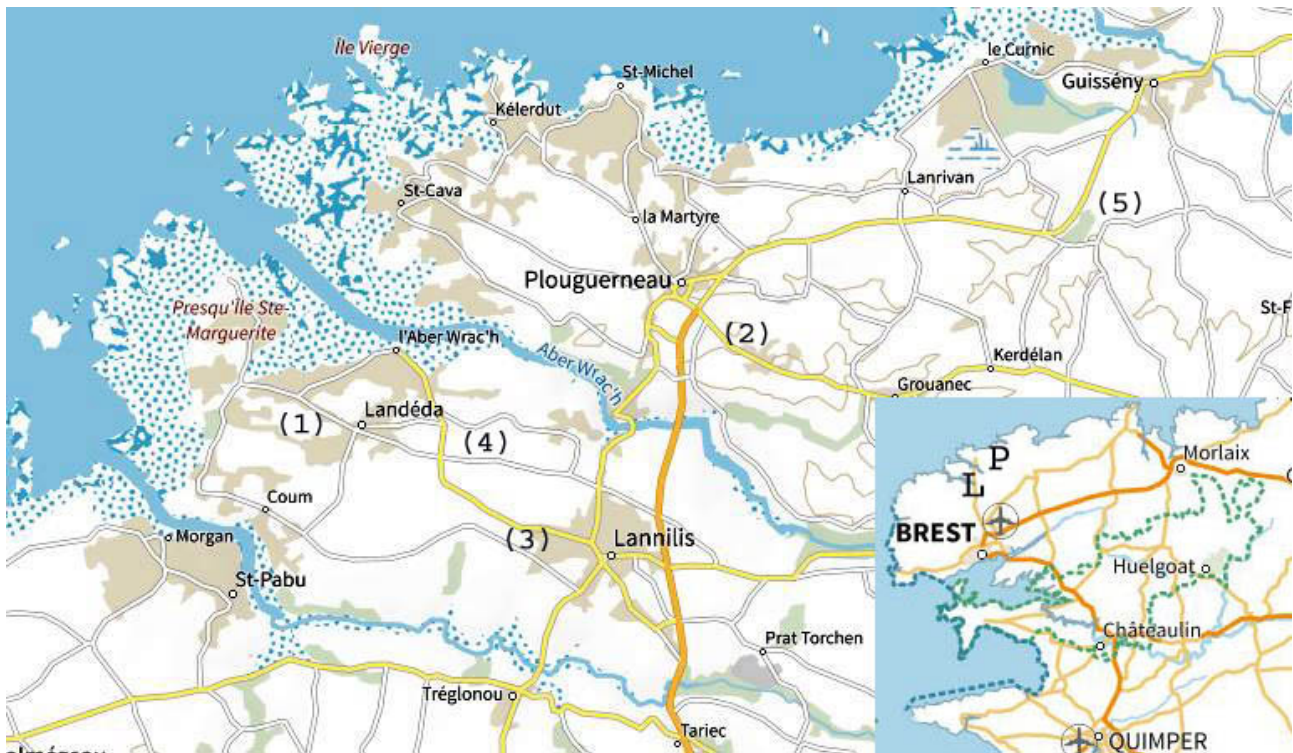
**Figure 1.** H.K.A.A. 1161 battery positions: (1) *Stp Av 34*, Croaz Huella en Landéda; (2) *Stp Av 64*, Ranorgat (Rann Enezi) en Plouguerneau; (3) *Stp Av 66a*, Flescou en Lannilis; (4) *Stp Av 67*, Cleus Fos en Landéda; (5) *Stp Av 55*, La Métairie/Le Veleury en Pluider; L Lannilis; P Plouguerneau.

From 1<sup>st</sup> March 1942, the future *1./H.K.A.A. 1161* (Unit 44 818B) is signalled at Landeda (likely at the *Stp Stützpunkt—Support Point Av Aber Wrac'h 34*—author's note). The *2./H.K.A.A. 1161* (Unit 44 818C), former *9./H.K.A.A. 746* (Unit 30 287) was at Ranorgat (Rann Enezi) en Plouguerneau at the *Stp Av 64*. The *3./H.K.A.A. 1161* (Unit 44 818D), former *10./H.K.A.A. 746*, comprising 3 officers, 9 non-commissioned officers and 69 gunners, was at Flescoul en Lannilis at the *Stp Av 66a*, with 4 × 150 mm guns. The *4./H.K.A.A. 1161* (Unit 44 818E), former *3./H.K.A.A. 347*, comprising 3 officers, 21 non-commissioned officers and 107 gunners was at Cleus Fos en Landeda at the *Stp Av 67* with 6 × 155 mm guns (Floch, 2009, 2012) (Figure 1).

The presence of *1/H.K.A.A. 1161* at *Stp Av 34* in Croaz Huella en Landéda is controverse. A first source (Floch, 2009) signals *1/H.K.A.A. 1161* at Landeda without providing evidences. A second source (Floch, 2012) reports that the *1/H.K.A.A.* was at La Métairie/Le Veleury en Pluider at *Stp Av 55* (Figure 1,

The visit of *Stp Av 55* took place on 22<sup>nd</sup> May 2016. The *Stp Av 55* identified components (**Figure 1, Figure 12**) have been described in a previous publication (**Tomezzoli, 2016**). The present study identified *1./H.K.A.A. 1161* as the German unit in service at *Stp Av 55*.

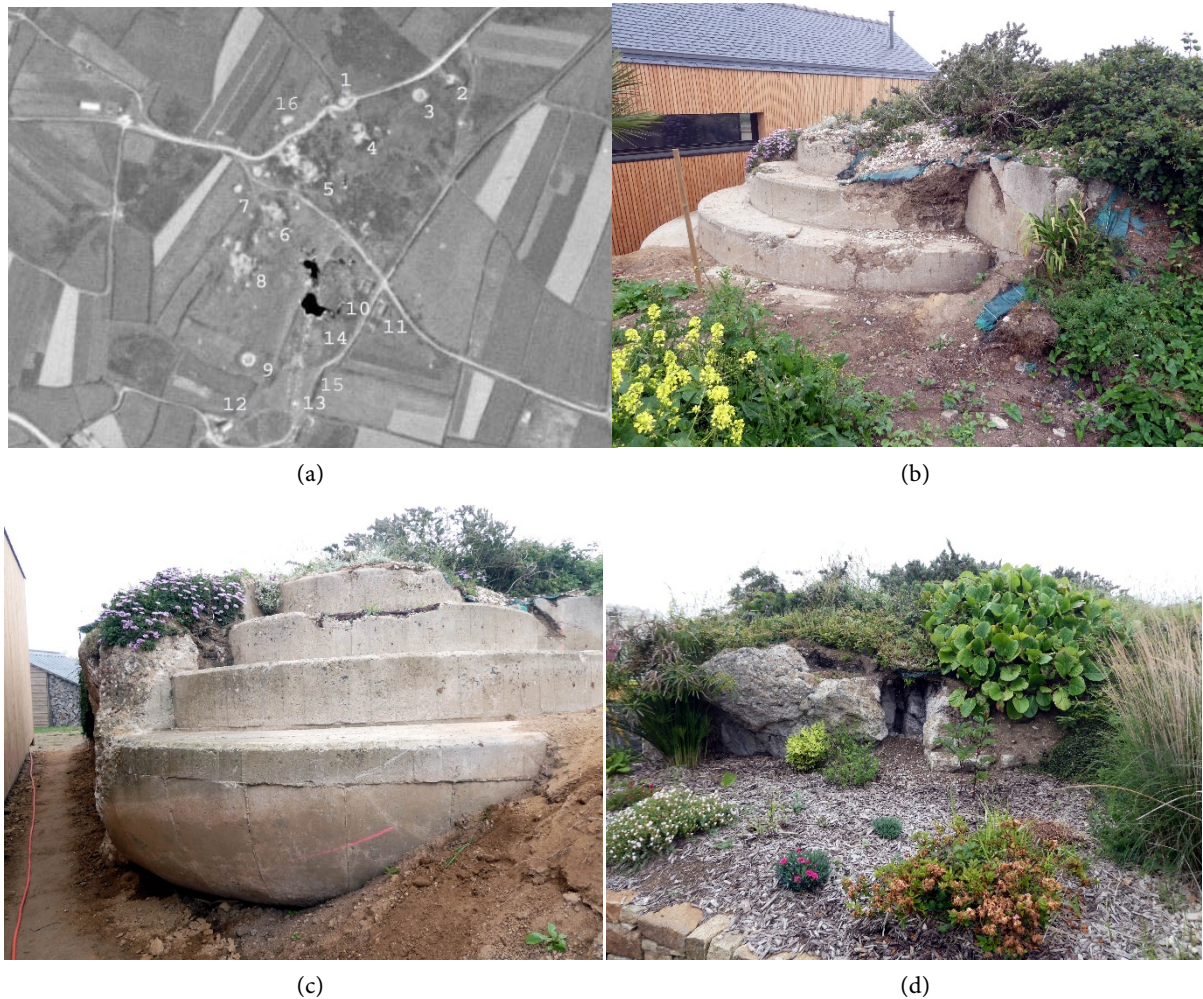
**Figure 2.** *Stp Av 34*: (a) general plan: (1) possible *Flak* emplacement, (2) unknown emplacement, (3) *Fl 243b* open gun emplacement, (4) *M 170* emplacement, (5) *M 170* emplacement, (6) *M 170* emplacement, (7) pentagonal watch post, (8) *M 170* emplacement, (9) *Fl 243b* emplacement, (10) shack emplacement, (11) shack emplacement, (12) possible shack emplacement or farm, (13) unknown emplacement; (14) one room bunker; (15) bunker of unknown type; (16) upside down fragment of *M 170* (5)—Mission C0816-0031\_1952\_F0216-0816\_0102, No. 102, 1/26600, Argentique 21/05/1952; (b) upside down fragment of *M 170* (5), side view; (c) upside down fragment of *M 170* (5), side view; (d) upside down fragment of *M 170* (5), rear side.

The post WWII French air reconnaissance image Mission C0816-0031\_1952\_F0216-0816\_0102, n°102, 1/26600, Argentique, 21/05/1952 (**Figure 2(a)**), and the fact that only one *Fl 243b*, a pentagonal watch post and a one room bunker were identified confirm that *Stp Av 34* components were completely destroyed by the Americans troops upon their arrival (**Lécuillier, 2010**). Their ruins were covered by terrain and vegetation or maybe were removed. Because of their destruction it was not possible to ascertain whether one or more *M 170* hosted a superimposed *Flak* emplacement. The *Fl 243b* probably hosted an 88 mm or a 105 mm gun and the niche on one side of the labyrinth entrance probably hosted a radio post (**Tomezzoli & Colliou, 2017**).

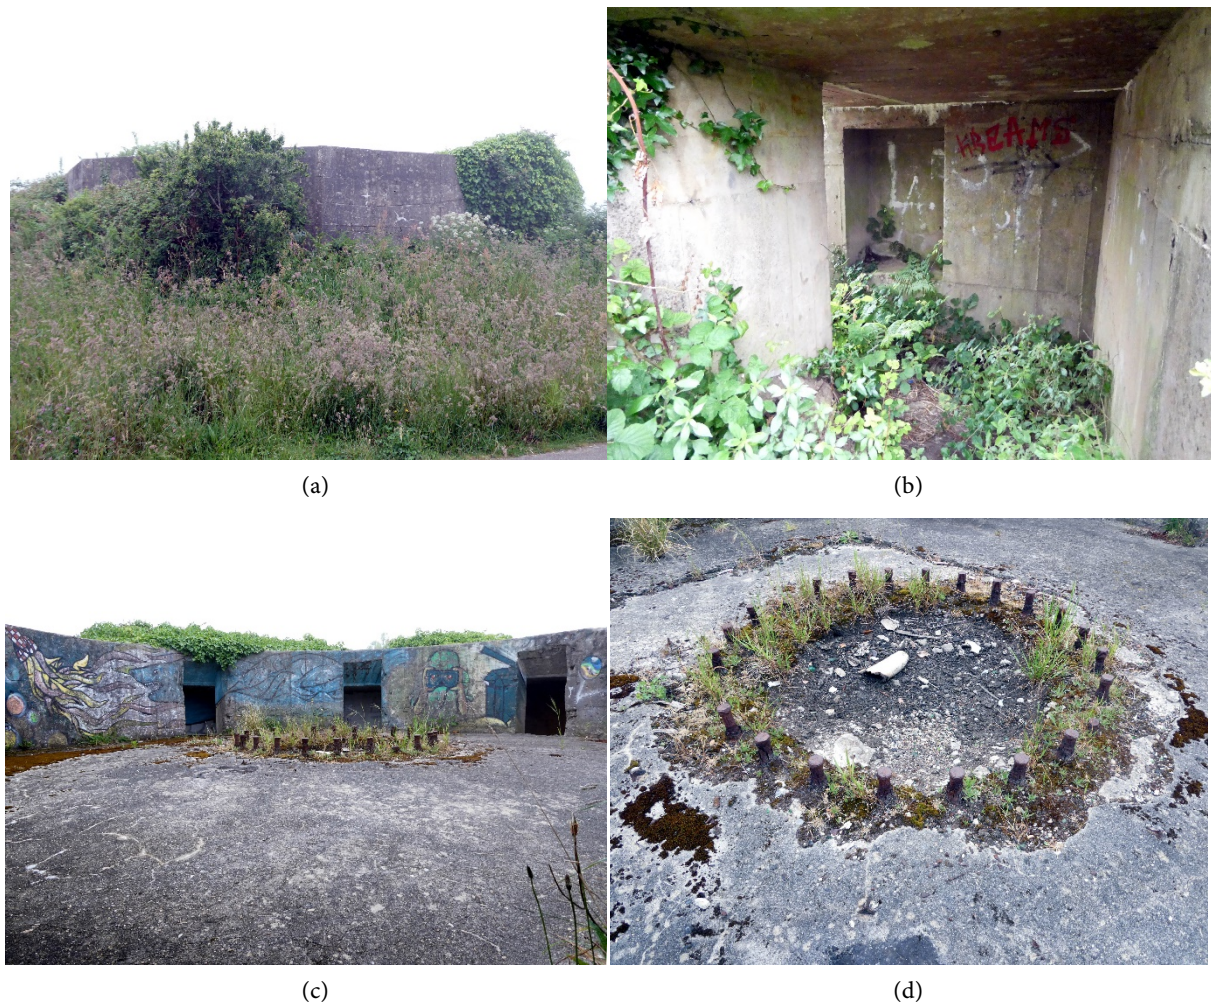
An *Fl 243b* (3) ( $48^{\circ}35'23.56''\text{N}$ ,  $4^{\circ}35'14.29''\text{W}$ , h 44.1 m) partially covered by vegetation so that the embrasure of its close combat room was not visible. Its concrete structure was in a good preservation state without damages due to combats. It preserved the *Flak* gun emplacement disfigured by modern graffiti, a labyrinth entrance on one side having a rectangular niche, ammunitions niches on each other side and at the centre a 21 screws ring for fixing the support of the *Flak* gun. The traces of the formwork boards typical of the German masonry and the pebbles of the *Ero Vili* (Tomezzoli & Marzin 2015) were clearly visible on the concrete structure.

**Figure 3.** *Fl 243b*: (a) External view; (b) Labyrinth entrance with rectangular niche; (c) Open gun emplacement; (d) 21 screws ring.

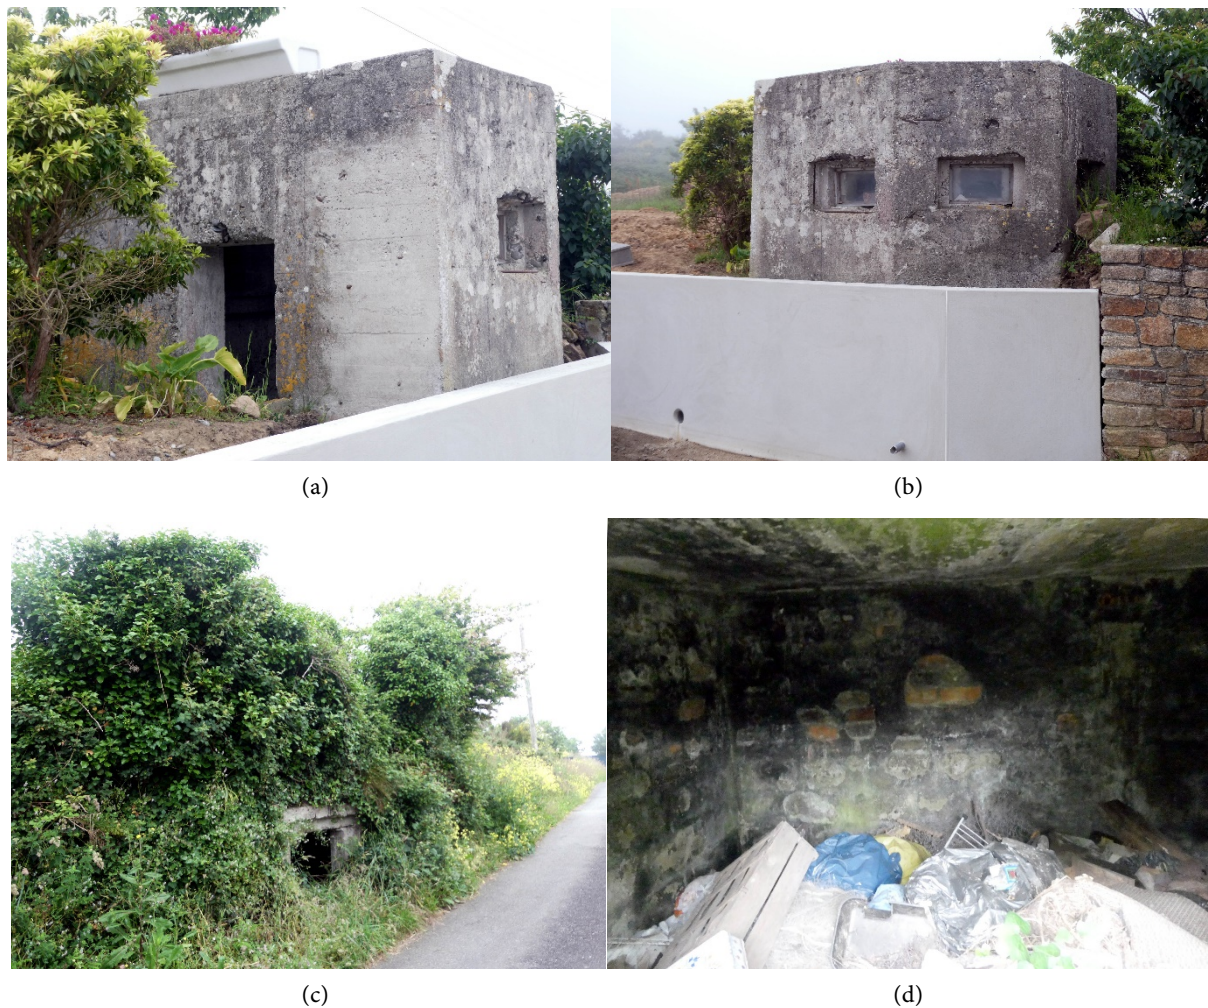
A pentagonal watch post (7) ( $48^{\circ}35'21.7''\text{N}$ ,  $4^{\circ}35'22.32''\text{W}$ , h 38.92 m). Its concrete structure was in a good preservation state without damages due to combats. Its entrance was on the longer side and an embrasure was on each of the shorter sides. The traces of the formwork boards and the pebbles of the *Ero Vili* were clearly visible on the concrete structure.

**Figure 4.** (a) Pentagonal watch post rear side; (b) Pentagonal watch post front side; (c) One room bunker (14) entrance; (d) One room bunker (14) internal room.

A one room bunker (14) ( $48^{\circ}35'17.06''\text{N}$ ,  $4^{\circ}35'16.5''\text{W}$ , h 47.93 m) on a side of a country road. Buried in the terrain and covered by vegetation, the preservation state of its concrete structure remained unknown. Its entrance was unobstructed allowing the inspection of the interior. All the original furniture disappeared. The floor was covered by scraps and debris of various kinds. The internal walls built by stones and the concrete ceiling had no damages due to combats.

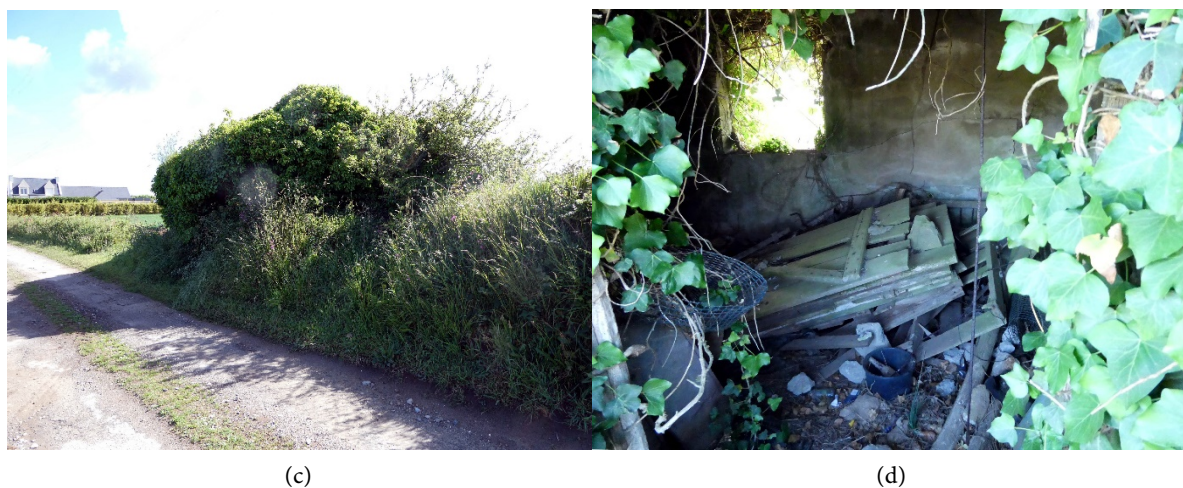
A watch post (1) ( $48^{\circ}35'55.95''\text{N}$ ,  $4^{\circ}29'43.49''\text{W}$ , h: 58.26 m) on the right side of the access road (7). Completely covered by vegetation, the preservation state of its external structure remained unknown. Its entrance was unobstructed allowing the inspection of the interior. All the original furniture disappeared. The floor was covered by wooden planks and scraps. The internal walls had no damages due to combats, preserving the original white painting faded by the time without traces of the formwork boards. An observation window on a wall permitted the surveillance of the east side of *Stp Av 64*.

**Figure 5.** *Stp Av 64*: (a) General plan (Rapport Pinczon du Sel, 1947-1948): (1) watch post, (2) non-concrete gun platform, (3) *R 669* with *Flak* emplacement, (4) *R 669*, (5) *R 669*, (6) *R 669* with *Flak* emplacement, (7) access road; (b) Photo 73 (Rapport Pinczon du Sel, 1947-1948), on the foreground *R 669* (3) with *Flak* emplacement, on the background *R 669* (4) and (5); (c) watch post (1) covered by vegetation; (d) watch post (1) interior.

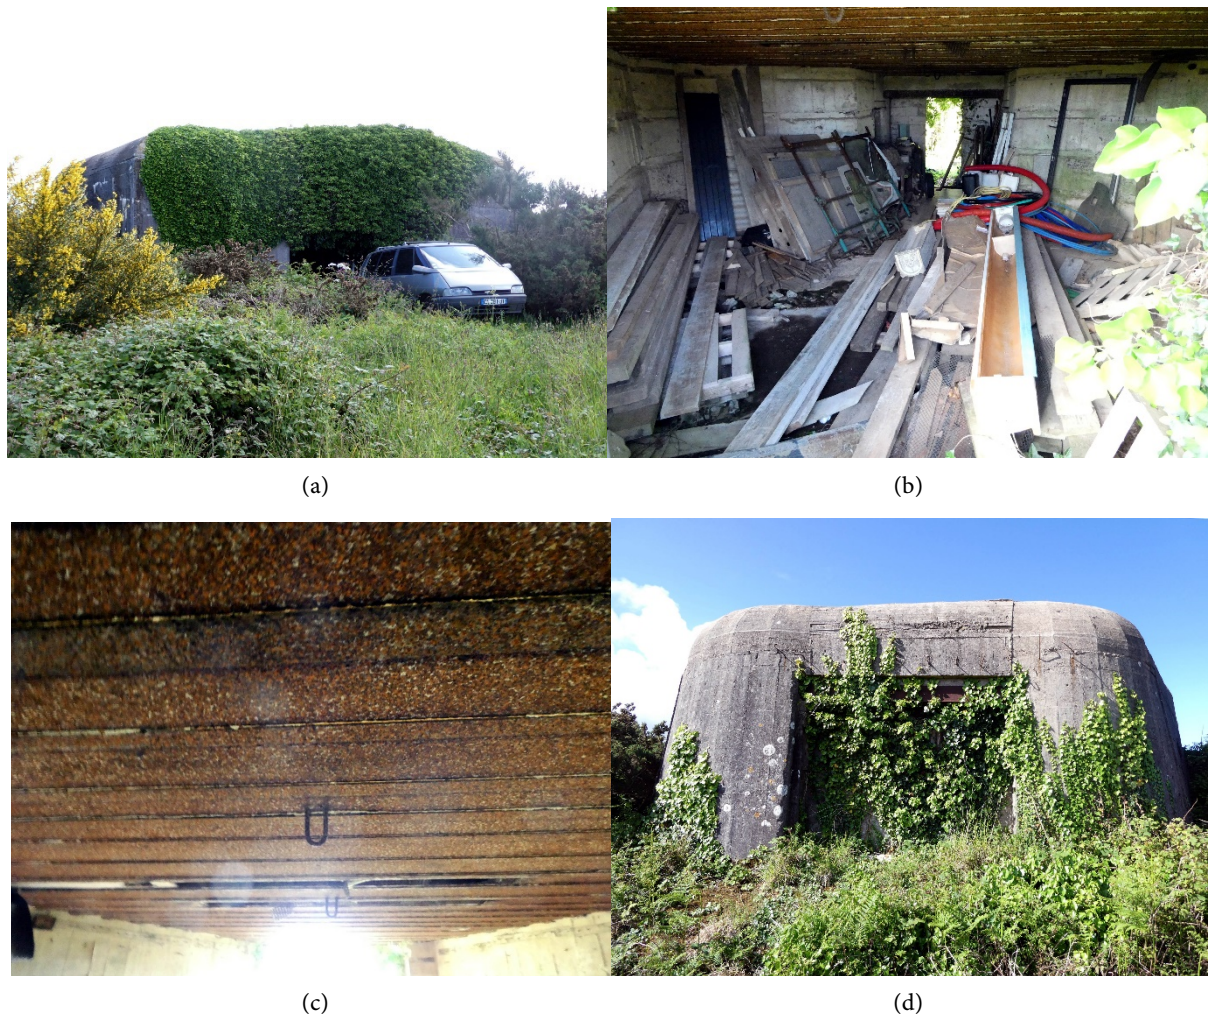
**Figure 7.** (a) *R 669 (5)* rear side; (b) *R 669 (5)* interior, (c) *R 669 (5)* rusted ceilings with two gun lifting joints and two elongate gates of the combat gas extraction system; (d) *R 669 (5)* front side.

A *R 669 (5)* ( $48^{\circ}36'1.59''\text{N}$ ,  $4^{\circ}29'40.87''\text{W}$ , h: 60.94 m) partially covered by vegetation, presenting a well-preserved concrete structure in the exposed portions without damages due to combats. The traces of the formwork boards and the pebbles of the *Ero Vili* were clearly visible on the exposed portions. The combat room rear opening allowed the interior inspection. All the original furniture

disappeared. Various materials and scraps were stacked on the floor masking all its features (Tomezzoli & Pottier, 2016). The walls preserved the original white

painting with no traces of a thermal insulation system. The rusted ceiling preserved two gun lifting joints and two elongate gates of the combat gas extraction system deprived of their original grids. Materials stacked against the walls prevented the inspection of the ammunition rooms. The rear side, covered by vegetation masked the grid of the exhausted combat gas pipe and a possible niche hosting it (Tomezzoli & Pottier, 2016). The combat room front opening was partially closed by bricks and obstructed by vegetation.

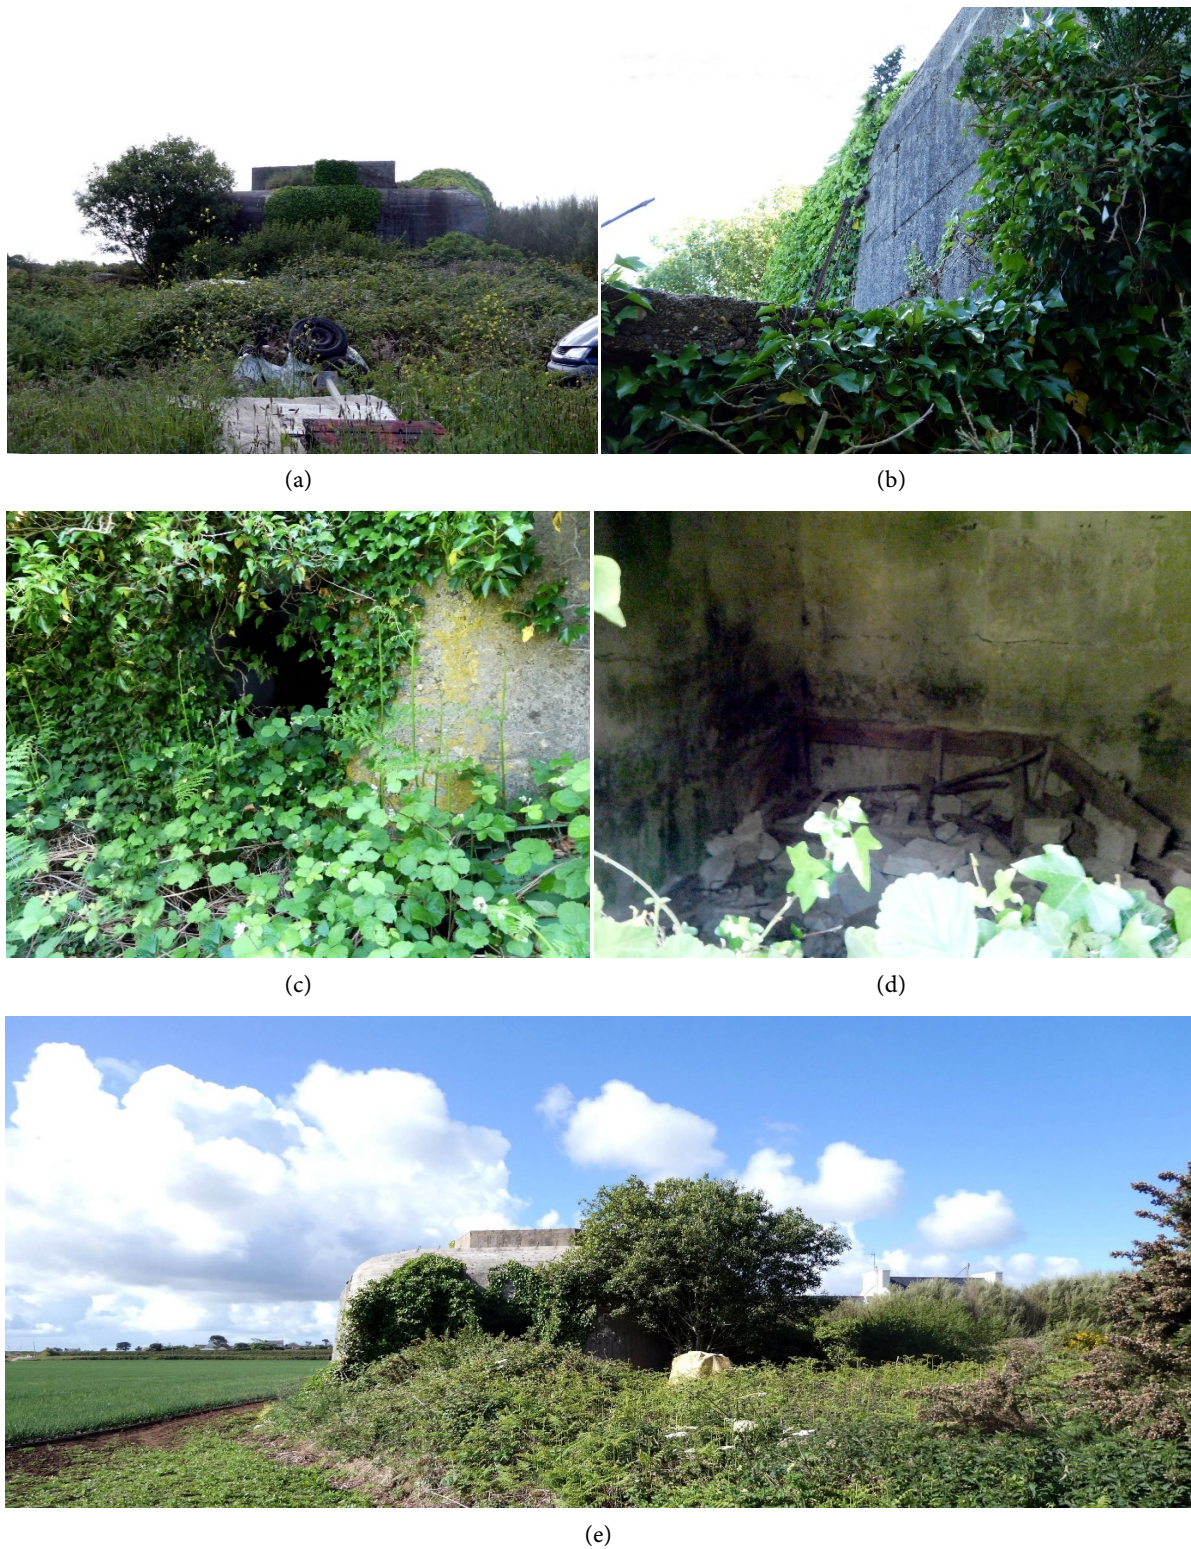
**Figure 8.** (a) *R 669 (6)* with Flak emplacement, rear side; (b) *R 669 (6)* and annexed construction, (c) Annexed construction entrance; (d) annexed construction interior; (e) *R 669 (6)* front side.

A *R 669* (6) (48°36'0.3"N, 4°29'40.1"W, h: 60.51 m) covered by vegetation, presenting a well-preserved concrete structure in the exposed portions without damages due to combats. On its coverage a well-preserved *Flak* emplacement was clearly visible. The combat room rear opening and front opening were obstructed by vegetation so that the interior inspection was not possible and its preservation state remained unknown. Covered by vegetation the access stair to the pentagonal *Flak* emplacement was inaccessible. However, post WWII French air reconnaissance images shown that its concrete structure and labyrinth entrance were well-preserved without damages due to combats. Covered by vegetation, the grid of the exhausted combat gas pipe was not visible. The vegetation covered a rectangular, annexed construction on the west side of *R 669* (6). Its entrance was unobstructed allowing the interior inspection. All the original furniture disappeared. The floor was covered by stones and scraps. A wooden plank was secured on one of the internal walls. The walls preserved the original white painting faded by the time without traces of the formwork boards.

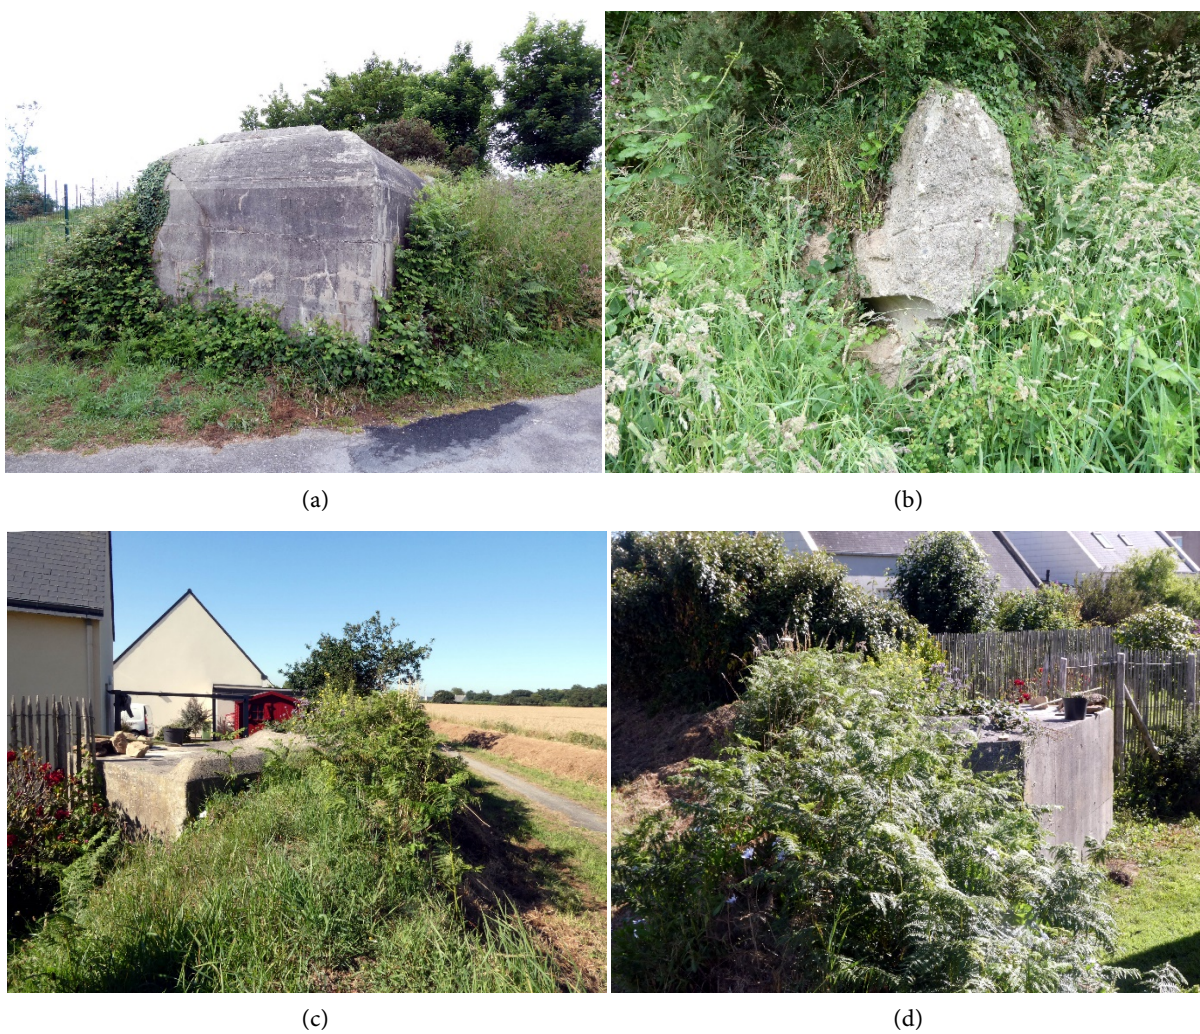
The ruins of a *R 650* (1) (48°34'24.1"N, 4°32'9.58"W, h 52.57 m) for 150 mm gun *K. 331* (Pinczon de Sel, 1947-1948) near the entrance of a water tower enclosure. Completely covered by terrain and vegetation, the concrete fragments let the original structure unrecognizable. The traces of the formwork boards and the pebbles of the *Ero Vili* on the fragments were clearly visible.

**Figure 10.** *Stp Av 66a*: (a) *R 650* (1) fragment; (b) *R 650* (1) fragment; (c) *tobruck* (8), side view; (d) *tobruck* (8), side view.

A *tobruck* (8) (48°34'18.94"N, 4°32'10.31"W, h 47.32 m) partially covered by terrain and vegetation, presenting a well-preserved external concrete structure in the exposed portions, without damages due to combats. The traces of the form-work boards and the pebbles of the *Ero Vili* were clearly visible on the concrete structure. The aperture of its combat room and its entrance were obstructed by terrain and vegetation; therefore, the interior inspection was not possible and its preservation state remained unknown.

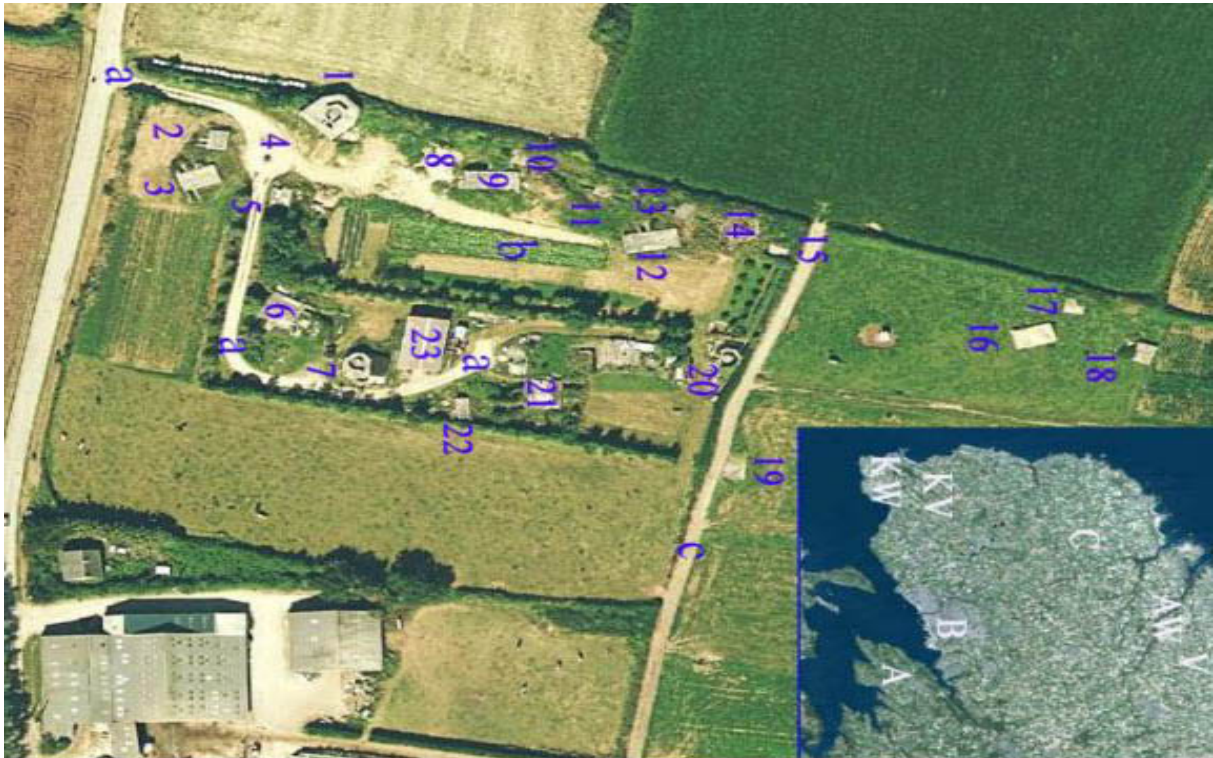
**Figure 11.** *Stp Av 67*: general plan—(1) *R 669*, (2) - (3) *Vfs*, (4) open emplacement, (5) *Vf*, (6) *M 134*, (7) *Flak Vf*, (8) open emplacement, (9) - (13) *Vfs*, (14) open emplacement, (15) - (18) *Vfs*, (19) possible bunker buried in the terrain, (20) *Flak Vf*, (21) *M 134*, (22) *Vf*, (23) agricultural shed; a access road, b central area, c external road; A Armorique peninsula; AW Aber Wrach; B Brest; C Cleus Foz battery; KW Keringar Wraz *M.K.B. Graf Spee*, KV Keringar Vihan base, V Vougo-Kerizoc radar base (Tomezzoli, 2016) [Geoportail].

The organization of *Stp Av 67* is rather different from the previous discussed *Stps*. Only one gun was located in a bunker *R 669* with superimposed *Flak* emplacement; the other three guns were placed in open emplacements. This permitted the guns to fire on 360°, but exposed them unprotected to possible air at-

tacks. The *R 669* and the gun emplacements were not aligned along a line or semi-circle as in the previously discussed *Stps*. The presence of many other bunkers suggests a logistic role of *Stp Av 67*.

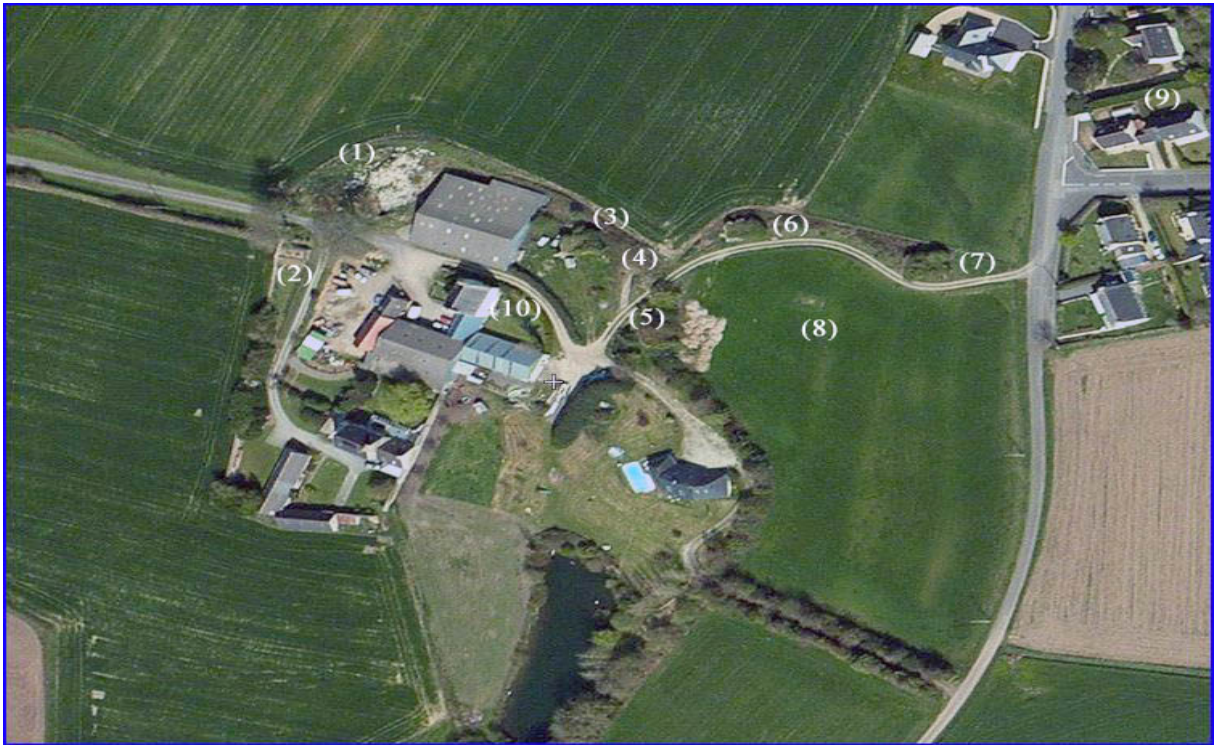
**Figure 12.** *Stp Av 55*: general plan: (1) dismantled *H 671*, (2) one room bunker, (3) *H 671*, (4) one room bunker, (5) one room bunker, (6) *H 671*, (7) *H 671*, (8) place of two bunkers buried in the terrain, (9) Plouider, (10) farm (Tomezzoli, 2016) [Flash Earth].
