Seismic and Geotechnical Study of Land Subsidence and Vulnerability of Rural Buildings

Department of Civil and Environmental Engineering, Shiraz University of Technology, Shiraz, Iran

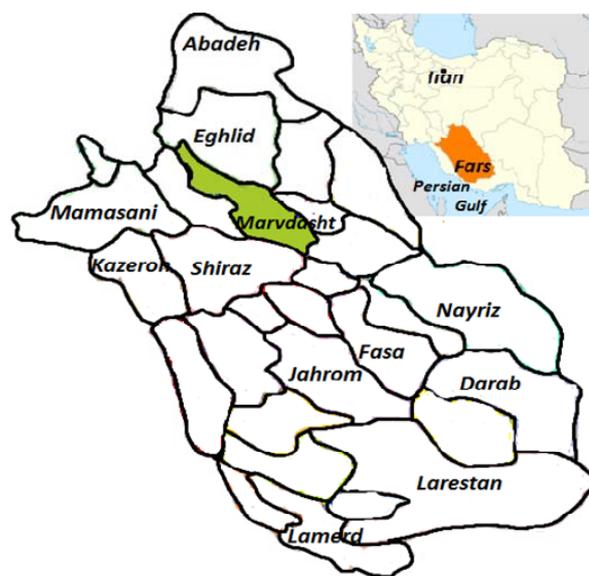
Figure 1. Location of Marvdasht plain in Fars province, Iran.

In this paper a case study is performed for Marvdasht Plain and rural regions in Fars province, Iran (**Figure 1**). All affecting parameters and their related damages are considered in the study. The variation of groundwater

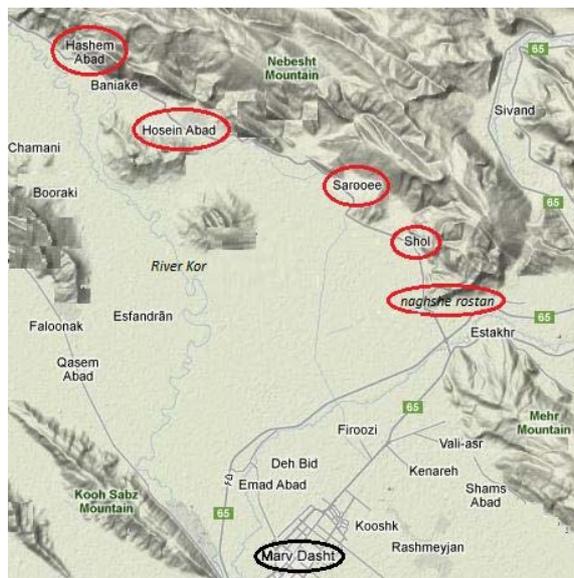
Figure 2. Location of the damaged villages near the mountain hillside in Marvdasht plain.

Shul Village is located southwest of Hossein Mountain hillside (**Figure 2**). The geological formations of this region consist of calcareous Dariyan and Soruk formations. The alluvial sediment of the village includes pebbles and cobblestones with some fine sediment in the range of clay size particles. The east part of the village is located on an unconsolidated alluvial consisting cobblestones with little silt, clay and sand. The west part is located in a floodplain including silt and clay with some amount of salt.

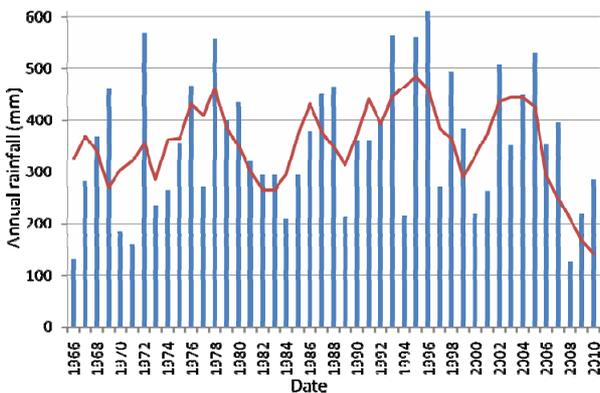
Figure 3. Annual rainfall curve based on the average values for 3 years.

According to the records of rainfall stations in Iran, because of the reduction of precipitation from the water year 2005-06, the nation is entered to a new drought duration. The reduction continued until 2010-11, and after that a slight increase in rainfall amount has been observed (Figure 3). Considering all related hydrographs and the specified hydrograph of the aquifer located in Shul village (Figure 4), the Groundwater level dropping has been initiated from 2005-06 and continued with a mild rate to 2008-09. Then the rate of water drop speeded up and continued until the water year 2011-12. Indeed, by the investigation of rainfall status and the hydrographs in Marvdasht plain it can be seen that there exists a 6-year era of drought unprecedented in the past 50 years.

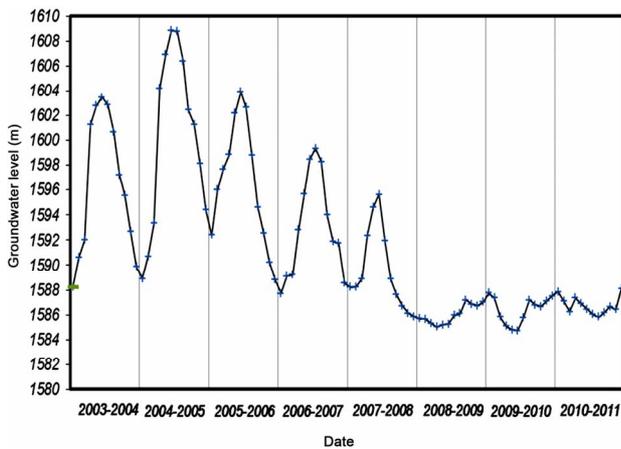
Figure 4. Hydrograph of the piezometer located in Shul village.

The piezometer located at Shul village shows 23.02 m drop of water surface during 6 years of drought from water year 2005-2006 to 2010-2011. The mentioned drop is the average value between all piezometer located around and within Shul village (Figure 4).

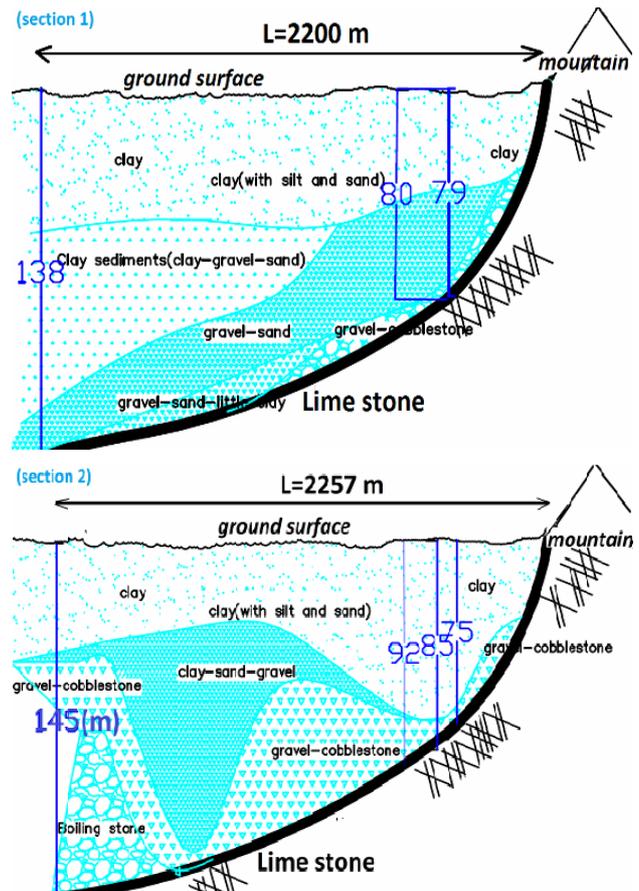
Figure 5. Soil layering profiling (horizontal scale: 1/100, vertical scale: 1/1000).

At the first step of study, the situation of all drilling wells (38 wells) and piezometers (8 piezometers) were specified on the map. Based on the obtained data from the drilling wells (logs of drilling, location), two profiles of the soil layering were plotted. The lengths of the obtained profiles were about 2.2 km at the hillside of Hossein Mountain. They were located at 1.5 km far from one another at the two sides of Shul village.

Due to the shallow depth of drilling wells and the presence of thick layers of alluvia, the depth of the bedrock is estimated from a limited number of wells shown in Figure 5 (thick blue lines). The depths of the bedrock obtained from the profiles at two sides of Shul village were the same. The thicknesses of the clay layers were also the same in both profiles. This consequently indicates the presence of thick clay layers and deep bedrock in the region.

The drought, dropping water table level and the presence of thick clay layers result in a significant amount of settlements and generation the lots of cracks in the region and consequently sever damages to the buildings in rural areas.

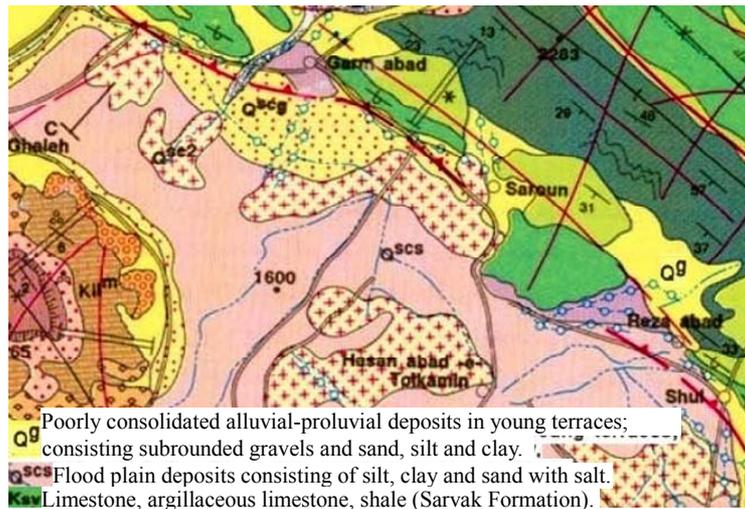
Figure 6. Geological map of Shul village.

Field studies over the cracked region showed that the direction of the main crack is along the side of Hossein Mountain. Shul village is also located on Garmabad Fault on the hillside of Hossein Mountain. The presence of this fault causes the anomalies in the sloped layering and the inversion of the slope in the southwestern side of Hussein Mountain anticline. The fault has appeared as a rupture zone in the domain. The precise status is shown in the geological map (Figure 6).

By mapping the situation of created cracks and gaps into the desired region, based on their geographical locations, it has been observed that the direction and vicinity of the cracks are along the fault. This indicates that the presence of fault accelerates the creation of cracks in conjunction with the groundwater level lowering.

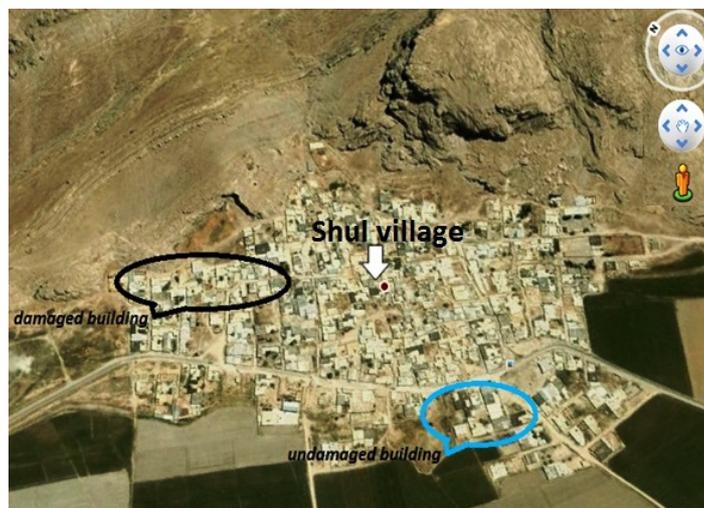
Figure 7. The location of damage and undamaged building.

The predominant frequency, amplification, earth vulnerability indices and vulnerability indices of damaged or undamaged buildings (Figures 7 and 8) have been determined by microtremor in the vicinity of Shul village.

Tests have been conducted over the damaged reinforced structures located near the Mountain hillside and the undamaged structures far away from the cracks and gaps domain.

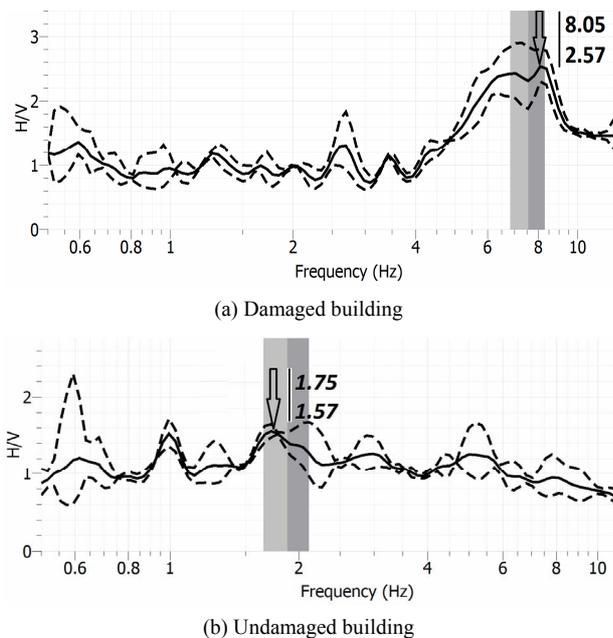
Figure 9. Spectral ratio H/V (ratio of horizontal component to the vertical component of the ground surface).

According to the obtained data, the earth vulnerability index at the Mountain hillside (0.82) is lower than its counterpart (1.4) at the plain area (far from the Mountain) which confirms the accuracy of obtained results from the microtremor analysis considering shallow depth of bed-rock near the Mountain and high thickness of the soil layer far from the Mountain. The vulnerability index can be calculated by the following equation.

where K_g , A_g and F_g are respectively, the vulnerability index, magnification factor (i.e. H/V as shown in Figures 9 and 10) and the predominant frequency of the site based on the spectral ratio [12,13].

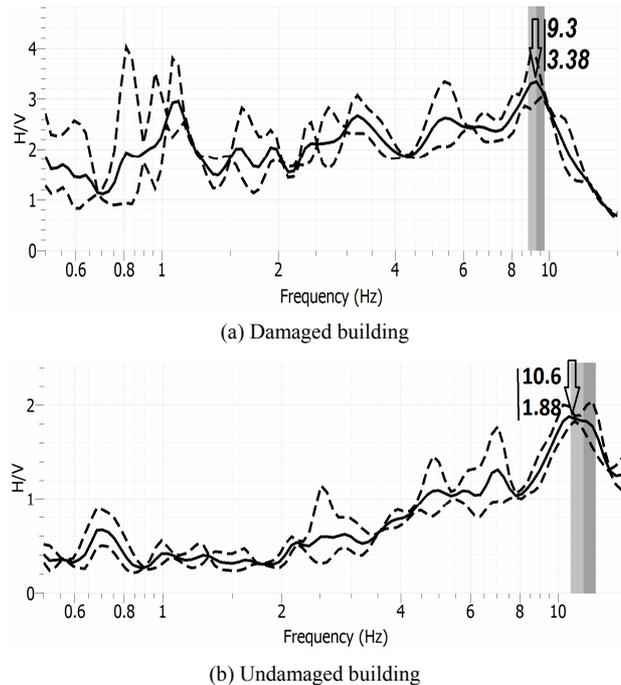
Figure 10. Spectral ratio H/V (the ratio of horizontal component of the building’s roof to the vertical component).

As it is manifest from the figures, by considering the ratio of the horizontal component at the building’s roof to

the vertical component of ground, the vulnerability index of the damaged structures is about 2.5 times higher than that of the undamaged ones, which shows the critical state of such structures with respect to the forthcoming earthquakes and future subsidence.

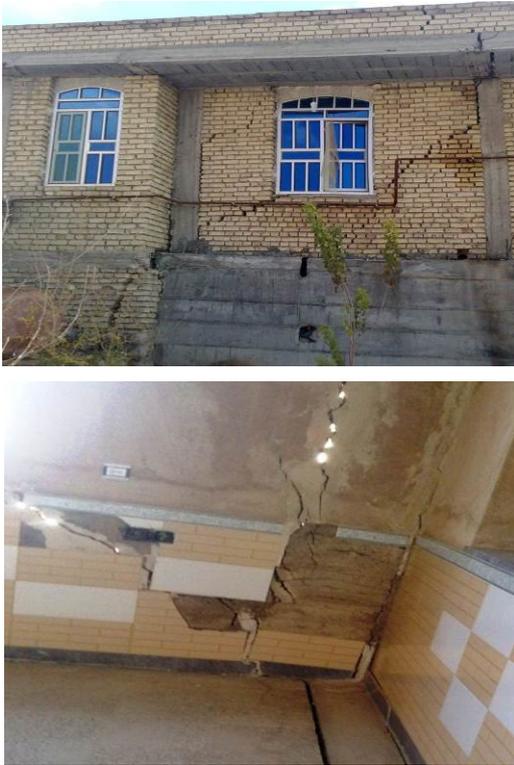
Figure 11. The created cracks inside and outside of the building due to land subsidence.

Considering the results of microtremor, the vulnerability index of damaged structures is high, which in turn shows the critical status of such structures. However by appearing extended cracks in the roofs, bases and walls of such structures as shown in **Figure 11**, their workability is lost and future financial and residential costs may be imposed.

prevention and control of damages to the structures due to the subsidence, the extraction of underground water resources should be managed properly, highly water-dependent plants should not be grown, unauthorized wells should not be drilled, farmers should be trained, irrigation systems should be improved and construction in the vicinity of cracked zone should be prevented.
