Performance Evaluation of Sediment Basins: Case Study of Keya Hydropower Plant in Rwanda

Keya Hydropower Plant, Sediment Basin Evaluation, Sebeya River, Rwanda

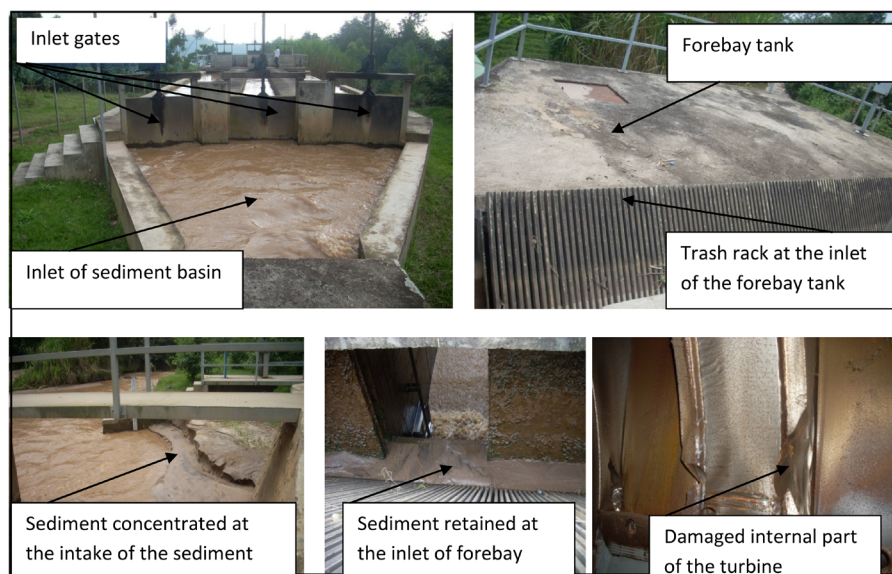
Figure 1. Sediment basin, forebay tank, and trash rack and sediment effects on turbines.

The inlet part at which the penstock is connected to its called forebay tank is basically a pool located at the end of sediment basin from which the penstock pipe draws the water. The forebay tank serves the purpose of providing steady and continuous flow into the turbine through the penstocks. The forebay also acts as the last settling basin and allows the last particles to settle down before entering the penstock. The forebay size depends on the length

of the penstock pipe. The longer the penstock pipe is, the bigger the forebay and the sediment basin will be [4]. A trash rack is mounted at the inlet of forebay tank to prevent floating debris from getting into the penstock. There are different types of trash racks either thinly spaced vertical steel bars or rods or a plate with holes or slots [5]. The trash rack should be built strong enough to withstand the water pressure. To allow simple maintenance during operation, the bars in any trash rack should be sufficiently spaced. If the space among the individual bars is too small, the gross head will drop down and the energy output will decrease.

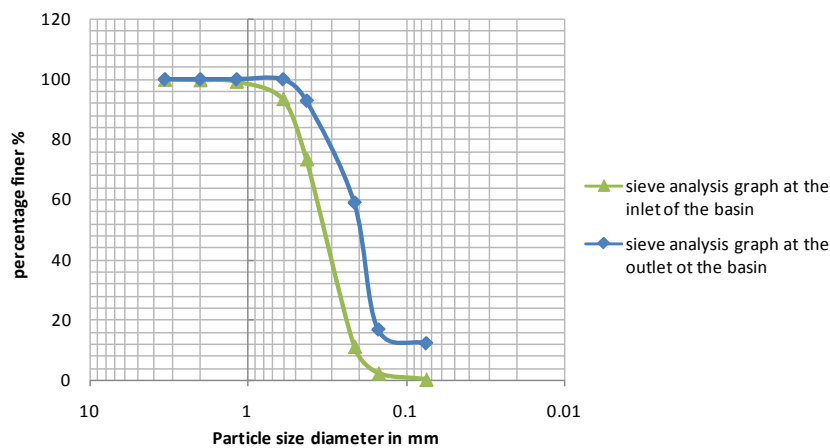
Figure 5. Inlet and outlet grading curves for sediment basin.

At the inlet of the basin, gradient curve is steeper between the sieve openings ranging from 0.15 mm to 0.425 mm which means that about 85.5% of sediment falls in that range, 10.25% ranges from 0.425 mm to 3.35 mm and 4.25% between 0.15 mm to 0.075 mm (**Figure 5**). Great amount of sediment that reaches the outlet of the basin range between 0.15 mm and 0.212 mm with 42.23% of the total amount of sediment that escape from the basin without being settled. From the remaining 2 portions of this outlet grading curve, 4.58% ranges between 0.075 mm to 0.15 mm and 40.97% range from 0.212 mm to 3.35 mm.

Figure 5 shows that quantitatively from the grading curves; **Table 3** indicates the type and the percentages of sediments removed by the sediment basin.

After all these percentages of particle removed, it was found that sediment basin removes fine and medium sand with silt and clay at the proportion of 21.68% say 22% of the total sediment that enters the basin.

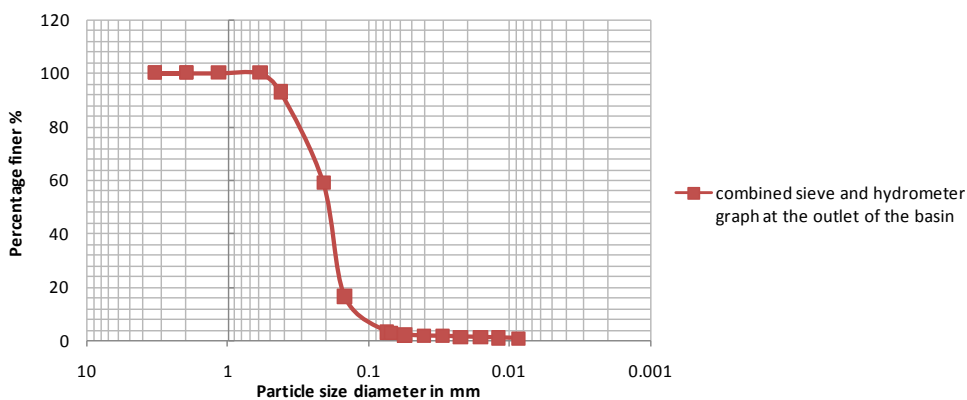
Figure 6. Typical grading curve at the outlet of the sediment basin.

Sieve analysis and hydrometer test results were plotted in a semi-logarithm graph called sieve analysis grading curves as shown in [Figures 4-6](#). In these figures, particle diameters were plotted in log-scale and corresponding percentage finer in arithmetic scale. Main advantage of using semi-logarithm graph is that it can bring out features in the data that would not easily be seen if both variables have been plotted linearly.

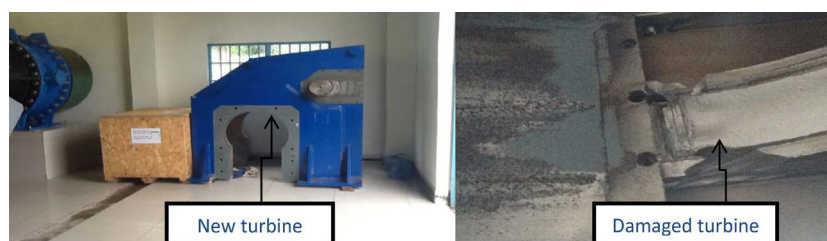
Figure 7. Turbine damaged 6 months only after its operation.

From the results obtained in Section 4.4.2, we found that the efficiency of sediment removal by sediment basin is only about 22%. This means that about 78% of particles including fine sand, silt containing quartz and clay escaping the sediment basin without settled. **Figure 6** shows a typical grading curve at the outlet of the sediment basin. Thus, sediment became a major technical challenge to the smooth operation of Keya HPP because sediment hampers the efficiency and productivity of this plant (see **Figure 7**).

Keya HPP started its operation in July 2011 but due to this sediment issues; the turbine was damaged after only six months of operation (**Figure 7**).

From October 2012 to December 2013, the plant was out of use waiting for a new turbine to replace the first damaged one. After installation of the second turbine, the new turbine was also damaged in May 2015. From May 2015 up to now, the plant capacity of 2.2 MW was reduced to 900 KW and the working hours were reduced from 24 hours to 5 hours per day from 17h00 to 22h00.
