The WWII Ringeltaube

Giancarlo T. Tomezzoli

How to cite this paper: Tomezzoli, G. T. (2019). The WWII *Ringeltaube*. *Archaeological Discovery*, 7, 193-210.
<https://doi.org/10.4236/ad.2019.74010>

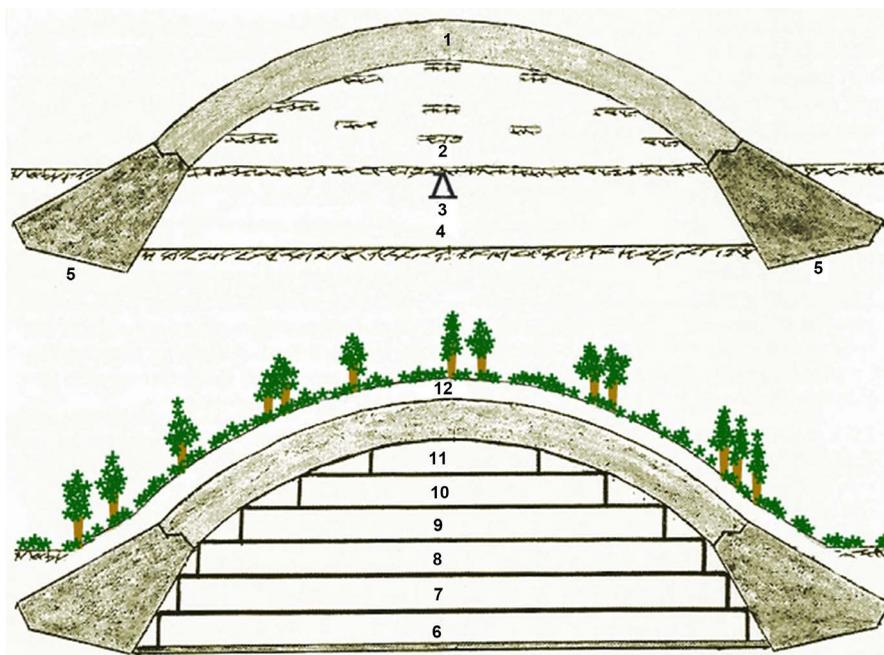
Figure 1. Bunker project: (1) arcuate coverage; (2) semi-cylindrical ground formwork; (3) removal tunnel; (4) final soil level; (5) concrete arch foundations; (6) 1st floor; (7) 2nd floor; (8) 3rd floor; (9) 4th floor; (10) 5th floor; (11) 6th floor; (12) forested layer (Start image Ehmke, 2005).

The bunker project (Figure 1), based on the ground formwork (*Erdschalung*) concept, was developed by the *OT* chief executive Xaver Dorsch, on the basis of the projects of the V-weapons bunkers in France, for reducing formwork wood, facilitating the concrete casting and save construction costs.

Each bunker had to be about 400 m long, 85 m wide and 32.20 m high of which 13 m above ground and 19.20 m underground. The arcuate coverage was formed by 12 arches, each 33 m long, separated by a 30 cm gap to be filled at the coverage completion.

top, had to be dug into the original terrain along the central axis of the foreseen arches. Two trenches parallel to the tunnel had to be dug and concrete poured inside for creating the arch foundations. Once dried, gravel and earth had to be collected between the arch foundations and over the tunnel to form a semi-cylindrical ground formwork. It had to be smoothed and flattened for receiving a 30 cm thick concrete layer of the first arch. Metal rods had to be fixed on it for supporting a second 5 m thick concrete layer accumulated by means of cranes and pumps. Twenty days later when the concrete was dried, the ground formwork had to be removed from below the arch by means of a convoy entering the removal tunnel and parking the wagons under the silo valves. The silo valves opening caused the ground formwork gravel and earth to fill up the wagons. The original terrain had to be excavated up to the underground soil level. These operations had to be replicated up to the last arch. Over the bunker arcuate coverage obtained, a final 3 m forested layer had to be formed to provide camouflage. A 5 m thick wall provided with entrances had to close each bunker extremity. A construction provided with six to eight floors had to be built in the bunker interior (Ehmke, 2005; Müller, 2007; Odinius, 2004; Cocconcelli, 2002; Zaloga, 2012).

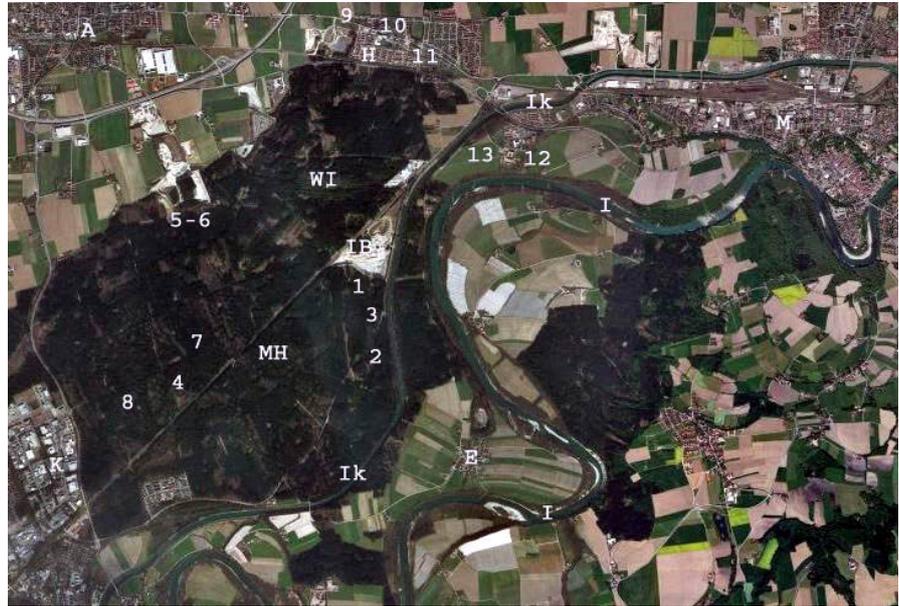
Figure 3. Weingut I area—(1) KZ Waldlager I; (2) KZ Waldlager II; (3) KZ Waldlager III; 4) KZ Waldlager IV in project; (5)-(6) KZ Waldlager V-VI; (7) KZ Waldlager VII in project; (8) mass grave; (9) KZ Mettenheim I; (10) KZ Mettenheim Hart Süd—Russian forced workers; (11) KZ Mettenheim Hart Süd—Russian voluntaries; (12) KZ Grümer; (13) KZ Ecksberg; A: Amping; E: Ebing; H: Mettenheim Hart; K: Kraiburg; I: Inn; IB: firm *Innbau Beton*; Ik: Innkanal; M: Mühldorf; MH: Mühldorf Hart; WI: Weingut I site (Zoom Earth).

The *Weingut I* (Vineyard I) site (48°14'25.6"N, 12°27'8.2"W) was in Mühlendorf Hart, on the left side of the river Inn (**Figure 3**). 600 OT employees in their

The *Weingut I* visits took place on 27th February 2005, 25th September 2005, 12th March 2016 and 4th May 2019. The access path started near the firm *Innbau Beton* (Figure 3) and proceeded in the forest up to the *Weingut I* site.

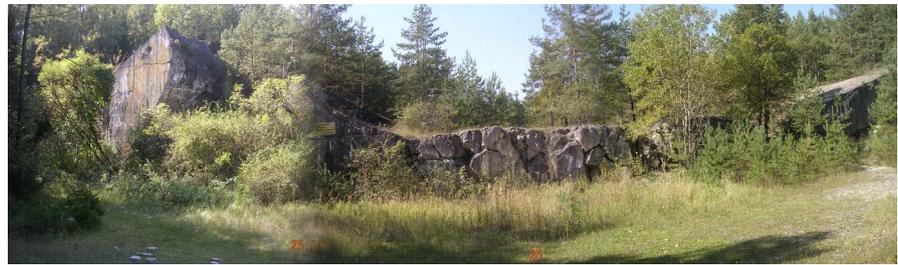
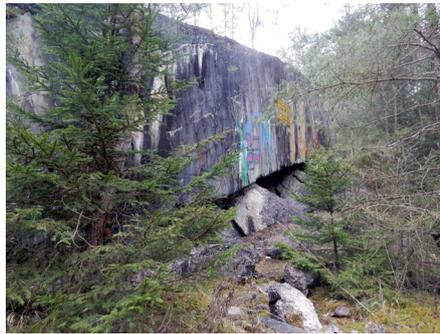
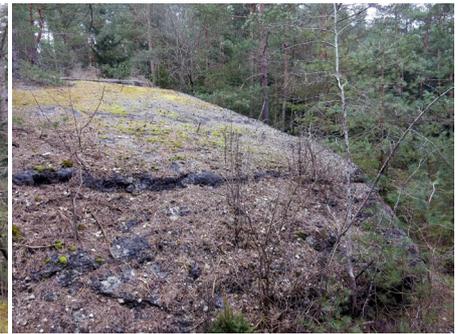
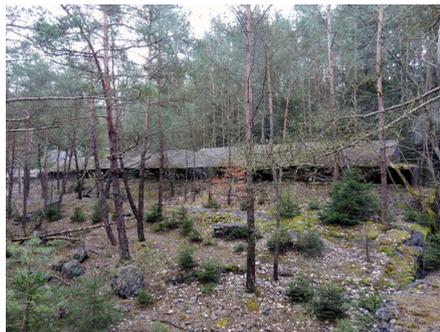
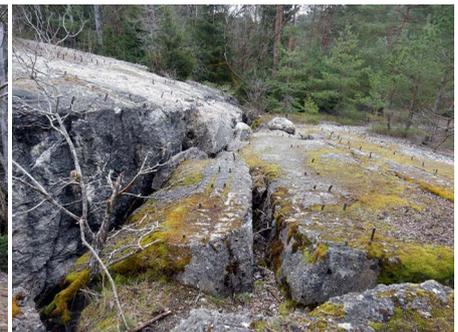
Figure 4. *Weingut I*—(1) 1st arch, overview; (2) front side; (3) coverage; (4) 1st and 2nd arches bases and details of the vegetation on the upper surface of the 2nd arch; (5) 2nd arch, fractured coverage with aligned extremities of the armour irons.

The 1st arch lay on the ground. Its structure was seriously fractured. Its front side showed that the collapse fragmented the arch in concrete blocks in the middle, larger blocks at the sides and two portions still in place at the extremities. Its rear side was masked by the 2nd arch front side. On its coverage formwork element traces and parallel aligned armour iron extremities, about 10 - 30 cm high, were well visible. Small plants grew sparse on its coverage (Figures 4(1)-(4)).

The 2nd arch lay on the ground. Its structure was seriously fractured. Its front and rear sides were masked respectively by 1st arch rear side and the 3rd arch front side. Two portions were still in their original position at its extremities. On its coverage formwork element traces and parallel aligned armour iron extremities were well visible. Young plants grew sparse on its coverage (Figures 4(4)-(5)).

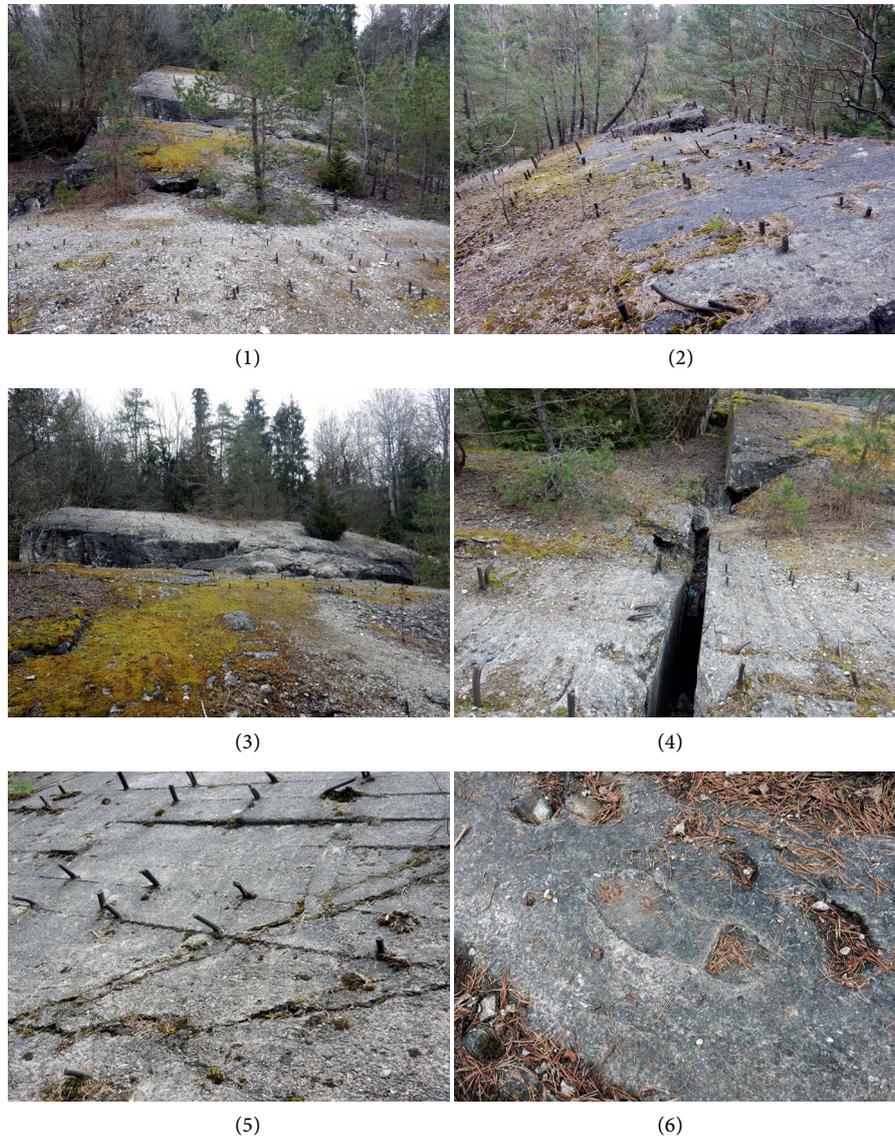
Figure 5. *Weingut I*—(1) 3rd arch fractured coverage with aligned armour iron extremities; (2) 4th arch fractured coverage with aligned armour iron extremities; (3) 5th arch fractured coverage; (4) 30 cm gap between the 4th and 5th arch; (5) 6th arch coverage with traces of the formwork elements and aligned armour iron extremities; (6) worker's shoe prints on the 6th arch concrete.

front side. On its coverage formwork element traces and parallel aligned armour iron extremities were well visible. Young plants grew sparse on its coverage (**Figure 5(1)**).

The 4th arch lay on the ground. Its structure was seriously fractured. Its front and rear sides were masked respectively by the 3rd arch rear side and the 5th arch front side. On its coverage formwork element traces and parallel aligned armour iron extremities were well visible. Young plants grew sparse on the coverage (**Figure 5(2)**).

The 5th arch lay on the ground. Its structure was seriously fractured. Its front and rear sides were masked respectively by the 4th arch rear side and the 6th arch front side. On its coverage formwork element traces and parallel aligned armour iron extremities were well visible. Hardwoods and conifers grew sparse on its coverage (**Figures 5(3)-(4)**).

The 6th arch lay on the ground. Its structure was seriously fractured. Its front and rear sides were masked respectively by the 5th arch rear side and terrain debris. On its coverage formwork element traces and parallel aligned armour iron extremities were well visible. Particularly touching were shoe prints left by a worker on the concrete. Hardwoods and conifers grew sparse on its coverage (**Figures 5(5)-(6), Figure 6**).

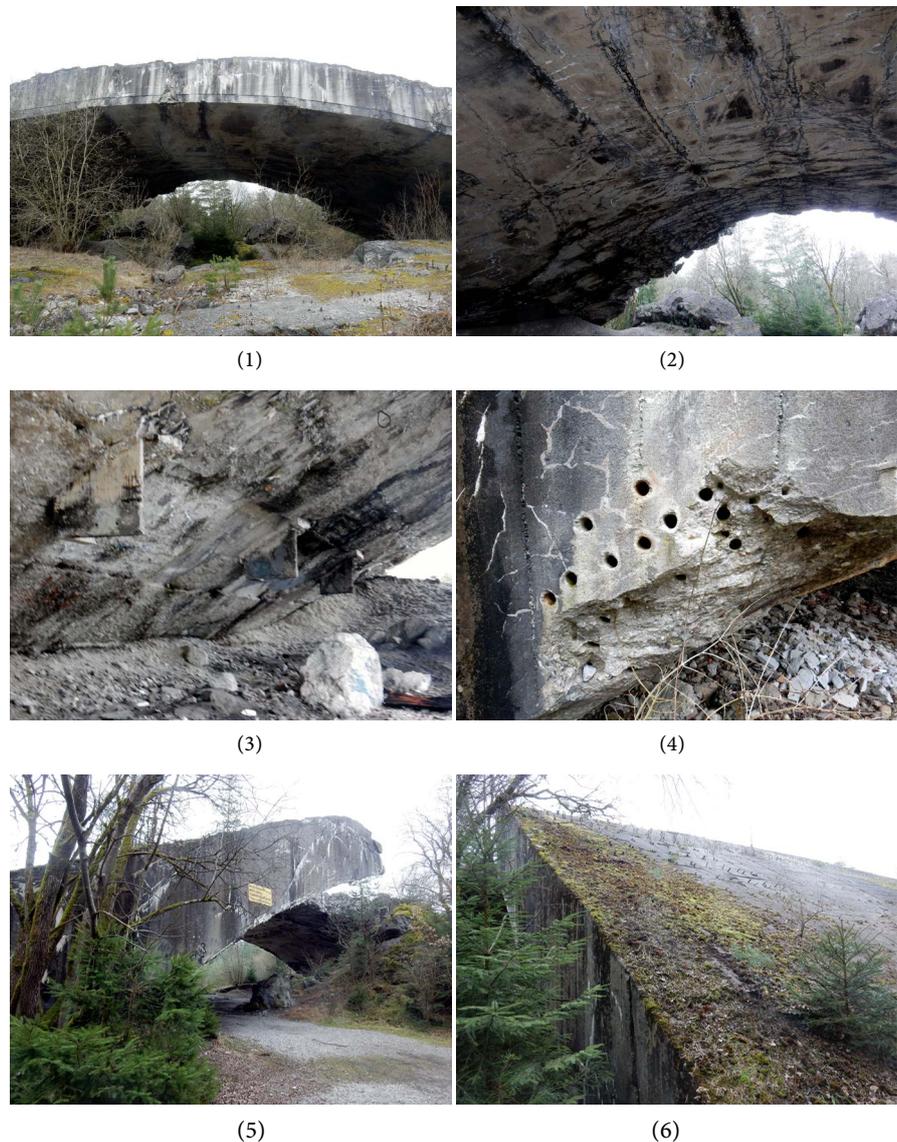
Figure 6. *Weingut I—7th arch*: (1) coverage rear side with 30 cm and 5 m concrete layers, in the foreground 6th arch coverage; (2) coverage with constructive segments; (3) coverage with constructive segments and aligned vertical protrusions; (4) dynamite holes on the rear side; (5) rear side with empty space of the fallen part and attached part; (6) coverage with aligned armour iron extremities.

The 7th arch survived the demolition and remained erected in its original position. Its front side toward the 6th and 5th arches clearly showed the 30 cm thick concrete layer supporting the 5 m thick concrete layer. Part of its rear side fallen on the ground letting an empty space on the arch and part remained attached to

the arch because of the internal armour irons. On its coverage formwork element traces and parallel aligned armour iron extremities were well visible. At the arch interior the coverage showed parallel constructive segments. On a lower side, extending from a constructive segment, were three aligned vertical protrusions. Near the protrusions, a partially collapsed rear side preserved 20 holes about 10 cm in diam. Small plants grew sparse on its coverage (**Figures 6(1)-(6), Figure 7**).

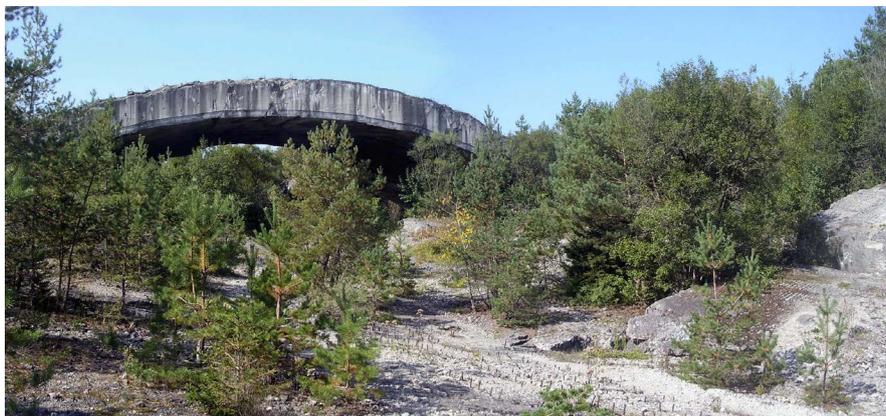
Figure 7. *Weingut I*—7th arch, front side overview from the 5th and 6th arches.

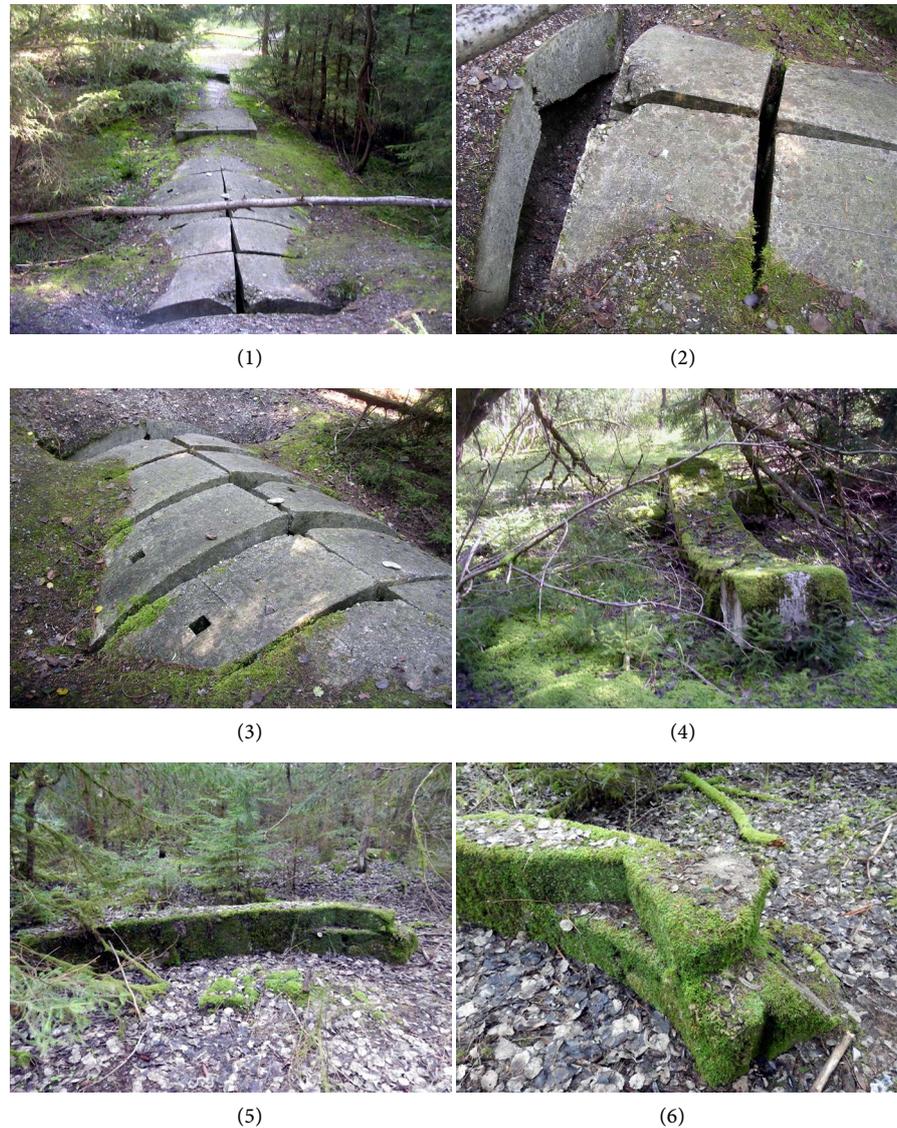
Figure 8. Removal tunnel: (1)-(3) partially detached arches and concrete filled silo valves; (4)-(6) abandoned removal tunnel precast arches.

The removal tunnel emerging part departed from the 7th arch rear side for about 20 m toward West. It was formed by precast arches. The emerging arch portions were partially detached from each other by the internally accumulated

terrain pressure and the emerging silo valves were filled by concrete (**Figures 8(1)-(3)**). Each portion had a square hole about 10 × 10 cm, and was erected in its original position indicating a good preservation state of the buried arch. The removal tunnel entrance was buried in the terrain; therefore, the interior inspection was not possible. Tunnel precast arch components were laying on the nearby terrain (**Figures 8(4)-(6)**).

the precast arches. The square hole of each precast arch allowed its handling. The short aligned armour iron extremities on each arch coverage appear insufficient for fixing in place the corresponding forested layer. The protruding armour iron extremities on the upper portion of the external wall of the two air intake/exhaust and the upper portion walls of the elongated rectangular construction were probably intended for supporting and fixing upper structures. The *Weingut I* electrical power supply came probably from the Töging power plant (*Kraftwerk*) at the end of the *Innkanal* (Ik) (Figure 3). A monumental conversion project for preserving the *Weingut I* remains was formulated in the past, but not yet been started. Therefore, in few decades it is possible that only the 7th arch will be visible.

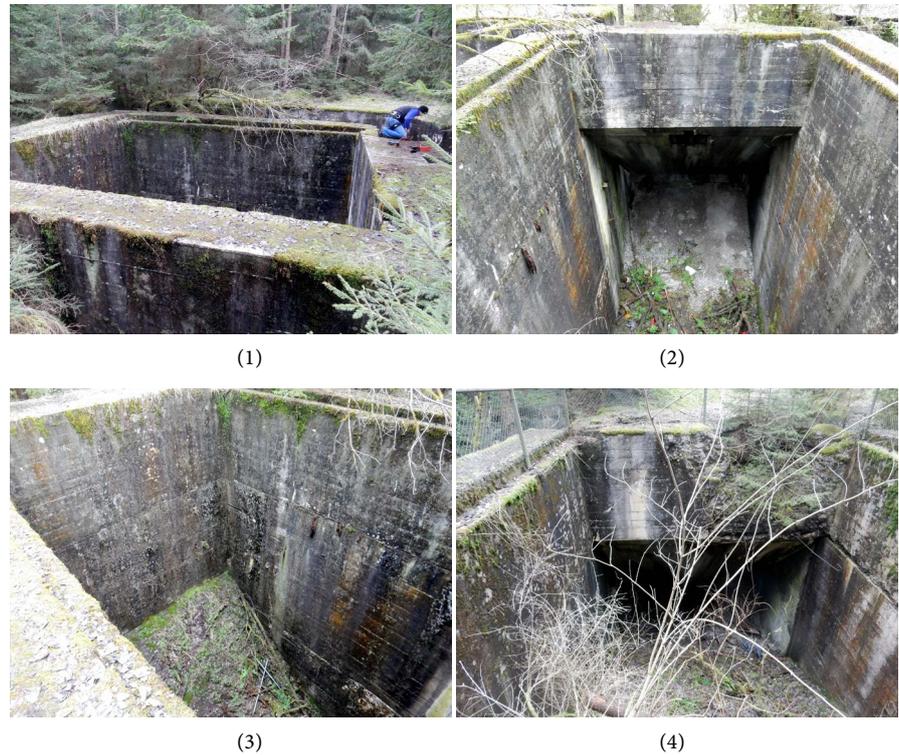
Figure 9. *Weingut I*—(1) first air intake/exhaust, square internal wall; (2) well entrance toward *Weingut I*; (3) well inclined floor; (4) second air intake/exhaust.

A first and a second air intake/exhaust opposed to the *Weingut I* axis were identified. Each presented an external square wall about 20 × 20 m and 3 m high. Its concrete structure was in good preservation state showing construction formwork element traces. Armour iron extremities protruded from the upper portion. The internal square wall was about 10 × 10 m, about 3 m high and 2 m thick with lowered inner edges. Its concrete structure was in good preservation state showing construction formwork elements traces. The internal wall protected a well about 10 m deep with the floor inclined toward the *Weingut I* interior (**Figures 9(1)-(4)**).

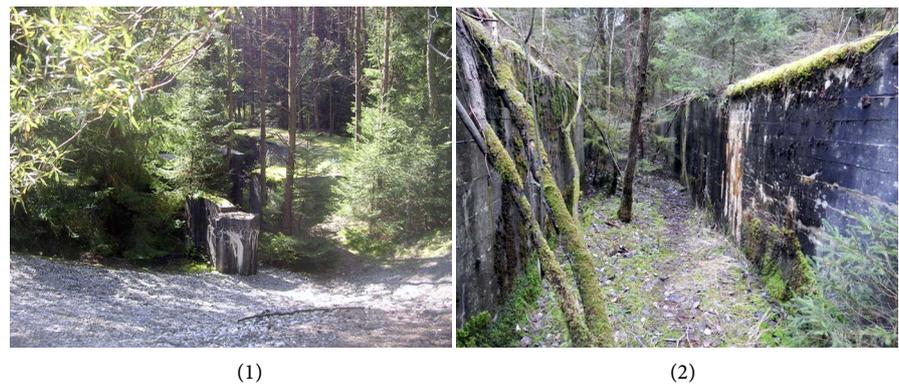
Figure 10. *Weingut I*—rectangular concrete construction: (1) entrances; (2) internal space.

Near the 7th arch rear side not far from the fallen and attached parts was an elongated rectangular concrete construction comprising a first entrance, a short corridor, a second entrance perpendicular to the first entrance and an internal elongated rectangular space. Its structure was in a good preservation state with traces of the construction formwork elements. The upper portion hosted protruding armour iron extremities (**Figures 10(1)-(2)**).

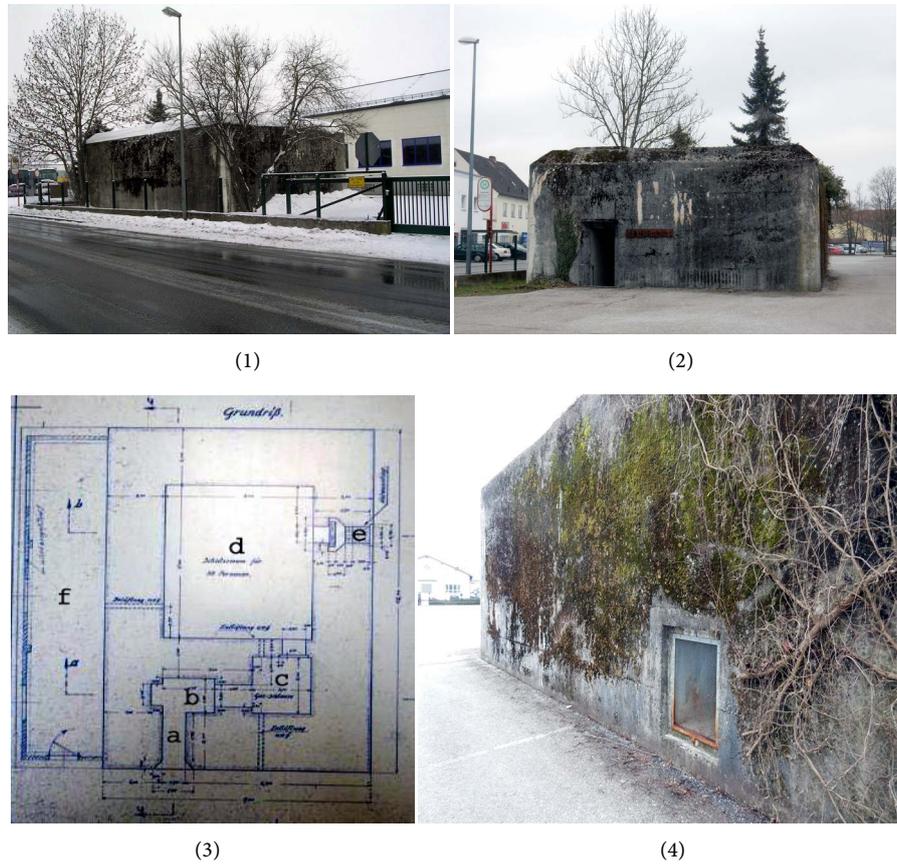
Figure 11. L-S bunker—(1) overview; (2) front side with entrance; (3) bunker plan: (a) entrance corridor, (b) perpendicular corridor, (c) gas lock room, (d) main room, (e) emergency exit, (f) annexed construction; (4) emergency exit, details.

In the nearby Mühlendorf, at about 5 km from *Weingut I*, on the site of the former *PZ* Workshop Mühlendorf, now MBM Industrie GmbH, on 1943 *PZ* built an air-raid bunker (*Luftschutzbunker*, *L-S* bunker) (18° 14' 44.7"N, 12° 20' 25.1"E), 12 × 9 m (**Figures 11(1)-(4)**). It comprised 558.151 m³ concrete and 9111 kg of armour iron. Its basement was 1.20 m thick, the wall thickness 2 m, the coverage 2.50 m thick. The entrance had no anti-gas armoured door. The entrance corridor (a) joined a perpendicular corridor (b) at the end of which was an original armoured door provided with a circular hole grate. The door opened on a gas

lock room (c) in connection with a 5.40×5.00 m main room (d) for the protection of up to fifty persons. On a side the main room had an emergency exit (e). The exterior and the interior structure were in a good preservation state without damages due to combats or bombardments. A construction (f) having an entrance and three windows, hanging on the bunker wall and opposed to the emergency exit wall, disappeared.

The bunker in the nearby Mühldorf was a special construction (*Sonderkonstruktion*) similar to *Regelbau R 501*. Its position on the parking of firm MBM Industrie GmbH ensures a long term preservation, although the annexed construction hanging on a wall disappeared for letting space to the actual Münchner road.

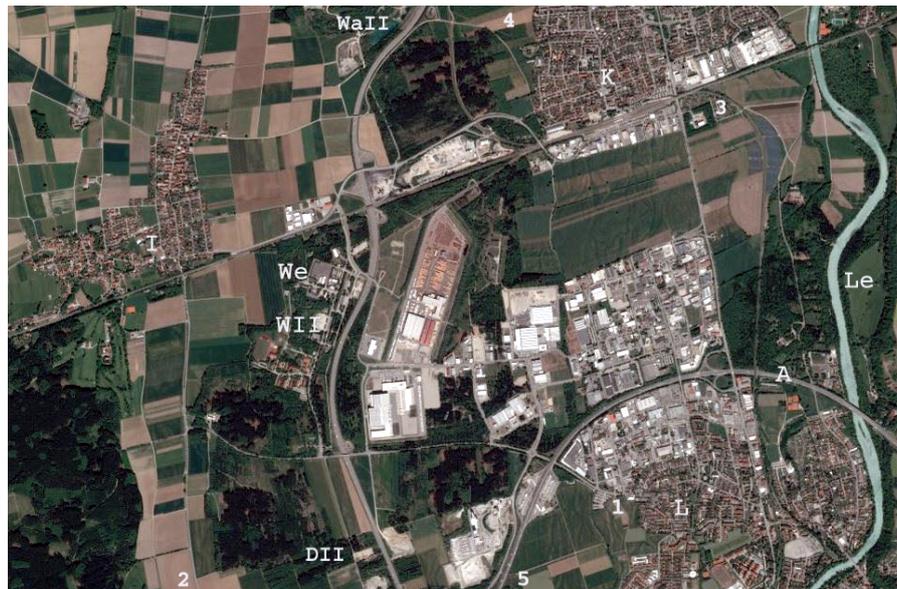
Figure 12. Weingut II area—(1) KZ Kaufering I; (2) KZ Kaufering II; (3) KZ Kaufering III; (4) KZ Kaufering IV; (5) KZ Kaufering XI; A Federal Highway 96; DII: Diana II site; K: Kaufering; L: Landsberg am Lech; Le: Lech; I: Igling; WII: Weingut II site; WaII: Walnuß II site; We: Welfen Barrack (Zoom Earth).

Despite the bombardments of Augsburg on 1942 and Munich on 24th-25th April 1944 which caused 70,000 homeless, in the period March-April 1944 it was decided to locate *Weingut II*, *Diana II*, *Walnuß II* in the nearby Landsberg area (Figure 12), although materials and workers had always to come from the exposed Augsburg and Munich areas.
