The Byzantine Eastern Church of Khirbet et-Tireh

Salah Hussein A. Al-Houdalieh

The Institute of Archaeology, Al-Quds University, Palestine

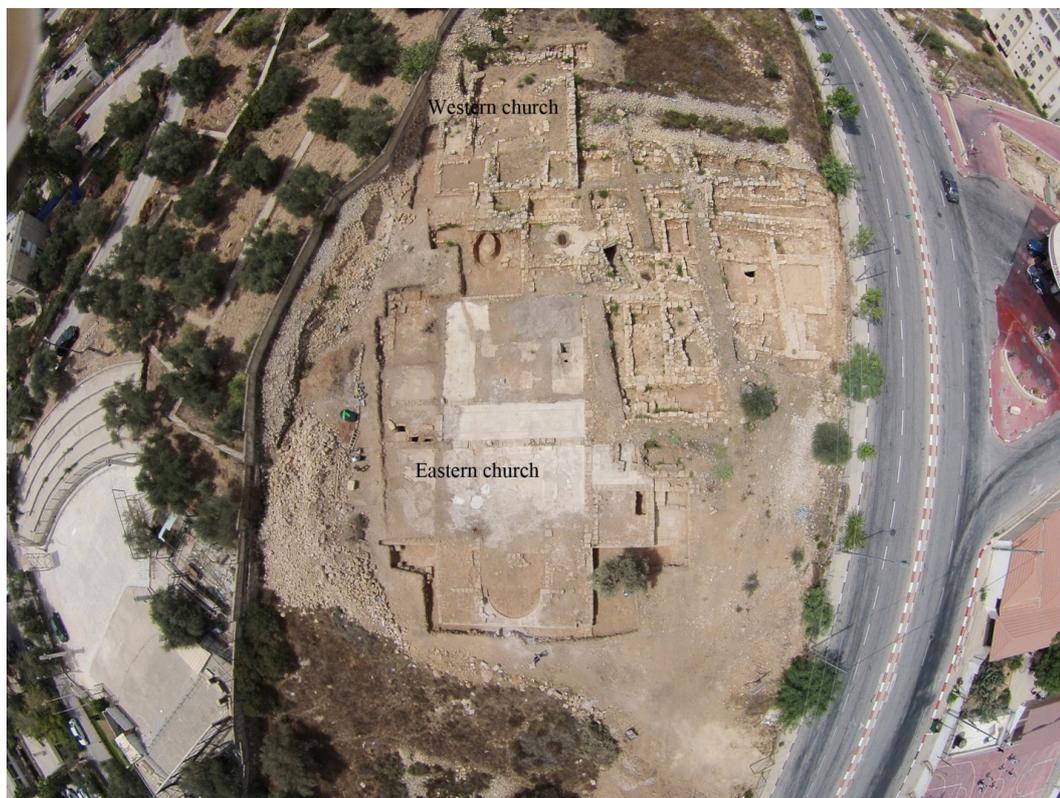
Figure 2. The areas excavated at Khirbet et-Tireh by the end of the third excavation season (photo by Khmees Al-Masri).

Two churches were excavated at the Khirbet, named by us according to their locations in relation to each other: the western and eastern churches (**Figure 2**). Most of the space of the western church was unearthed in the 2013 excavation campaign, however a new section of its southeastern extent was unearthed during this third campaign (2015), with a small section as yet hidden beneath a large heap of stones. This church follows a basilical plan and consists of two main parts, northern and southern. The northern part consists of a narthex and a main hall. The internal measurements of this part are 16.2 m × 9.2 m. The narthex measures 9.2 m × 2.5 m, with two doorways providing entry on its northern and southern ends. The main hall is divided by two rows of columns into a nave and two aisles. The entire area of this part of the church was once paved with mosaic carpets consisting of simple geometric designs, with the richly colored tesserae encompassing various shades of white, black, gray, orange, and pink (Al-Houdalieh, 2014). The southern part of the western church, which is only partially excavated, consists of a narrow hall connected with the church proper via two doorways. The hall's internal measurements are 2.15 m wide and its length might reach 12 m. The unearthed area of this hall is paved with well-cut stone slabs of different sizes, some of them measuring 1.2 m × 0.7 m.

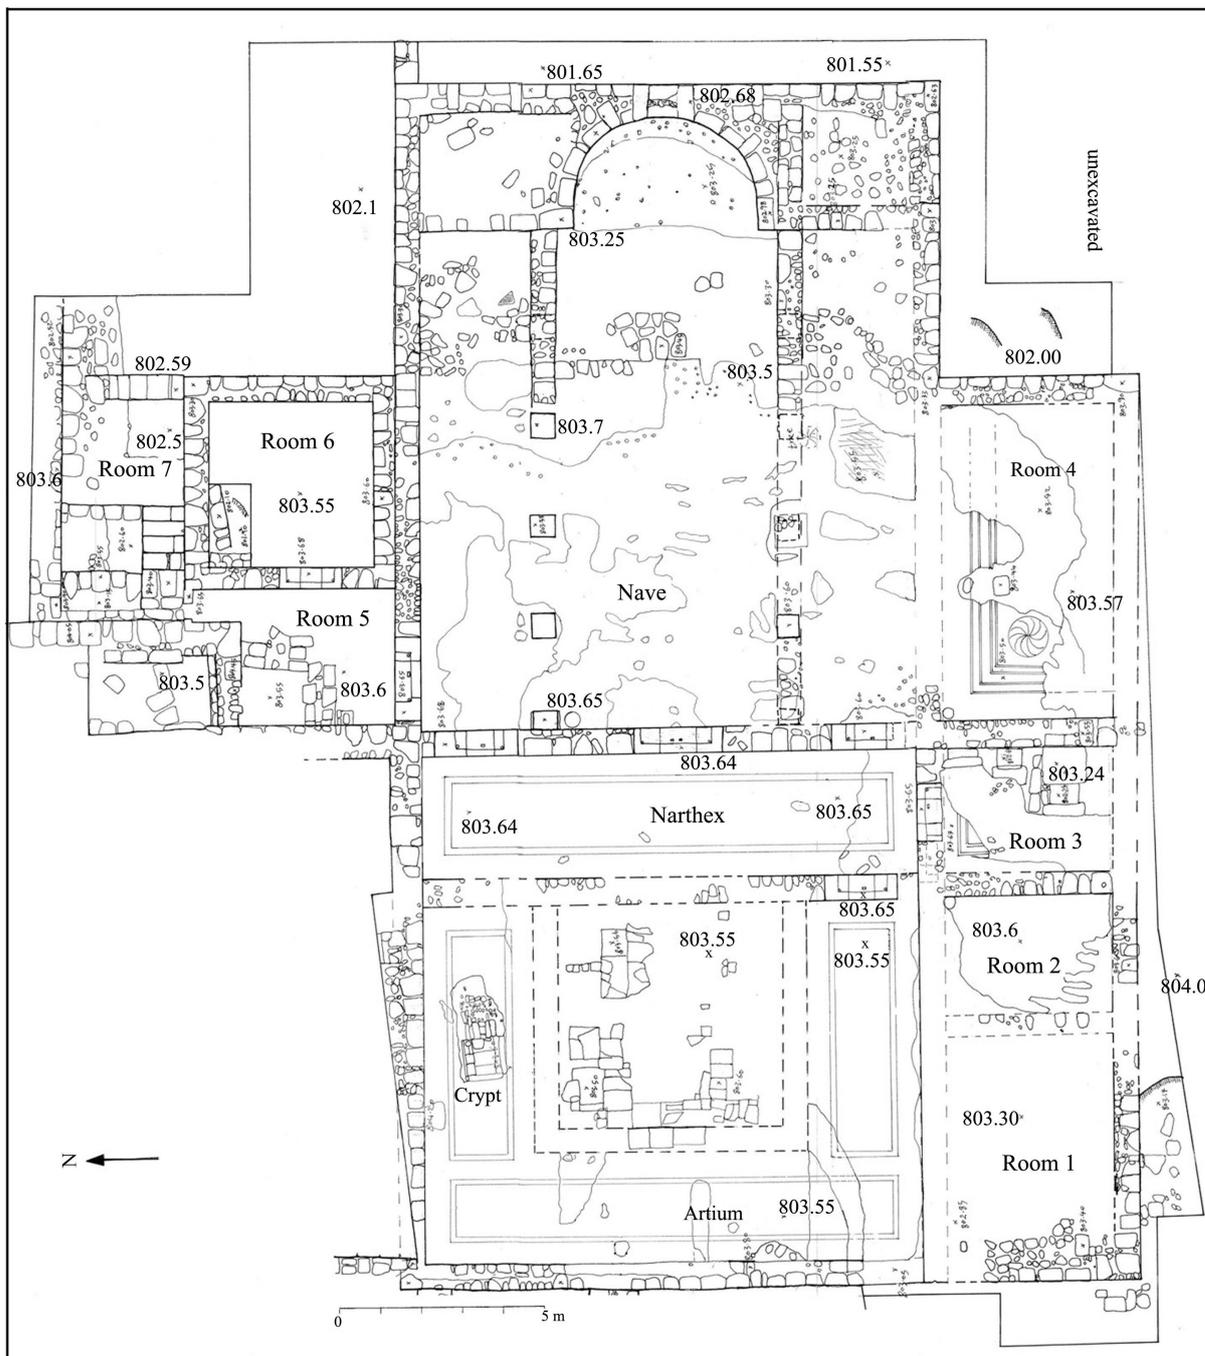
Figure 3. Top plan of the eastern church of Khirbet et-Tireh (drawing by I. Iqtait).

The external measurements of the unearthed part of the church complex are approximately 28.5 m long along its east-west axis and 25.5 m wide in its maximum north-south dimension (including side rooms). It follows a basilical plan and its unearthed area consists of five parts: four south side rooms, an atrium; a narthex; a main hall divided by two rows of columns into a nave and two aisles; and three northeast auxiliary side rooms (**Figure 3**). No traces of a doorway were uncovered in the external walls of the atrium or in the southern wall of the south rooms. The only entrance to the church proper found thus far is in the southern wall of the narthex, from Room 3. So, the church might have been approached from the west through an opening in the western wall of Room 1. Even the atrium is accessed only from the narthex, through a wide doorway opening into the southern portico. The eastern wall of the narthex has three doorways which lead into the main hall. The latter is basilical in form with, as mentioned, a central nave and two side aisles; the nave terminates at its eastern end in a single inscribed (internal) apse. From the western end of the northern aisle, a doorway opens into a square room; this in turn provides access to another square room to the east and also another room on the north.

The narthex measures 11.85 m by 3 m, and three entrances in the east wall connect the narthex with the main hall: a large central doorway opens into the nave, and smaller doorways on either side open into the aisles (**Figure 3**). The main hall is divided by two rows of columns into a nave and two aisles. The measurements of the nave are 14.5 m long by 5.35 m wide. Each of the aisles is about half as wide as the nave. Four plinths of the northern row and one plinth of the southern row were found *in situ*, while the remainder had been removed or destroyed completely. Each plinth consists of a single large well-cut and dressed stone of 0.6 m by 0.6 m. The top surfaces of the uncovered plinths stand a few centimeters higher than the level of the floor pavement (although their complete vertical height was not explored). Based on the regular distance between the intact plinths of the northern row and on the total length of the nave, we believe that the two rows consisted of six columns each. The top surfaces of two east-west oriented walls were also traced on either side of the nave, on the hall's eastern and western ends, where the mosaic pavement and its substrate were found completely destroyed. These walls were built of different sized stones to 0.6 m in thickness and run exactly in line with the rows of the columns. Thus, we believe that the two walls run immediately beneath the plinths and were built to create a solid foundation (*stylobate*) for the rows of columns. Related to this, we noted that the adjacent fill deposits below the level of the floor pavement measured up to 1.7 m in thickness (down to bedrock). Finally, traces of two short north-south oriented walls built of different sized stones and measuring 0.6 m thick were uncovered on either side of the apse. Since these walls were destroyed to below the floor level, no evidence of doorways passing through them was identified. However, we believe that the apse was flanked by two small side chambers of equal dimensions, 2.4 m by 2.8 m.

From the church's north aisle a doorway opens into Room 5, which in turn provides access to two other rooms (**Figure 3**), one to the east (Room 6) and the other to the north (Room 7). The internal measurements of Room 5 are 2.8 m × 2.3 m, plus a short corridor 1.2 m long and 0.7 m wide in its northeastern corner. Traces of two perpendicular partition walls were unearthed in the northwestern part of this room. They are roughly built of large and medium-sized stones, immediately on top of the mosaic pavement. These two later walls, together with parts of the original western and northern walls of the larger room, enclose a small square space only 3 square meters in area. Based on archaeological evidence, it is believed that the partitioning of this room occurred after the destruction of the church, to create a living space for a survivor of the earthquake.

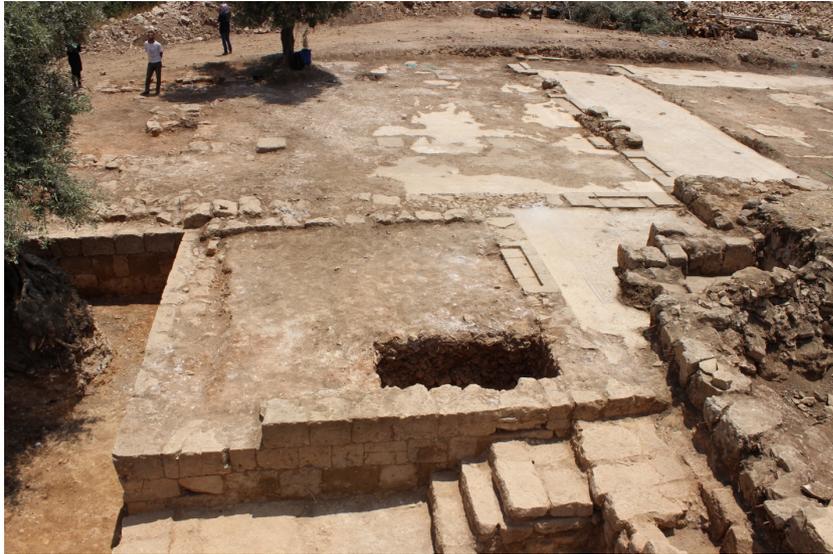
Figure 4. The doorways of the church, looking south (photo by S. Al-Houdalieh).

Within the excavated area of the church, traces of eight doorways were excavated (**Figure 4**). These doorways are quite similar to each other in their ground plan and method of construction, except for the doorway leading to Room 7. Six of the doorways are nearly identical, measuring 1.15 m wide and 0.6 m deep, however the central entrance from the narthex into the nave is considerably wider (1.6 m). Most of them consist of three well-cut and well-dressed pieces of hard limestone forming a sill and splayed jambs. In the corners of the recessed portion of the sills, pivot holes on either side (ca 1.5 cm deep and 5 cm wide) terminate in rounded depressions for the door hinges; rectangular slots (6 cm × 3.5 cm × 1.5 cm deep) in the center of the sill mark the positions of vertical locking bars. The smaller and anomalous doorway to Room 7 has a 0.65 m-wide sill-stone, with only an angular recess along its outer edge and one pivot hole for a door hinge.

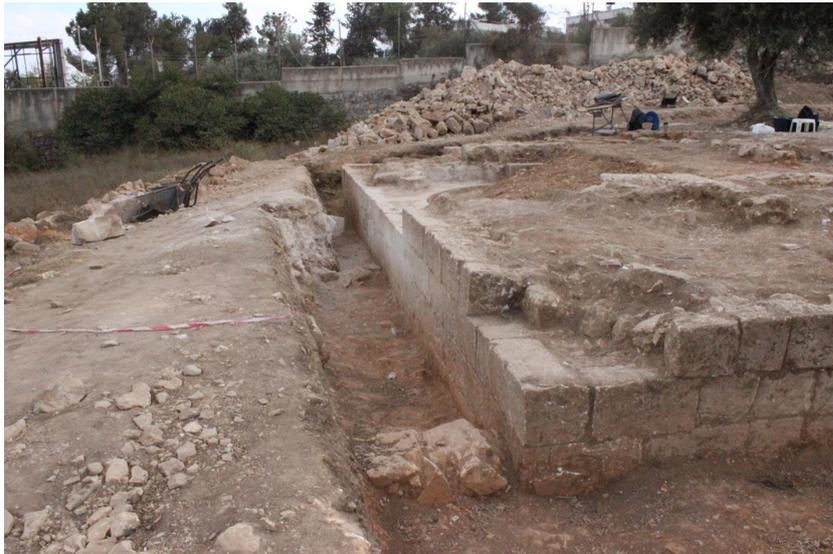
Figure 5. The masonry of the eastern walls of the eastern church of Khirbet et-Tireh, looking south (photo by S. Al-Houdalieh).

0.9 m. The outer walls of the church were built with the exterior face composed of large, dressed stones and the interior face of medium-sized stones bonded with a lime mortar mixed with brownish soil.

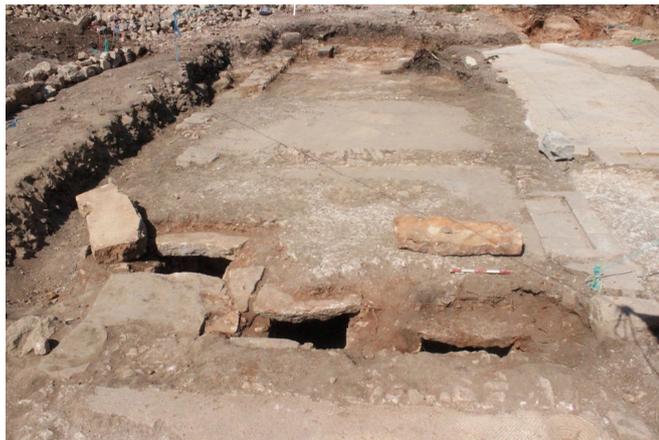
Figure 6. Three ground graves found in Room 3, looking west (photo by S. Al-Houdalieh).

In Room 3, since the eastern part of the mosaic floor and its substrate are totally destroyed, we discovered here three parallel ground graves (Figure 6). They are oriented east-west, extending on the west beneath the intact section of mosaic pavement. The graves are all of the same length (2.2 m) and width (0.75 m); they are most likely of the same depth as well (1.2 m), although only one grave was cleared down to its floor. These graves were found entirely covered with large, unshaped limestone slabs, and the empty space beneath these cover-slabs down to the earthen deposits in the three discovered graves was 0.8 m on average (Figure 7 and Figure 8).

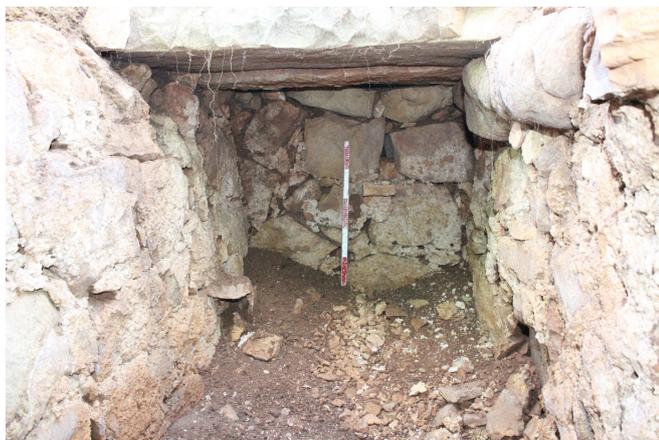
Figure 7. Ground grave 1 (the southern) before excavation, looking west (photo by S. Al-Houdalieh).

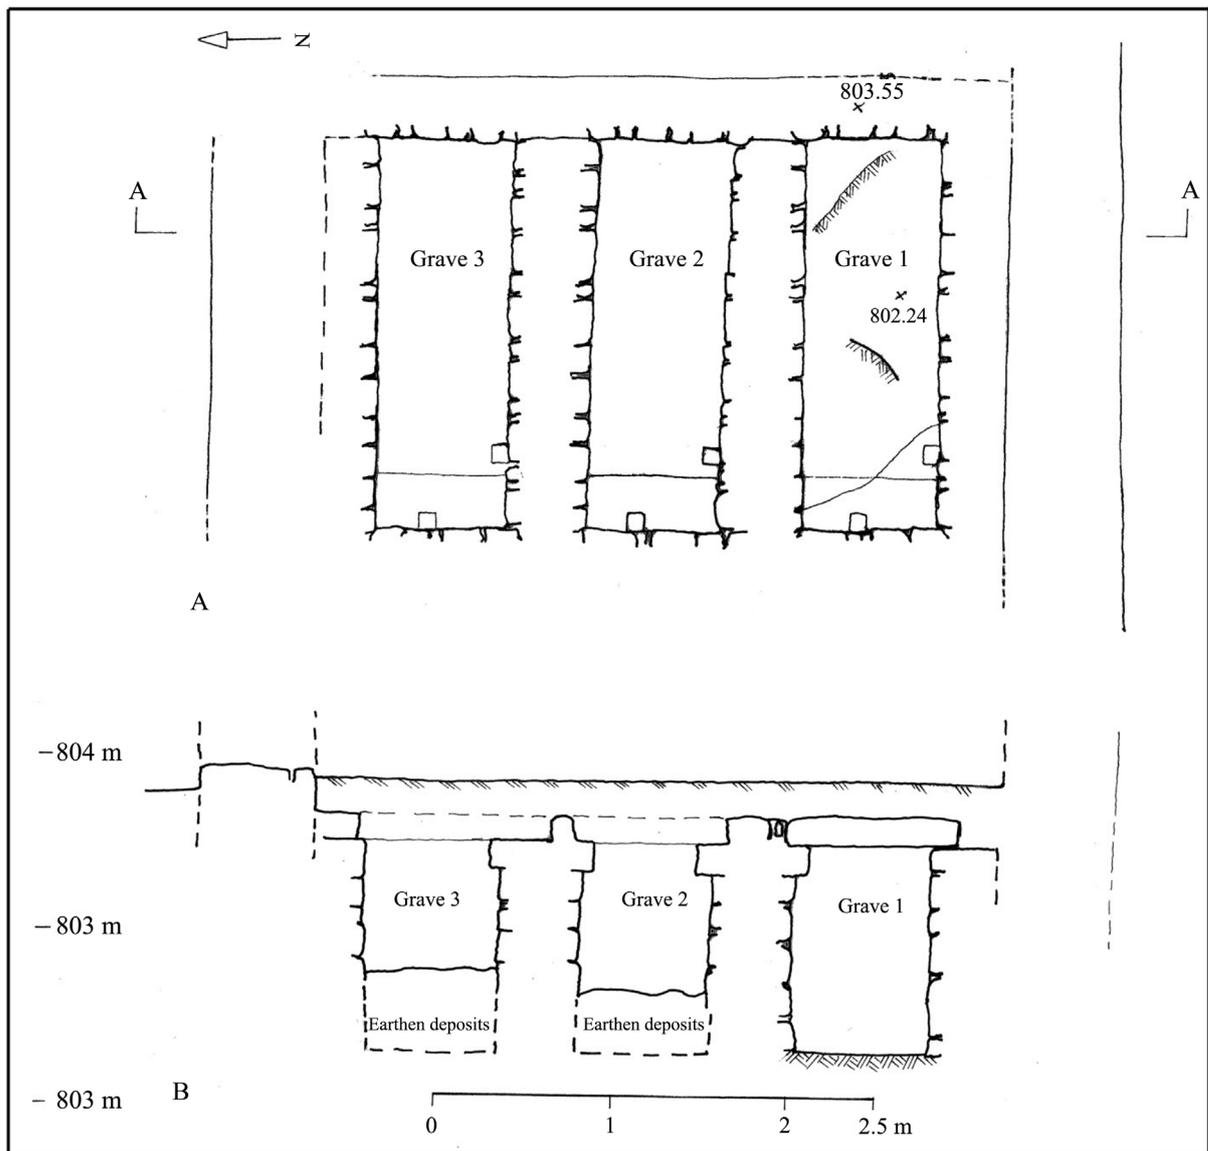
Figure 8. Three ground graves in Room 3, A: Top plan and B: Cross-section A-A (drawing by I. Iqtait).

The grave walls were built of medium-sized and large, roughly worked limestone blocks; they also have projecting stones near their southwest corners to serve as footholds. Remains of two plaster layers were uncovered, either *in situ* on the walls of these tombs or irregularly mixed with the upper surface of the earthen deposits accumulated inside them. The first (older) plaster layer is coarse, consisting of lime applied over small, thin stones to a thickness of 5 cm on average. The second (newer) layer measures 1 cm thick on average and has a polished surface. Due to time constraints toward the end of the excavation season, we fully excavated only one of these three tombs, the southern one. The floor surface of this grave was found covered with a yellowish-brown earthen deposit, 0.35 m thick on average, of the same characteristics as a leveling layer found above, between the covering slabs of the graves and the overlying stone substrate of the mosaic pavement. Therefore, we believe that the deposits in all three graves, being of the same composition and color, infiltrated the graves through the small spaces between the covering slabs during the preparation of the room for tessellating. No artifacts or bones of any kind were found in this one fully excavated grave. We believe that this grave, and probably the other two found in the same room, were constructed at the same time as the adjacent church, to serve as memorials for three different persons.

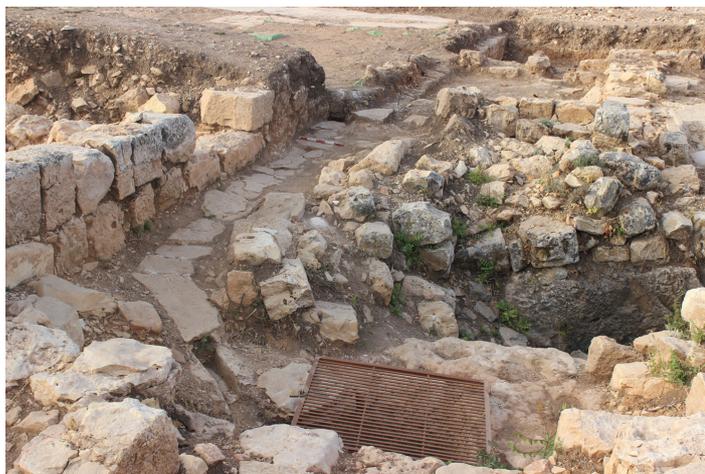
Figure 9. The water channel at Khirbet et-Tireh, looking south (photo by S. Al-Houdalieh).

A channel, mostly intact, leads from the northwestern corner of the atrium to a rectangular cistern opening lying ca. 6 m to the northwest. This uncovered (northern) part of the channel traverses an open space and has been traced for a distance of 6.5 m (Figure 9), while a southern extension (not excavated completely) runs beneath the mosaic pavement just inside the western wall of the atrium. The northern part of this channel measures 0.15 m wide and 0.15 m deep in cross-section, its sides and floor constructed of small stones covered with plaster; the floor gradient descends toward the northwest. The plaster layer consists of lime, ash, grog and small natural aggregates, with a thickness ranging between 8 mm and 5 cm. The channel is covered by stone slabs sealed with lime mortar in between. These slabs covering the northern, excavated part of the channel were laid side-by-side along the western exterior wall of an elongated room (mentioned above), as was the practice during the second phase of the Byzantine period. This would seem to indicate that the channel was constructed after the adjacent room. It is believed that the channel was connected to vertical drain pipes located in the western corners of the atrium and thus used to collect rainwater from the roofs of the building, as well as from the surface of the atrium's courtyard.

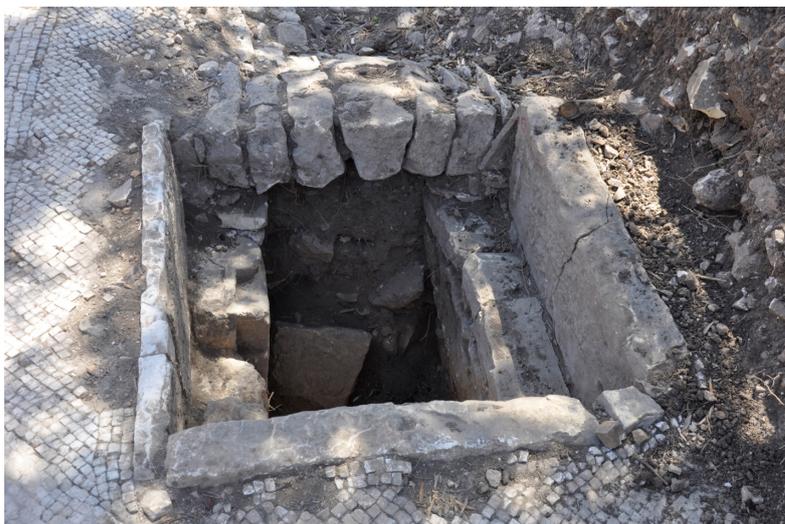
Figure 10. The vertical and the lateral openings of the crypt, looking east (photo by S. Al-Houdalieh).

A crypt was unearthed in the northern portico of the atrium, consisting of a vertical and then a lateral opening, leading down to a subterranean chamber (**Figure 10**). The well-constructed, squarish vertical opening measures 0.85 m × 0.9 m × 1.1 m deep, and its northern, southern and western edges are built of well-cut and dressed stone slabs, with their top edges protruding 1 cm above the level of the mosaic pavement. Going down, this opening is narrowed by shallow ledges installed on either side of a short staircase consisting of two steps descending to the crypt. The two ledges measure 0.85 m long and 0.16 m wide, built of dressed, medium-sized stones, with their top surfaces 0.35 m below the level of the mosaics. The uppermost step is built of dressed, medium-sized stones, while the lower one is cut into the bedrock. It is believed that the two ledges were used to support the edges of stone slabs (or perhaps one large slab) that covered the opening in antiquity. Descending through the opening, the below-floor space opens eastward through another doorway, which is intact and well-preserved, with internal dimensions (in cross-section) of 0.8 m high × 0.5 m wide.

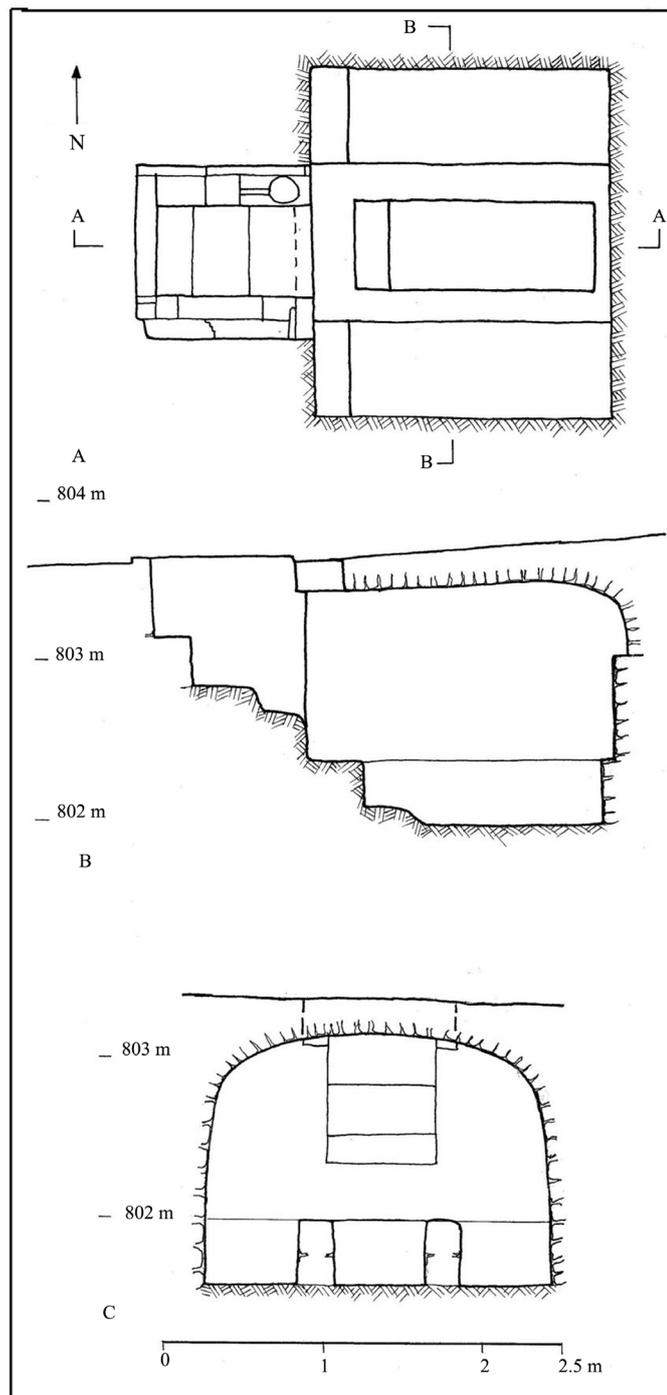
Figure 11. The crypt, A: Top plan; B: Cross-section A-A; C: Cross-section B-B (drawn by I. Iqtait).

The subterranean chamber itself measures 2.2 m × 2 m × 1.55 m high and includes three east-west oriented ground graves separated from each other by upright stone slabs 0.15 m in width (**Figure 11**). The northern and southern graves are similar in shape and size (2 m long × 0.66 m wide × 0.4 m deep), while the middle one is smaller (1.5 m long × 0.55 m wide × 0.4 m deep). The walls of this chamber are constructed of medium-sized, unshaped stones 0.25 m long and 0.2 m wide, while the vaulted ceiling is fashioned from smaller stones (0.2 m × 0.1 m on average) laid carefully edge-to-edge and bonded with a lime mortar; the chamber's ceiling construction served also as the stone substrate of the mosaic pavement directly above. Remains of two plaster layers were uncovered on the walls of the crypt: a base coat and a finish coat. The base layer, 3 to 6 cm thick, was applied so as to render the surface of the walls quite even; where there was sufficient thickness, small thin stones and pottery sherds had been pressed into the mortar while it was wet. The finish coat is 1 cm thick, on average, and has a polished surface. Both layers consist of lime, grog, and small aggregations.

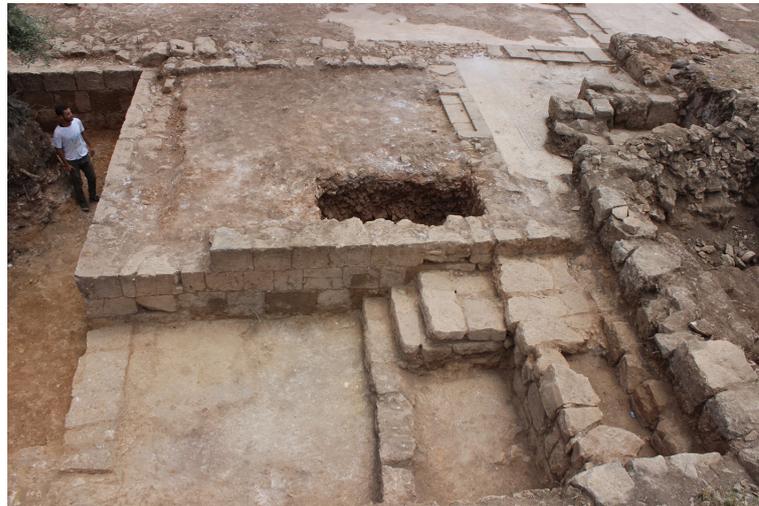
Figure 13. The staircase in room 7, looking south (Photo by S. Al-Houdalieh).

Room 5 also opens to Room 7, through a corridor and doorway located in its northeastern corner. The internal measurements of the Room 7 are 4 m × 2.9 m, and its floor level is 1.1 m below that of the rest of the church complex. A staircase built directly on the plain white mosaic pavement was unearthed in the southwestern corner of this room (**Figure 13**). It is constructed of large, roughly-cut pieces of limestone and consists of two steps

and two landings leading up to the above-mentioned doorway connecting with Room 5. The topmost landing is actually part of a platform built of large pieces of limestone and running the length of the room's western wall. The rest of the staircase is 0.95 m wide and all the risers are 0.22 m in height; the two steps measure 0.3 m in depth and the landing (and platform) between 0.9 m and 1.15 m. The presence of a platform just at the top of this staircase might indicate a further stairway once leading to the roof or to a second story above Rooms 5 and 6. The walls of this room are still standing to a height of 1.1 m on average, except its eastern wall which was dismantled down to the floor level. Thus, there is no actual evidence of an opening in the east wall of the room. Nevertheless, since the level of the remains of a stone pavement in the adjacent area to the east matches the level of the mosaic pavement of Room 7, a doorway in the east wall would be expected.

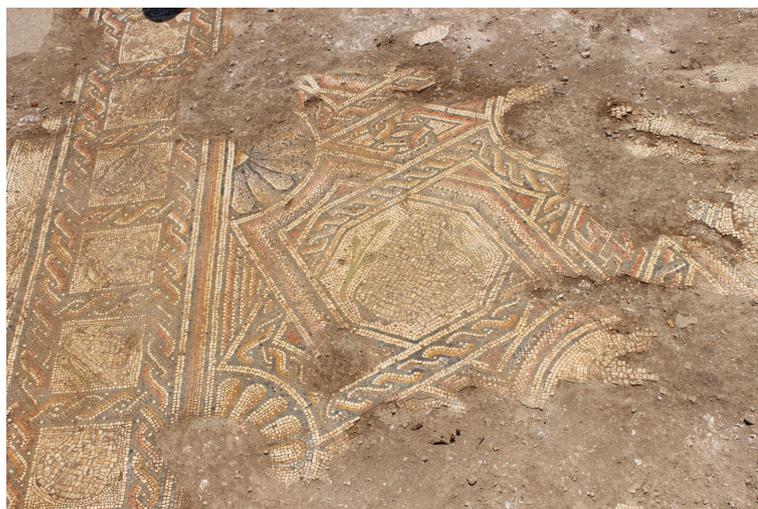
Figure 14. Mosaic pavement of the main hall (looking east), showing iconoclastic alterations (photo by S. Al-Houdalieh).

The mosaic pavement of the main hall is preserved only on the western end, being completely destroyed over the rest of the hall. The tesserae of the main hall are smaller than those in the atrium and the narthex (150 cubes on average per 100 square centimeters) and laid in geometric and figurative patterns of black, grey, yellow, orange, pink, wine red, green and blue, all on a white background. Parts of several mosaic carpets, varying in size, physical condition and decorative pattern, were revealed in this pavement. The pavement of the nave was planned as a single framed unit, but was divided geometrically into panels. It consists of two rows of small panels on the western end, one row of small panels on both the northern and southern sides, and of large carpets in the central areas. Each small panel is framed by a single line of black tesserae and measures 0.28 m square on average; the panels, which feature geometric or figurative patterns, are separated from each other by 0.12 m-wide braids or crosses. All of the figurative ornamentation of this pavement was altered in antiquity and replaced with white tesserae (**Figure 14**). Based on the trace remains of the original figures, and on the shapes filled in by the alteration, we can conclude that the depictions were of human, animal, bird (**Figure 15**), fish and floral figures. A bowl-shaped depression 0.31 m in diameter and 0.2 m deep was found in the northwestern corner of the nave. This depression is tessellated with white cubes and might have been used to hold a jar or to collect water which drained off the floor during cleaning. The remains of the pavements of the two aisles indicate that, unlike the nave, they consisted only of geometric patterns on a white background.

Iconoclasm: Archaeological evidence shows that the mosaic floor pavements suffered from the impact of iconoclasm, which might have occurred during the first half of the eighth century. The mosaics, especially in the nave, were altered: the colored cubes forming human figures, animals, birds or fish were picked out and replaced crudely with white tesserae of a larger size than the original cubes (Figure 14 and Figure 15). The deliberate defacing of the mosaic pavement of Khirbet et-Tireh resembles that of others in the Levant, such as: al-Quwaysmah (Schick & Suleiman, 1991: p. 325-340), Um al-Rasas and Ma'in (Ousterhout, 2001: p. 32-33), Deir al-A'das (Schick, 1995: p. 205-206), Nabha (Ousterhout, 2001: p. 33), 'Ain al-Kanisa (Schick, 1998: p. 87).

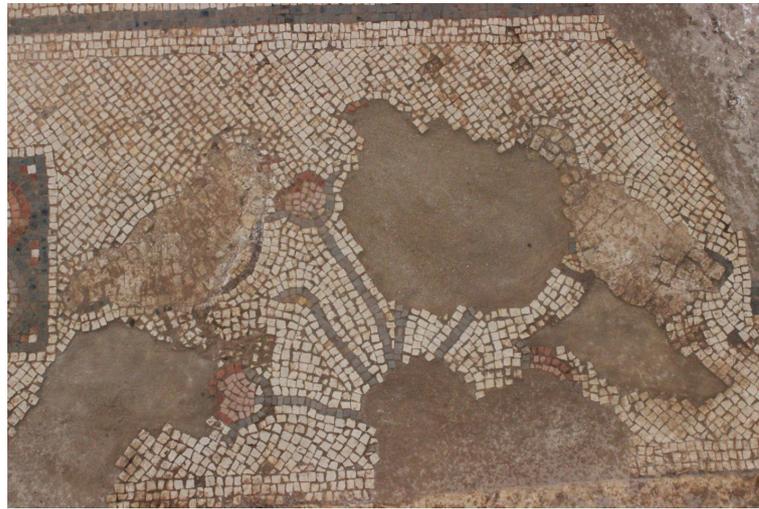
Figure 15. Alteration of two birds flanking a floral pattern (photo by S. Al-Houdalieh).

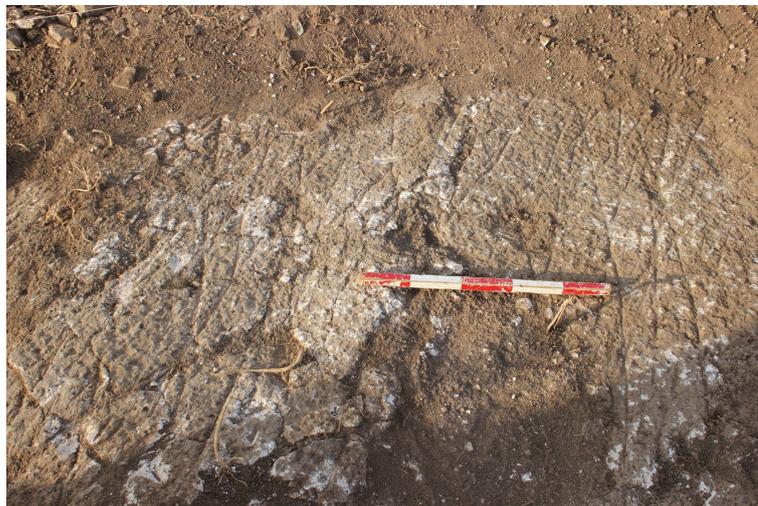
Figure 16. Plow marks in the southern aisle, looking north (photo by S. Al-Houdalieh).

The depth of the earthen deposits found above the mosaic floor pavement of the church ranged from a mere 0.2 m - 0.25 m in the eastern part to between 0.5 m and 1 m in the western part. Not surprisingly then, characteristic plow marks were clearly visible in many areas of the bedding layer of the mosaics (Figure 16). Plowing has contributed dramatically to the damage to the architectural remains of this complex. Indeed, the consequences of plowing are more dire on the eastern area of the church, which stood higher above the surrounding terrain. Thus the process of plowing there precipitated greater erosion as new, deeper layers were disturbed with each subsequent plowing. The plowing carried out in this eastern area of the complex led to the total destruction of the mosaic floors, including the bedding layer, nucleus and statumen.
