# The German Radar Surveillance around the Aber Wrach during the WW II

Giancarlo T. Tomezzoli

**How to cite this paper:** Tomezzoli, G. T. (2017). The German Radar Surveillance around the Aber Wrach during the WW II. *Archaeological Discovery*, 5, 22-41. <http://dx.doi.org/10.4236/ad.2017.51002>

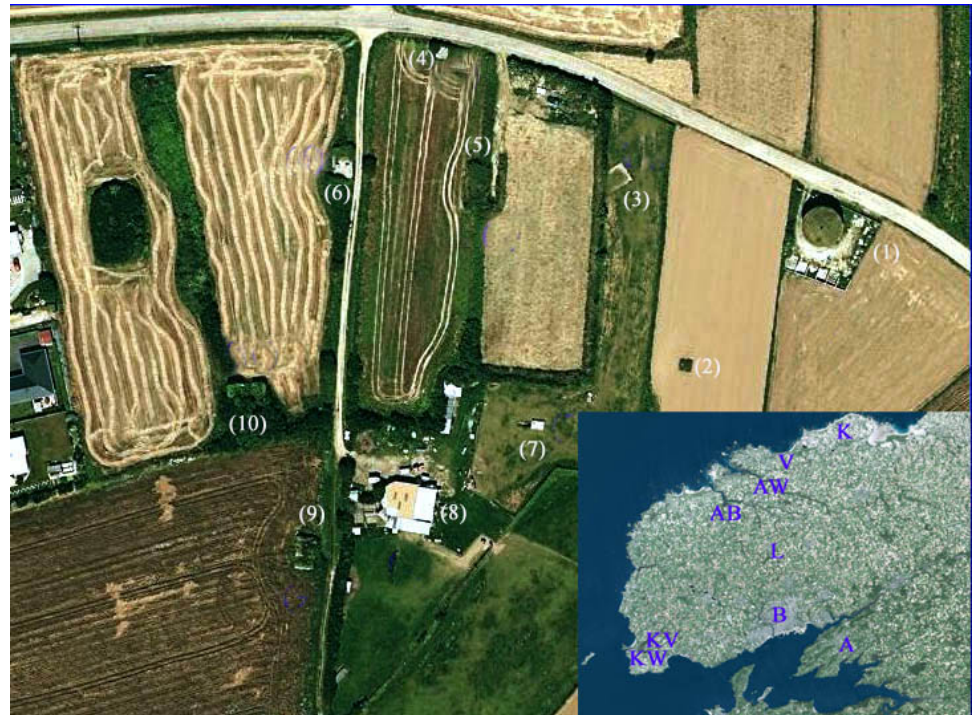
The water reservoir tank (Figure 1, Figure 2(a)) was included in a municipal area dedicated to materials store and recycling. It was formed by a concrete tank of about 15 m in diameter placed on six concrete supports legs about 4 m height. The preservation state of its concrete structure was good without damages due to combats. Linked to conduits, it appeared still accomplishing its function of water supply. Due to its elevation and the absence of a *Flak* emplacement, it is possible that, during the war, it hosted on its coverage only a light machine gun emplacement and/or an observatory. A possible small bunker (2), in a cultivation field, was buried in the terrain and covered by the vegetation. Its type and purpose remained unknown. Bunker (3) (Figure 1, Figure 2(b)) about  $10 \times 5$  m was covered by ground and emerged from the terrain for less than 1/2 m. Its entrance/s was buried in the terrain, so that its interior was not accessible,

**Figure 1.** Keringar Vihan radar base-(1) water reservoir tank, (2) bunker of unknown type and purpose, (3) bunker of unknown type and purpose, (4) bunker of unknown type and purpose at the entrance of the base, (5) bunker of unknown type, probably either troop lodgment, or *Flak* fire control bunker, or a bunker type *I406A* for permanent machinery like power generators, (6) *Flak* bunker, (7) bunker of unknown type and purpose, (8) type 1 split wall emplacement for radar *Freya*, (9) *Flak* bunker, (10) type 5 brick, split wall version for radar *Freya* A Armorique peninsula, AB Aber Benoît, AW Aber Wrach, B Brest, K Kervinagam-Kerdené radar base; KV Keringar Wraz M. K. B Graf Spee, KV Keringar Vihan radar base, V Vougo-Kerizoc radar base, L Lesneven [Geoportail].

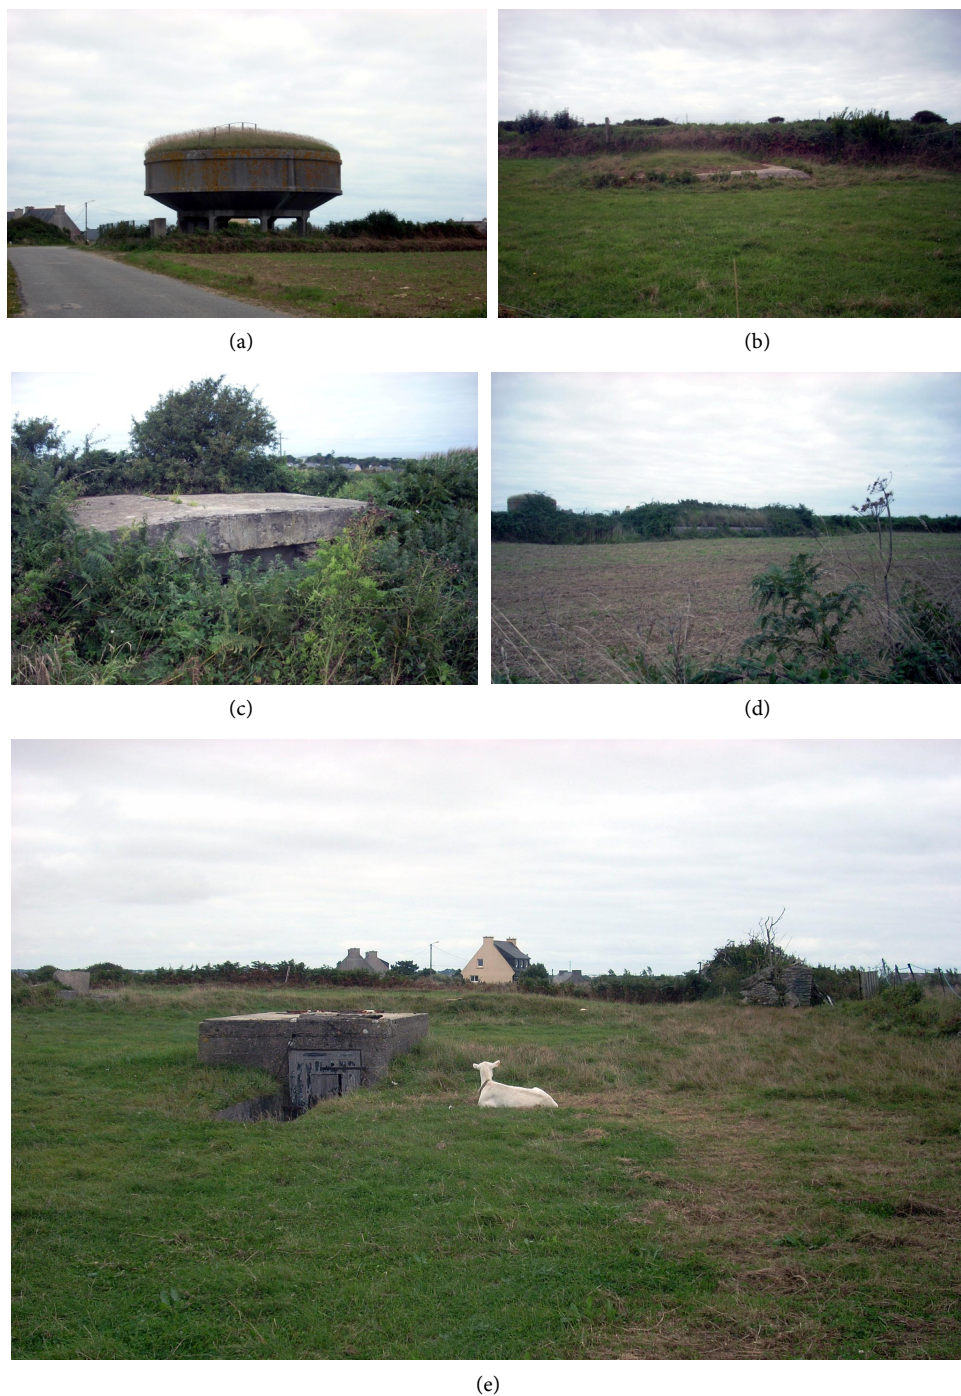
and its type, purpose and preservation state of its concrete structure remained undetermined. The small, square bunker (4) (**Figure 1**, **Figure 2(c)**) about  $3 \times 3$  m, at the entrance of the site, emerged less than 1 m from the terrain and was encircled by vegetation. Its entrance/s was not accessible, so that its type and purpose remained undetermined. The portions of its concrete structure not covered by the vegetation appeared in a good state of preservation without damages due to combats. Bunker (5) (**Figure 1**, **Figure 2(d)**) about  $15 \times 10$  m emerged less than 1 m from the terrain and was completely covered by vegetation. Its entrance/s was buried in the terrain, so that its interior was not accessible and its type, purpose and state of preservation of its concrete structure remained undetermined. Its dimensions suggest either a bunker type *R621*, *R622* or *R656* shelters for one or two group of soldiers, or a *Flak* fire control bunker, or a bunker type *I406A* for permanent machinery like power generators, (6) *Flak* bunker,. The small, rectangular bunker (7) (**Figure 1**, **Figure 2(e)**) about  $4 \times 3$  m emerged about 1 m from the terrain. An inclined ramp gave access to its entrance closed by a wood door, probably not of origin. The access of the interior was not possible, but its isolated position and reduced dimensions suggests a function of ammunition or depot bunker. The preservation state of its concrete structure was good without damages due to combats. No rests of a guard corps and a possible metallic barrier encircling the base re-

**Figure 2.** Keringar Vihan radar base—(a) water reservoir tank of German construction; (b) bunker (3) of unknown type covered by ground; (c) bunker (4) of unknown type at the entrance of the base; (d) bunker (5) possible shelter for a group of soldiers or *Flak* fire control bunker; (e) small bunker (7) possible ammunition or depot bunker.

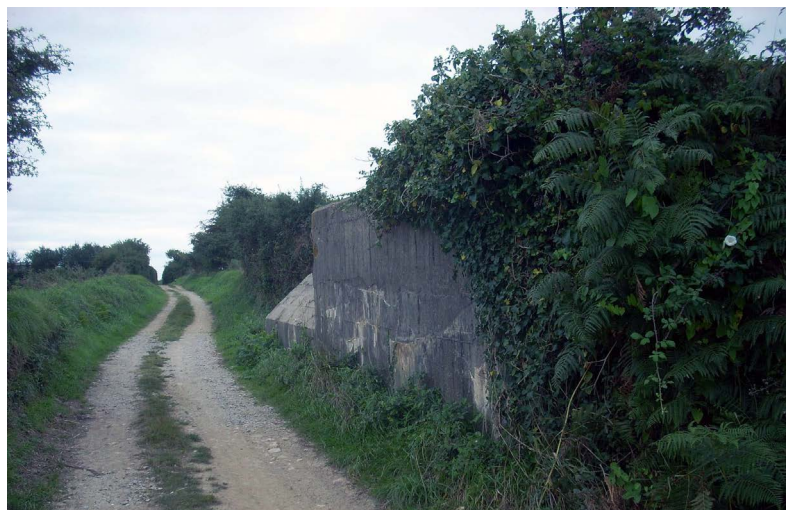
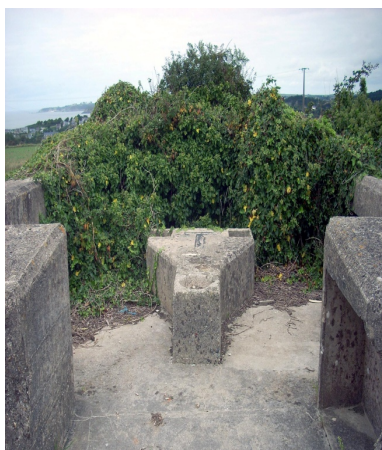
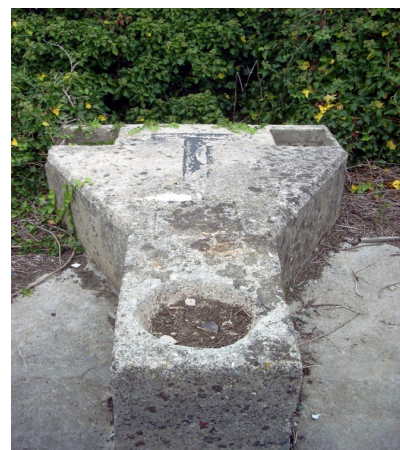
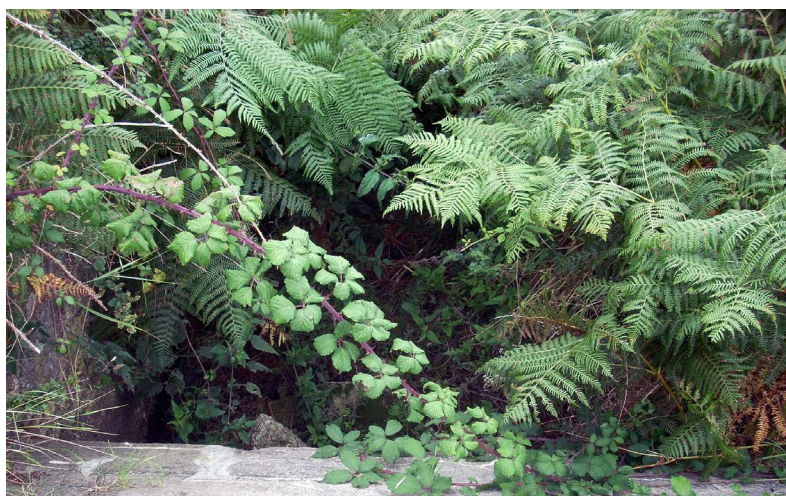
Bunker (6) (**Figure 1**, **Figure 3**), located on a side of the base access road, was a Vf (Verstärkt Feldmäßigen-field reinforced) or a Sk (*Sonderkonstruktion*-special construction) *Flak* bunker. It was partially covered by vegetation which obstructed its apparently unique entrance (**Figures 3(a)-(c)**), so that its interior was not accessible. Its

**Figure 3.** Keringar Vihan radar base-Vf or Sk*Flak* bunker (6)—(a) base access road and bunker concrete structure covered by vegetation; (b) *Flak* gun emplacement, in the middle gun support deprived of gun support joints, on the right ammunition niche; (c) square and round cavities of the gun support; (d) vegetation obstructing the bunker entrance.

coverage, accessible through a metallic stair above the entrance, hosted a square about  $5 \times 5$  m gun emplacement, similar to those of bunkers *L409*, *L410*, for a 37 mm *Flak* gun, with ammunition niches. The gun support presented a triangular shape with two square and one round cavities at its extremities of unknown purpose and no fixation joints for a gun support. The preservation state of the bunker concrete structure, in the portions not covered by the vegetation, was good without damages due to combats.

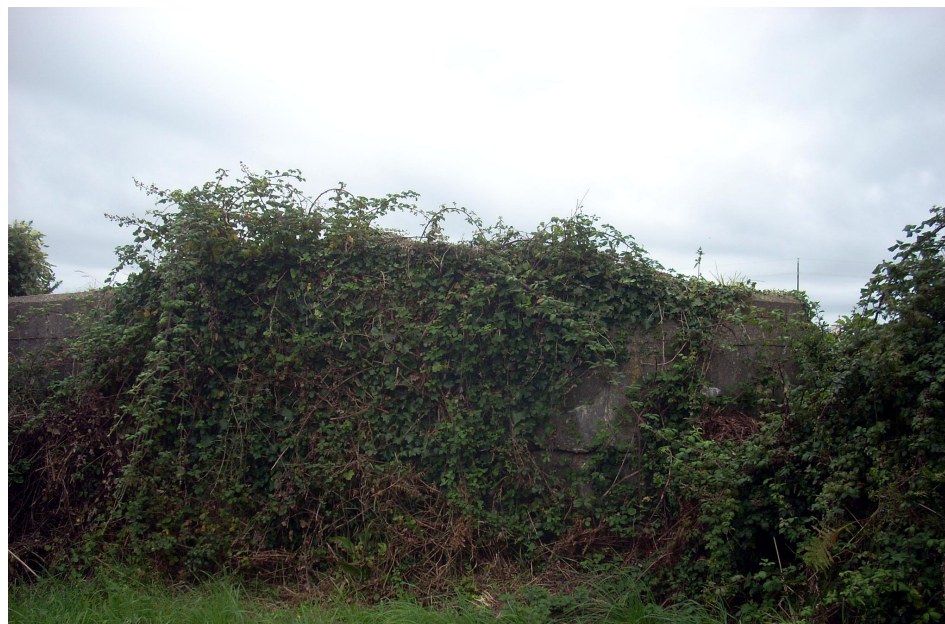
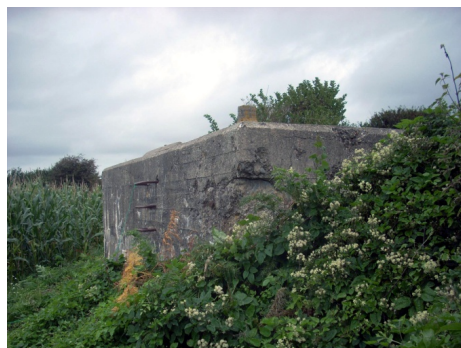
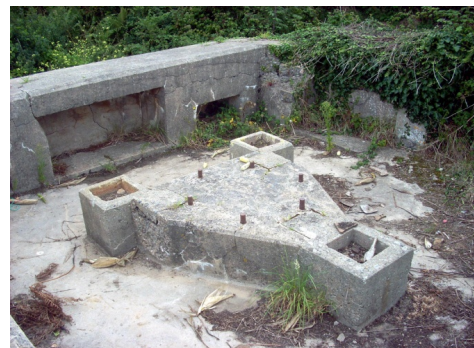
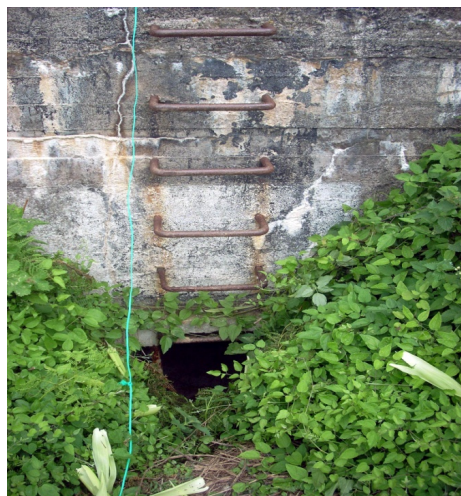
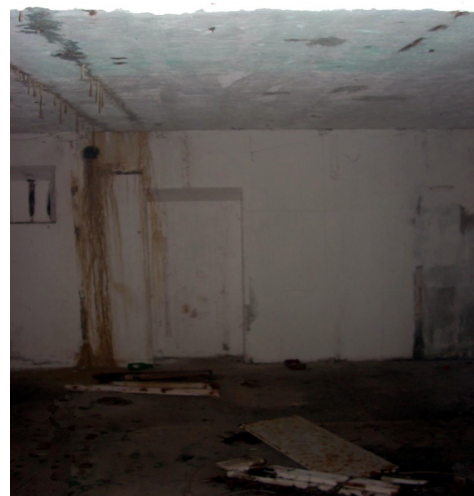
Bunker (9) (**Figure 1**, **Figure 4**), located at the end of the base access road, was a Vf or Sk*Flak* bunker, twin of bunker (6). It was too partially covered by vegetation which fortunately did not obstruct its entrance (**Figures 4(a)-(c)**). Its coverage, accessible through the metallic stair above the entrance, hosted a square *Flak* gun emplacement like that of bunker (6). The triangular gun support presented three square cavities at its extremities and gun support fixation joints disposed along a circle. The visit of the interior showed that it was composed by a large, single room deprived by all the original furniture and no traces of thermal insulation. Its floor was partially invaded by water. The preservation state of the bunker concrete structure, in the portions not covered by the vegetation was substantially good, with the exception, on one side, of impact cavities (**Figure 4(b)**) due to projectiles of small or medium caliber gun.

**Figure 4.** Keringar Vihan radar base-Vf or Sk*Flak* bunker (9)—(a) bunker concrete structure covered by vegetation; (b) metallic stair above the entrance; (c) *Flak* gun emplacement, in the middle gun support with square cavities and circularly disposed gun support joints, on the upper side ammunition niches; (d) bunker entrance; (e) bunker interior with probably original white painting.

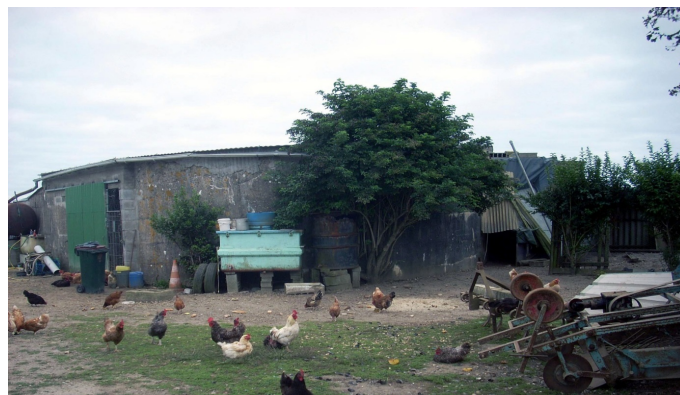
The hexagonal bunker (8) (**Figure 5**) was a type 1 concrete, split wall emplacement for *Freya* radar. The owner of the site, born after the war, therefore an indirect witness, declared that at its origin the bunker was uncovered and that it hosted a radar device, but he appeared also puzzled by the news received by a relative that, during the war, the Germans had no radar. The bunker, was arranged as hen-house and workshop, and presented, in the portions not covered by the vegetation or agriculture materials, a concrete structure in a good preservation state without damages due to combats. The visit of the interior showed a well preserved concrete floor with no V229 support for *FuSE* 65, which confirmed that it hosted the *Freya FuMO 2* Calais B radar (DAWA, 2013) mounted on its leg metallic support. On the floor, some original grooves, probably for radar cables connections, were filled with concrete by the owner after the war. The upper side of an interior wall presented impact cavities (**Figure 4(d)**) due to projectiles of small caliber machine gun. The owner declared that the nearby bunker (10) had, during the war, the same function of bunker (8), suggesting the presence, actual or foreseen, of another *Freya* radar at the base.

The rectangular bunker (10), about  $10 \times 5$  m, was a type 5 concrete, split wall emplacement for *Freya* radar. Its interior, completely filled by debris and vegetation, was inaccessible and, consequently, it was not possible to ascertain whether, on the contrary, it contained a support V229.

**Figure 5.** Keringar Vihan radar base—(a) type 1 concrete, split wall emplacement (8) for *Freya* radar, main entrance on the left, secondary entrance on the right covered by materials; (b)-(c) details of the main entrance of the type 1 split wall emplacement; (d) internal wall with, on the upper side, impact cavities; (e) type 5 concrete, split wall emplacement (10) for *Freya* radar.

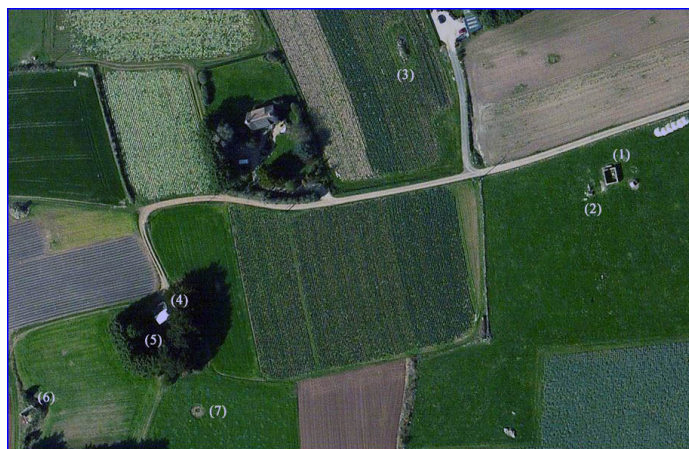
**Figure 6.** Kervingam/Kerdené radar base—(1) *Freya* radar emplacement, (2) ruins of an antenna emplacement, (3) ruins of a possible observatory, (4) residence, (5) megalithic stone circle, (6) observatory, (7) possible anti-aircraft gun emplacement [Zoom Earth].

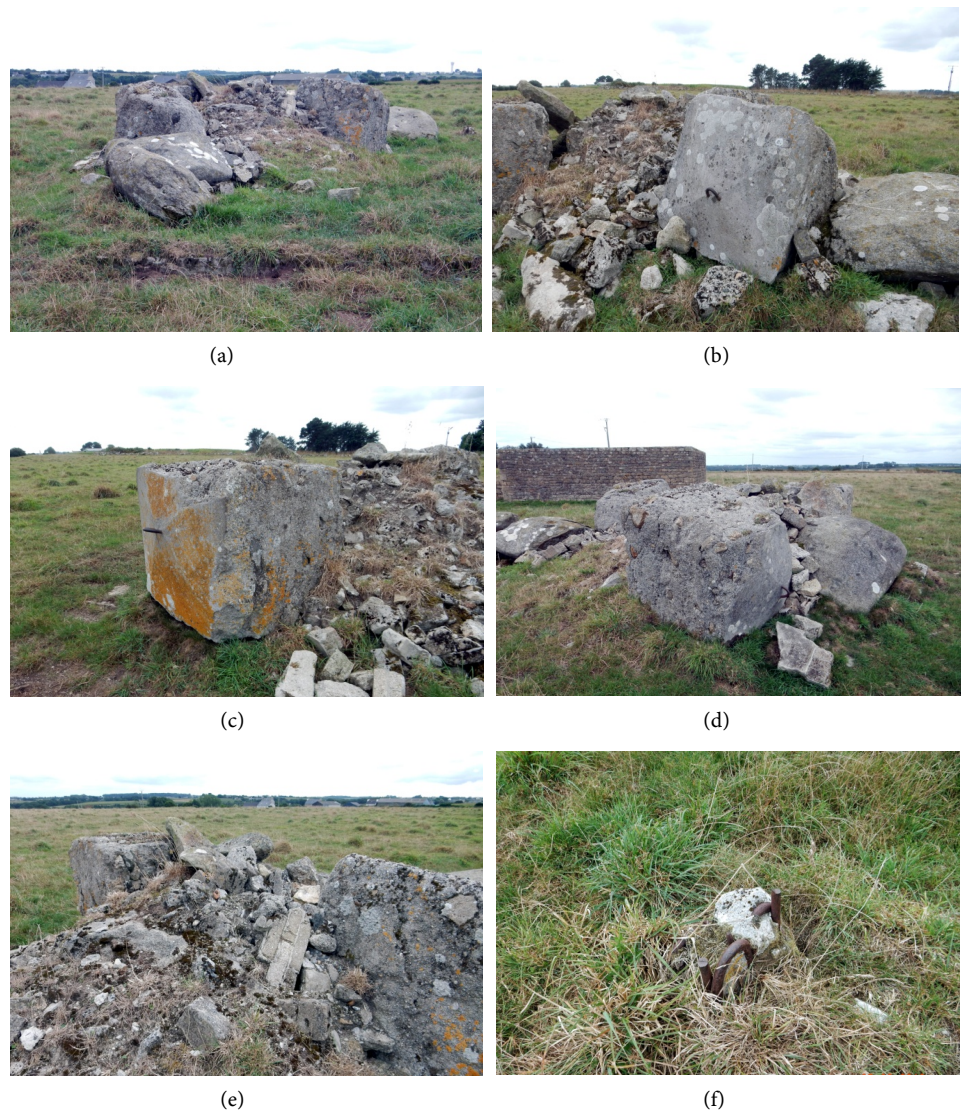
About 10 meters away from the *Freya* emplacement, a heap of stones marked the presence of an antenna emplacement (Figure 6, Figure 8). It was constituted by a single antenna support and three concrete, cubic blocks for antenna anchoring cables. The antenna support, in its original position, presented a crumbled concrete structure due to the antenna eradication or blasting. The anchoring blocks preserving their original concrete, cubic structure and originally located far from the emplacement, were collected on the support for facilitating field cultivation. The single antenna support and the three anchoring blocks suggested a vertical telecommunication antenna of unknown type and height, which, although close to the emplacement, has not obstructed the northern coastal surveillance sector of the *Freya* radar.

**Figure 8.** Kervingam-Kerdené radar base—(a) heap of stones; (b) crumbled support structure and first concrete, cubic anchoring block; (c) second concrete, cubic anchoring block; (d) third concrete, cubic anchoring block; (e) crumbled antenna support; (f) anchoring joint in the terrain.

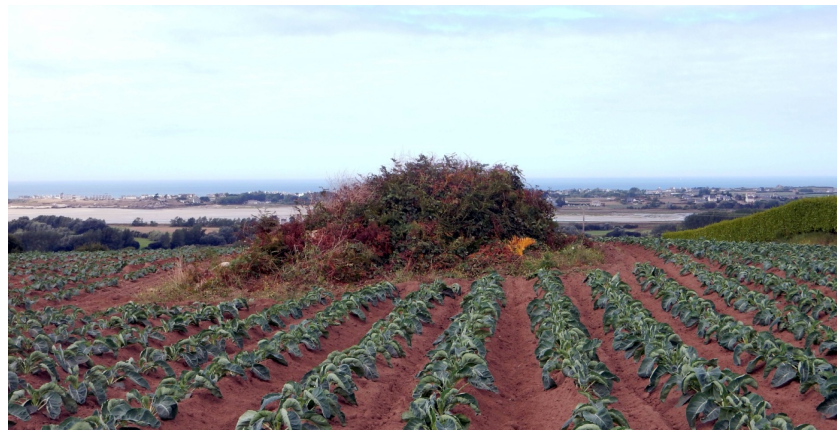
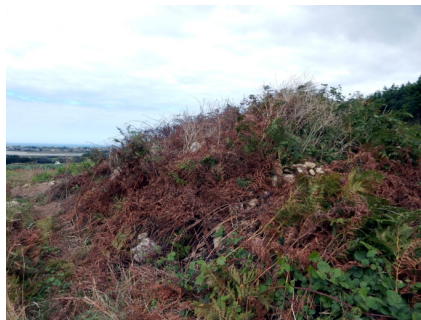
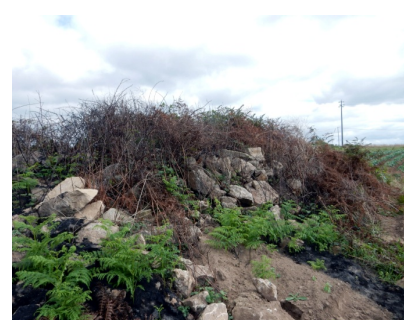
Isolated in a field of artichokes, about 100 m far from the *Freya* emplacement, a heap of stones marked the ruins of a construction (3) (Figure 6, Figure 9). Its much degraded preservation state did not permitted to identify its shape and purpose. It is possible that it was a preexisting small house used by the Germans as observatory for improving the surveillance of the Kerdené coastal sector, dynamited at the retreat of the German troops.

**Figure 9.** Kervingam-Kerdené radar base-possible small observatory (3)—(a) ruins in front of the Kerdené coastal sector; (b) ruins, west side; (c) ruins, east side.

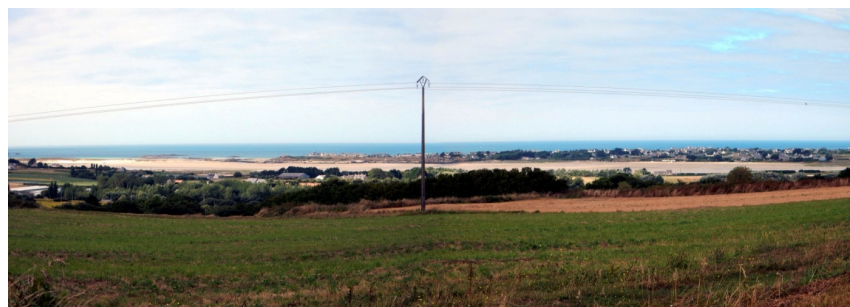
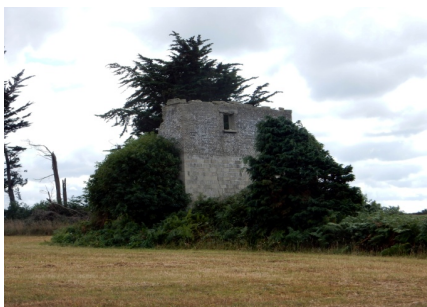
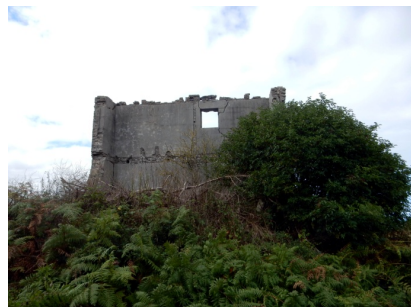
The observatory (Figure 6, Figure 10) was a  $10 \times 5$  m, two floors construction. The stones used for its lower floor and the bricks used for its upper floor (Figure 10(a)) suggested that a preexisting local, one floor house was elevated by one floor by the Germans and provided with an observation window. The observatory structure was rather degraded: the rear portion was collapsed and covered by the vegetation. The collapse reason, i.e. structural failure, combat damage or blasting, remained unknown.

**Figure 10.** Kervingam-Kerdené radar base-observatory—(a) surveilled coastal sector; (b) front side with observation window; (c) collapsed rear side covered by the vegetation.

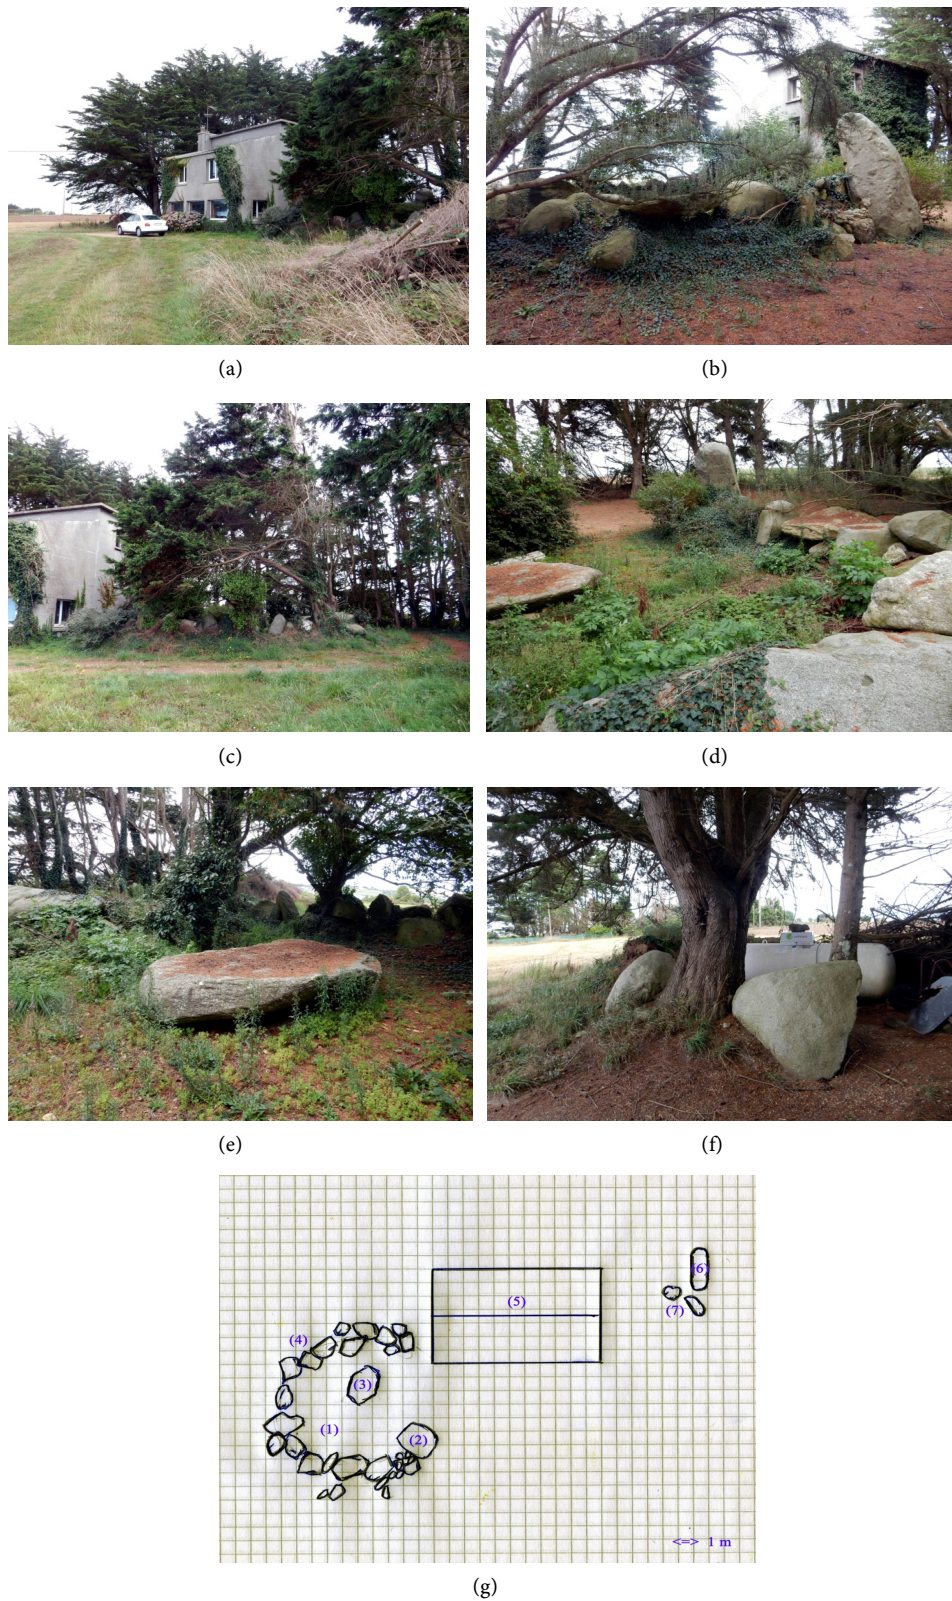
It is not infrequent in visiting German military structures in Brittany to discover rests of much more ancient megalithic constructions. In the case of the Kervingam-Kerdené radar base, the visit allowed to discover, close to a residence, a megalithic stone circle or horseshoe stone circle or *cromlech* ( $48^{\circ}38'17.32''\text{N}$ ,  $4^{\circ}11'49.57''\text{W}$ ) (**Figure 11**). Certainly

**Figure 11.** Kervinam-Kerdené megalithic stone circle—(a) residence; (b) stone circle south side, on the right the *menhir*; (c) stone circle north side; (d) internal area with the *menhir* in the middle and the recumbent stone on the left; (e) recumbent stone and internal area north side; (f) stone circle plant: (1) internal area, (2) portal *menhir*, (3) recumbent stone (4) stone circle, (5) residence, (6) Antargaz cisterna, (7) east stones.

known by the proprietors and visitors of the residence, nobody was present on the site for confirming its authenticity. Located on the top of the plateau, about 60 m a.s.l., hosting the radar base, it is not mentioned in the literature considered (*Patrimoine Region Bretagne, 2003a; Burl, 1985*). It was formed by a stone circle (4) of about 12 m in diameter, comparable with the diameters of about 20 m of the similar recumbent stone circles in Scotland and Ireland. The circle was provided with a portal about 4 m wide, with, as flanker, a 2 m high *menhir* (2). The difference between this stone circle and the recumbent stone circles in Scotland and Ireland resides in the recumbent stone (3) of about  $3 \times 2$  m located not on the south-west side of the circle, but rather in its internal area. No relief or other decoration was remarked on the recumbent stone and the *menhir*. The determination of the stone circle age was not possible, but, if authentic, according to the ages of the stone circles in Britain, Ireland and Brittany (*Burl, 2000*) (*Burl, 2010*) it could be ascribed to a period comprised between 3300 and 900BC.

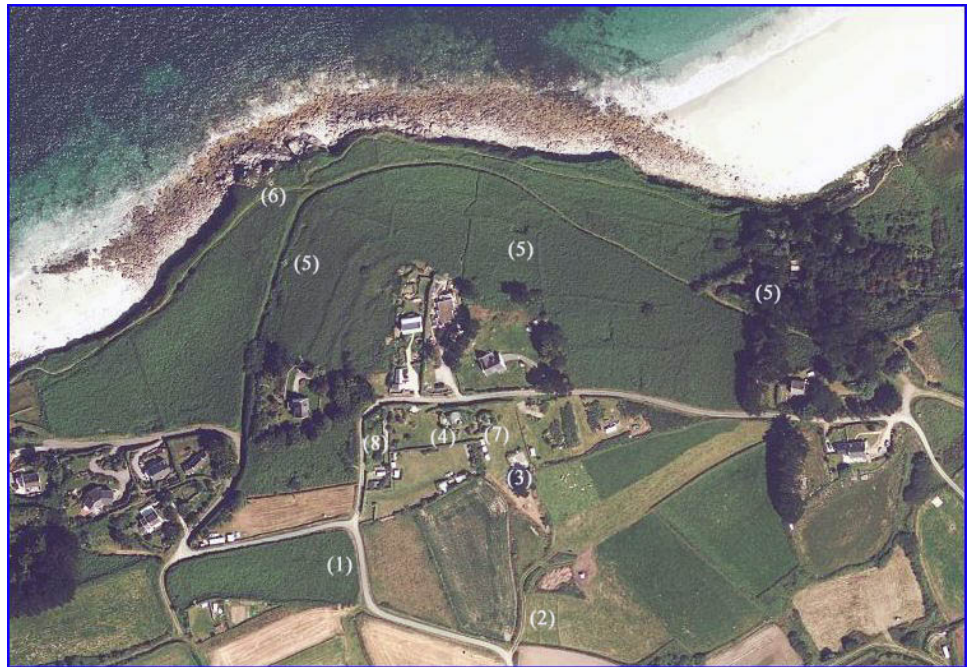
**Figure 12.** Vougo-Kerizoc St.P. AV 24 radar base—(1) main road, (2) narrow side path, (3) bunker *L406A*, (4) splitting wall radar emplacement, (5) bunkers covered by the vegetation, (6) gun emplacement (7) radar emplacement without splitting wall, (8) disappeared wooden barracks.

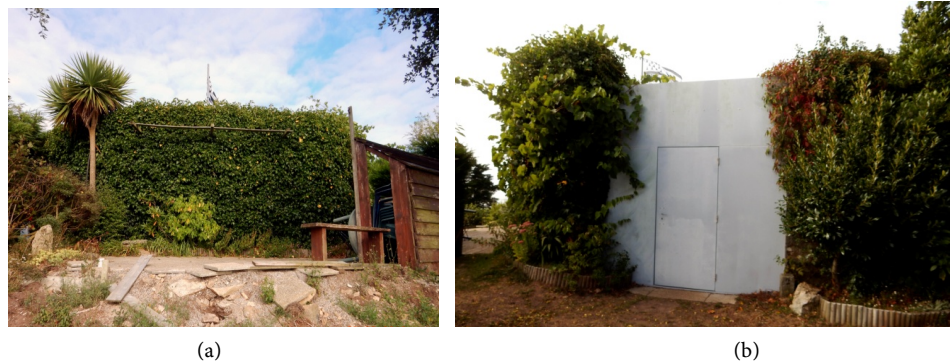
Not far from the *L406A*, he indicated a type 1 splitter wall emplacement probably for the *Freya FMG40G* (gB) Calais (**Figure 14**). The splitter wall was covered by vegetation therefore the preservation state of its concrete structure remained unknown. The entrance was closed by a modern metallic door and thus not accessible, so that the presence or absence of a *V229* for *FuSE 65* was not ascertained. He did not remember the square radar antenna of the *FMG40G* (gB) but remembered a rotating circular radar near the splitter wall. The antenna diameter he reported, about 3 - 4 m, let think that a

**Figure 14.** Vougo-Kerizoc St.P. AV 24 radar base—(a) type 1 splitter wall emplacement; (b) closed entrance of the splitter wall emplacement.

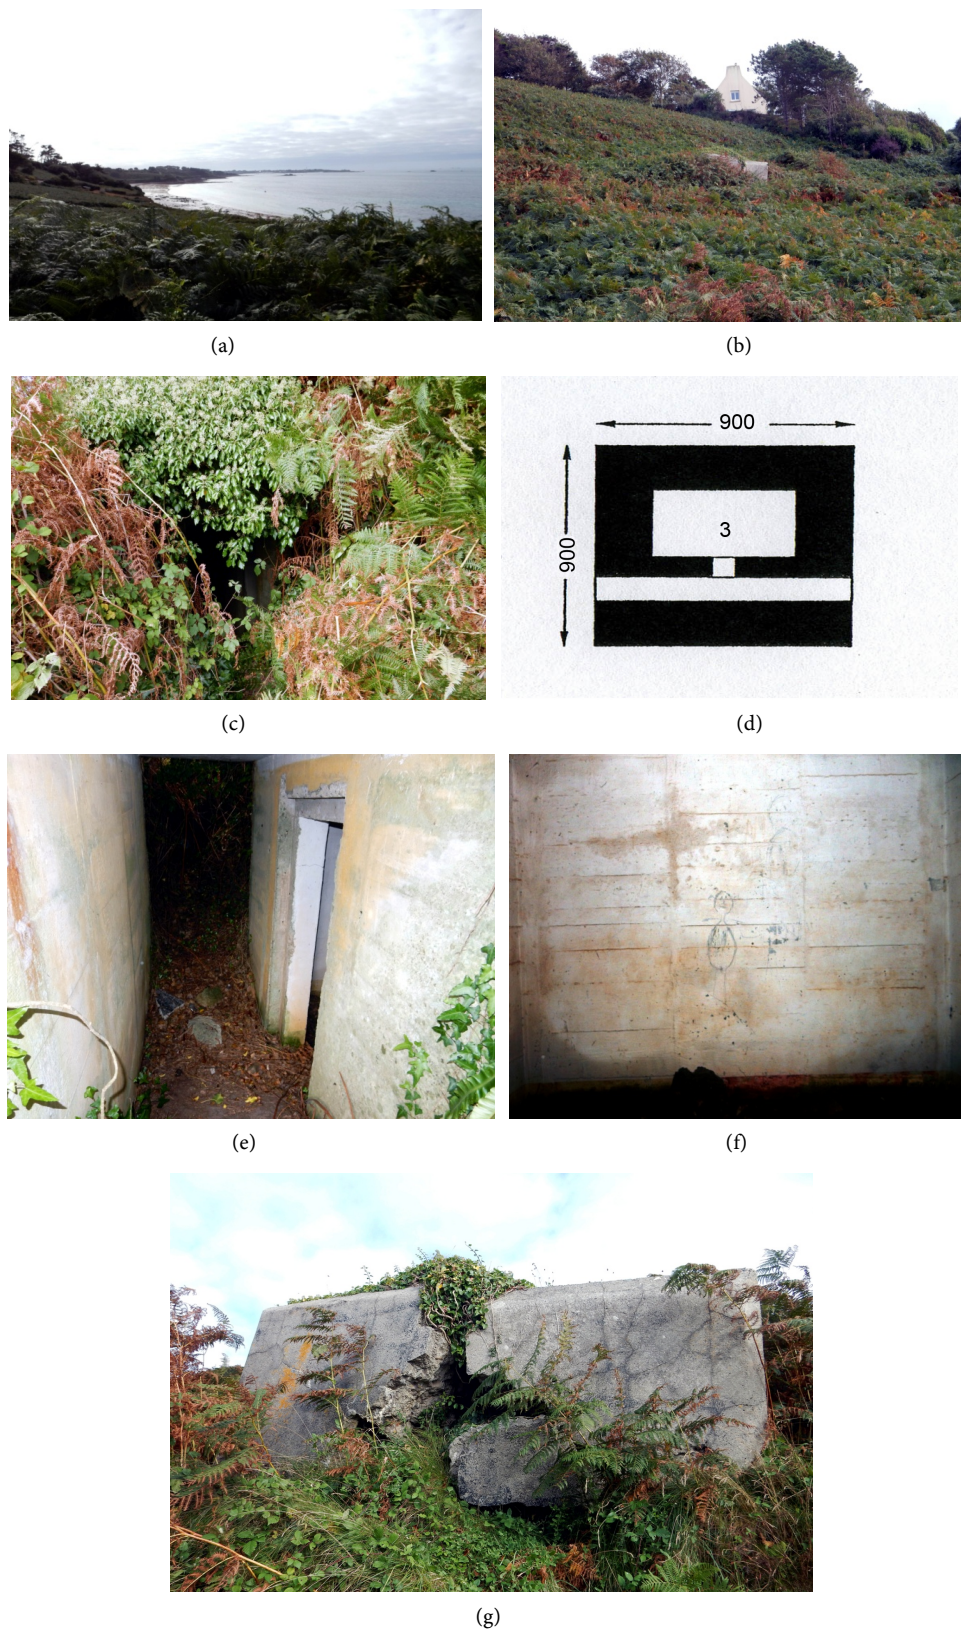
Mr. Gwennec indicated a footpath along the sea coast and declared that some bunker, buried in the terrain or covered by the vegetation, were located along it. He indicated one small bunker rather far from the pathway (**Figure 15(b)**). Closely surrounded by the vegetation, it was inaccessible and its type remained undetermined. He indicated a hole in the vegetation near the footpath, masking one of the corridor entrances of a bunker type *R702* for a group with small gas-lock, provided with a  $4 \times 3$  m room (**Figures 15(c)-(f)**). The room, deprived of all the original furniture, preserved its original white painting. The absence of traces of a chimney and thermal insulation, let think that it was not intended for lodging a group of soldiers, but rather for storing ammunitions and/or materials. He indicated a small bunker (**Figure 15(g)**) just emerging from the vegetation, presenting a concrete structure severely damaged. He declared this one and several other bunkers were dynamited during the retreat of the Germans troops. This declaration confirmed the execution by the German343. *Inf. Div.*, responsible of the Finistère, of the order KR Ft 4.8.44, 11:21 (RM 45/IV 464, 1944: p. 202), to evacuate the coasts, destroy all the Marine St.P (Stützpunkte-support points) and dynamite devices and light houses.

**Figure 15.** Vougo-Kerizoc St.P. AV 24 radar base—(a) coastal line; (b) inaccessible bunker encircled by vegetation; (c) hole in the vegetation masking one of the corridor entrances of a bunker type R702; (d) R702 plant: 3. crew room; (e) R702 corridor and room entrance; (f) R702 room preserving its original white painting; (g) dynamited small bunker.

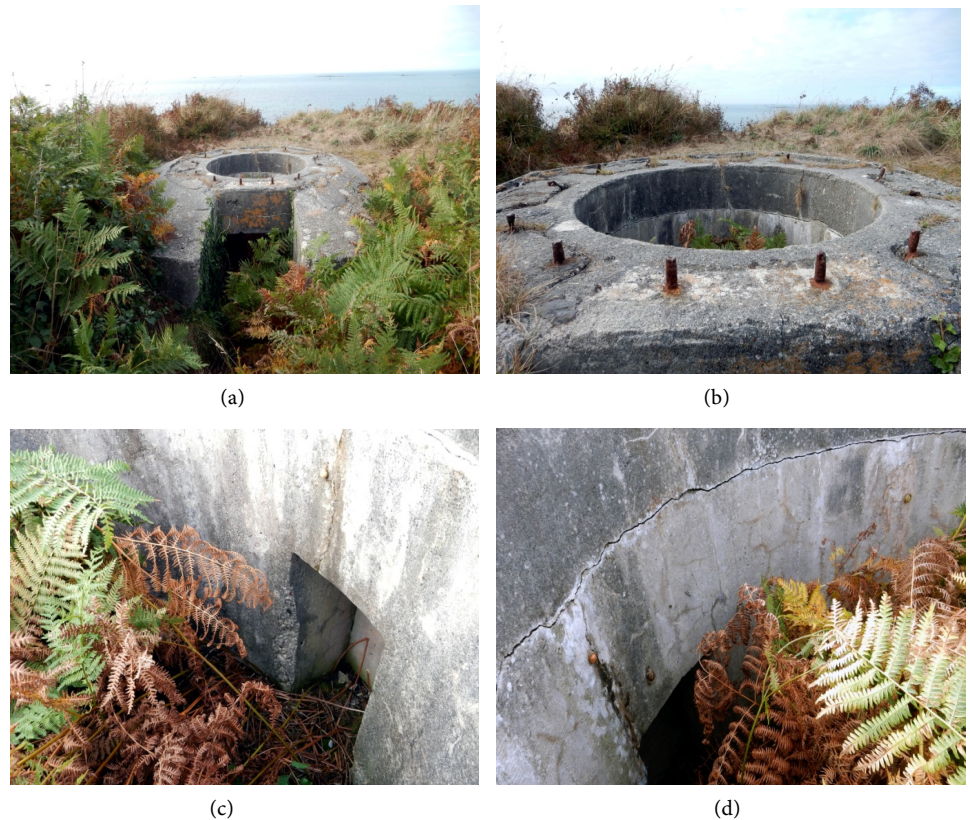
Mr. Gwennec prosecuted along the footpath up to a small gun bunker. It consisted in a well preserved, non-dynamited concrete structure comprising a circular aperture surrounded by circularly disposed gun support joints on its couverture (**Figure 16(a)** and **Figure 16(b)**). Under the couverture, a small entrance gave access to a circular room, partially invaded by the vegetation, hosting ammunition niches (**Figures 16(c)-(d)**). He

**Figure 16.** Vougo-Kerizoc St.P. AV 24 radar base—(a) small gun bunker with circular aperture on the couverture and small entrance to a circular room, in the foreground, barely visible, neighboring reefs (b) circularly disposed gun support joints; (c)-(d) internal circular room with ammunition niches.
