The WW II German *Stützpunkt* on the Menez-Hom (Finistère-FR)

Giancarlo T. Tomezzoli

How to cite this paper: Tomezzoli, G. T. (2017). The WW II German *Stützpunkt* on the Menez-Hom (Finistère-FR). *Archaeological Discovery*, 5, 224-237. <https://doi.org/10.4236/ad.2017.54013>

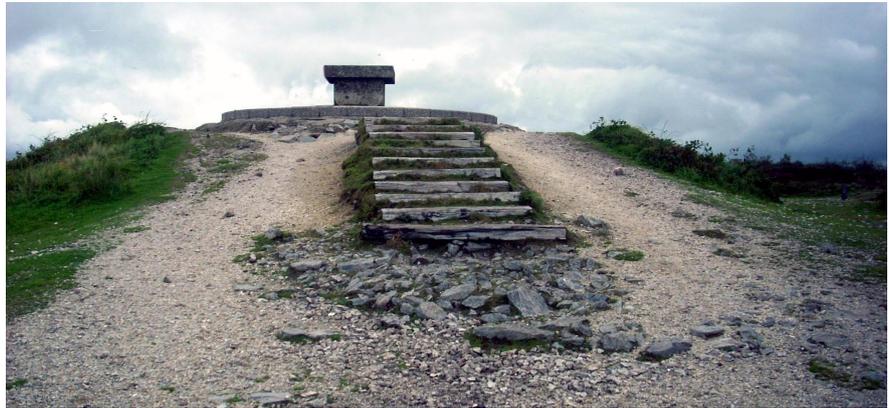
An orientation platform 2 (Figure 1 & Figure 2) ($48^{\circ}13'11.13''\text{N}$, $04^{\circ}14'06.62''\text{W}$) formed by a circular, concrete platform about 4 m in diam., 20 cm thick, hosting at the centre a concrete block made by a cylindrical portion with a superimposed four sided square portion having on the top a circular depression several cm deep. Not identifiable in Figure 1, it was not an original *Stützpunkt* component; and was built on 1952 (Blanchard, 2017). The concrete block, although similar to others seen on the site, appears of recent masonry, therefore not a retrieved original *Stützpunkt* component.

Figure 2. Menez-Hom hill—orientation platform with concrete block.

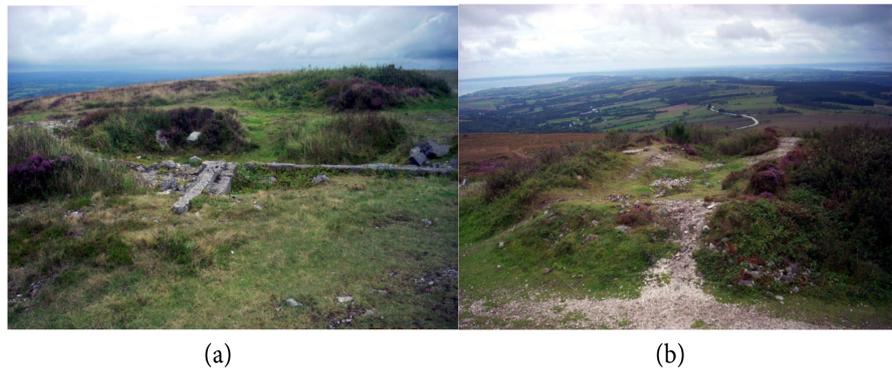
The area of a barrack emplacement 4 (Figure 1, Figure 4(a)) ($48^{\circ}13'12.47''\text{N}$, $04^{\circ}14'04.98''\text{W}$) and a circular emplacement 5. Their cavities were completely filled by terrain and vegetation and no longer visible. Only a damaged portion of the cavity concrete wall slightly emerged from the terrain. The cavity dimensions, estimated on the basis of the cavity dimensions of the barrack emplacements 6 - 10 (Figure 1), were about 18×10 m, i.e. slightly bigger than the cavities of said barrack emplacements, the circular emplacement was about 6 - 7 m in diameter.

Figure 4. Menez-Hom, hill top—(a) view of the rests of the barrack emplacement 4; (b) underground structure, in the foreground left the Douarnenez Bay in the foreground right, the Brest harbor.

A possible underground structure 21 (**Figure 1, Figure 2(b)**) ($48^{\circ}13'07.94''\text{N}$, $04^{\circ}14'04.03''\text{W}$) about 5×10 m covered by terrain and vegetation. Three possible entrances were visible, all obstructed by vegetation; so that the interior was not possible.

The location of said radars on the hill is problematic. Published images (Floch & Le Berre, 2001) give the impression that the *Seetakt* was installed on the terrain without protection, but looking to **Figure 1** it appears much more logic that it was installed in the circular emplacement 5 which protected its cabin letting only the antenna to emerge outside (**Figure 13**). After the war, it is possible that the damaged radar structure was extracted from said circular emplacement and for a certain period let near emplacement 5 attending its transport to the demolition. Said published images were made during that period and gave said impression. Other possible locations could be the underground structure 21 (**Figure 4(b)**) (Blanchard, 2017).

The underground structure 21 was probably a refuge in case of air or land bombardments.

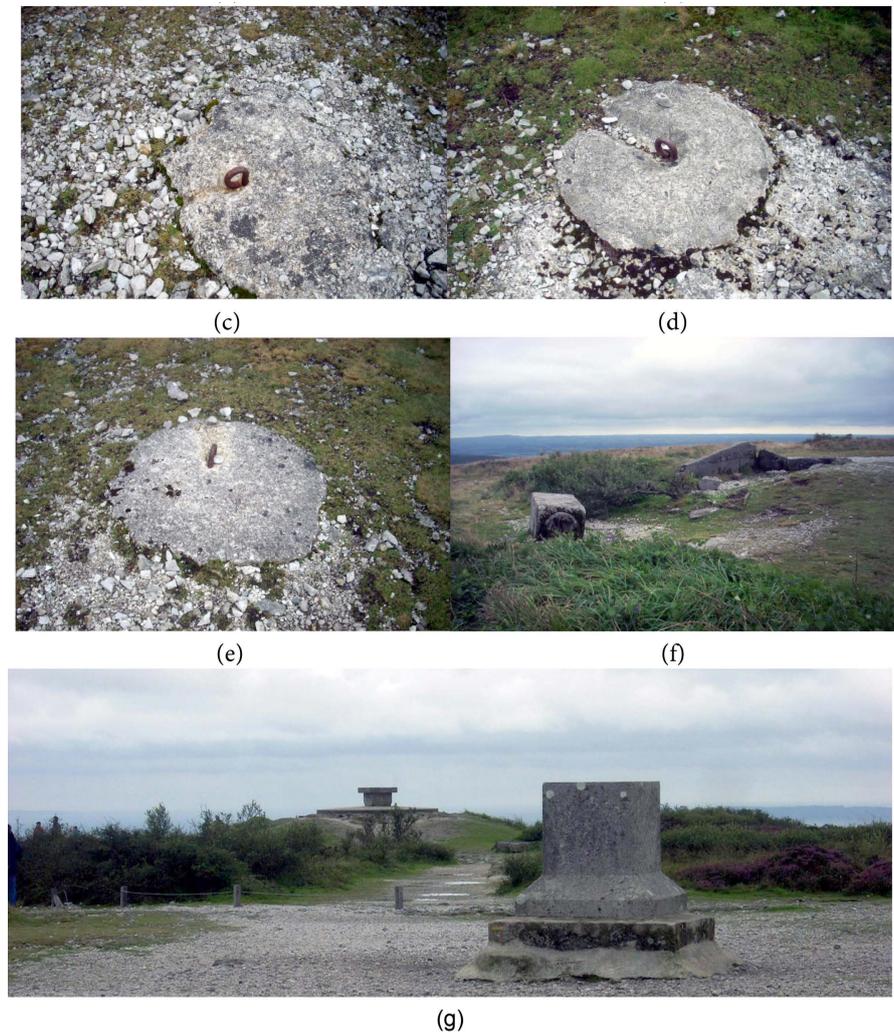
Several different components on the hill top, comprising: a concrete rectangular block about 20 cm thick, covered by the vegetation (Figure 5(a)); a 2×3 m rectangular support having an L-shaped concrete block at each corner (Figure 5(b)); three antenna anchoring bases (Figures 5(c)-(e)); a damaged concrete wall about 3 m long and 1 m height with a neighbour, reversed, concrete block (Figure 5(f)) ($48^{\circ}13'12.15''\text{N}$, $04^{\circ}13'59.50''\text{W}$); a geodetic stone (Figure 5(g))

(48°13'12.10"N, 04°14'02.48"W), certainly not an original *Stützpunkt* component because of the engraved inscription: Station Astronomique du Menez-Hom 1957 on one side and a metallic, oval plate, on the other side, with the inscription: Institute Geographique National-Reseau Geodesique Francais-Ne pas detruire-Art 257 du Code Penal.

Figure 5. Menez-Hom, hill top—(a) concrete block covered by the vegetation; (b) concrete blocks of a rectangular support; (c)-(e) antenna anchoring bases; (f) damaged concrete wall and reversed concrete block; (g) geodetic stone, in the foreground the orientation table.

The antenna anchoring bases on the hill top indicate that at least one light antenna was mounted there. The barrack at the barrack emplacement 4 hosted the radio and radar stations offices as well as their operators (Richtlinien, 1943). The radars had to be sufficiently spaced from the barrack so as to avoid malaises to the personnel and excessive length of the connection cables (Richtlinien, 1943).

The rectangular support (**Figure 5(b)**) probably supported a structure of un-

The damaged concrete wall and the reversed, concrete block (**Figure 5(f)**) were part of an unknown construction probably destroyed during the bombardments and combats.

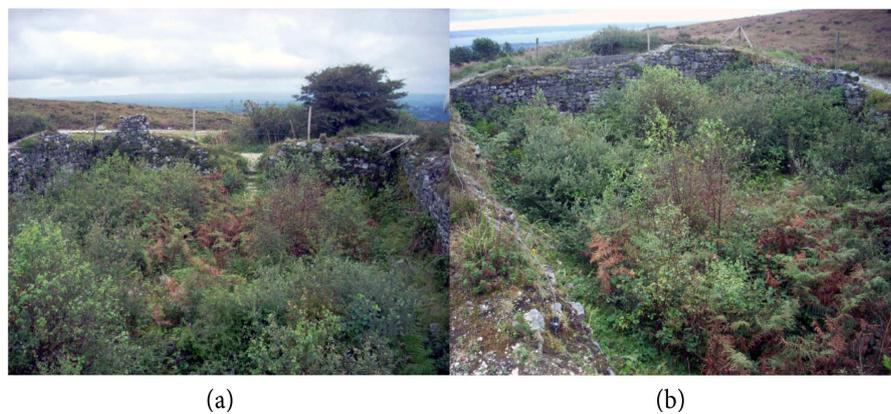
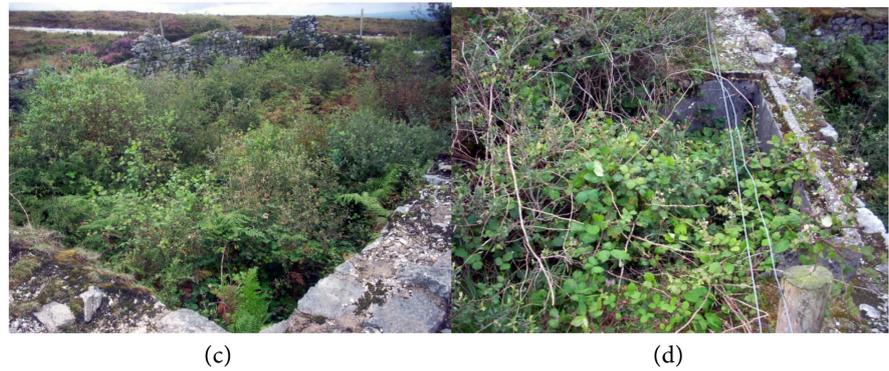
A barrack emplacement 6 (**Figure 1**, **Figure 6**) (48°13'11.21"N, 04°13'56.52"W) formed by a cavity about 15 × 10 m. The entrance with a descending stair was on the northern side. The cavity sides were formed by stone bricks, inclined toward the exterior. The cavity was only partially invaded by vegetation so that it was possible to ascertain the absence of ruins of a hosted barrack. At the exterior of the cavity south side were visible the rests of a damaged, rectangular pit.

Figure 6. Menz-Hom hill, barrack emplacement 6—(a) north side entrance and descending stair; (b) south side and cavity invaded by vegetation; (c) cavity invaded by vegetation; (d) possible pit at the exterior of the south side.

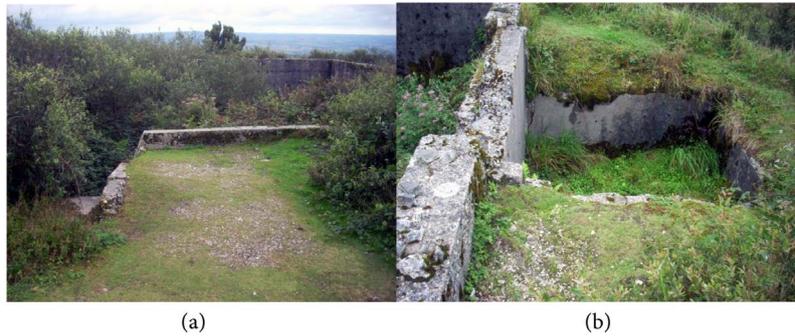
A barrack emplacement 8 (**Figure 1, Figure 8**) ($48^{\circ}13'10.03''\text{N}$, $04^{\circ}14'01.05''\text{W}$) formed by a cavity about 14×10 m. The descending stair was situated on the northern side. The vertical, concrete cavity sides were about 0.5 m thick. They were quite well preserved with the exception of the west side in which, for

structural reasons, two breaks, near a square pit about 2×2 m caused the displacement of a side portion. The cavity was completely invaded by vegetation, so that it was not possible to ascertain the presence of ruins of a hosted barrack.

Figure 8. Menez-Hom hill, barrack emplacement 8—(a) descending stair and cavity invaded by the vegetation; (b) displaced side portion and pit at the exterior of the west side.

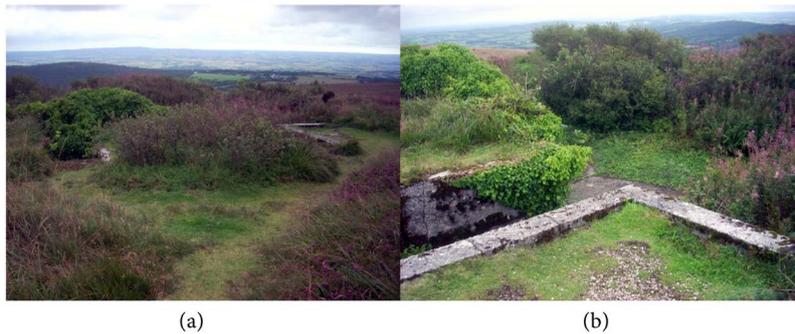
A barrack emplacement 9 (**Figure 1, Figure 9**) ($48^{\circ}13'07.92''\text{N}$, $04^{\circ}14'01.41''\text{W}$) formed by a cavity about 13×10 m. Two concrete, descending stairs were situated on the northern side. The vertical, concrete, cavity sides were about 0.5 m thick. One descending stair, free from vegetation, allowed accessing the cavity, to ascertain the good preservation state of the visible side walls, of the cavity bottom as well and the absence of ruins of a hosted barrack. The vegetation, covering the south side of the emplacement, did not allowed to identify the possible presence of a pit as in barrack emplacements 6 - 8.

Figure 9. Menez-Hom hill, barrack emplacement 9—(a) two descending stairs; (b) unobstructed descending stair and cavity partially invaded by vegetation.

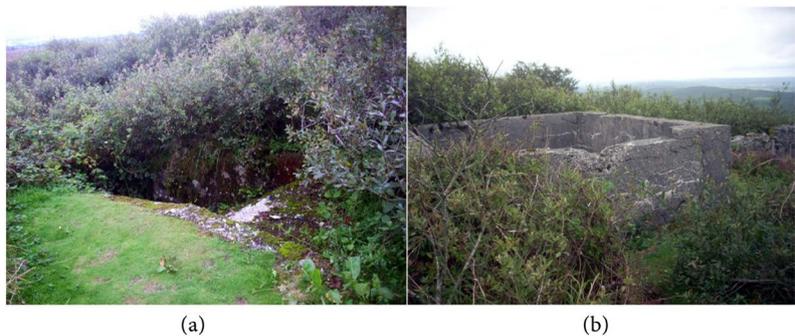
A barrack emplacement 10 (**Figure 1, Figure 10**) ($48^{\circ}13'07.94''\text{N}$, $04^{\circ}14'04.03''\text{W}$) formed by a cavity about 14×10 m. The descending stair was situated on the northern side. Vegetation invaded the descending stair, the cavity and its exterior, so that it was not possible to ascertain the presence of ruins of a hosted barrack. Emerging about 2 m above the upper level of the cavity was a concrete, square pit about 2.5×2.5 m. The pit was quite well preserved except for a minor projectile impact damage on one side.

Figure 10. Menez-Hom hill, barrack emplacement 10—(a) descending stair obstructed by the vegetation; (b) projectile impact on the external concrete pit.

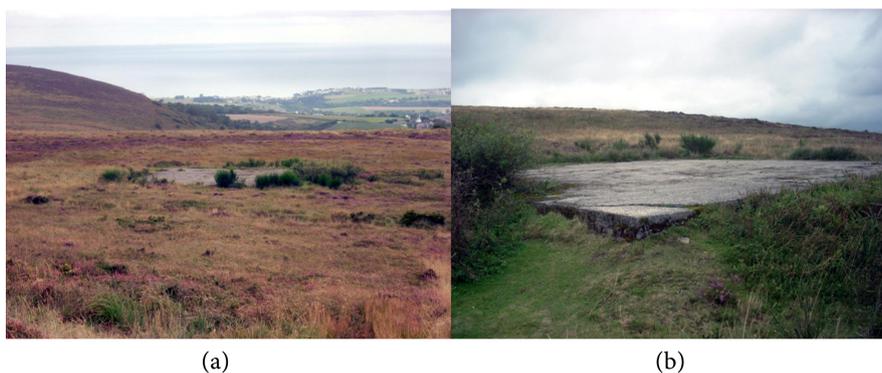
A concrete platform 35 (**Figure 1, Figure 11**) ($48^{\circ}13'09.30''\text{N}$, $04^{\circ}14'12.76''\text{W}$) about 10×10 m. It was in a good preservation state with a minor damage due to a structural failure at a corner.

Figure 12. Menez-Hom hill, concrete platform 35—(a) complete view; (b) side view, cover with damaged corner.

The platform 35, possible coverage of a buried bunker, is not identifiable in **Figure 1**. It is visible for the first time on an image of the years 60s (C0518-0021_1966_F0418-0518_0004, n°4, 1/38931, Argentique, 31/05/1966), therefore it was not an original *Stützpunkt* component. Its purpose is unknown.
