A late dissociation of the ceramic component of a sandwich liner cup in a total hip arthroplasty

—Case report and review of the literature

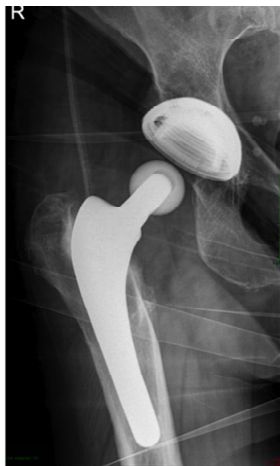
Figure 1. Radiograph of the dislocated THA.

In 2000, an Allofit S acetabular component (Zimmer[®]) with a sandwich Alfa Cerasul liner (Zimmer[®]) and a cementless Emeraude femoral component (Zimmer[®]) with a 28 mm medium ceramic Cerasul head (Zimmer[®]) were placed in a 59-year-old woman for right hip osteoarthritis. In 2011 she experienced a traumatic dislocation (**Figure 1**). Intra operative testing after reduction revealed a stable hip and fluoroscopy showed no abnormalities. The patient was instructed to avoid deep hip flexion. In 2012 a second dislocation occurred with intra operative testing

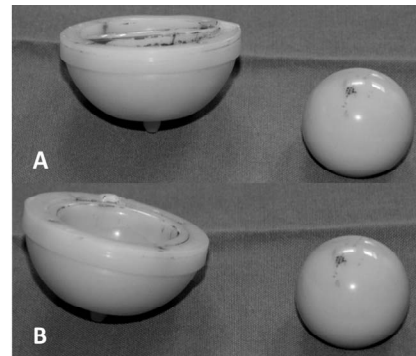
Figure 2. The sandwich cup with the ceramic insert in-place (B) and out-of-place (A).

revealing instability in deep flexion and endorotation. Afterwards the patient reports an intermittent crunch and unstable feeling. Radiography revealed neither ceramic debris nor signs of loosening. Due to the clinical symptoms a revision of the acetabular component was performed. On arthrotomy of the hip we noticed loosening of the ceramic component within the sandwich cup (**Figures 2(A)** and **(B)**). Flexion and endorotation of the hip resulted in motion in retroversion of the ceramic shell thus leading to a posterior dislocation of the hip. No signs of fracture or ceramic debris were seen. The liner could easily be removed and the Allofit shell revealed no signs of wear or loosening and had a stable fixation. A high wall all polyethylene liner was inserted. A 32 mm medium ceramic head was placed to augment stability (**Figure 3**). Rehabilitation was initiated with full weight bearing and crutches were used as necessary. The patient was seen at 6 and 12 weeks post-operatively. A normal mobility of the hip was noted, no residual pain.

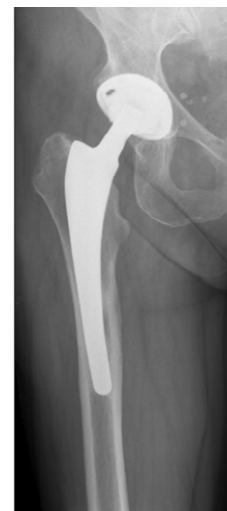
Figure 3. Radiograph of the revision THA.
