Social Issues of Urban Road Rehabilitation

This article provides a snapshot of social issues diagnosed in an urban road recently rehabilitated in Tajikistan.

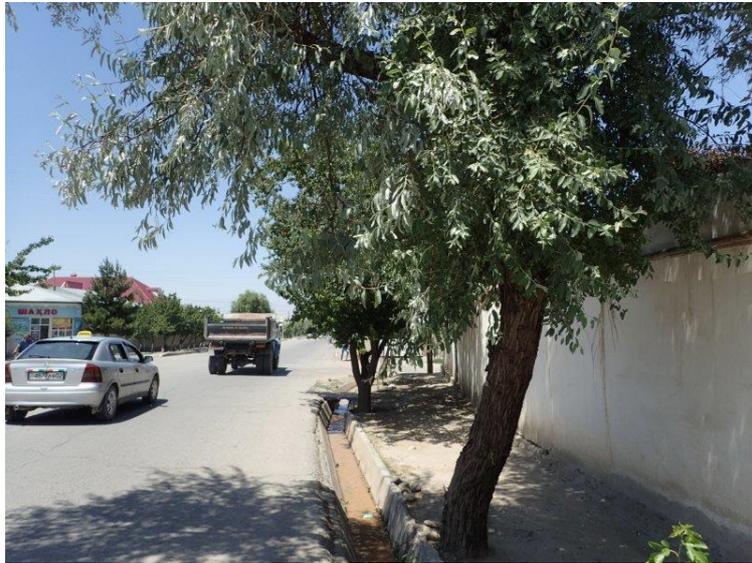
Photo 4. Before.

There are several issues associated with street trees in this road section. First, though the road is well-rehabilitated with smooth surface, platform, ditches, shoulders, underground electric wires and street furniture, is minus any trees now (**Photo 4** and **Photo 5**). People met by the study team, in particular all women met expressed their concern over the absence of trees to minimize the impact of hot sun during June to October. Moreover, all 3 community leaders responsible for the road section identified absence of road side trees as a weakness of the rehabilitation program. The second issue is that the city administration is planning to facilitate tree planting in the autumn 2019. However, it will be entirely pine species, which is based not on a regulation or a practice recommended by research, but a taboo without any valid reason. The residents are expected to follow this prescription and plant pine seedlings procured by themselves in 2019, though their preference is to plant fruit, nut and other trees useful to people and animals. It is noted that women in particular question about the decision to plant pine as their preference based on what existed before is a mixture of fruit-tree species. City Councils elsewhere have a policy to plant and maintain fruit trees along roads. Examples come from several city councils such as Wellington Shire, City of Latrobe ([Cambridge City Council, 2005](#)), etc. in Australia (<https://roadsidefruittrees.weebly.com/>). However, the Konibodom Council does not have a policy helps administrators to decide on type of trees that should be planted. In the absence of such a policy, it is axiomatic that their personal choice dominates in street planting. [Galenieks \(2017\)](#) based on a study in California points out that poorly conceived policies or the absence of effective policies does not lead to maximize street tree benefits. This conclusion is well

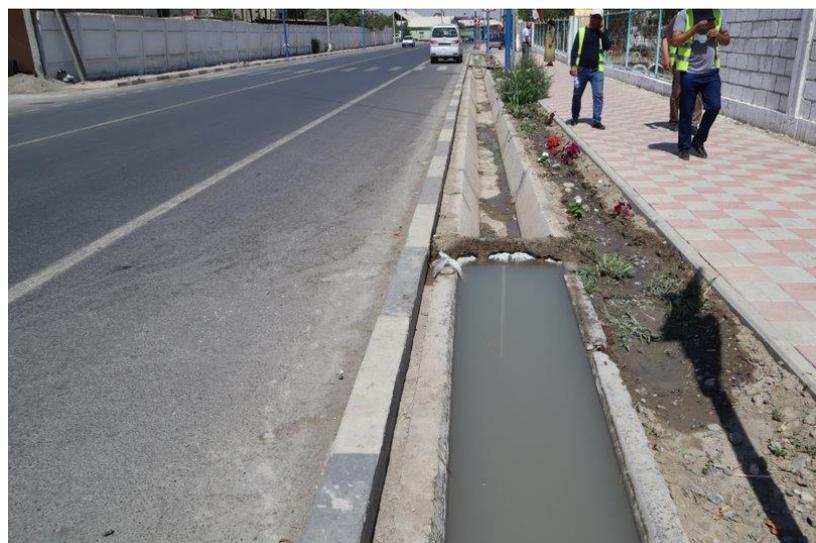
Though the roadside ditch is used to convey water, residents are not provided with a method to abstract it and use for irrigation of trees and plants. Instead, they adopt two methods to abstract water for irrigation. First, the ditch is blocked by packing material such as old rugs, rocks, boards and soil in selected locations (**Photo 6**). This helps to increase water head in the ditch to a level high enough until it automatically flows into the road platform. The issues are that it floods the street and platform too making it unsafe for walkers and motorists. The ditch and culverts get frequently choked making the system to disfunction. There are also attempts by residents to damage the ditch network when it fails to function, all of which are adding to the city management cost. Second, the frequent wetting and run off over the road impacts the road structure making it does not last long. Another issue is that the cleaning agency has to clean ditch more frequently and thus costs more.

Photo 6. Blocked Ditch.

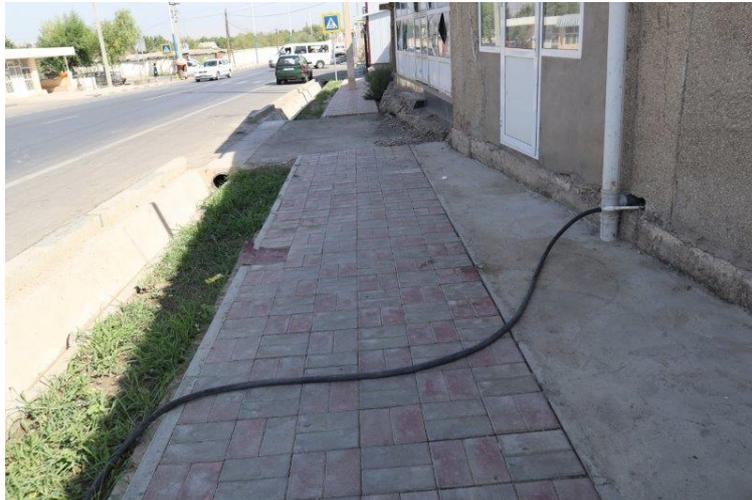
There are few instances where residents have used a garden horse fitted to their house tap to irrigate plants (**Photo 7**). The presence of horse pipes across road platform can also be a risk to walkers. Moreover, it does give an ugly appearance to the newly built road.

Photo 7. Horsepipe over road platform.

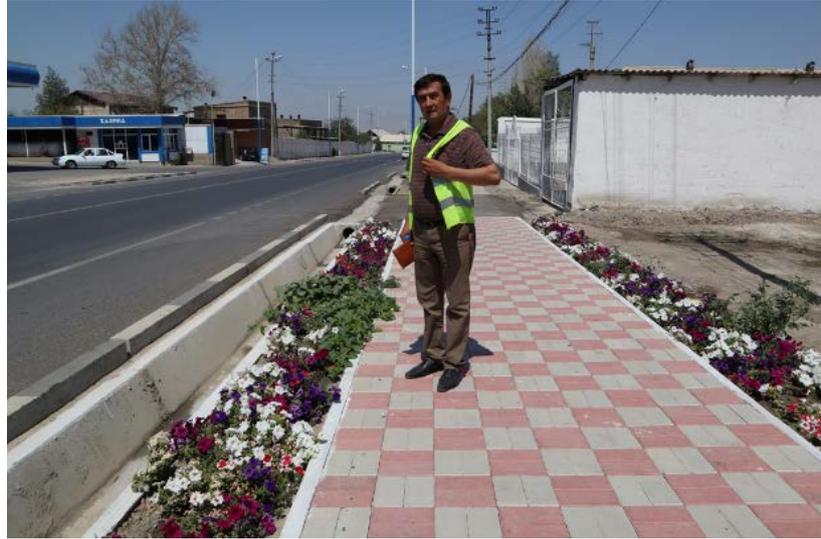
The new road design has allocated a space adjacent to the ditch for planting flowers and annual plants (**Photo 8**). This was not available for residents in the past, is not the preferred option. The residents however, have commenced planting not only flowers but also vegetables, grain and fodder (for animal feeding). Such planting does give street a green and pleasant appearance but lasts only for a few months. The benefits are much less than trees that existed before. The other issues of planting annual plants are: securing irrigation water from the ditch and that the residents, walkers and motorists will not have the benefits of roadside trees. It is to be highlighted that tree scape in urban road provides about 25 different benefits which are applicable in here as well.

Photo 8. Roadside flower beds.
