# Runoff Harvesting and Storage for Rice Crop at Hamelmalo, Semiarid Region of Eritrea

Ramesh Prasad Tripathi\*, Woldeselassie Ogbazghi, Semere Amlsom, Simon Measho

Department of Land Resources and Environment, Hamelmalo Agricultural College, Keren, Eritrea  
Email: [rp.tripathi52@gmail.com](mailto:rp.tripathi52@gmail.com), [wogbazghi@gmail.com](mailto:wogbazghi@gmail.com), [semereamlesom@gmail.com](mailto:semereamlesom@gmail.com),  
[simonmeasho@gmail.com](mailto:simonmeasho@gmail.com)

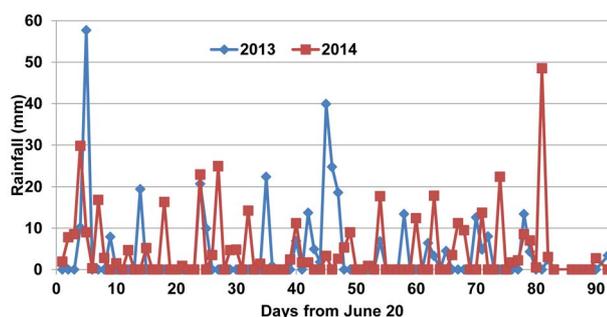
**Figure 1.** Rainfall during the crop season of 2013 and 2014.

Study was undertaken in 2013 and 2014 in a 6 ha partly cultivated watershed at Hamelmalo Agricultural College (15°52'20.6"N and 38°27'57.6"E at 1280 msl), located in the semiarid region of Eritrea. Annual rainfall in the past seven years ranged from 370 - 663.1 mm with a mean of 488 mm and average annual pan evaporation of 1931 mm. Highest mean monthly temperature occurred in May (35.7°C) and lowest in January (11.1°C). Total rainfall was 388 mm in 2013 and 429 mm in 2014 (Figure 1). Monsoon season in the two cropping years started from third week of June and ended by third week of September. Highest storm rainfall was 57.7 mm in July, 2013 and 48.5 mm in September, 2014.

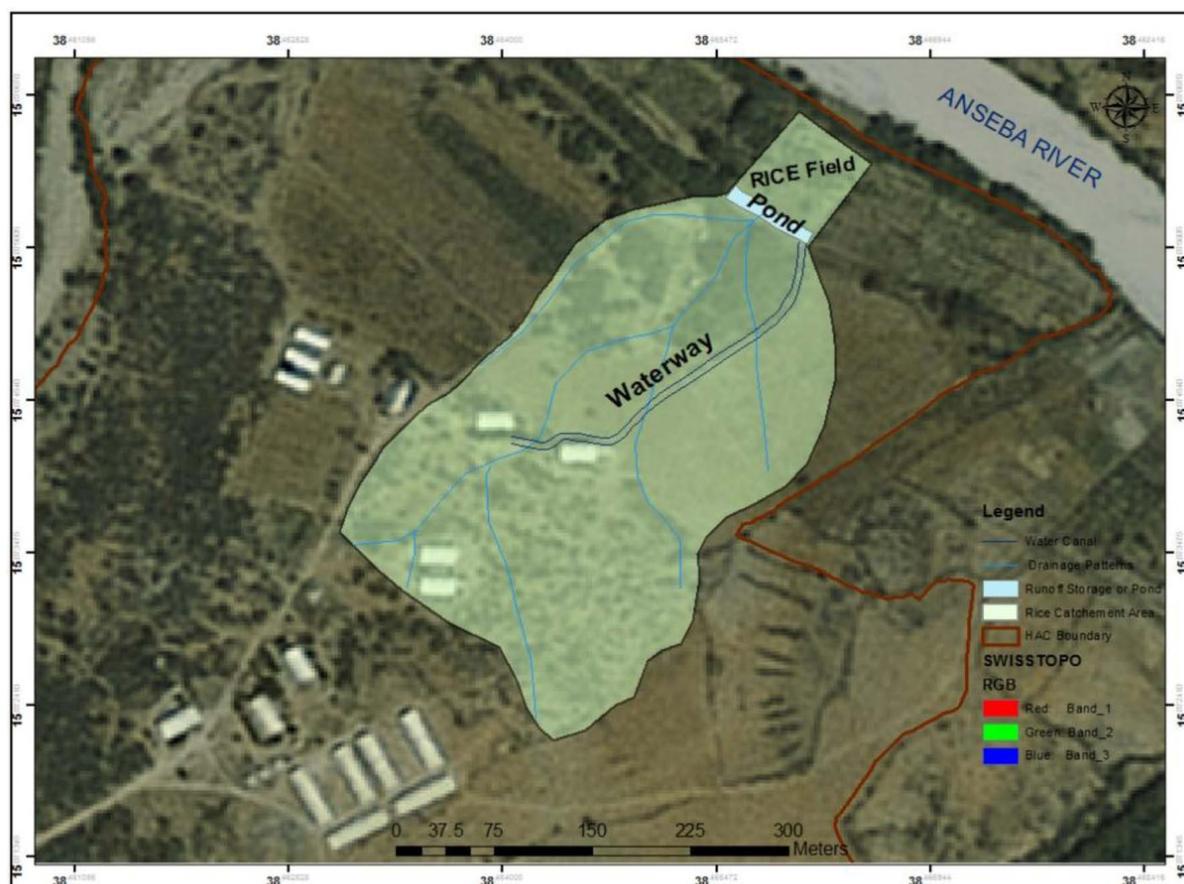
**Figure 2.** Rice field and catchment area contributing runoff.

Waterway was designed to intercept and carry runoff from the two drains of the uncultivated land together about 3 m upstream of the cultivated land into a pond constructed adjacent to the rice field (Figure 2). The two drains at the junction of cultivated and uncultivated lands were about 10 m wide and 40 m apart. Slope of the land, about 3 m upstream from the cultivated land, was <1% - 1.5%. The waterway was thus proposed from 3 m on upstream side of the cultivated land running about 50 m across the slope dividing the cultivated and uncultivated land before turning downslope towards the pond. Minor bending was allowed to accommodate local land surface conditions. To ensure non-erosive velocity of flow, channel bed slope was maintained zero by providing successive drops in bed level at the points of sudden change in slope. Equation (1) guided vertical interval between the successive channels [17].

and release of extra runoff from the pond. Gross capacity of the pond was  $>1000 \text{ m}^3$ . Location of buildings, natural drains, Anseba River, rice field and designed waterway can be seen in [Figure 2](#).

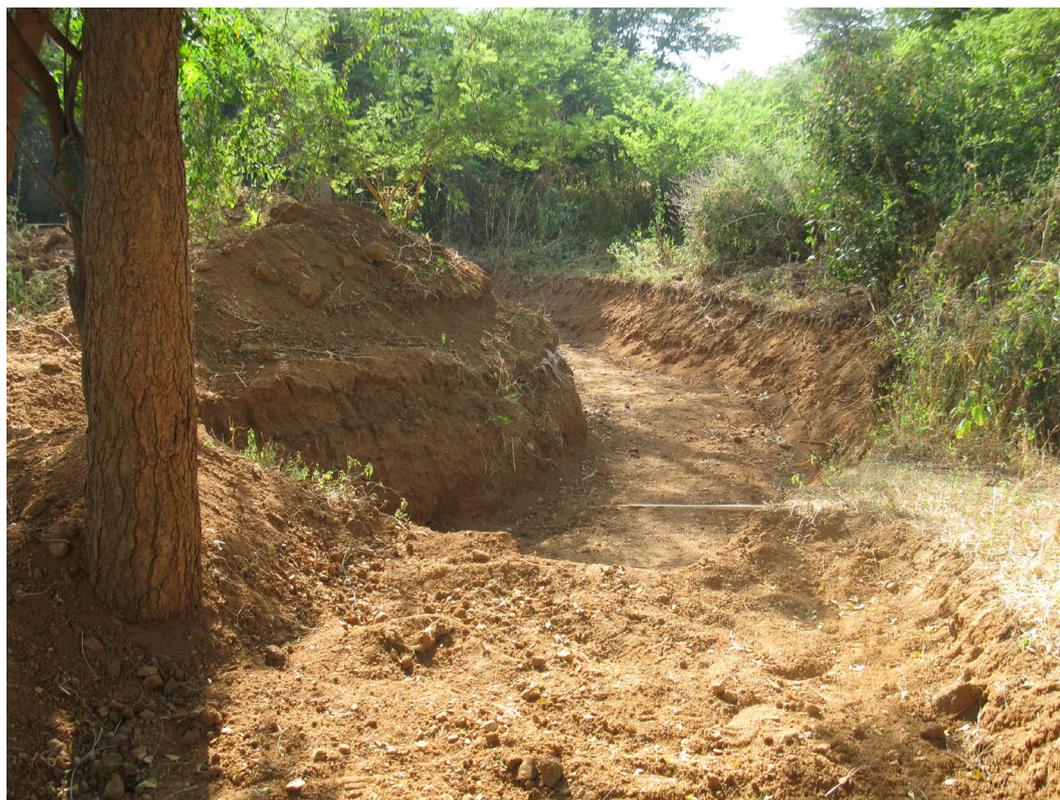
**Figure 3.** Waterway to intercept runoff.

As per design, waterway was constructed to intercept and carry runoff from 3 m upstream of the cultivated land, running 50 m across the slope with minor bending to accommodate local land surface situations before turning downslope towards the pond (**Figure 3**). The waterway downslope followed one of the drains almost centrally dividing the lower catchment. Soil excavated from the first 50 m waterway running across the slope was placed only on the downstream side of the embankment (**Figure 3**). Embankment on the upstream was natural ground level to facilitate runoff interception. However, embankments were formed on both sides after turning downslope until next 120 m. Thereafter slope of the cultivated land on the right side was perpendicular to the waterway and, therefore, embankment was again made only on the left bank to facilitate direct runoff interception from the right side. The waterway depth was varying with slope. Entire runoff from the cultivated land joined the waterway in its lower 1/4 section. Provision for inflow of runoff from left side of the waterway was also made at appropriate locations.

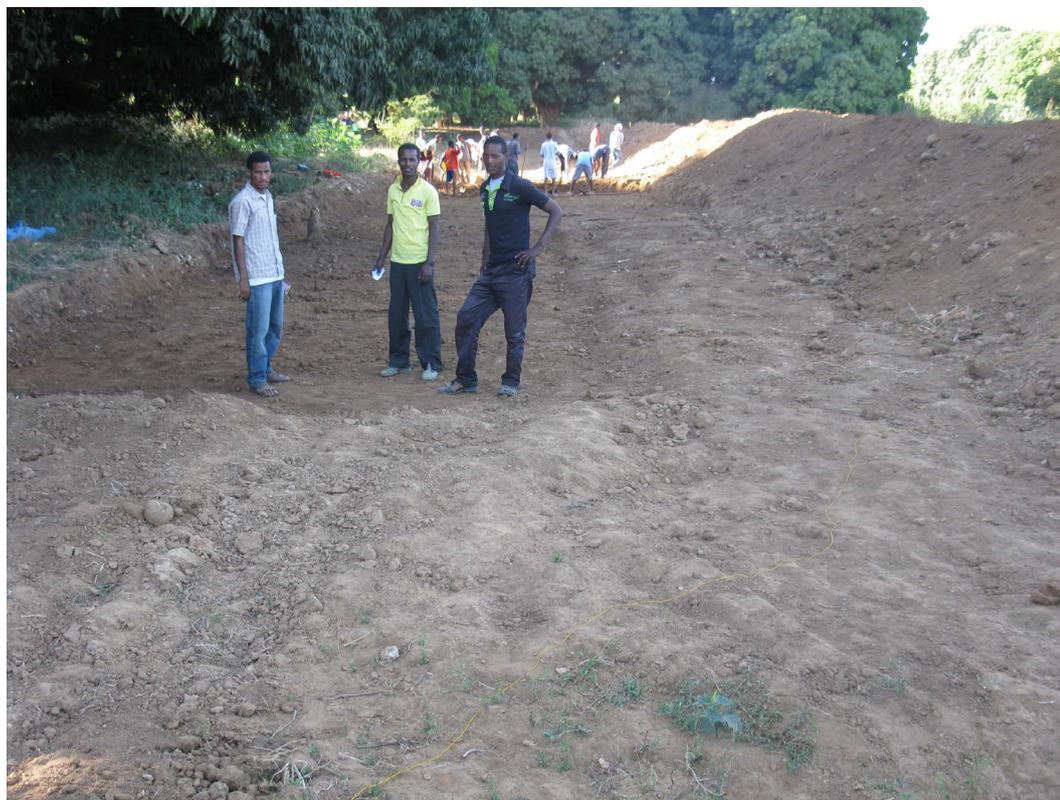
**Figure 4.** Students digging the pond.

The pond of designed size (60 m × 9 m × 1 m) was constructed adjacent to rice field on the upstream side. Pond embankment (dam) adjacent to rice field was of base width 4 m, top width 2.5 m and height 1.5 m from ground surface. The remaining 3 sides were undisturbed mango orchard land sloping towards the pond, which facilitated not only direct inflow of local runoff into the pond but also increased pond capacity with rising water level above the land surface. Soil excavated from the pond was used for construction of the dam after removing gravels and stones. Two orifices of diameter 0.125 m were installed at ends of the dam for safe release of excess runoff from pond into 1 m wide (base width) field channel constructed on the two sides of the rice field. The dam was repeatedly compacted by moving a 600 kg tractor driven roller. Thorough passage of tractor and human traffic was allowed over the dam for its safety and proper use of the farmland. Entire work was done manually by students (**Figure 4**). In case of emergency, provision for natural spillway was also made on eastern side of the embankment from where overflowing runoff could be diverted into another safety channel of 1.5 m base width made along irrigation channel in the rice field. Natural inflow of runoff from sides was also intercepted

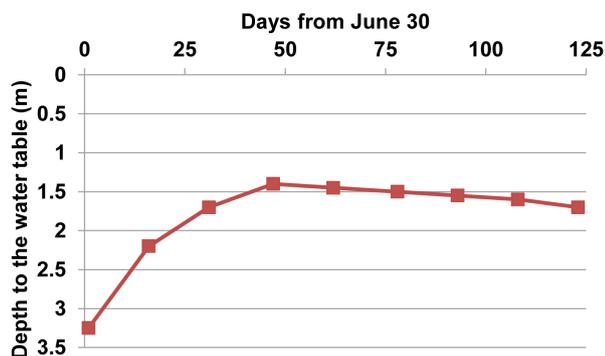
**Figure 5.** Two-year average water table fluctuation during the crop season.

Seepage from Anseba river, runoff stored in the pond and irrigation channels and wetness in the rice plots raised groundwater table in the rice field from 3.25 m depth in June end to 1.4 m by 4<sup>th</sup> week of August, which receded down to 1.7 m by crop maturity (**Figure 5**). Rate of rise of water table was faster than receding. The water table rose by 1.85 m in about 48 days but receded only 0.3 m in next 75 days. The water table was oscillating within  $1.5 \pm 0.1$  m for about 2 months during grand growth to reproductive stages of rice crop.

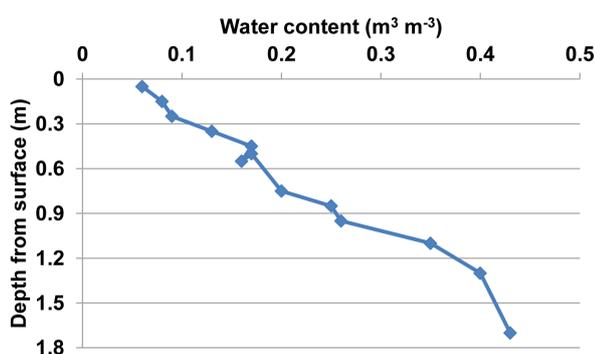
**Figure 6.** Soil moisture profile in the rice field.

The shallow groundwater table greatly affected wetness in the root zone. Soil water content in the third week of September showed upward gradient (**Figure 6**). Whereas surface soil was dry forming cracks, soil wetness below 0.7 m depth was near field capacity and was increasing with depth (**Figure 6**). Roots of NERICA rice were observed down to 0.8 m [3] and, therefore, parts of the rice roots were receiving water by capillarity from the fluctuating water table and the crop was greener until October (**Figure 7**). The rising groundwater table due to combined effect of water level in the river and percolation from the pond and rice field may serve as a natural source of sub-irrigation to the rice crop. The crop was harvested in November first week.
