Reliability Analysis of Super 13Cr Tubing in Ultra-Deep Gas Well

Lihu Cao¹, Hongtao Liu¹, Junyan Liu¹, Hailong Geng¹, Haotian Wei²

¹Petro China Tarim Oilfield Company, Korla, China

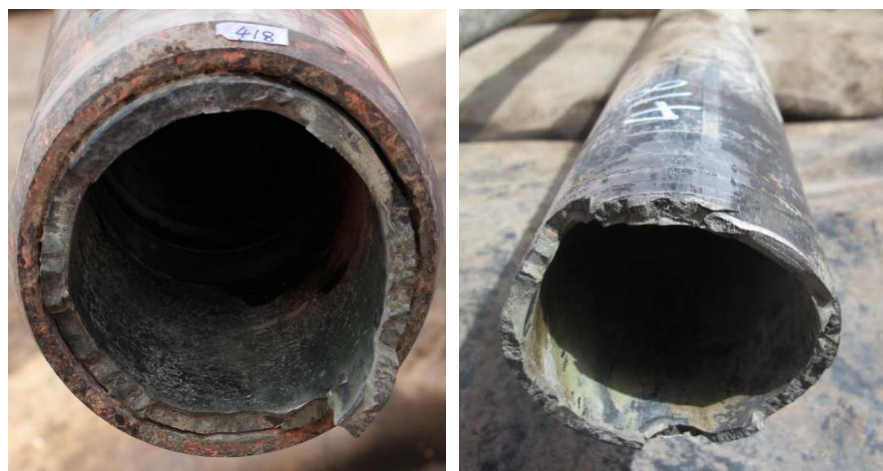
Figure 1. Morphology of root break of 418 tubing.

After salvage, it was found that the root of the end wire buckle of 418 tubing ($3\ 1/2'' \times 6.45\ \text{mm} \times 13\text{Cr-110/BEAR}$ tubing) was broken, and the fish top was 4146.14 m at the depth of tubing body, and the root fracture was shown in **Figure 1(a)**. According to the observation of the root of the fracture, it is found that there are scouring marks in 50% of the fracture area of the root of the tubing, and slight necking can be seen on the side of the pipe body in the instantaneous fracture area of the root fracture. Combined with the fracture form, it is considered that the erosion fracture is the first fracture area. In the process of killing well, the erosion trace should be produced by circulating drilling fluid, and the rest of the fracture is the last irregular fresh fracture area.

At the same time, the main fracture surface of 418 tubing is analyzed, as shown in **Figure 1(b)**, 80% of the main fracture surface has scour marks, which is the erosion first fracture area, the fracture is not in the same plane, the local flat fracture depression, the depression depth 4 mm, depression perimeter 9 mm; the other oblique fracture is transient fracture area, slight necking can be seen on the side of the pipe body, the fracture position is both transverse crack and longitudinal crack.

(a) Root port

(b) Body fracture

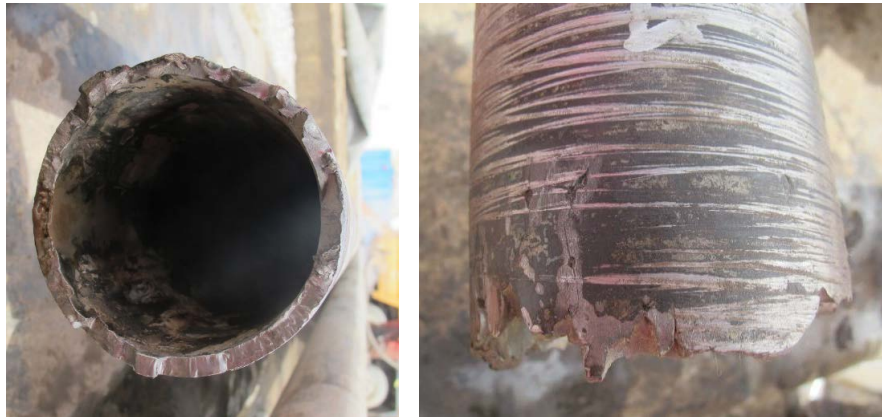
Figure 2. Morphology of root break of 418 tubing.

After continuing the salvage of the kava fishing tube, the 432 tubing also broke, and the fracture morphology was shown in **Figure 2**, and the fracture form was basically the same as that of 418 tubing. In addition, there are many cracks and cracks in the lifting and salvage pipe string, which are mainly concentrated at the screwed end of the pipe string. The forms of cracks include transverse cracks (60 mm, 89 mm, 120 mm, 165 mm, 170 mm, 190 mm) and longitudinal cracks (40 mm, 50 mm). The depth of the cracked string is mainly distributed in the range of 4146.14 m - 4712.41 m.
