Stability Analysis of Cut Slopes Using Continuous Slope Mass Rating and Kinematic Analysis in Rudraprayag District, Uttarakhand

R. K. Umrao, R. Singh, M. Ahmad, T. N. Singh

Department of Earth Sciences, Indian Institute of Technology Bombay Powai, Mumbai, India

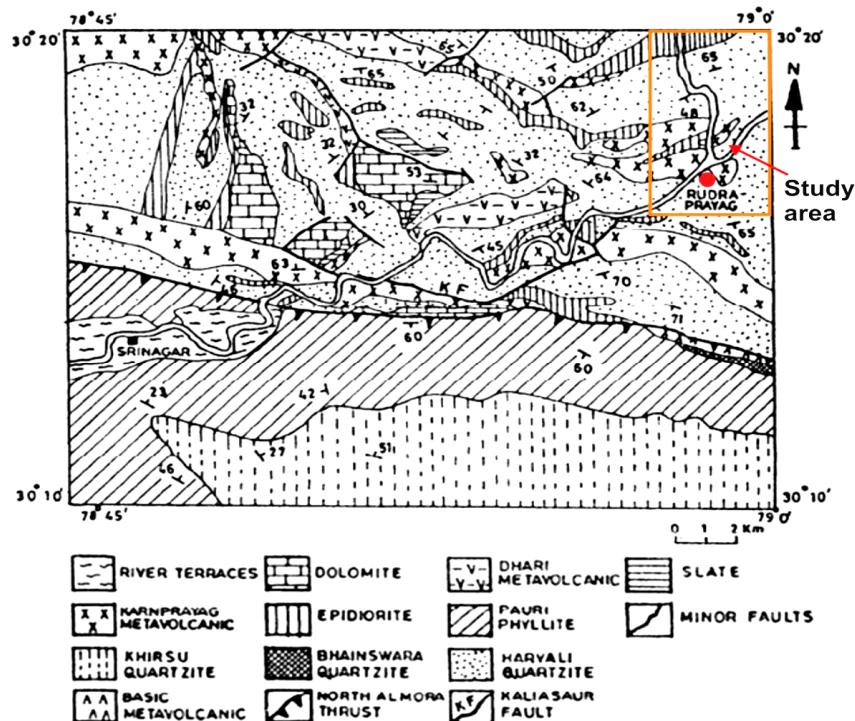
Figure 2. Geological map of the area (after Kumar and Agrawal [15]).

The study area comes in Garhwal group of lesser Himalaya and comprises diverse rock types ranging in age from Paleoproterozoic to Mesoproterozoic (**Figure 2**). The Main Central Thrust (MCT) and Almora Thrust mark the boundary of Garhwal group [15]. It consists of thick succession of low grade meta-sediments made up of quartzite along with penecontemporaneous metabasics and carbonate rocks. The Garhwal group has been divided into five formations as the Uttarkashi, Khattukhal, Rautgara, Deoban and Berinag formations in an ascending order. The rocks of Garhwal group were intruded by acid and basic igneous rocks [16]. The Garhwal group has been undergone three phases of tectonic deformations [15].

Mehdi *et al.* [17] and Kumar and Agrawal [15] were probably first to formulate the geology of the area. Negi *et al.* [18] have given the detailed report on geology and structure of Rudraprayag-Tilwara-Mayali area. The rock types exposed in the study area are Rudraprayag metavolcanics, Haryali quartzites, Tilwara quartzites, Tilwara metavolcanics, epidiorites and Rampur chlorite phyllites. Rudraprayag metavolcanics are massive and jointed in rock mass with quartz, pyroxene, plagioclase, epidote as mineral constituents. Quartz veins as infilling along joints are exposed 1 Km north from Rudraprayag.

Haryali quartzite as named by Kumar and Agrawal [15] is very less metamorphosed, thick bedded, varying white to purple/pink in colour and well exposed between Rudraprayag and Tilwara. Along the joint planes, jasper, chert and talc occur as infilling material. Tilwara metavolcanics, light to very dark green in colour, are more metamorphosed and deformed than the Rudraprayag metavolcanics. It is mainly composed of feldspar and pyroxene which are altered. Tilwara quartzites are different than Rudraprayag/Haryali quartzite as are thin bedded, highly deformed and metamorphosed. In the east of Tilwara, the quartzites are metamorphosed into talc-quartzites and towards Rampur, the Tilwara quartzites are mainly of schistose type. The most of the formations of the study area have been intruded by sills and dykes of dolerite which have later been metamorphosed into epidiorite. Hornblende and plagioclase are the major mineral constituents with hornblende altering into chlorite and biotite, ilmenite, epidote as minor constituents. The light to dark green colour friable chlorite phyllite/schist is best exposed on the right flank of the Mandakini River near Rampur.

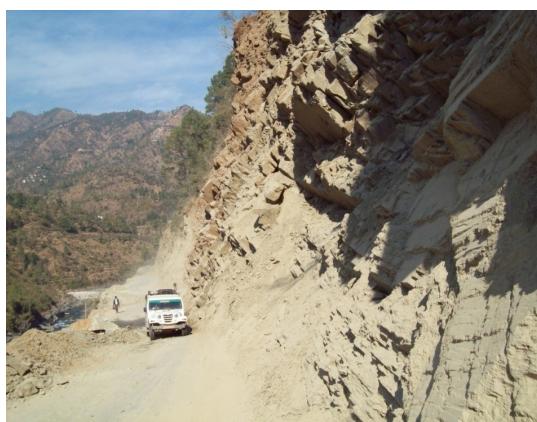
Figure 3. A cut slope section of the study area showing negative slope with 3 sets of joint.

Detailed geological investigations including structural mapping were made in the study area at Rudraprayag-Agastmuni road section along NH-109. The road cut sections of varying slope height constitute the best outcrops for determining the lithological variations, weathering conditions, and structural geological characteristics of the outcrops and rock excavation to record discontinuities and joint patterns (**Figure 3**). The study comprised of investigation of slopes at five locations which have

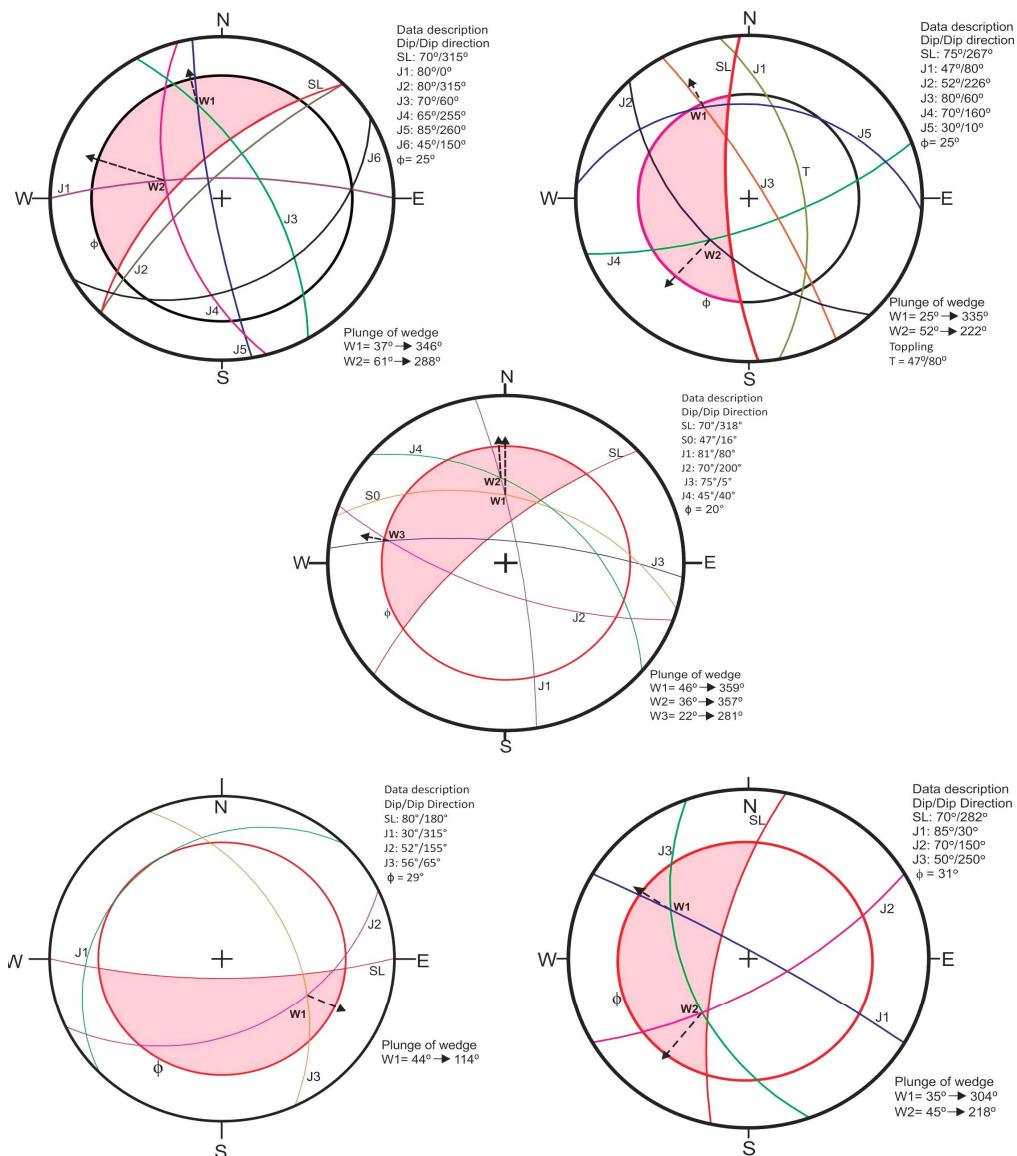
Figure 4. Plot of joints and slope at locations L1, L2, L3, L4 and L5. The pink coloured area indicates the critical zone of failure. The symbols used in figure are as SL: Slope; S0: Bedding, J1, J2, J3, J4, J5, and J6: Orientation of joints; W1, W2 and W3: Wedge formed by intersection of joints; T: Toppling.

The cut slopes have steep to very steep dip angle with a developed system of joints (**Table 3**). In general, the rock mass has been covered by soil of quaternary age with scanty vegetation. Kinematic analysis indicates mainly wedge type of failure along with few toppling and planar based on the joint patterns (**Figure 4**). The joint forming planar type is not day-lighted (**Figure 4(a)**). The critical zone of failure has been shown in pink colour in stereographic projection for all five locations (**Figure 4**).

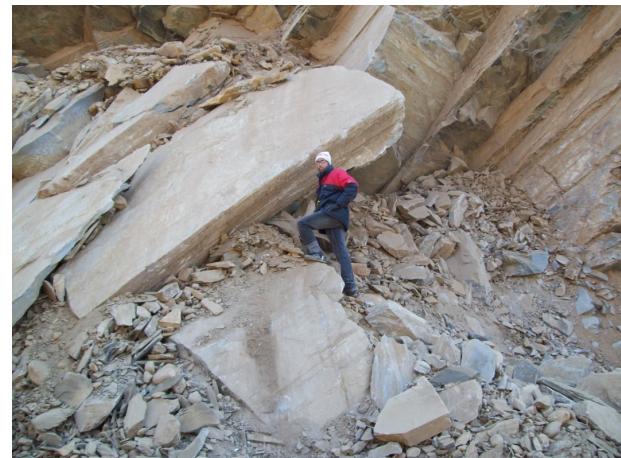
**Figure 6. Large size rock blocks failure due to blasting.**

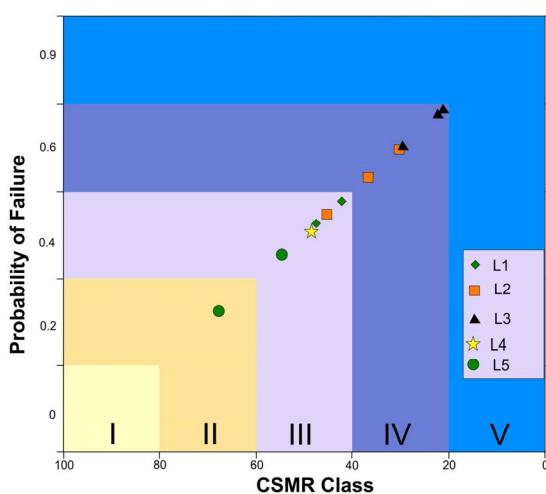
**Figure 7. The plot of CSMR values of five different locations.**

During field investigations and petrographic study, it has been observed that Tilwara quartzites rock is more deformed and crushed grains in internal atomic arrangement that shows protomylonitic behavior under microscope. So it is considered in class IV. At L3, phyllite rock with three wedges with CSMR values 21, 22 and 29 respectively. The slope can be classified under class IV as unstable. At L4, Haryali quartzite with CSMR value 48 may be classified in class III as partially stable. At L5, Rudraprayag Metavolcanics with two wedge (W1 and W2) and CSMR values 51 and 65. Slope may be classified as partially stable for W1 and stable for W2. The observation from field indicating that slope at L5 is stable. The CSMR values obtained for all five locations have been plotted in CSMR class- Probability of failure chart based on Romana standard classification of SMR [8] (Figure 7).
