Geotechnical Characterization of Sakakini's Palace Stones and Other Construction Materials, Cairo-Egypt

Sayed Hemed

Conservation Department, Faculty of Archaeology, Cairo University, Cairo, Egypt
Email: hemeda@civil.auth.gr

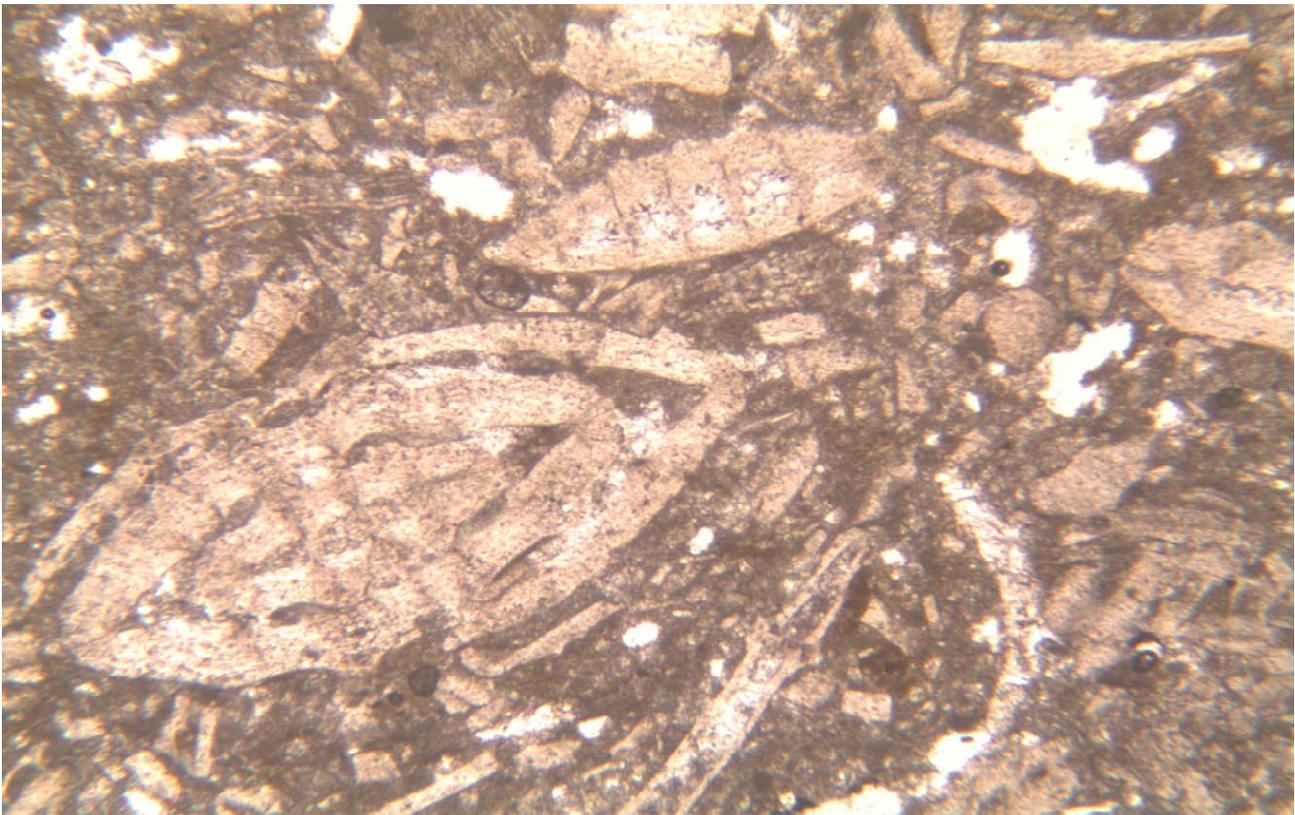
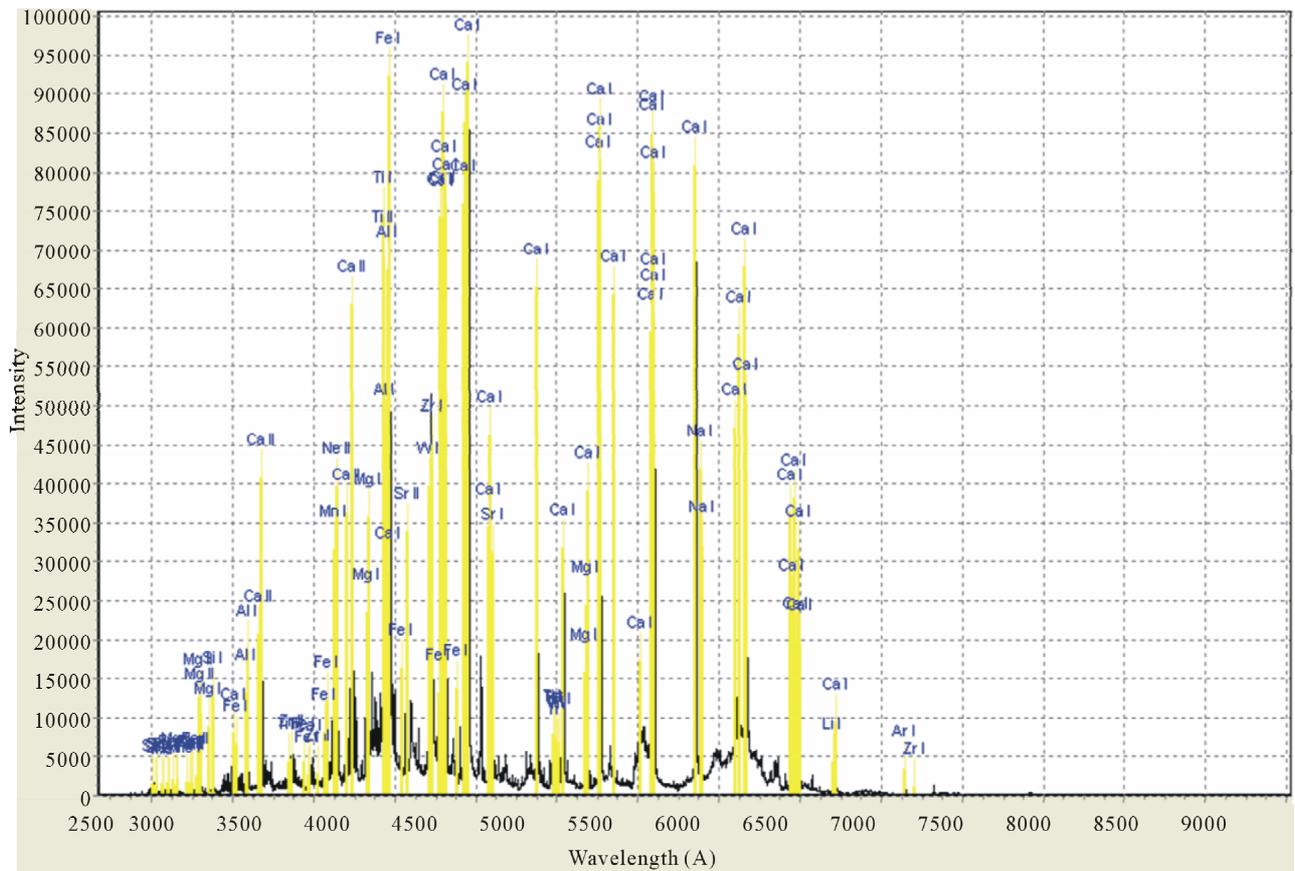
Figure 2. Thin section and Libs spectrum for an analysis spot on building limestone.

The limestone can be characterized as medium grained with uniform relative grain size, angular to sub angular grain shape with equidimensional form and rough surface texture. Sound or non weathered pieces of stone can be characterized of medium compactness and durability and the weathered pieces characterized of low compactness and durability. It must be mentioned that weathering attacked strongly the masonry units, started from the sur-

face and continuing inward thus losing the mineral fabric, **Figure 2**.

LIBS spectrum, **Figure 2**, and The EDX micro analyses indicated that, the elemental arrangement for the chalky limestone samples collected from Sakakini place can be put in a decreasing order according to their concentration as follow:

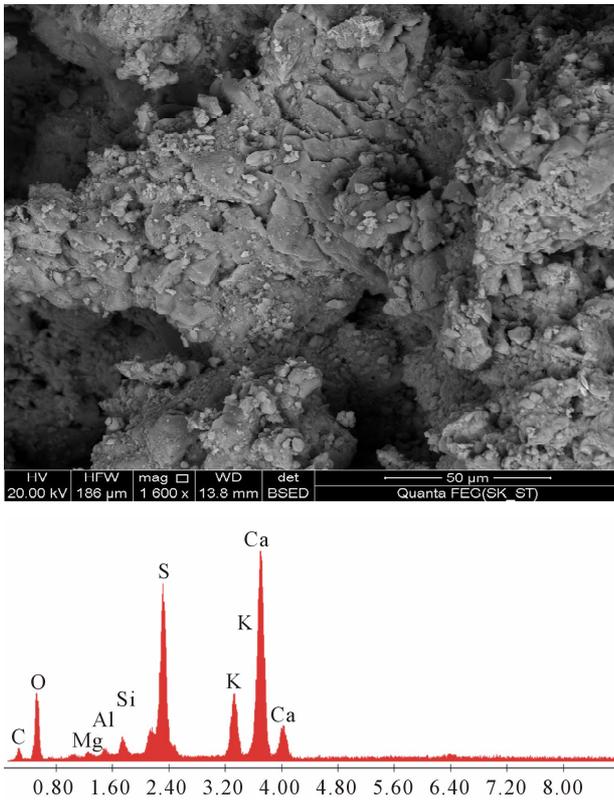
Figure 3. SEM with EDX analysis results of chalky limestone.

Ca (33.50%), O (29.80%), S (16.94%), K (9.01%), C (6.53%), Fe (1.76%), Si (1.48%), Al (0.55%), Mg (0.44%). Total 100.00% (wt%). see **Figure 3**.

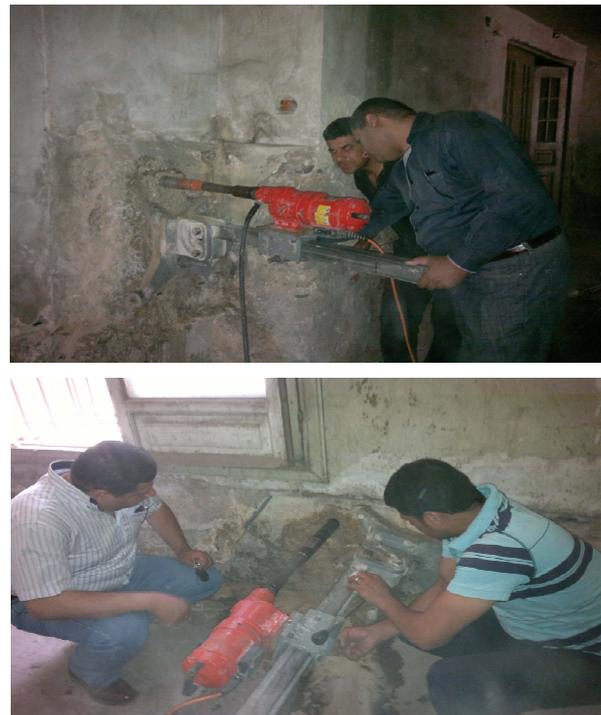
Figure 4. Core samples extracting from the basement.

The testing program includes extracting seven cylindrical cores from the basement stone walls of Sakakini's mansion in down town Cairo. **Figure 4** The cores are extracted using rotary cylindrical diamond blade coring machine. The top and bottom surfaces of every core were prepared to be flat circular surfaces perpendicular to the vertical axis of the core, **Figure 5**.

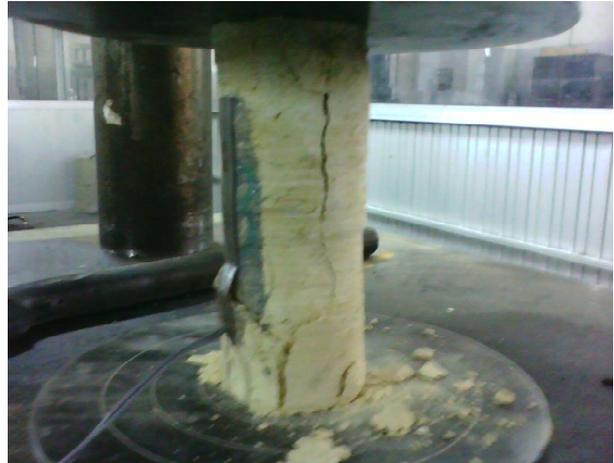
Figure 6. Test set-up.

Three samples were equipped with 100 mm long electric strain gauges. One strain gauge was fixed to the core parallel to its vertical axis to measure the longitudinal compressive strain corresponding to the applied compressive stress, **Figure 6**. The vertical compressive stress was increased gradually until failure. The compressive strength of every core was determined. **Table 3** shows the results of the compressive strength of the three cores, **Figures 7** and **8**.

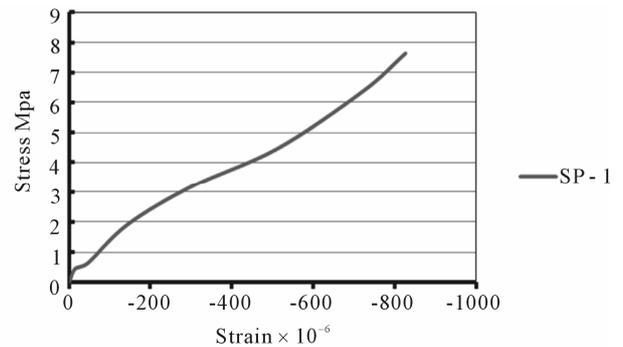
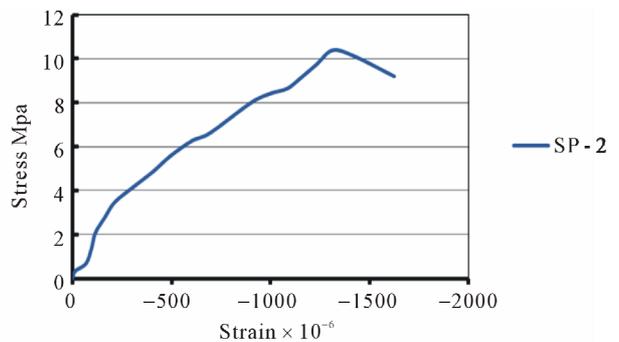
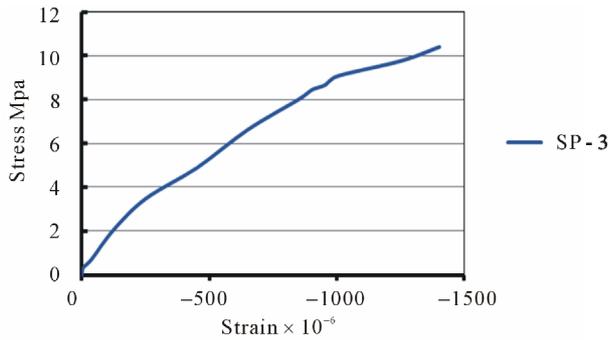
The recorded stress-strain data for the three samples are graphed as shown in **Figures 9-11**. From these figures, the value of the modulus of Elasticity can be obtained. For brittle materials with non-linear stress-strain relationship; the modulus of elasticity may be determined as the chord modulus between a low stress value (0.5 MPa) and a stress value equals one third of the compressive strength. For such definition the values of the modulus of elasticity obtained for the three tested samples are given in **Table 4**.

Figure 9. Stress-strain curve for sample 1.

Figure 10. Stress-strain curve for sample 2.

Figure 11. Stress-strain curve for sample 3.

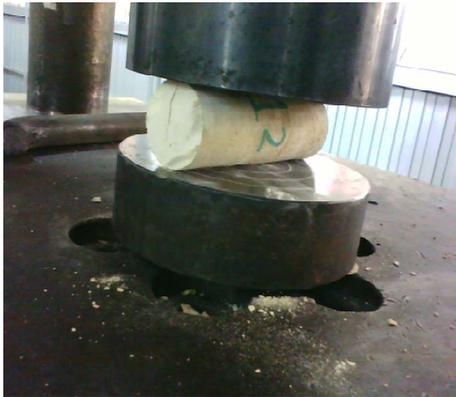
Figure 12. Splitting tensile test sample at failure.

Three samples were tested to determine the average splitting tensile strength of the stone. **Figure 12** shows a sample in the test set-up at failure. **Table 5** gives the details of the test results.
