Analysis of the Impact of Aquatic Weeds in the Shire River on Generation of Electricity in Malawi: A Case of Nkula Falls **Hydro-Electric Power Station in Mwanza District, Southern Malawi**

Maureen Kapute Mzuza^{1,2*}, Lostina Chapola¹, Fanuel Kapute³, Innocent Chikopa¹, **Jimmy Gondwe¹**

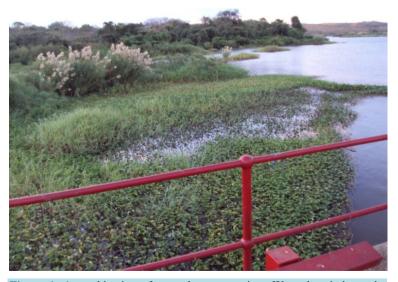
Figure 1. A combination of several grass species—Water hyacinth, reeds, water lettuce and others at the Nkula Falls Intake.

Electricity is a backbone to the development of a country. Many manufacturing industries use electricity for their production and people rely on electricity for their daily domestic jobs such as cooking. Hospitals too need electricity for their day-to-day activities. The need for electricity can therefore not be undermined. However, Malawi has recently been facing intermittent electricity blackouts and the Electricity Supply Corporation of Malawi (ESCOM), which provides about 98% of the electricity in the country [1] [2] is facing a great challenge to meet the demand for power. Its major hydro-electricity power (HEP) station at Nkula Falls along the Shire River, together with other HEPs of Tedzani and Kapichira Falls along the same river are not able to generate enough electricity to meet the ever increasing demand. Only 8% of the population in Malawi has access to electricity [3]. Malawi is in fact, one of the least electrified countries in the SADC region, with an average per capita consumption of 111kWh per annum, rated among the lowest in the world [4]. [5] reported that Malawi's power outages are the highest in Africa. [1] reported that Malawi's installed generation capacity is approximately 287 megawatts, of which only about 267 megawatts is available against an estimated demand of approximately 325 megawatts. It further reported that with a projected peak demand of 757 megawatts by 2020, electricity generation capacity needs to increase at an average annual growth rate of 10%. According to [6], in 2005 alone, Nkula Power Station lost 349.19 hours resulting into load shedding and consequently loss of revenue for ESCOM. [7] estimated that the country is losing 215.6 million dollars a year due to the power outages. These power shortage problems reached a climax when one of the consumer rights body in Malawi-the Consumer Association of Malawi (CAMA) challenged ESCOM in court to stop their motto of "power all day everyday" as this did not reflect their output. ESCOM eventually changed its motto to read "towards power all day everyday". While ESCOM admits that its power generation capacity is below consumer demand, it has directed the problem of persistent power outages on the weeds in the Shire River (Figure 1) where Nkula Hydro-electricity power station is built.

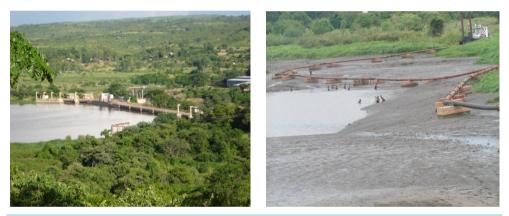
Figure 2. The water intake dam at Nkula Falls on the Shire River (left); heavy siltation (right).

Since late 1990s, aquatic weeds which have not caused any environmental concern in the Shire River have found their way into the power generation plant at Nkula Falls HEP [2]. Increase in the aquatic weeds has resulted into an increase in floating aquatic weeds and debris in addition to siltation at the intake ponds (Figure 2).

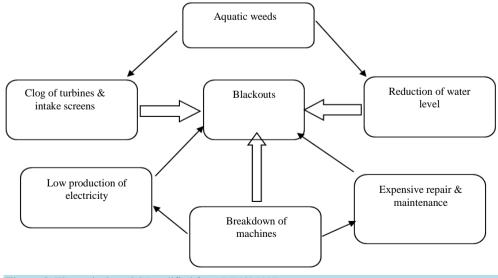
Figure 3. Theoretical model (modified from [6] [8] [11]).

Theoretical model gives the possible reasons that could explain some of the causes of blackouts. For example, the presence of aquatic weeds causes clogging of turbines and intake screens and reduction of water level consequently resulting in frequent blackouts. The machines used are old and commonly breakdown resulting in low production of electricity which also result in blackout.

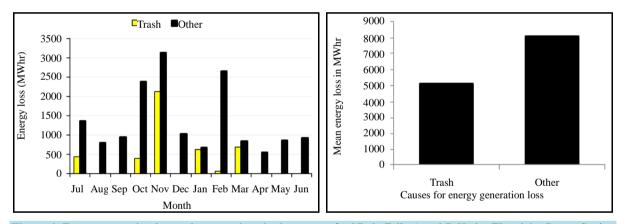
Figure 4. Energy generation losses due to trash and other causes for Nkula Falls A and B Hydro-Electricity Power Station between July 2007 and June 2008 (left) and summary (right).

crassipes), had been seen in the Shire River since the 1990s. One of the longest serving employees who started working with ESCOM in 1979 also reported to have seen Water hyacinth in the Shire River in the 1990s. Results from data on energy loss in megawatts per hour (MWhr) from July 2007 to June 2008 are presented in **Figure 4**.

Based on results in **Figure 4**, it was apparent that energy generation losses that were incurred by ESCOM due to removal of trash at the intake were far much lower compared to losses due to other problems that affected power generation. In fact, there were highly significant differences (P < 0.05) (**Table 1**) confirming the observation that more energy was lost as a result of some factors other than effect of aquatic weeds.

Except for the situation in 2009 (Figure 5) where effect of trash was observed in rainy season (January to March), results (Figure 4) also indicated that aquatic weed accumulation at the intake was not only in rainy season. The observation that the effect of trash was also recorded in July and October (Figure 4) *i.e.* months

However, despite the reported significant impact that is brought about by aquatic weeds in the Shire River, results in this study (**Figure 4** and **Table 1**) showed that generation of power was not entirely or directly due to the effect of aquatic weeds but rather other reasons. For example, losses in electricity generation due to the removal of weeds at the intake dam did not even amount to half of the period between July 2007 and June 2008. Engineers spent more time fixing problems such as low oil level in the turbine bearing basin, turbine bearing basin leaking, trip due to loss of station supplies, repairing and replacing Gov main oil pump/removing pump etc. [16] reported that frequent equipment breakdown has contributed to losses in power generation in Malawi. [3] quoted a senior ESCOM employee saying "during the Easter Holiday, ESCOM repairs equipment from the head-ponds. We lose revenue once we halt operations but such repair works on Easter Holidays are crucial to us as ESCOM. Just this year, we first closed Tedzani Power Station on Friday and Sunday and then Nkula Power Station later to ensure that most parts still have power." It is sufficing to note that by 2007, ESCOM reported that the aquatic weed problem had been put under control through a program of vegetation cutting and harvesting, combined with a system to trap floating weeds [2] [5] suggesting that the maintenance of equipment may not have been as a result of damage by aquatic weeds.
