Natural Disaster in Tbilisi City (Riv. Vere Basin) in the Year 2015

George Gaprindashvili, Merab Gaprindashvili, Emil Tsereteli

LEPL National Environmental Agency, Department of Geology, Tbilisi, Georgia

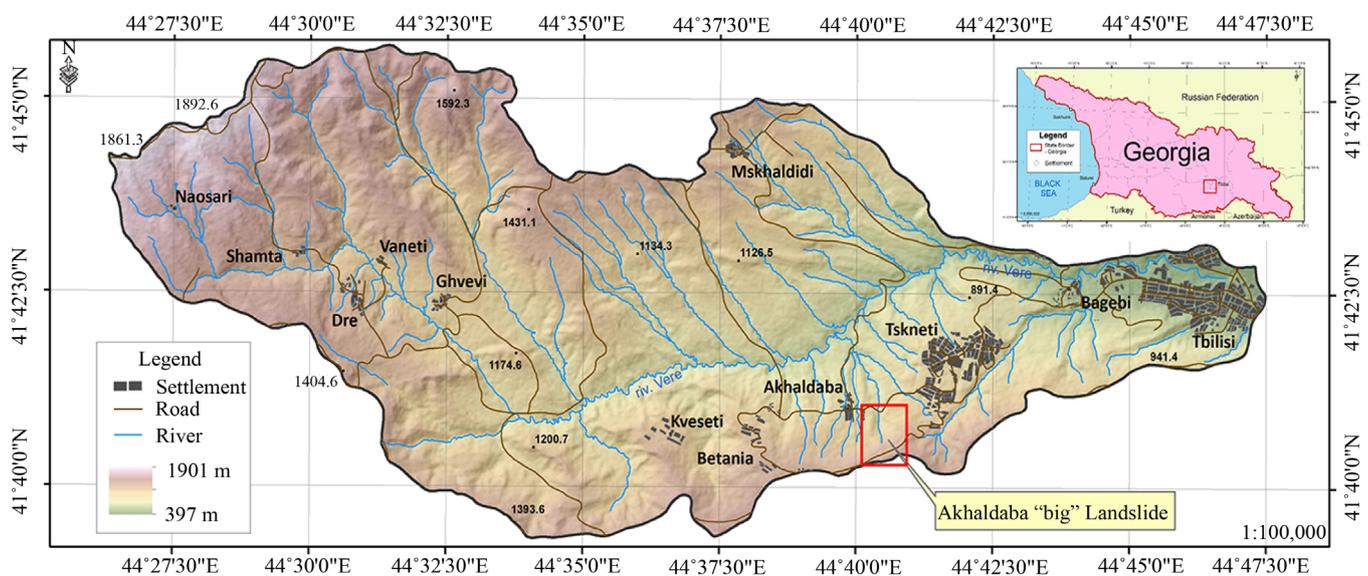
In Tbilisi city area and among the Riv. Vere tributaries the catchment basin of Riv. Vere and its gorge occupies a distinguished place in respect of relief peculiarities and the significance of development (**Figure 1**). Riv. Vere flows into Riv. Mtkvari from the right side at the Heroes Square. The total length of it is 38 km and the catchment basin is 194 km². There are many important facilities and historical or cultural monuments in this catchment basin, such as Tbilisi State University buildings, TV and Circus buildings, Zoo, residential buildings and historical cultural monuments.

Figure 1. Study area (riv. Vere basin).

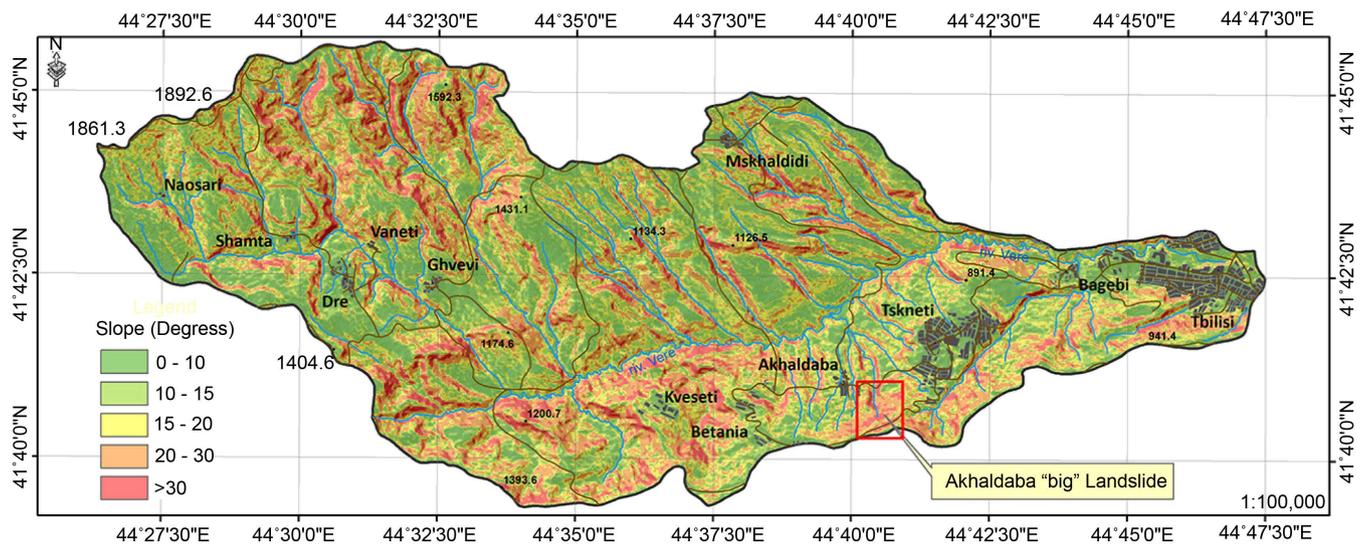
In hypsometric terms, the catchment basin of riv. Vere is located within three geomorphological zones: plain-terrace relief of the valley; low-mountainous piedmont; and average-mountainous mountain-gorge zones [3]. Tectonic conditions, varied sensitivity towards erosive-denudation processes of the constituent rocks, virgation of rocks folding, inclination in different directions and tectonic faults with numerous regional and local faults, -on the basic substrate of which a diversified relief is formed through erosive-denudation and gravitational process (**Figure 2**).

Figure 2. Slope map of riv. Vere basin.

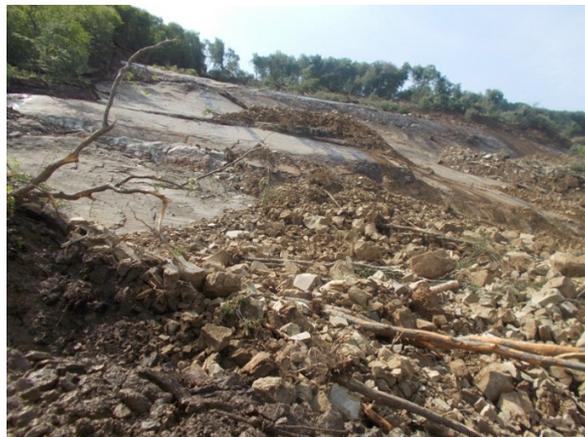
300 meters where along with the movement significant quantity of sandstone blocks and fractured rocks remain on the slope (**Figure 3**). Further, up to Village Akhaldaba at approximately 700 meters it transfers into liquid-soft state below the village road where it appears in quite a deeply down cut gully of Jokhani Tskali. After appearing in the riverbed with a significant inclination, it transforms into a typical debrisflow movement regime, the rocks-muddy stone material hits with great energy on the bed of the Riv. Vere Gorge and congests it with short intervals increasing the level of Riv. Vere up to 3 - 4 meters, though it did not play a significant role in increasing the total flow. The flow leaves behind the rocks (**Figure 4**) and continues flowing in the Vere Gorge, mostly saturated with fine-grained fraction, which brings along the wooden materials brought down from the body of the landslide. This mix of water-mud-stones along with a large amount of the vegetation got down on the territory of the City. We consider that it was the vegetation mixed with the muddy mass which became a key reason of blocking the tunnels in the riverbed and leading to overflowing in the outer space of the riverbed, which caused such a big tragedy in the City claiming the lives of up to 20 persons, de-

Figure 3. Sandstone blocks and fractured rocks remain on the slope.

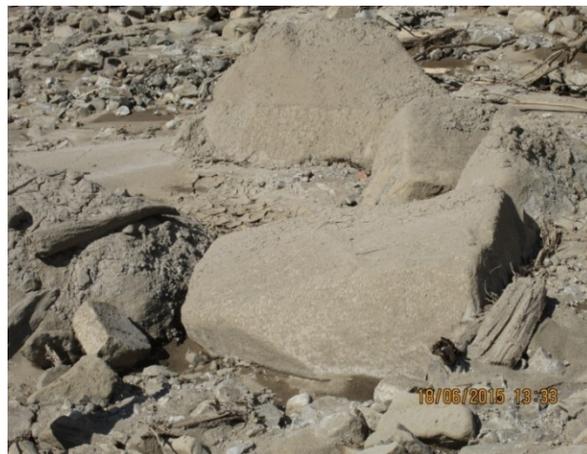
Figure 4. Jokhani-Khevi debrisflow material near riv. Vere.

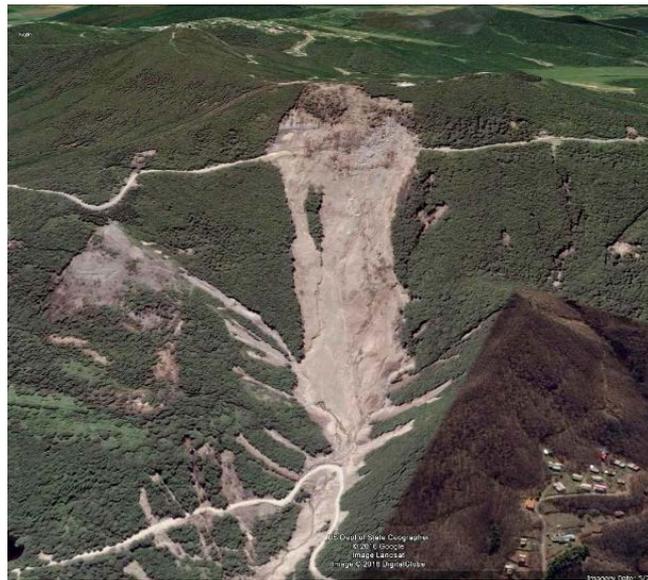
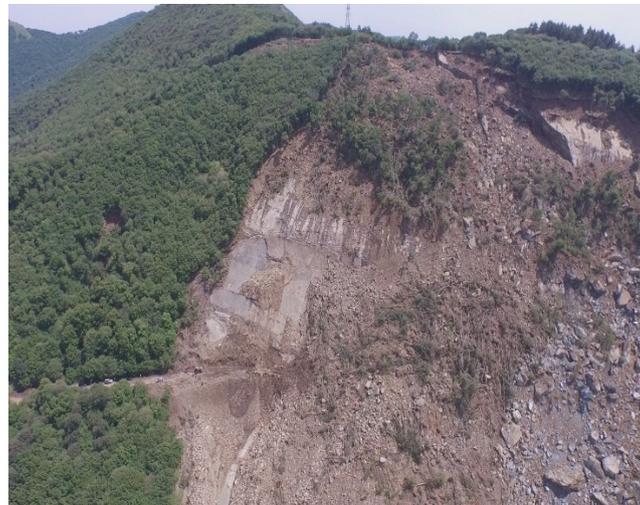
The Akhaldaba big landslide is developed on $40^\circ - 50^\circ$ inclination slope with the North-North/West exposition starting from its crescent and spreading up to environs of Village Akhaldaba (**Figure 5** and **Figure 6**).

The landslide is of elliptical shape in the plan with small landslide activations adjacent to it. Its upper part is located in the crest part at 1415 - 1420 meters of absolute

Figure 5. Akhaldaba “big” landslide [8].

Figure 6. Akhaldaba “big” landslide.

elevations, while the basis is the territory adjacent to the motor road of Akhaldaba-Tskneti at 1250 - 1280 meters within the absolute elevations. The difference in height between them is 150 - 180 meters with the length of 1 km while the average width of the landslide body is 350 meters. Visually the capacity of the landslide, following its slide layers and outcrops, constitutes 3 - 4 meters at the East wing and at the West wing; it ranges from 2 - 3 meters to 6 - 8 meters.

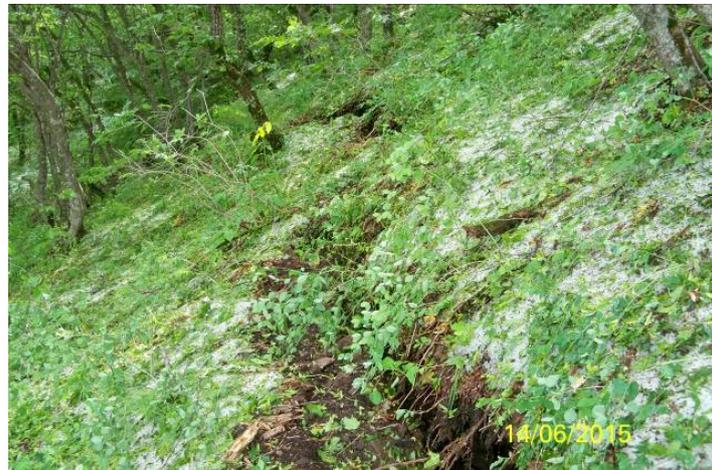
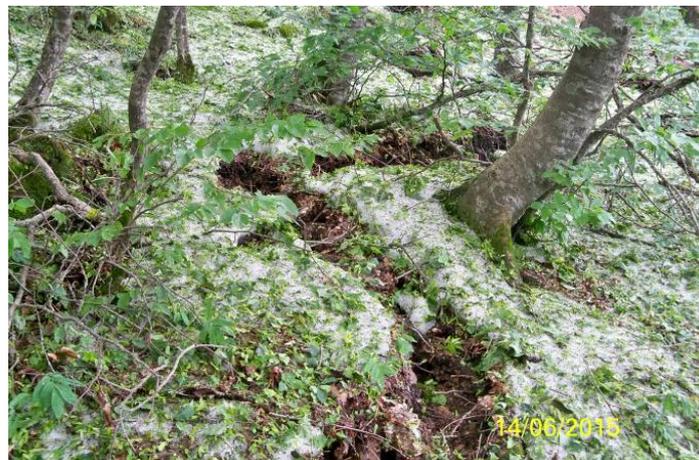
Adjacent to the East wing of the landslide there are three landslide fractures of East-West direction developed with the length of 20 - 30 meters, and the width of it is from 0.5 to 1.0 meters and with the visual depth from 0.2 to 1 - 1.5 meters (**Figure 7** and **Figure 8**).

Figure 7. Fractures on Akhaldaba big landslide.

Figure 8. Fractures on Akhaldaba big landslide.

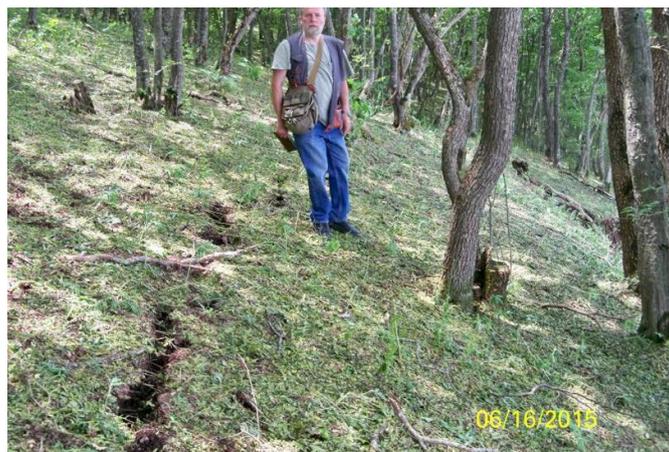
Adjacent to the West of the landslide there are two landslide raptures developed. One of them is located at the crest, at 100 - 150 meters from the military road and with the length of 100 meters and with the width of 0.2 - 0.4 meters (**Figure 9**). In addition, the other one is at 1274 meters absolute elevation, below the motor road, and of a semi-circle shape, with the width up to 0.5 meters, and the visual depth is from 0.5- to 1.0

Figure 9. Fractures on Akhaladaba big landslide.

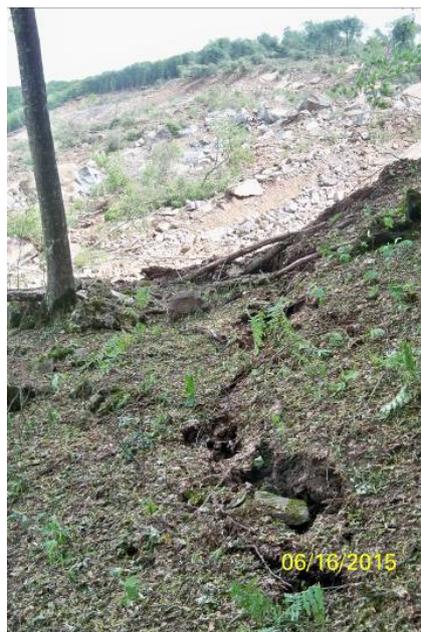
meters (**Figure 10**).

Figure 10. Fractures on Akhaladaba big landslide.

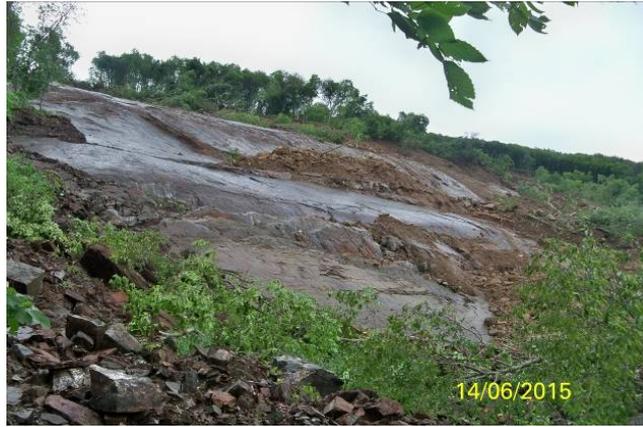
The landslide steps are not observed since the landslide is represented by mirror wavy surface of the rocky layers (**Figure 11**) on which detritus is accumulated in which several stepped accumulation can be identified, especially in the upper part of the landslide body. Detritus are represented with various size broken rocks and boulders (from 5 - 6 to 10 - 12 meters) (**Figure 12**).

Figure 11. Mirror wavy surface of the rocky layers.

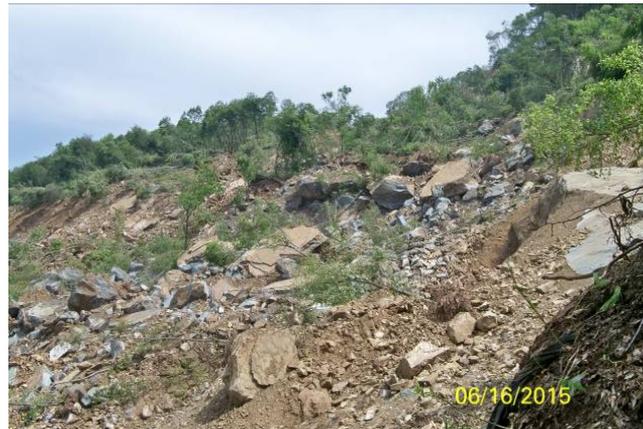
Figure 12. Various size broken rocks and boulders.

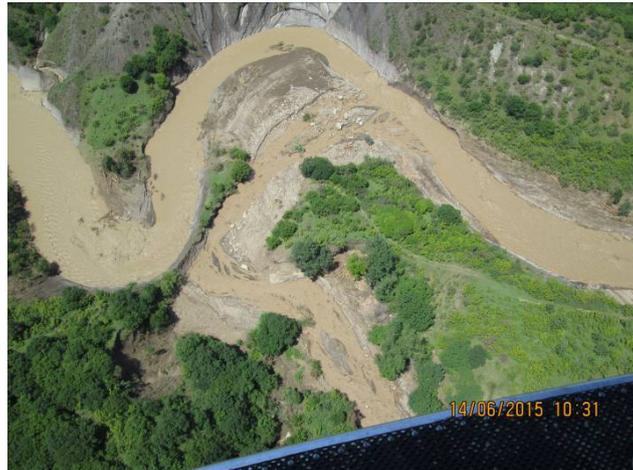
type, further up to the Village Akhaldaba it transforms into liquid-soft section (with the width of 70 - 100 m) and in the last section up to the Riv. Vere it transforms and acquires a debrisflow nature (Riv. Jokhani Gully). The total length of the landslide development from the crescent up to the Riv. Vere is 3.8 km [6] (**Figure 13**).

Figure 13. Connection of riv. Jokhanikhevi and riv. Vere.

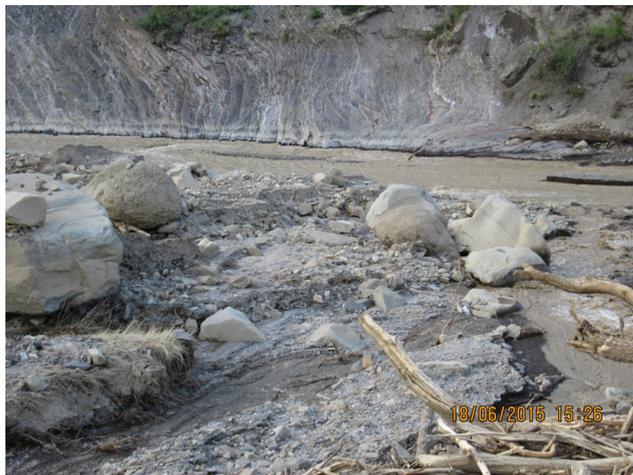
The debrisflow temporarily (for 1 - 2 minutes) congested Riv. Vere though no classic congestion and its breaking through were not observed and consequently, the discharge of Riv. Vere did not increase significantly. At the merging site diameters of certain rocks reaches 1.5 - 2.0 meters (**Figure 14**)

Figure 14. Debrisflow material of Jokhani-khevi alluvial fan.

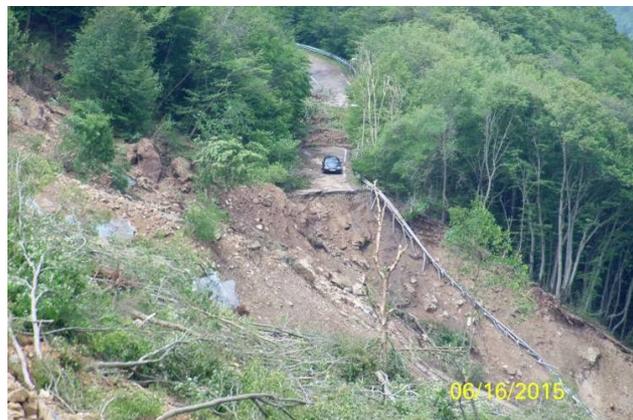
The landslide area affected three motor roads: 1) First road—the road in the crest part of the landslide, the local ground road (for energy specialists) which is torn off at several tens of meters length and also the high voltage transmission tower adjacent to it also slid; 2) Second road—the motor road connecting Tskneti-Samadlo, is torn off at meters 350 length (**Figure 15**); 3) Third road—the motor road with asphalt pavement, that

Figure 15. Destroyed Tskneti-Samadlo road.

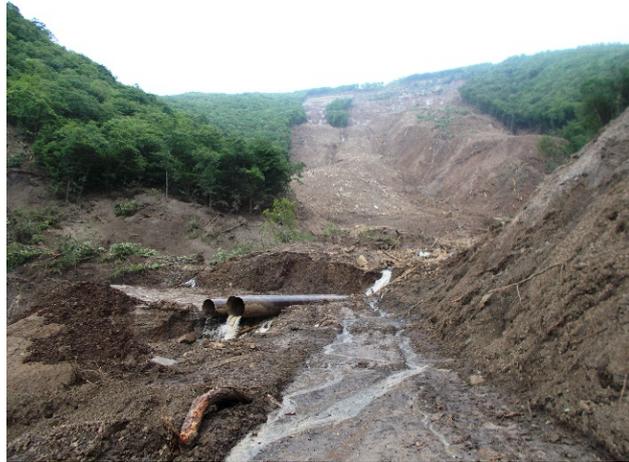
connects Tskneti-Akhaldaba, is damaged and overlaid by landslide broken rock-clay materials (**Figure 16**).

Figure 16. Destroyed Tskneti-Akhaldaba road.
