Cardiac imaging of prosthetic valve dysfunction by transesophageal echocardiography

Melek Zekiye Ulucam

Cardiology Department, Baskent University School of Medicine, Ankara, Turkey
Email: melekulucam@gmail.com

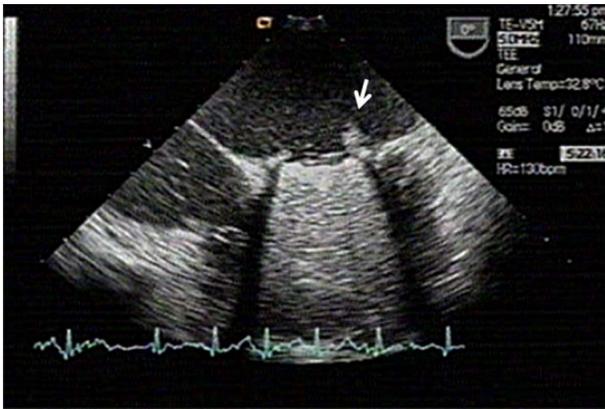
Figure 1. A large left atrial thrombus built-in mechanical prosthesis at mitral position.

Prosthetic valve obstruction, may develop due to thrombus, vegetations, pannus formation, or combinations thereof [1]. Most frequent cause [2] of prosthetic mitral valve obstruction is thrombus, while the prosthetic aortic valve is pannus (Figures 1 and 2).

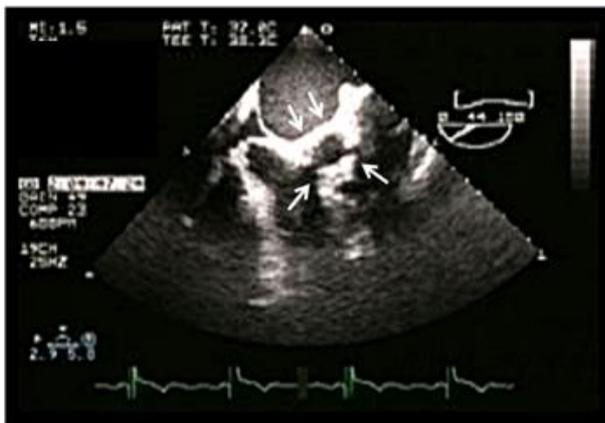
Figure 2. Pannus view at a mechanical prosthetic valve at aortic position (arrowed).

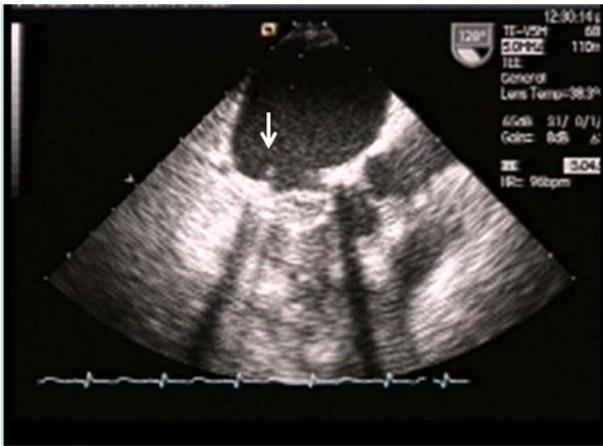
Figure 3. Arrow points fibrin cluster at mechanical mitral valve prosthesis.

During thromboembolism attacks, cardiac imaging methods of heart and organ where the embolic incident occurred establishes the diagnosis and determines the relation of the heart and the situation. Built-in fibrin clusters which can be viewed by at the atrial surfaces of the mitral prosthesis and at ventricular surfaces of the aortic prosthesis often cause thromboembolic events. These clusters can be monitored easily by TEE. In a study of Isada *et al.* [10], fibrin clusters are observed that 18% of the mitral prostheses, and they has been caused hemodynamic problems in 53% of it (**Figure 3**).

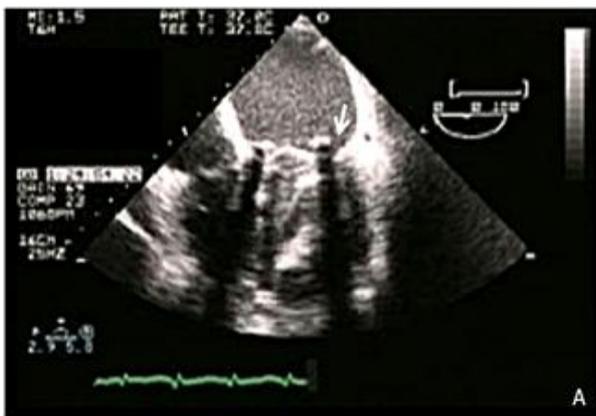
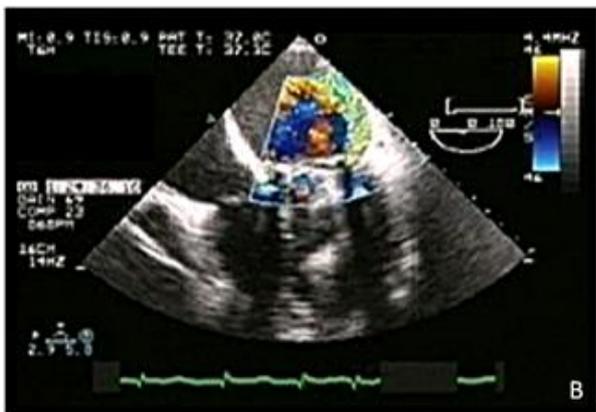
Figure 4. (A) Dehiscence of a mitral mechanical prosthetic valve (arrow); (B) Severe paravalvular mitral regurgitation and Coanda effect.

Paravalvular regurgitant jets usually depends on the separation of the PHV and annulus (valve dehiscence) (**Figures 4(A)** and **(B)** and **Figures 5(A)** and **(B)**) caused by infective endocarditis. However, it may caused by improper valve placement and suture line breakage [4]. In severe paravalvular mitral regurgitation, Coanda effect in TEE (circular jet motion on the walls of the left atrium) can be observed [8]. Paravalvular jets are important because they require replacement of PHV or repair of

Prosthetic mitral valve regurgitation, should also be evaluated by multiple methods. When assessing hemodynamic effects of mitral regurgitation, whether the regurgitation is acute or not is very important. For example, even a moderate degree of acute mitral prosthetic regurgitation may lead to pulmonary edema, because of the inflexible left atrium. In contrast, patients with chronic and severe mitral prosthetic regurgitation may have no symptoms due to compensatory mechanisms. Evaluation of mitral regurgitation of a mechanical prosthesis by TTE is limited due to reverberations. This problem is less pronounced in bioprosthesis. So, as a general rule, if pathological mitral regurgitation is suspected, regardless of the type of prosthesis, TEE should be done. Markers of severe prosthetic mitral regurgitation: 1: Increased mitral inflow velocity (≥ 2.5 m/s) and normal mitral valve pressure half time (≤ 150 ms); 2: Intense Continuous wave Doppler mitral regurgitation jet; 3: Regurgitant fraction $\geq 55\%$; 4: effective regurgitant orifice area ≥ 0.34 cm², 5: systolic pulmonary venous reversals. Proximal isovelocity surface area (PISA), which can be determined not only by TTE, but by TEE, highlights a severe mitral regurgitation. In a study of prosthetic mitral regurgitation, PISA was compared with the Doppler signal intensity and the intensity of the jet in the left atrium and PISA was found more sensitive but less specific [11]. Unexplained worsening in clinical status or new pulmonary hypertension, may be signs of severe mitral regurgitation [8]. Pulmonary venous Doppler flow is suggestive of the diagnosis of severe prosthetic mitral valve regurgitation, disappearance of systolic wave and return of systolic flow reversals in favor of seriousness. Pulmonary venous flow reversal, more evident in acute prosthetic mitral regurgitation, compared to the chronic prosthetic mitral regurgitation. However, there are no standards available for pulmonary venous flows for the evaluation of prosthetic mitral regurgitation. Coanda effect in TEE [8] indicates severe mitral regurgitation in valve dehiscence (**Figure 4(B)**).

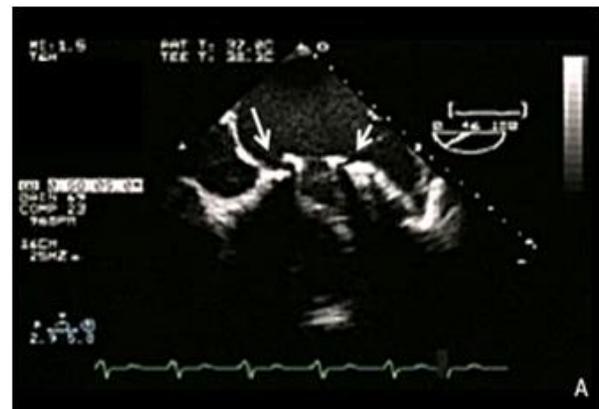
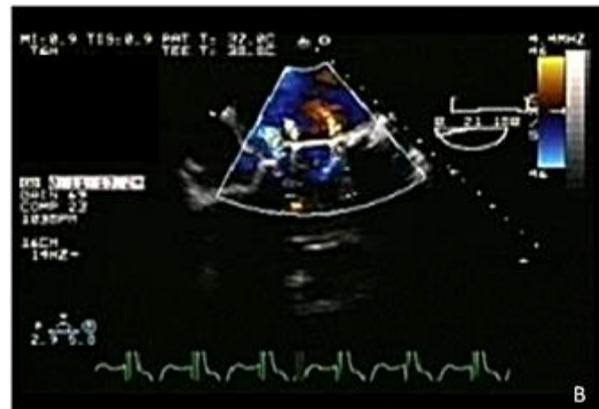
Figure 5. (A) Valve dehiscence in a prosthetic mitral valve (arrow); (B) Double tilting disc mechanical mitral prosthesis with 3 regurgitation jets. The first jet at the left is a paravalvular jet, and results from the valve dehiscence. The other two jets are physiological.
