# Root-Fusion Characteristic of Eucalyptus Trees Block Gully Development

Soil erosion by water resulting in gully formation is a common occurrence in western Kenya. Establishment of local and sustainable countermeasures to prevent gully development/expansion in western Kenya is an urgent issue. This study presents the proposal to prevent gully development/expansion by planting Eucalyptus trees in gully prone regions. A survey study was undertaken in Kenya from 2008 to 2011. Roots of adjacent *Eucalyptus citriodora* trees fused forming a dense network of closely woven mass of root system holding large amount of soil thereby checking erosion by water and hence gully development. The network of roots among adjacent Eucalyptus trees also supported the standing and normal growth of the other Eucalyptus trees whose root systems were completely free from soil. Recognizable aging and breakdown of root networks were not observed during the survey period.

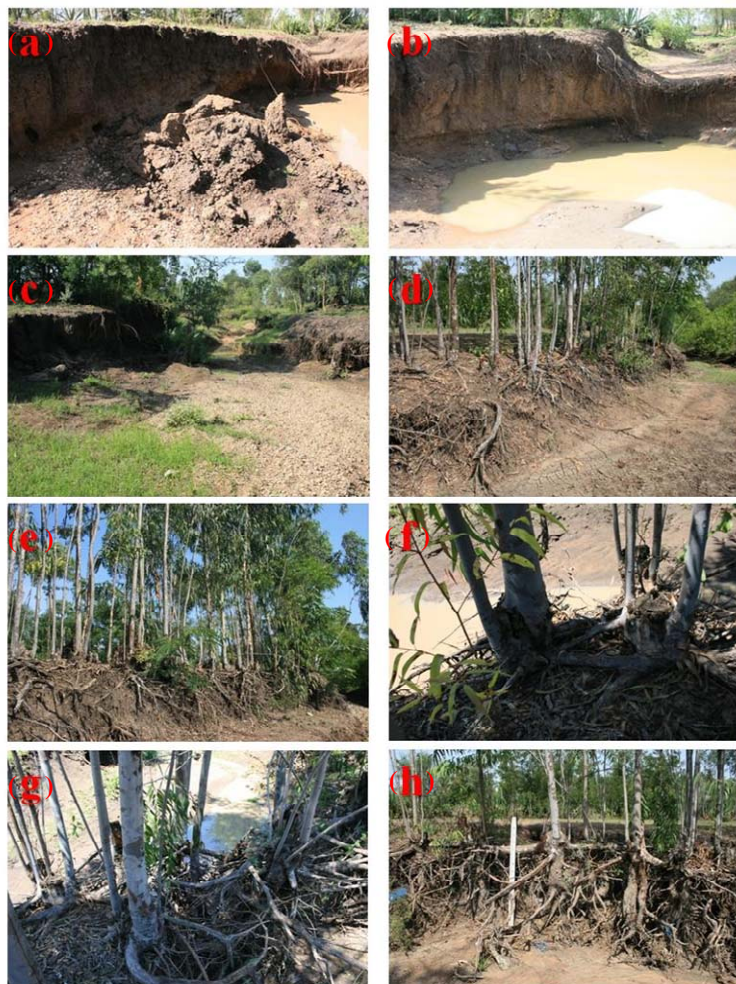
**Figure 1.** Field survey of Eucalyptus root system and its performance in blocking gully erosion development at Kokal village in Kisumu, western Kenya. Slumping of gully walls occur in the absence of Eucalyptus roots (a)-(c). Eucalyptus root system hold large soil mass preventing slumping of gully walls (c)-(e). Eucalyptus roots fused forming intimate mass of root system (f), (g). Neighboring Eucalyptus supported adjacent tree whose roots were freed of soil by water erosion (h).

Gully erosion to the depth of 1 - 3 m is common in Kisumu area and the depth is within the root systems of Eucalyptus trees. At the Awach-type erosion site in Kokal village the gully expanded during the 3-year period [10]. In the absence of Eucalyptus trees the gully expanded by slumping of banks (**Figures 1(a)** and **(b)**). In contrast, the site where Eucalyptus trees (*E. citriodora*) grew along the bank of the stream did not result in gully expansion during the 3-year period. The root system of Eucalyptus trees held large soil mass, prevented the slumping of bank wall by water erosion, and blocked further development of the gully (**Figures 1(c)-(e)**).

tem networks between adjacent Eucalyptus trees. Their roots were connected intimately to each other by root fusions (Figures 1(f) and (g)). The network of roots among adjacent Eucalyptus trees by root fusion also supported the standing of the tree whose root system was completely free from soil. Besides, fused-root system seemed to supply the nutrients and water from the neighbors to the Eucalyptus tree whose root system was completely free from soil by soil erosion and which kept green as neighbors (Figure 1(h)). Recognizable aging and breakdown of root networks between adjacent trees were not observed during the survey period.

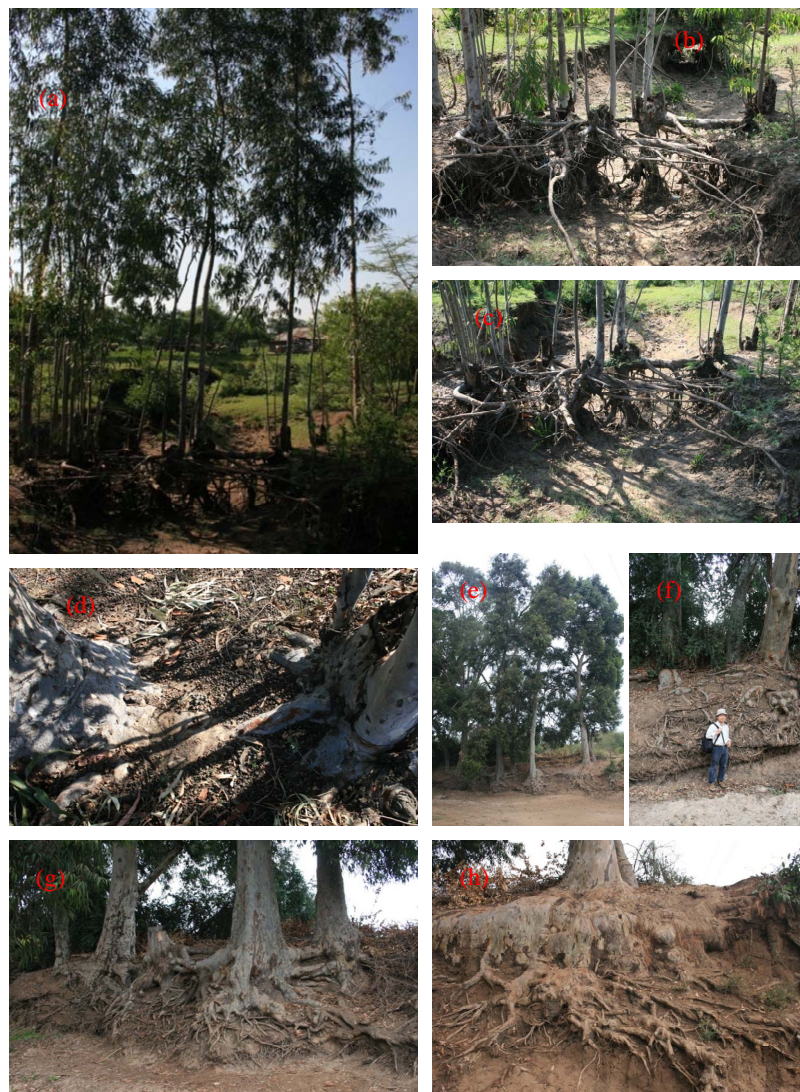
**Figure 2.** Field survey of Eucalyptus root fusion in Kenya. Eucalyptus root fusion phenomenon was also observed at Luanda village in Kisumu, western Kenya (a, b, c) and at Kenya Israel village in Machakos, eastern Kenya (d, e, f, g, h). Eucalyptus root fusion takes different forms (g, h).

The root fusion was common occurrence for Eucalyptus trees and it was observed at Luanda village in Kisumu (Figures 2(a)-(c)). Any soil erosion was not observed at the site where the trees were grown along the

border of upland fields (Figures 2(d)-(f)). Root fusion of Eucalyptus trees was also found at Kenya Israel village near Machakos town, eastern Kenya (Figures 2(g) and (h)). Gully erosion at the site reached to 3-m depth and dense root network of Eucalyptus trees completely blocked further gully expansion. Eucalyptus trees were nearly 20 m tall (Figure 2(e)) and root systems and root networks were denser than those observed in Kisumu (Figures 2(f) and (g)). Some roots were platy in appearance and held the soil completely inside the platy mass of roots (Figure 2(h)).
