Cultural Heritage and Flood Need of Interdisciplinarity

Klára Nedvěďová

Institute of Theoretical and Applied Mechanics, Academy of Sciences of the Czech Republic, Prague, Czech Republic
Email: nedvedova@gmail.com

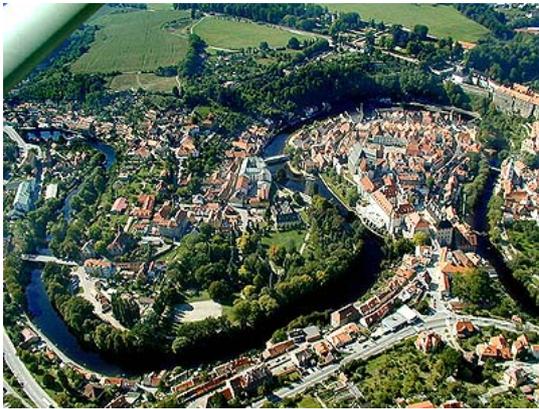
Figure 1. Meanders of the Vltava in Český Krumlov (source: Lubomir Mrázek).

Český Krumlov is located in the southern part of the Czech Republic near the Austrian border. The town is situated in the Vltava river valley in the foothills of the Blansky Forest Nature Reserve. It has an historical centre designated as a UNESCO World Heritage Site and which is the second largest castle complex in the Czech Republic. The Vltava River plays a crucial role in the setting and environment of the town. According to legend, the name Krumlov is derived from the German “Krumme Aue”, which can be translated as “crooked meadow”. The name comes from the natural topography of the town, specifically from the tightly-crooked meander of the river embracing the core of the town (**Figure 1**).

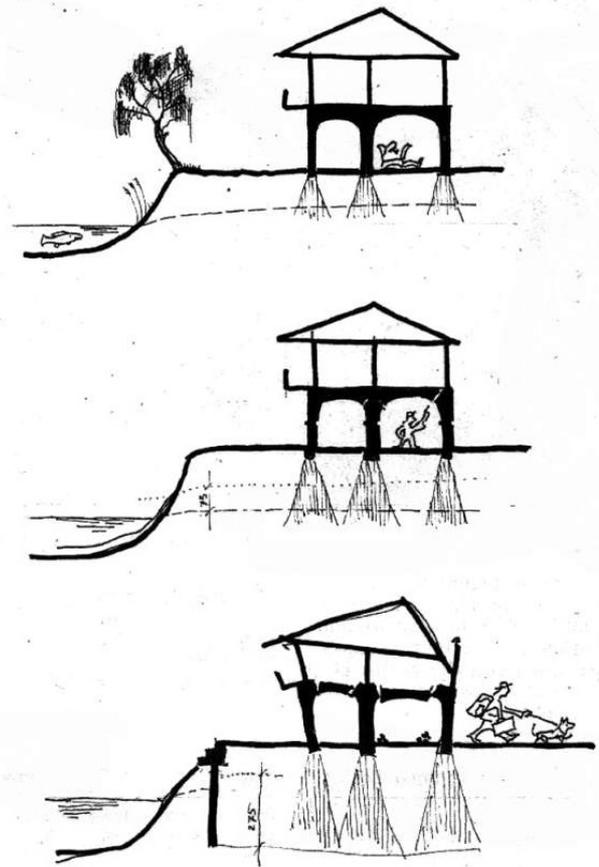
Figure 2. Changes in foundation soil caused by lowering the water level (source: Petr Pešek).

portrayals of the town. There have been complains about esthetical impact of flood protection system in historical site and the UNESCO status is in danger. Furthermore, two years later another great problem appeared. 400 hundred years old houses are cracking and experiencing constructional problems. The river bed was deepened and widened to be able to absorb Q_{100} flood (*i.e.* quotation 100 which means that the probability of a flood of such severity occurring is 1 in 100 years). Due to these measures, the water level was reduced by about 80 cm. Experts assume that lowering of water level about almost one meter causes changes in bedrock and therefore the foundations of the houses began to move (**Figure 2**). It is a very serious situation and now many experts gather together to solve the problem. All work has to be stopped. The whole project has to be revised and there seems to be a requirement for much more extra money to solve the problem.

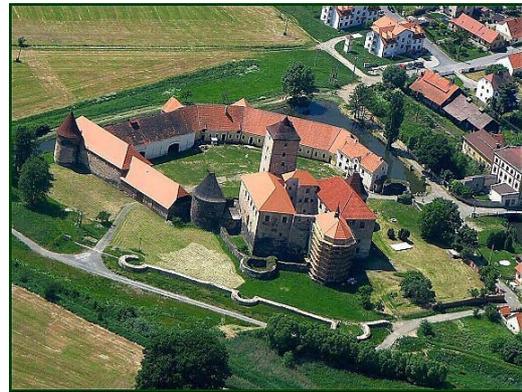
Figure 3. Reconstruction of the fortification wall.

The old fortification wall was renewed and became a part of the flood protection rampart (**Figure 3**). The visible surface is made from stone masonry identical with the masonry of the castle. The wall is optically isolated from the rest of the barrier. It is brought tight together by a movable flood-protection barrier only when there is a flood threat. The castle water channel was locked by a new flood gate.
