# Performance of a Panelized Brick Veneer Wall System under Lateral Loads

Jianhai Liang<sup>1</sup>, Ali M. Memari<sup>2</sup>

## ABSTRACT

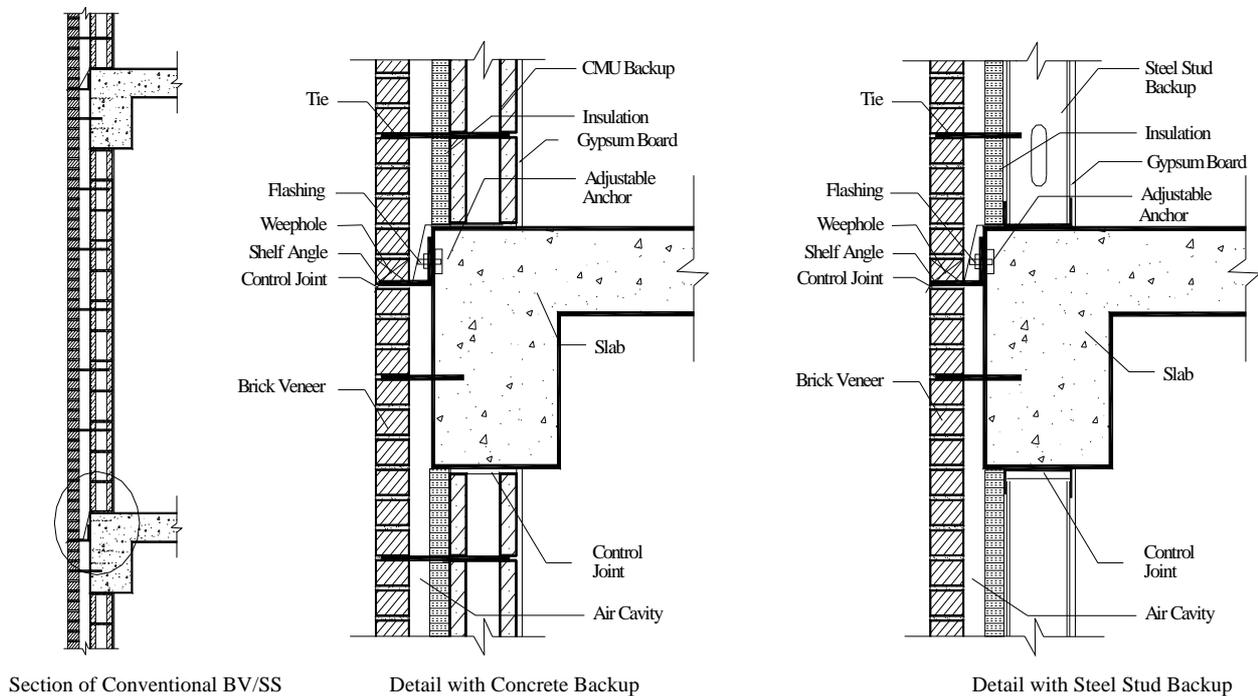
Figure 1. Typical sections of BV/SS and BV/CMU wall systems.

Conventional BV over CMU backup walls (BV/CM) and BV/SS walls have gaps under shelf angles as shown in **Figure 1**. These gaps serve as horizontal movement joints and are supposed to prevent BV from participating in in-plane load resistance. However, in practice the gap is sometimes filled with mortar instead of deformable sealant and can lead to participation of the BV in lateral in-plane load resistance and subsequent damage [8]. Another reason for the closure of gaps is attributed to differential movement between the BV and the backup. This problem, along with the out-of-plane flexural cracking problem due to wind, has been a concern for the use of BV/SS system in some areas.

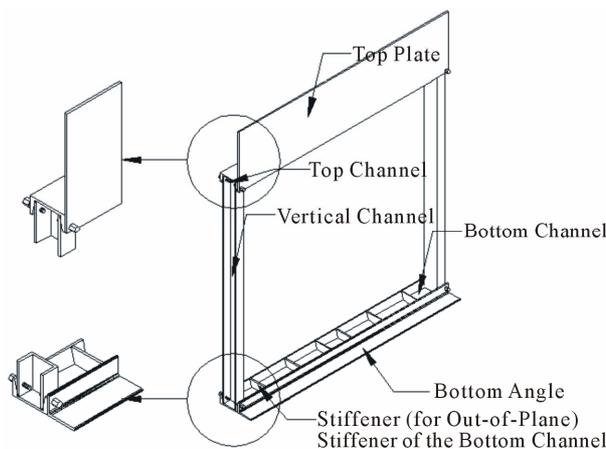
Figure 2. Isometric view of the steel support frame.

The proposed PBVSS system is based on prefabricating the entire BV and SS backup wall as a panel. While the BV resembles that of a conventional BV/SS, the light gauge SS backup system is made to be much stiffer and more robust than conventional SS backup system in order to control the maximum SS deflection and thus the BV crack width. The SS backup takes advantage of a rolled steel frame made up of top and bottom built-up steel beams and two vertical channels on the sides. The bottom beam is made up of a channel supporting the SS and a steel angle supporting the BV. Therefore, the bottom beam serves the function of a shelf angle in conven-

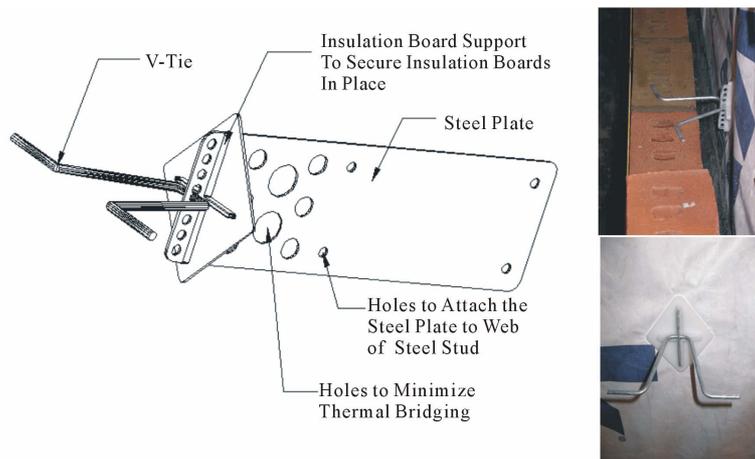
Figure 3. Shear connector [24].

The SS backup is connected to the BV with shear connectors (**Figure 3**). As opposed to conventional flexible adjustable ties that are anchored to SS flanges, stiffer shear connectors are used [24]. Because of their higher axial stiffness and strength, shear connectors can transfer out-of-plane loads from the BV wythe to the SS more efficiently. In addition, shear connectors are directly anchored to the SS web, hence provide more reliable connections and can prevent buckling of the studs flanges. Typical horizontal and vertical tie spacing used is 400 mm, which is the spacing of SS members, while smaller vertical tie spacing is used at the top of the wall to address the conventional non-uniform tie force distribution discussed previously.

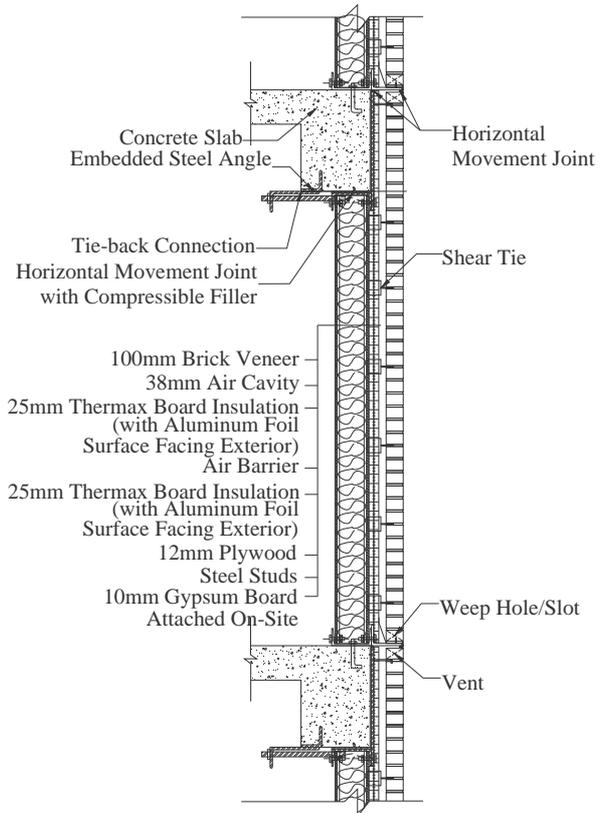
Figure 4. PBVSS elevation.

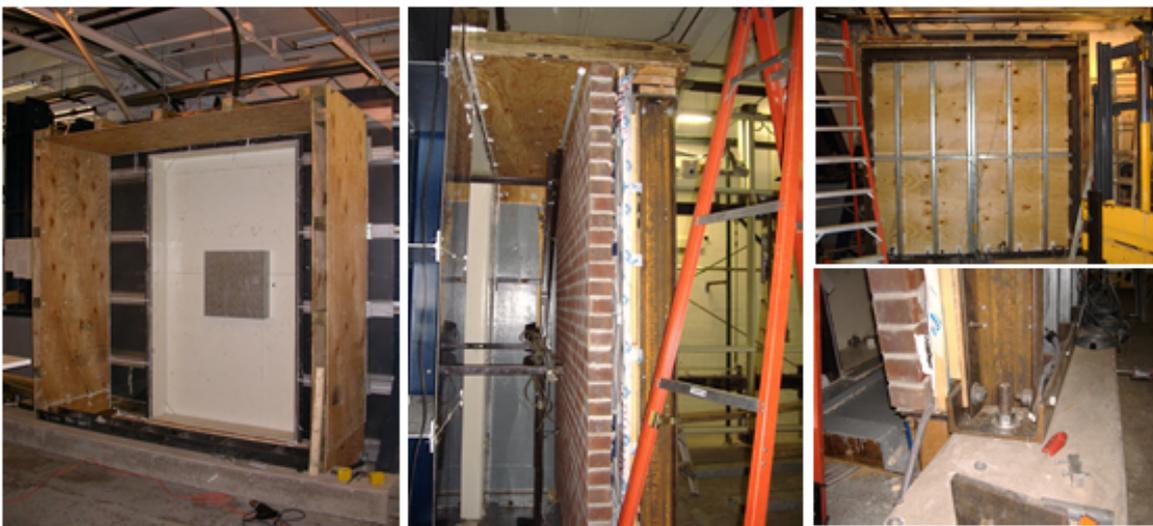
**Figure 5.** Wind loading test setup.

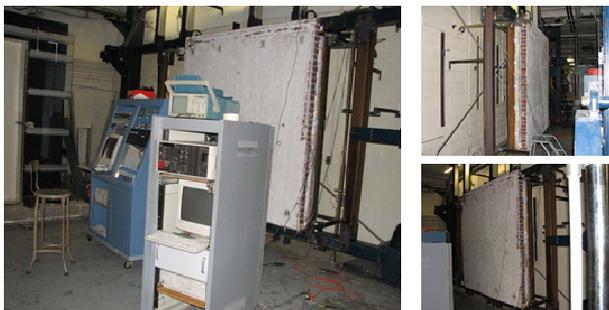
**Figure 6. Racking test load facility (DRTF).**

The test facility shown in **Figure 6** is made up of two sliding steel tube beams and two steel tube columns with two steel threaded rods providing diagonal bracing. The columns are fixed at the bottom and the beams are supported by the columns with brackets. A hydraulic actuator ram controlled by an electrohydraulic servovalve and connected to the bottom beam pushes the beam in the horizontal direction. The actuator ram is supported by a separate reaction frame. The maximum drift capacity of the bottom beam is  $\pm 76$  mm. Magenes and Calvi [21,22] recommended 1% drift limit for in-plane movement of the brick wall alone, and the building code used, ASCE 7 - 10 [28], called for a 2% story drift, which is equivalent to about 48mm for this specific specimen. However, a higher drift ratio had to be tested to investigate the ultimate drift ratio capacity of the system. Therefore, a fulcrum assembly and a pivot arm were used on the racking test facility to couple the top and bottom beam. The mid-point of the pivot arm was attached to the mid-point of the column so that when the bottom beam was moved by the hydraulic ram, the top beam would be moved with the same amount in the opposite direction. As a result, the drift capacity of the facility with the fulcrum assembly was doubled to  $\pm 152$  mm. At the same time, however, the maximum frequency at higher drifts had to be de-

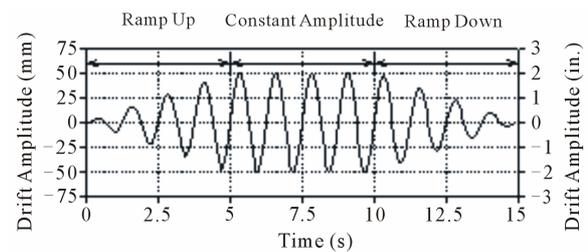
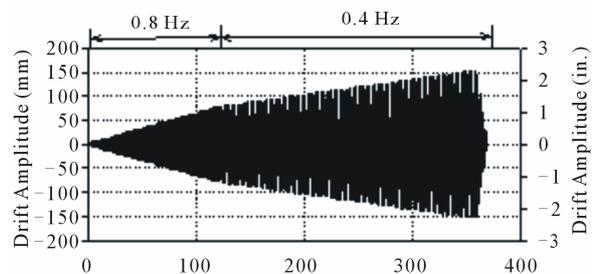
**(a) Typical Cyclic Racking Step (Step 8: 0.8 Hz)**

**(b) Cyclic Racking Displacement Controlled Loading Protocol**

**Figure 7. Drift time history for cyclic racking test. (Note: each racking step consists of ramp up, constant amplitude and ramp down cycles).**

creased because of the system capacity limitation. Since this test did not intend to simulate a real earthquake, the frequency was not a major concern. The main objectives of the experimental racking study were to investigate the performance of the tie-back connections, the BV, as well as determining the drift capacity of the system under cyclic racking displacements as a means to develop an understanding of the behavior of the wall under earthquake induced movement. Displacement controlled cyclic racking history (**Figure 7**) developed originally for curtain walls were used as input for this test [30]. To facilitate the data acquisition and observation of the specimen during the test, the whole racking history was divided into shorter segments [31]. Each segment started with 10 cycles of  $\pm 2$  mm displacement. Then for each step, the displacement amplitude was increased to the peak value in four cycles, kept constant for five cycles, then returned to zero in four cycles, as shown in **Figure 7(a)**. In order to determine the drift limit of the PBVSS wall system, the maximum stroke of the loading facility was used. The maximum magnitude of drift in each step started from 6 mm and increased by 6 mm in each step up to 152 mm or until the specimen failed. Therefore, there would be 24 steps in the test if the specimen did not fail during the test. The frequency of the accelerogram was 0.4 HZ or 0.8 HZ depending on the magnitude of movement. **Figure 7(b)** shows the complete loading history used.

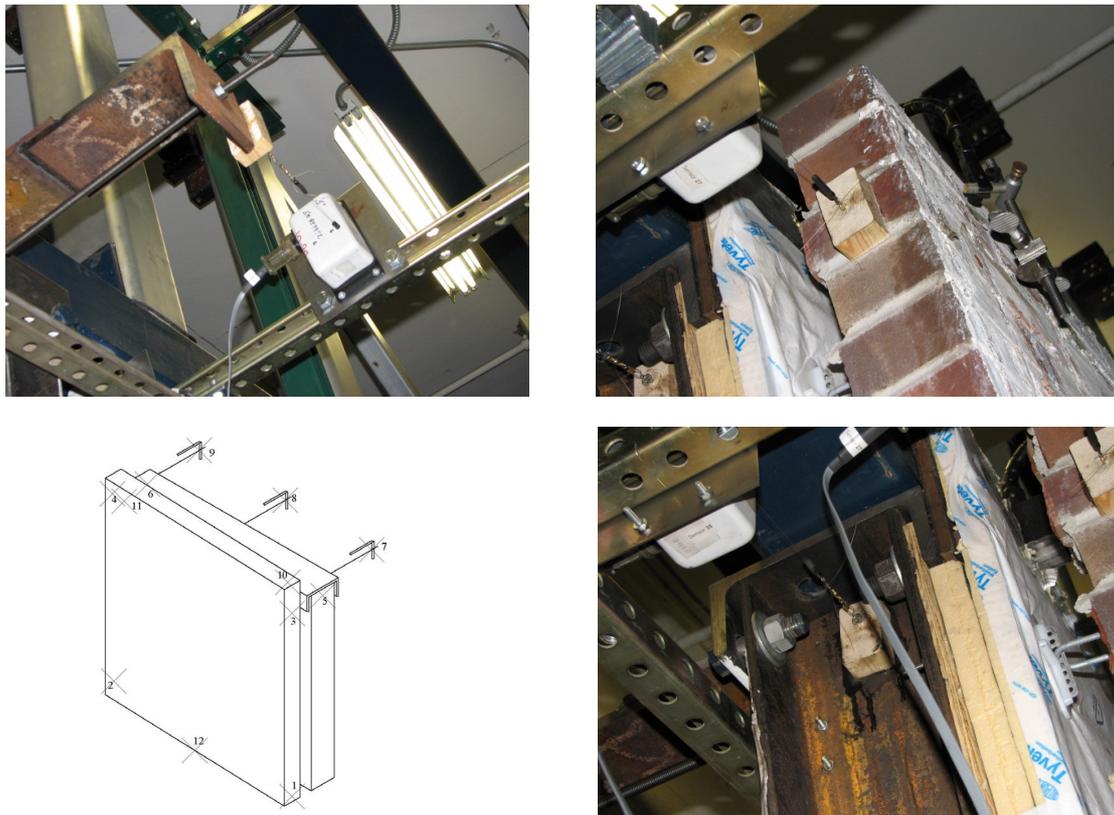
**Figure 8.** Example photographs and schematic locations of sensors for seismic test.

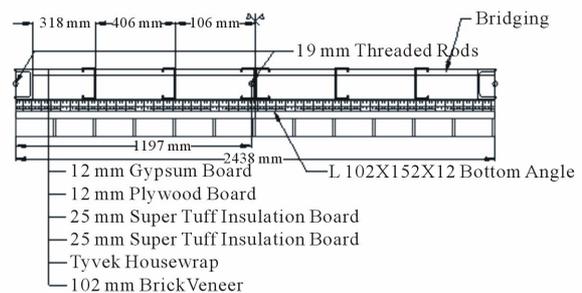
Figure 9. Horizontal section of the test specimen.

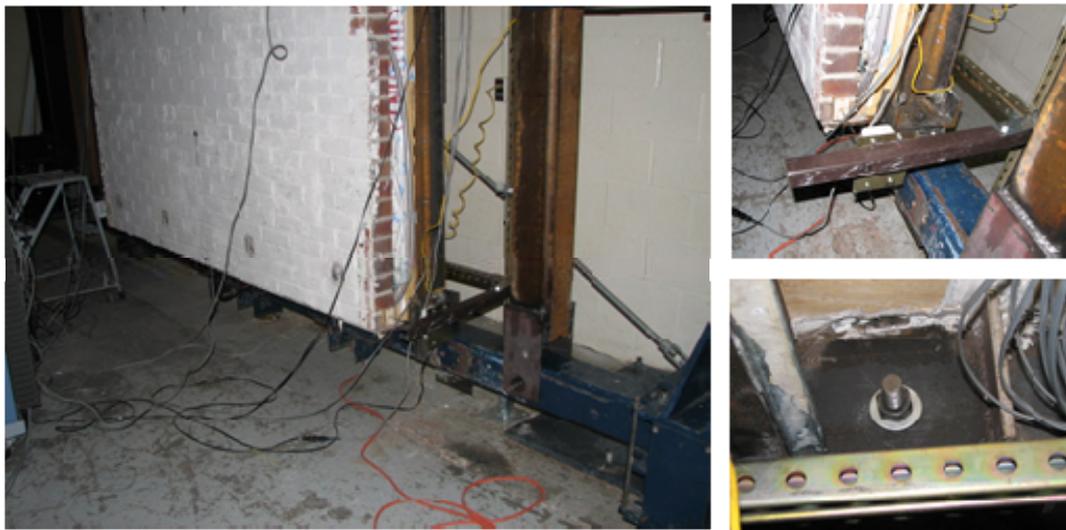
Figure 10. Attachment of the bottom channel to the lower spandrel beam of DRTF.

Figure 6 shows photographs of the PBVSS specimen mounted on the DRTF. Boundary conditions of the test specimen simulated the actual construction. The bottom of the specimen as shown in Figure 10 was attached to the bottom spandrel beam of the test facility using three threaded rods. Locations of attachments were at the bottom corners and middle of the specimen. Similarly, L203 × 102 × 12.7 steel angles were welded to the side of the top spandrel beam next to the top corners and middle of the specimen. Then a L203 102 × 12.7 angle was welded to the long leg of each angle. The specimen was then connected to these angles through 432 m long 13 mm

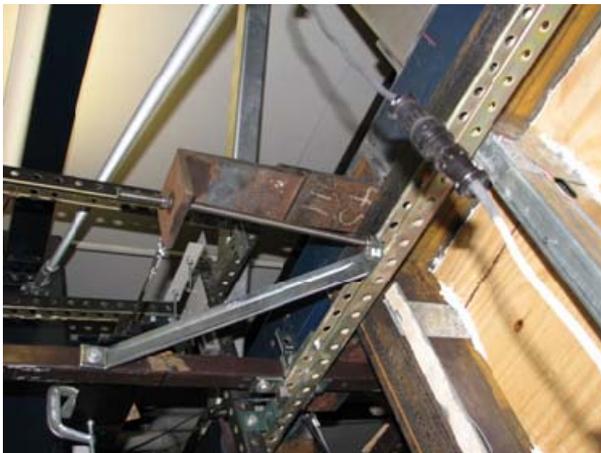
Figure 11. Attachment of threaded rod to the top spandrel beam of DRTF.

diameter threaded rods, as shown in Figure 11. These connections were designed to provide out-of-plane lateral supports (*i.e.* axial force in the threaded rods). Figure 12 shows details of the top connection, while a vertical section of the entire test specimen is shown in Figure 13.

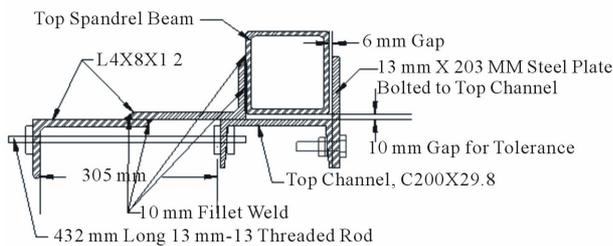
Figure 12. Details of seismic isolation connections at the top.

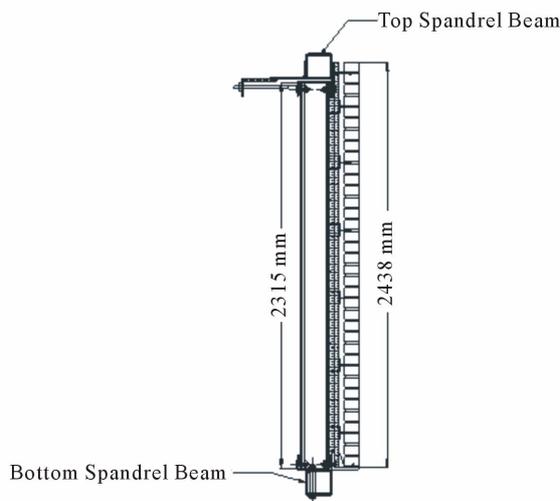
Figure 13. Elevation of seismic test specimen.

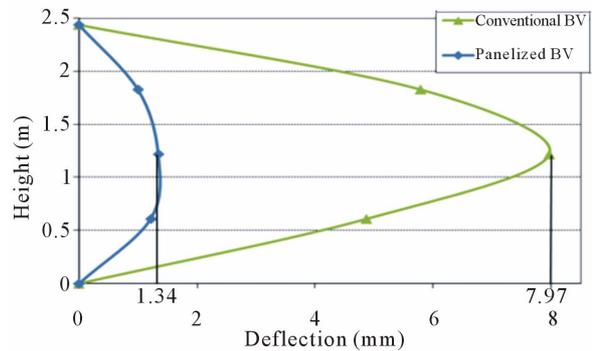
Figure 14. Comparison of deflection along height under  $6 \text{ kN/m}^2$  pressure.

The conventional specimen was first tested under simulated wind load followed by water penetration test. Then the PBVSS was tested following a similar procedure. Figure 14 compares the deflection of BV components of the two specimens under the maximum air pressure of 6.0 kN/m<sup>2</sup> along the height of the specimens. The figure shows that the maximum (mid-height) deflection of the conventional BV (7.97 mm) is approximately six times the maximum deflection of the PBVSS specimen (1.34 mm). Figure 15 compares tie forces versus pressure for the two specimens. Data shown are for the second tie from the top on the BV centerline. The relationship between tie forces and the pressure applied was generally linear for the conventional specimen, with some nonlinear portion at higher pressure levels. The maximum force

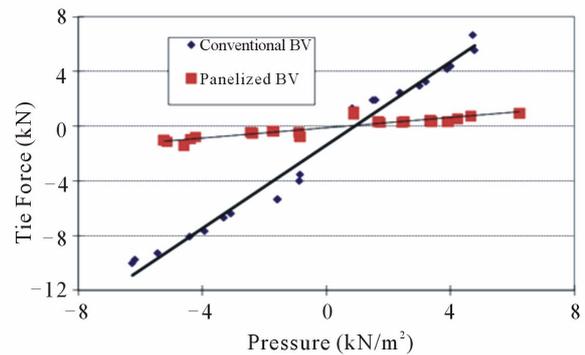
Figure 15. Tie force vs. pressure.

in this tie under  $6.0 \text{ kN/m}^2$  negative pressure reached  $10.0 \text{ kN}$ , which is much higher than the tie capacity, and the tie likely behaved nonlinearly. This suggestion was supported by the fact that many ties were actually pulled out during the test of the conventional specimen. The relationship between pressure and tie force for the PBVSS specimen did not have the same level of linearity

as that of the conventional specimen. Tie force distribution was not uniform for either specimen.

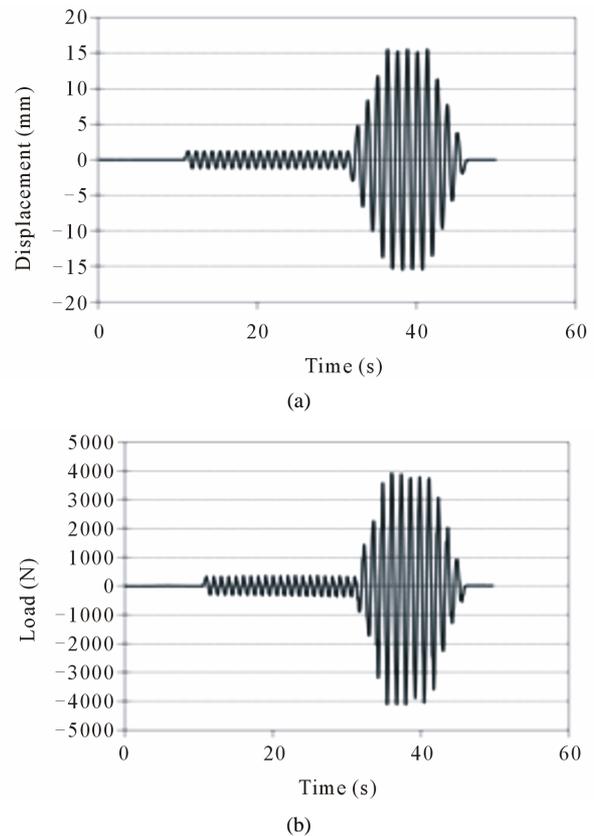
**Figure 16.** 13 mm diameter rods, 5<sup>th</sup> step; (a) Displacement vs. time; (b) Load vs. time.

The specimen with 13 mm diameter threaded rods was tested first. Later, the 10 mm diameter threaded rods were attached and the specimen was tested again. **Figure 16(a)** shows one sample of input displacement versus time plots for 13 mm diameter rods at the 5<sup>th</sup> step with the input displacement of 15 mm. **Figure 16(b)** shows the corresponding load in the actuator vs. time for this step. The figure shows that at this step, it takes approximately 3.88 kN to move the specimen 15 mm, which is equivalent to a stiffness of  $0.259 \text{ kN/mm}$ . This value is quite small and shows that the BV wall does not effectively participate in lateral load resistance, considering the in-plane stiffness of typical masonry walls [36]. Comparison of the load-time plots for the 13 mm tie rod (**Figure 16(b)**) with the plot for 10 mm tie-rod (not shown) showed that the magnitude of the peak load in the 13 mm tie-rod specimen plot was 24% higher than that for the 10 mm plot.

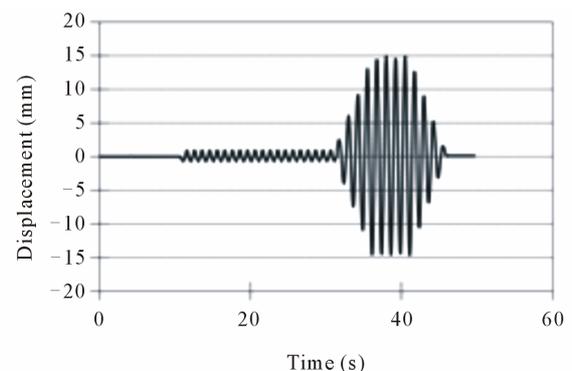
**Figure 17.** In-plane displacement of top left corner of the BV: 13 mm diameter rods, 5<sup>th</sup> step.

In-plane movements of all four BV corners were recorded during the test. **Figure 17** shows displacement of the top left corner of the BV with 13 mm diameter threaded rods under 16mm input displacement during the 5<sup>th</sup> step. The measured displacement on the veneer is only very slightly smaller than the actuator input displacement (**Figure 16(a)**) and shows that the “plays” in the loading frame system is minimal. This was also further confirmed by looking at the plots of the displacements of the four corners of the BV wythe such as that shown in **Figure 18(a)** which shows the displacements of

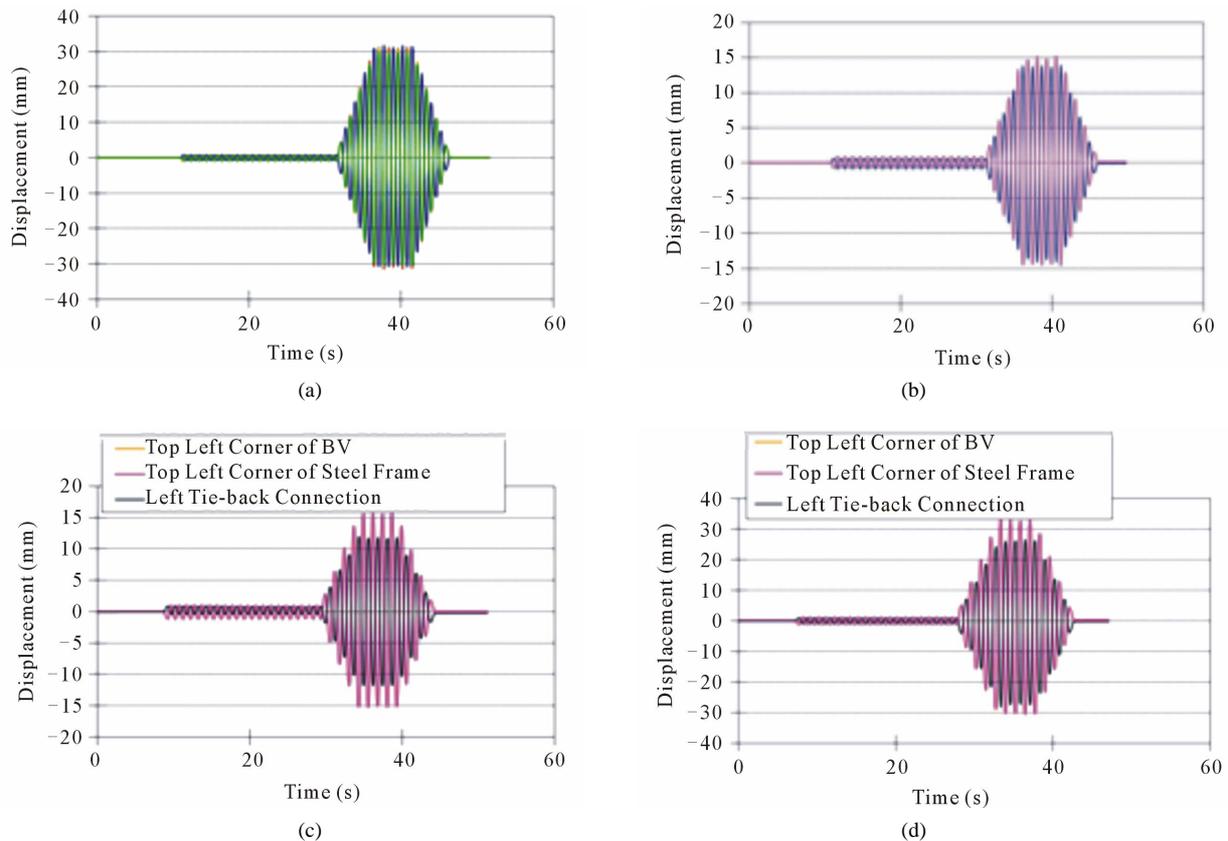
**Figure 18. Comparison of in-plane displacement: (a) 13 mm diameter rods, 10th step; (b) Steel frame at corners: 13 mm Diameter rods, 5th step; (c) Top left corner of the BV, top left corner of the steel frame, and left tie-back connection: 10 mm diameter rods, 5th Step; (d) Top left corner of the BV, Top left corner of the steel frame, and left tie-back connection: 10 mm diameter rods, 10th step.**

the specimen with 13 mm diameter tie-rods during the 10<sup>th</sup> step. Such corner plots indicated that there was no rotation of the BV. This is a desirable behavior for panelized walls under seismic effects because this means that adjacent panels will not touch each other during an earthquake (assuming input movements are the same for adjacent panels). Furthermore, the displacement of the top spandrel beam in the opposite direction (which was transferred to the steel angles of the connections) did not have any effect on the brick veneer. This is important for

**Figure 18(b)** shows the in-plane displacement of top corners of the steel frame for the specimen with 13 mm diameter threaded rods under 16 mm input displacement. The plots show that the magnitude of the steel frame displacement was the same as the input displacement, which indicates that the in-plane movement of the top spandrel beam did not have any effect on the steel frame either. Furthermore, since the two sensors had the same readings, the steel frame did not rotate either. **Figures 18(c) and 18(d)** show comparison of the in-plane displacement of top left corner of the BV, top left corner of the steel frame, and the left tie-back connection during the 5<sup>th</sup> (16 mm displacement) and 10<sup>th</sup> (32 mm displacement) steps for the specimen with 10 mm dia. tie-back connection. These are points on the three components (BV, steel frame

backup, and tie-back connection) on the left side approximately at the same elevation. Similar figures were obtained for the specimen with 13 mm tie-back connection. The plots show that absolute magnitudes of the three measurements are very close, and are approximately equal to the input displacement. However, at any given time, the displacement of the tie-back connection was in the opposite direction of that of the BV and the steel frame because the input displacement of the tie-back connection was from the top spandrel beam and in the opposite direction to that of the bottom spandrel beam, which provided input displacement for the BV and the SS backup. The magnitude of the displacement of these three components are exactly the same as the input displacement, which means the displacement of the connection and the displacement of the main body of the PBVSS did not interfere with each other. The main body of the PBVSS was isolated from the input displacement of the tie-back connections.

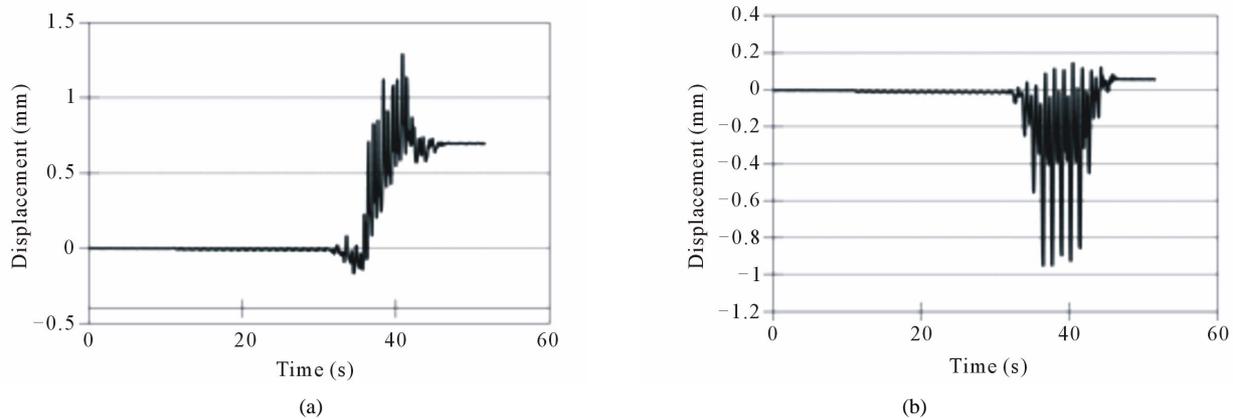
**Figure 19. (a) Out-of-plane displacement of BV top right corner: 13 mm diameter rods, 10th step; (b) Vertical displacement of bottom of the BV: 13 mm diameter rods, 10th step.**

**Figures 19(a) and 19(b)** show the vertical and out-of-plane displacement of the specimen under 32 mm input displacement for the specimen with 13 mm diameter tie-back. Similar displacements were also obtained for the

specimen with 10 mm diameter tie-back. As expected, movements in these two directions were negligible. The specimen moved as a rigid body horizontally without any vertical or out-of-plane movement. Therefore, there was no contact between the steel plate at the top and the top spandrel beam either.

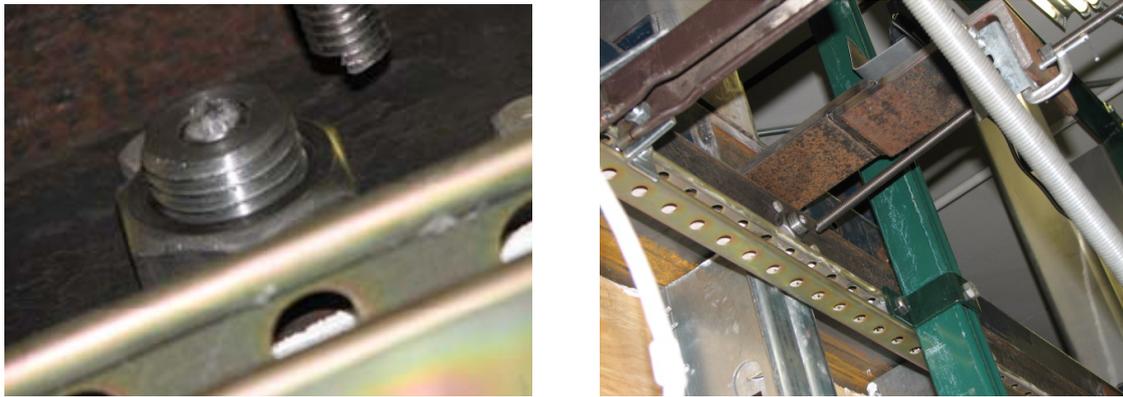
Figure 20. Typical failure mode of tie-back threaded rods.

The failure mode of the tie-back in both specimens was by shearing off of the threaded rods at large drifts. The threaded rods sheared off at the points that they were connected to the top channel of the PBVSS, as shown in **Figure 20**. In the test of specimen with 13 mm diameter threaded rods, two of the threaded rods failed at the 11<sup>th</sup> step, which had the maximum wall drift of about 70 mm and a corresponding load of 5.34 kN. The left and the middle tie-back connections sheared off at approximately the same time, while the right connection was still good. The specimen with 10 mm threaded rods experienced shearing off of the left tie-back connection first at the 10<sup>th</sup> step, with the maximum wall drift of about 64 mm and a corresponding load of about 6.03 kN. The test was then continued with larger displacement and eventually the middle tie-back connection sheared off too at the 14<sup>th</sup> step with the maximum wall drift of about 88 mm and the corresponding load of about 10.0 kN. In both cases, no vertical or out-of-plane movement was recorded. The BV moved horizontally as a whole rigid body. It was not affected by the movement of the top spandrel beam at all. No crack or other form of damage of the BV was noticed.

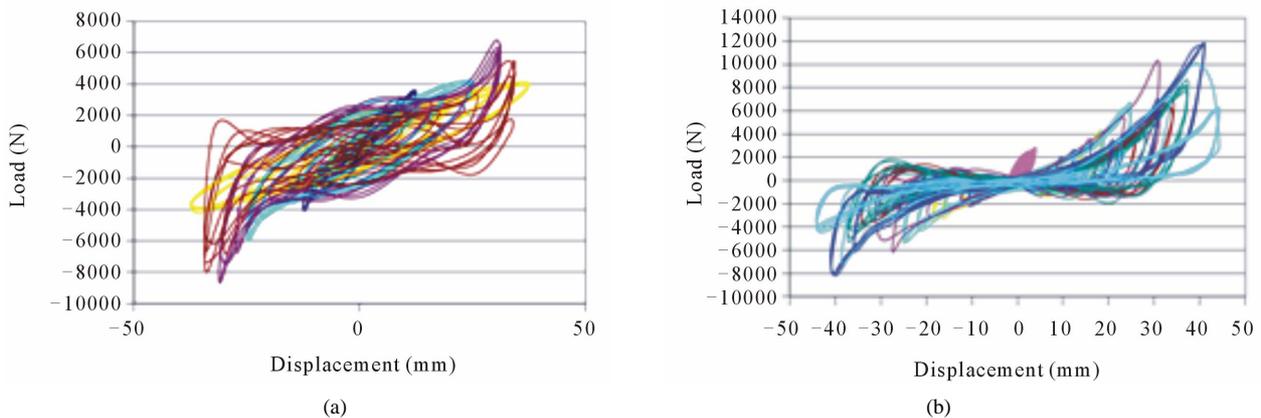
Figure 21. (a) Hysteresis curve for specimen with 13 mm diameter threaded rods; (b) Hysteresis curve for specimen with 10 mm diameter threaded rods.

placement than the specimen with 13 mm diameter threaded rods. It also took more load to break the specimen with 10 mm diameter threaded rods. Finally, **Figures 21(a)** and **21(b)** show the hysteretic displacement versus load curves for different steps of both cases. In both cases, the stiffness of the specimen decreased with increased input displacement, more so for the specimen with 10 mm diameter threaded rods.
