Indicators Benchmarking of Cement-Based Construction Technologies: Brazilian Case Study

Alberto Casado Lordsleem Júnior, Bárbara Eloá Gonçalves de Lima

Department of Civil Engineering, Polytechnic School of Pernambuco University, Recife, Brazil
Email: acasado@poli.br

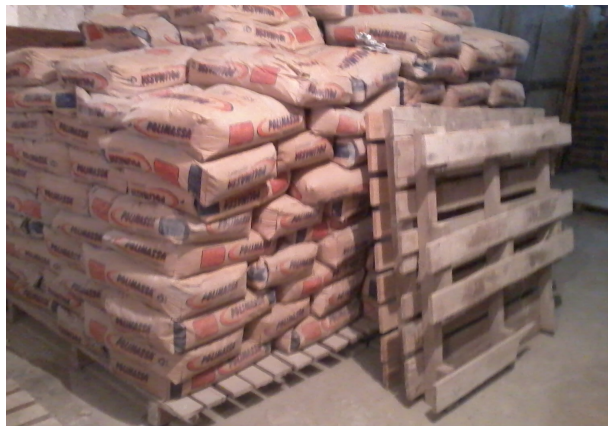
Figure 1. Mortar stocked on pallets.

The storage of mortar sacks was performed properly to avoid the action of humidity over the material. For such, the mortar was stored on pallets (**Figure 1**) and it was aimed to ensure that the warehouse was always ventilated.

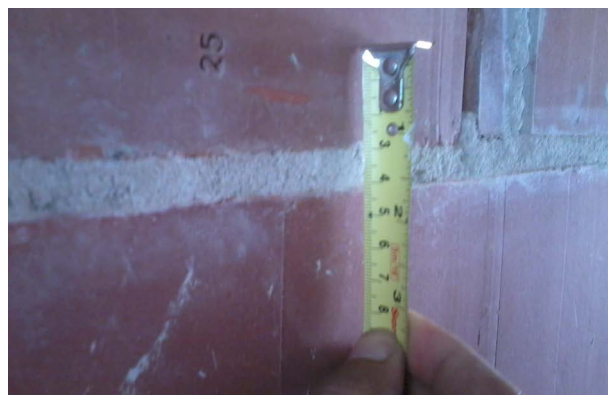
Figure 2. Joints within specifications.

The volume of mortar going up to the apartments was always compatible with the amount of blocks that would be settled at that moment, secured by the design for the production of masonry. According to specifications, the vertical and horizontal joints did not exceed one (01) centimeters (cm), avoiding unnecessary use of mortar (**Figure 2**).
