Mechanisms of the Deterioration of the Wall Reliefs at Shenhur Temple, Upper Egypt and Concepts for Conservation

The Roman Period temple of Isis at Shenhur was built and enhanced amid the rule of Augustus (30 BCE-14 CE) through that of Trajan (98-117 CE). It was built of two sorts of local limestone and decorated with reliefs. Examination of conservation state uncovered that it was collapsed and only partly preserved and it disposed of some still buried rooms. The temple is exposed to different deteriorations processes created by internal and external stresses because of the mineral composition of the building materials, atmosphere variables, salts crystallization and groundwater. In this study, the deterioration problems of the wall reliefs were examined for the aim of its conservation. For this purpose, the chemical, physical and structural characterization were performed by means of X-Ray Diffraction (XRD) and observation of thin section by transmitted light optical microscopy (LOM), polarized microscope, Scanning Electron Microscope (SEM) attached with EDX and thermogravimetric (DTA & TGA). Additionally, microbiological study and chemical analyses of ground water were carried

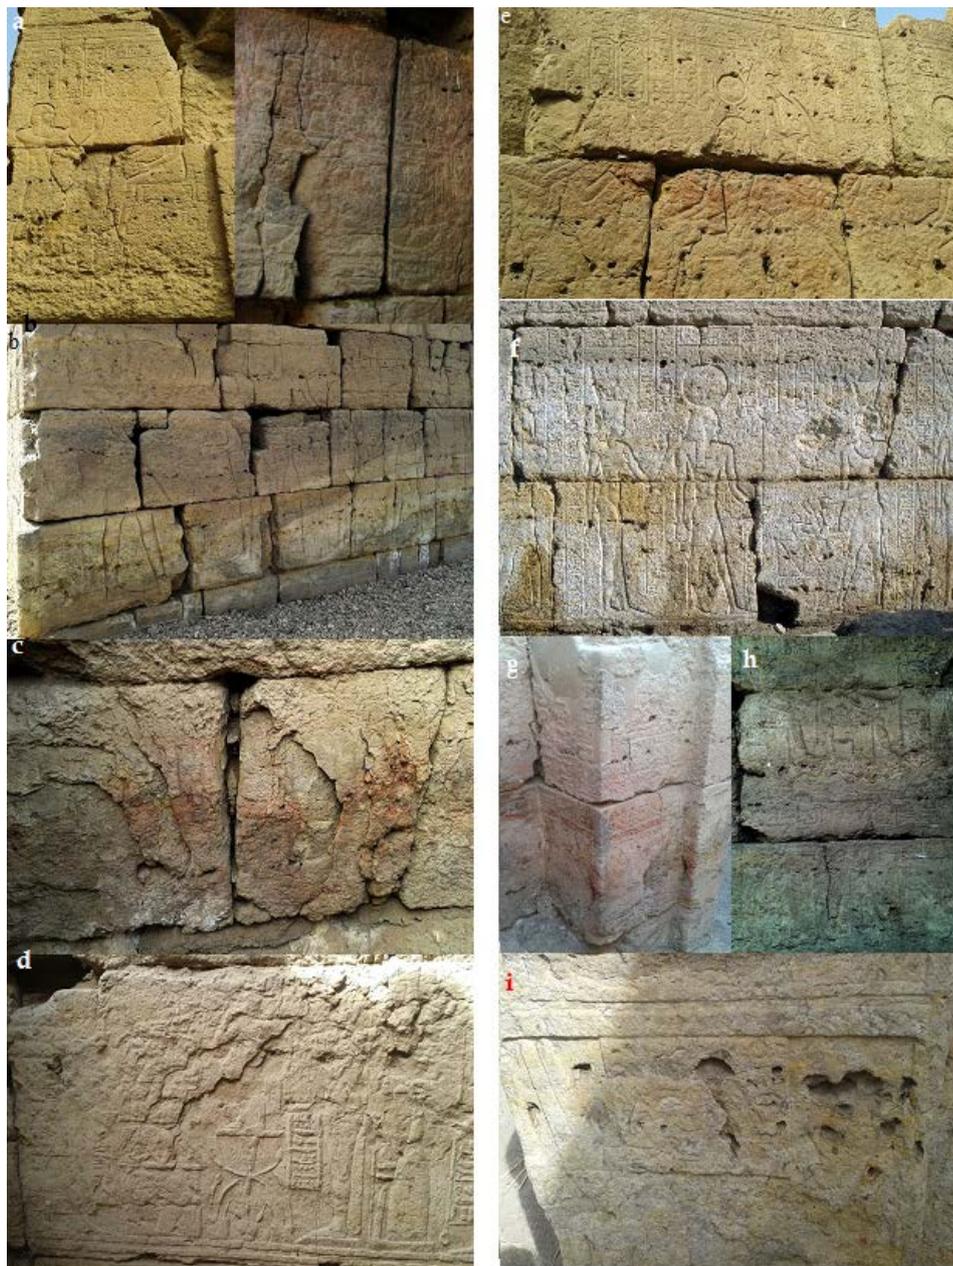
maintenance work related both to aggressive climatic and ground water resulting from dramatic rise of the water level. The major causes of deterioration and degradation of Shenhur murals are variation in temperature and humidity. According to the bio-climatic provinces of Egypt, the area is hyper-arid with mild winters and hot summers [4]. This variations in the long run caused different biological, physical and chemical alterations such as; crumbling, splinting and crumbling to splintering, mortars loss of cohesion and walls cracking, single and multiple scales, disintegration and exfoliation, alveolar weathering and pitting, presence of salt efflorescence and sub-efflorescence as shown in (Figures 3(a)-(f)). The visual inspection show also, the wall reliefs suffer

Figure 3. Detonation features at the wall reliefs of Shenhur temple. (a) Splitting and crumbling to splintering; (b) Mortars loss of cohesion; (c) Single and multiple scales (d) The detachment of reliefs, exfoliation and disintegration; (e) Alveolar weathering, pitting and coloration; (f) Efflorescences to light-colored crust tracing the surface; (g) Soiling the stone surface by coloration; (h) Soiling by pollution; (i) Weathering out of stone components (fossil inclusions) rendering a large portion of the inscriptions illegible.

from coloration, soiling by particles from the atmosphere, soiling by anthropogenic impact soot from fire and soiling by particles from water as shown in (Figure 3(g), Figure 3(h)). Furthermore, impacts of human-made deterioration corruption can be found in the evacuation of great limestone blocks from the temple (spoliation or stone robbing). Lime-burning activities destroyed most of the hypostyle hall, pronaos, and lateral chapel, built of better quality limestone for the lime-burning activities to produce lime. Traces of the burning of lime have been found in the form of layers of ashes mixed in with small fragments of limestone beside Shenhur temple in the southern part. The northern part of the temple was constructed with low quality local limestone, containing many fossilised shells. The fossil inclusions in the stone, however, have led to an uneven pattern in weathering, rendering a large portion of the inscriptions illegible (Figure 3(i)). The wall reliefs at Shenhur temple suffer from extensive microbial colonization. It demonstrated a phenomenology of adjustment varying from green, brown and dark duff patinas (Figure 4(a), Figure 4(b)). These phenomena might be linked to different microbial colonization and microflora. Different types of micro-organisms superficially distribute on the lower parts of the walls and some of microorganisms prefer to grow in the fissures and cracks present in the wet blocks of stone. Microbiological colonization by higher, vascular plants and roots are growing in the temple which disfigured the blocks (Figure 4(c)) hid their reliefs and caused both mechanical and chemical deterioration. Because of these aspects the aesthetic beauty of the reliefs is genuinely influenced. The neglect of maintenance work in the temple and left prey groundwater impact exert a powerful human influence are the dangerous deterioration factor at Shenhur temple. In this work an incorporated investigative methodology has been utilized for the assessment of stone materials degradation in the Greek–Roman temple of Shenhur by method for the combined utilization of surface and mass strategies with a specific end goal to protection form.

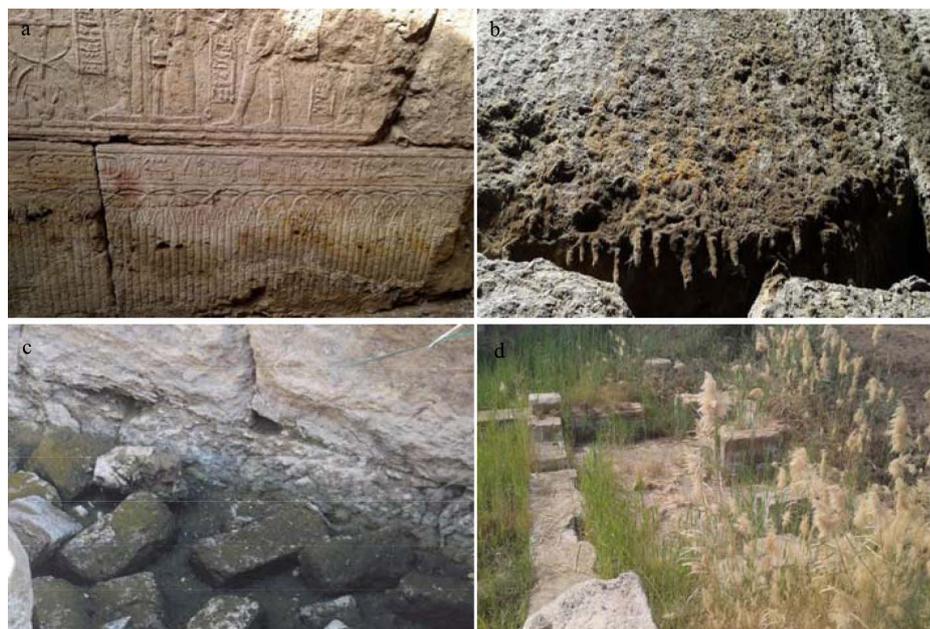
Figure 4. Biodeterioration of wall reliefs of Shenhur temple. (a) Microbiological infestation causing discoloration; (b) Microbiological colonization to dark-colored crust tracing the surface; (c) Concentrated microbial colonies on the surface of stone; (d) Colonization by higher plants.

The microorganisms found on the Shenhur temple, in Cyanobacteria and fungi, are among the most dangerous to the stone. Thus, a future action for the removal of these microorganisms should be taken into consideration [10].
