The Debris Flow of 1st August 2012 in Kakpenyi-Tinta (Akwaya Sub Division) Southwest Cameroon—I: Event Description, Causes and Impacts

Abstract

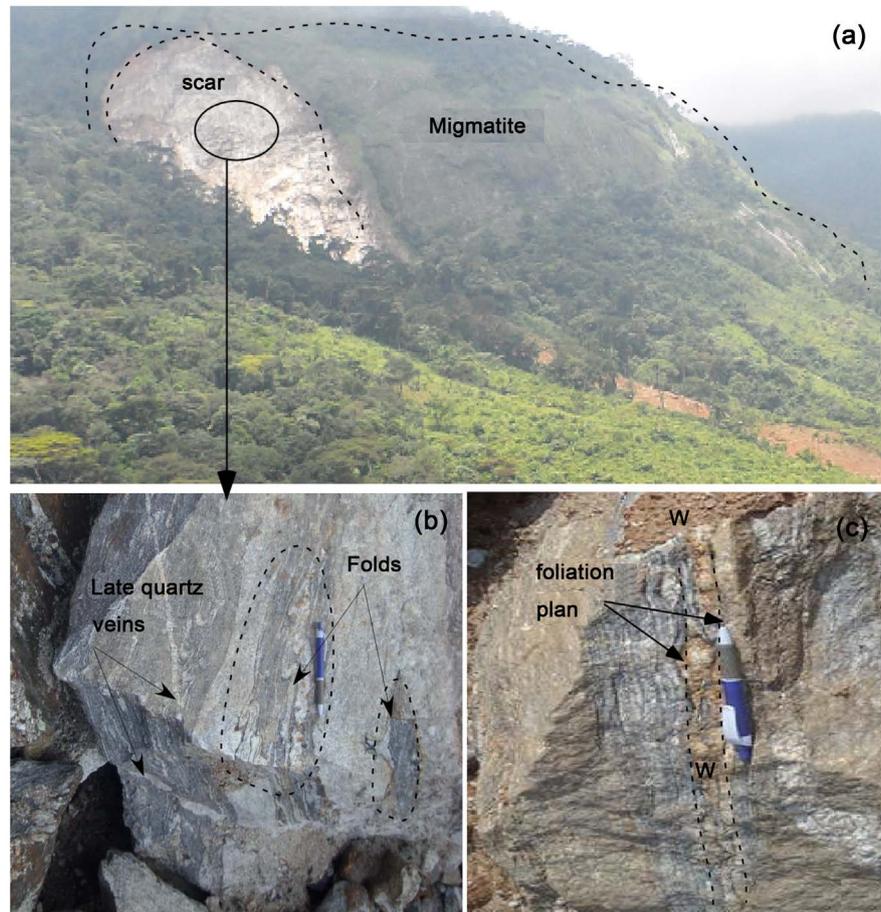
Figure 2. (a) Migmatite that forms the Precambrian bed rock of Kakpenyi. The migmatite is folded and contains late quartz veins (b) together with foliation planes (c) which facilitate infiltration of water as an agent of chemical weathering (w). The pen used as scale is 18 cm. Source: this work.

The geology of Akwaya consists of old Precambrian rocks [17] [18]. Kakpenyi is built on highly folded and fractured migmatitic gneisses cut by numerous late E-W quartz veins and gneissic foliation planes (**Figure 2**). The fractures act as infiltration routes of rain water into the rocks that have been highly altered to give thick soils on which are planted cocoa, palm trees, cassava, groundnuts and rice.

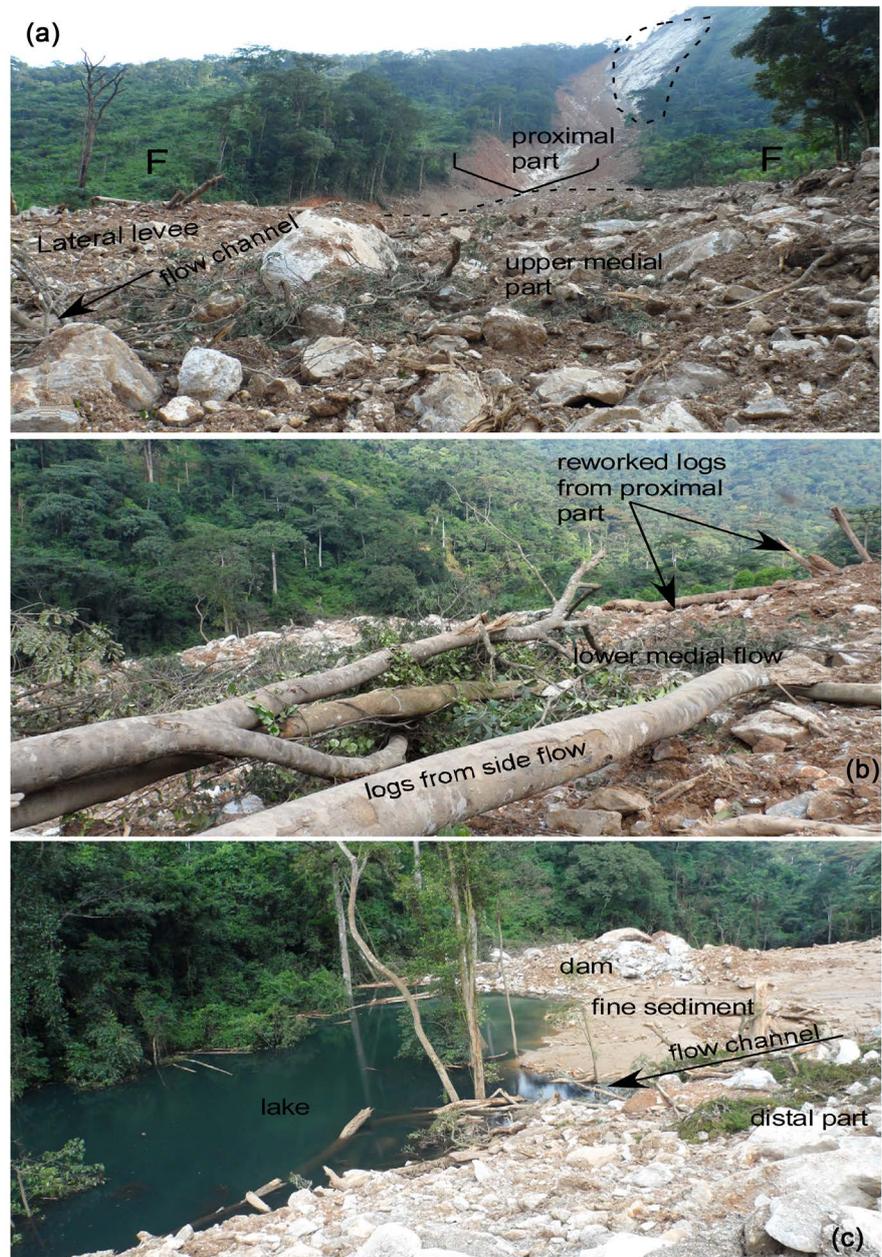
Figure 3. (a) Proximal and upper medial parts of the Kakpenyi debris flow. The flow cut through farmland (F). Note the lateral levee; (b) Tree trunks and reworked logs in the medial part; (c) Lower distal part with dammed river that created a temporary lake. Source: this work.

Scattered literature on mass movements in Cameroon is dominated by landslides [6] [7] and rock falls [21]. Even though debris flows are a form of landslide, they are distinguished from landslides by the fact that debris flows contain grains with greatly differing sizes and irregular shapes. They include mudflows which are debris containing mostly sand, silt and clay-sized particles; debris floods that are very rapid surging flows of water, heavily charged with debris in a steep channel; debris avalanches that are a very rapid to extremely rapid shallow flow of partially or fully saturated debris on a steep slope. They also differ from lahars that are volcanic mudflows [20] [22]. The consistency of debris flows ranges from watery mud to thick, rocky mud that can carry large items such as boulders, trees (Figure 3), houses and cars. A feature distinguishing debris flows from many other shallow flows is the presence of roughly equal volumes of diverse solid grains and incompressible, viscous interstitial fluid that interacts with the solids. Solid-fluid interactions and sediment movement by formation of lateral levees and lobes are important characteristics of debris flow behavior [23] [24]. Debris flow also differ from slides in that they are made up of loose particles that move independently within the flow, compared to a slide that is a coherent block of material that slides over a failure surface [22]. The sequence of events involved in the development of debris flows and its characteristic deposits is given by [23]. From our field observations, we consider the Kakpenyi event to be a debris flow because it contained a wide variety of particle sizes (incoherent), had levees and lobes on its medial part (Figure 1(e)), and had dewatered and consolidated enough to allow secure passage on foot only after a few days (Figure 3).

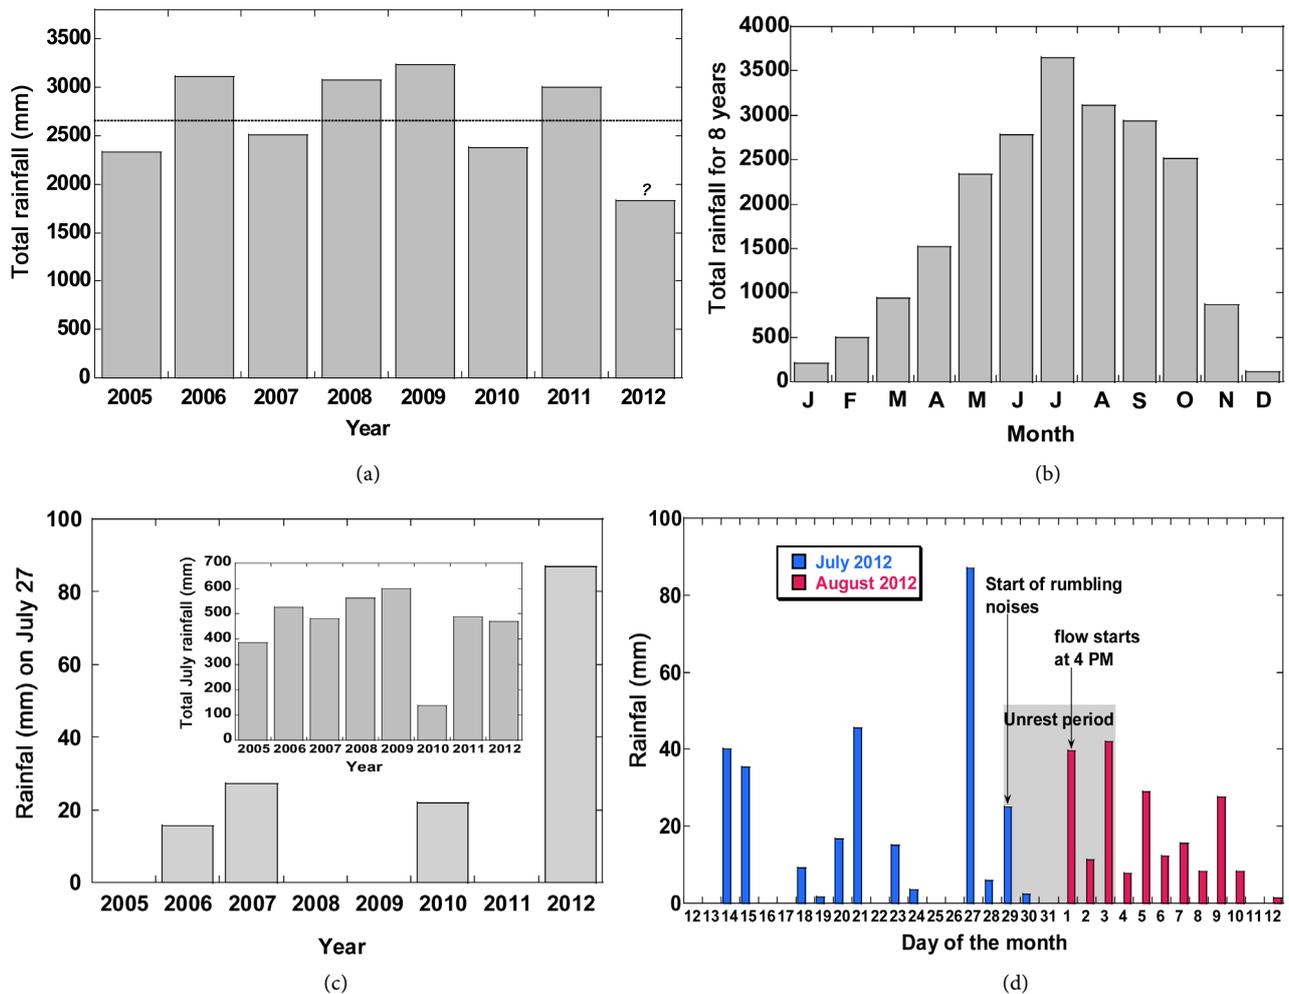
Figure 4. Distribution of yearly (a) and monthly (b) total rainfall for 8 years (January 2005 to 12 August 2012) at the Bisongabang meteorological station. Horizontal dashed line in (a) shows the average yearly rainfall; (c) shows the 27 July rainfall for each year from 2005 to 2012 (inset shows the total July rainfall for the 8 years); while (d) shows the daily rainfall from 12 July to 12 August 2012. Note that the debris flow occurred on August 1st, but the unrest period lasted from July 29 to August 3rd. Rainfall data for 8 years (2005 to 2012) was taken from the Bisongabang Meteorological Station run by the Directorate of National Meteorology, Cameroon Ministry of Transport.

The closest rainfall station in the same hydrological basin like Kakpenyi is the Bissongabang meteorological station in Mamfe run by the Cameroon Ministry of transport. We got rainfall data on this station from January 2005 to August 2012. Total rainfall for 7 years (2005-2011) was 19649 mm. Note that Debundscha which is found in the windward slope of Mt. Cameroon records 52% of this rainfall only in one year. The driest year (2005) recorded 2337 mm of rain; meanwhile the wettest year (2009) recorded 3232 mm of rainfall (**Figure 4(a)**). **Figure 4(b)** shows that May to October are the rainiest months of the year in the area, with a peak in July. Even though the total July rainfall for the 8 years shows that July 2012 was not the rainiest (**Figure 4(c)** inset), data for July 27 only, of each year from 2005 to 2012 clearly show that July 27 of 2012 recorded the highest (87 mm) amount of rain over the 8 years (**Figure 4(c)**). The first 26 days of

July 2012 recorded 349.3 mm of rain (average of 13 mm/day), meanwhile 46% of this fell in only 5 days from 27th July to 1st August (average of 32 mm/day). The unrest that preceded the debris flow on 1st August started on July 29 (**Figure 4(d)**). Lack of information on rainfall duration and the rainfall mean intensity that resulted in the slope failure prevents us from pushing this analysis further to derive rainfall thresholds for the area [29] [30] [31]. However, on more general terms, it can be speculated that heavy rainfall will provide the water that is channeled and soaked down through rock cracks and crevasses (**Figure 2**). Such water not only hastens chemical break down of the rock, thus rendering its blocks loose, it also lubricates the material and adds weight to it. We suggest that inappropriate land use activities in the area (see above) predisposed the steep slope. The 8 year-high 27 July 2012 rainfall then acted as antecedent rain that

increased the initial moisture content of slope materials [31]. The August 1st rainfall (39.6 mm) triggered the event by increasing the rate and depth of wetting, as well as the soil pore-water pressure that led to failure [24] [32] [33].
