Intervention Retrofitting and Rehabilitation of Al-Gawhara Palace at the Saladin Citadel, Cairo, Egypt

Abstract

Al-Gawhara Palace, Structural Deficiency, Restoration, Intervention Retrofitting, Rehabilitation, Structural Analysis, Reuse

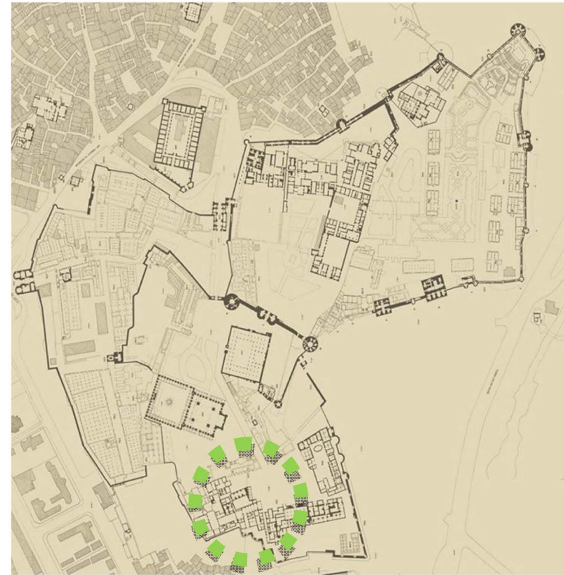
Figure 1. Maps and aerial views of the citadel of Saladin and the location of the Al-Gawhara Palace.

Al-Gawhara Palace also known as Bijou Palace is located in the south of the Mosque of Muhammad Ali in Saladin Citadel in Cairo (**Figure 1** and **Figure 2**). It was commissioned and constructed by Muhammad Ali Pasha in 1814. Al-Gawhara Palace is one of the most famous historical royal palaces in Egypt and the most important modern architectural heritage that reflects an important historical period of the Egyptian modern history—the period of the rule of the family of “Muhammad Ali Pasha”. The causes of structural deficiency of the palace could be attributed to many reasons and actions, mainly due to the earthquakes and seismic events (in particular the Dahshuur earthquake, in October 1992), degradation of drainage and feeding systems leading to water leakage, lack of awareness of the palace values, deterioration resulting from the use of old government agencies and the conflicts among authorities supervising historical buildings. The present study includes many phases: 1) the significance of the original building from the circumstances and date of construction; 2) detailed studies of the architectural features and design of the building as well as construction type, methods and techniques of construction; 3) characterization of the construction and building materials; 4) stability analysis of the structure under static and the impact of seismic loadings; 5) engineering measures for intervention retrofitting of the palace (this pilot study presents the main design studies for intervention retrofitting and the rehabilitation and re-employment of Al-Gawhara Palace, started from the static monitoring, old and modern documenting of the current state of preservation thorough the strengthening project implementation; 6) the study also presents the reuse designs to convert the palace to be a national museum, for the purpose of preserving it by proposing the best means to apply the cor-

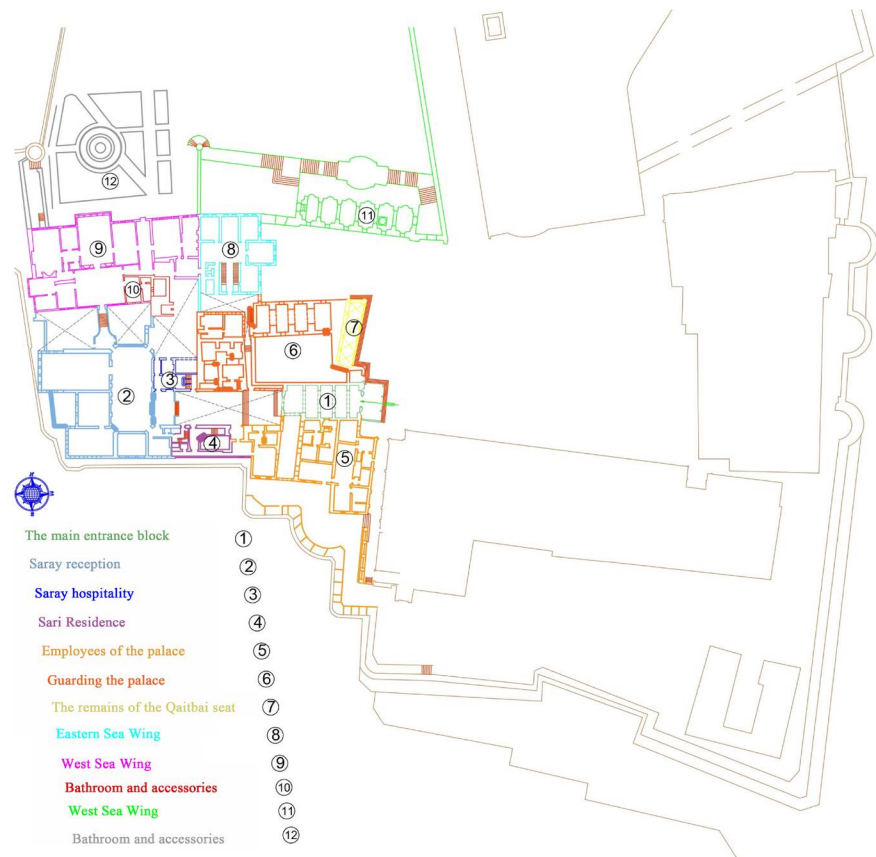
Figure 3. General layout of Al-Gawhara Palace in the Cairo Citadel, the present state.

that leads to the palace and reception halls. The receptions of Mohammed Ali and her Iwan supplement and two rooms are in addition to the Throne Hall, the largest halls of the Serail. From the reception hall we reach the sea jag by means of stairs and it contains two sections and the black garden because there are statues of the black Alabaster, and the suite contains a bathroom. It is known as the alpaster bath, while the second floor is the reception suite and leads to the guest cabins (Figure 3) [5].

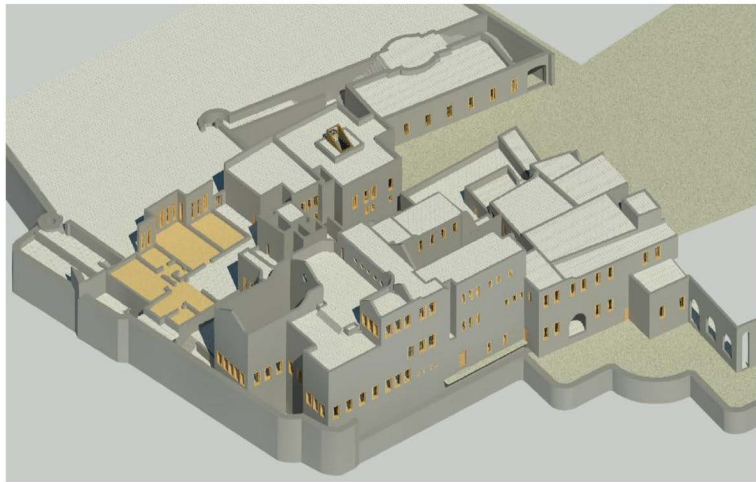
Figure 4. 3D Revit model of Al-Gawhara Palace in the Cairo Citadel.

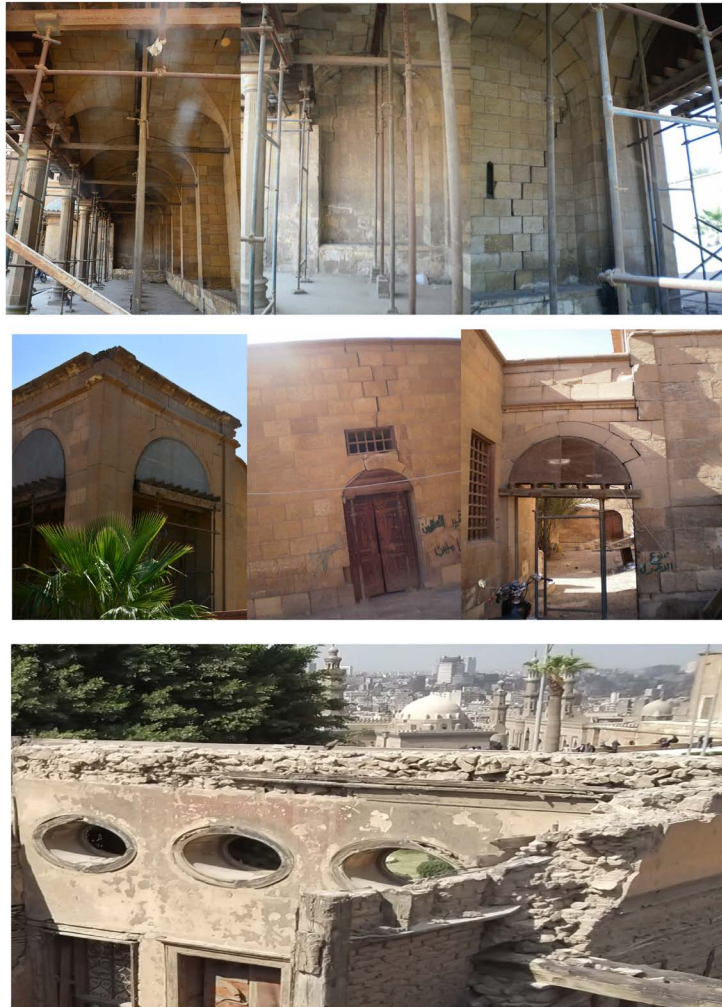
Figure 12. In and out of plane deformations and cracking pattern in different structural elements of the palace.

The superstructure and substructure of the palace has suffered considerable damage due to extensive cracking associated with bearing foundations displacements and movements undergoing a shear failure accompanying with large displacement both towards to the western and northern directions as well as the center of the palace [17].

Cracks widths were 30 - 100 mm and exhibiting periodical widening. The cracks had a preferential orientation in all principal directions, which includes typical views of major cracking in the masonry walls and foundations. Such effects were attributed to earthquakes damages, permanent deformations and large settlement of the bearing old reused foundations of the previous underneath palaces and houses in the same place due to overloading, natural wear of construction materials and the construction history of the complex (Figure 12).

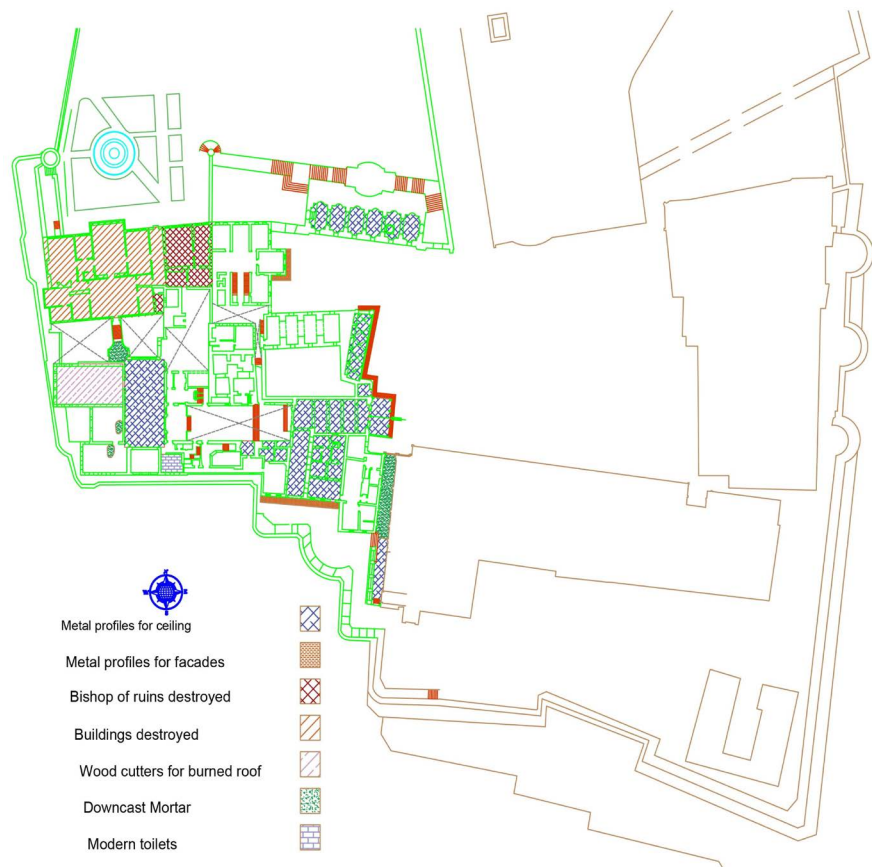
Figure 13. Al-Gawhara Palace, present state of preservation.

a) One of the most affected areas of the earthquake in 1992 and has many parts with swings, supports and reinforcements and new and dangerous cracks in the roofs and walls;

b) The internal and external walls are in poor condition and are filtered for water, bleaching, bleaching, and accumulation of waste and dust (**Figures 13-15**).

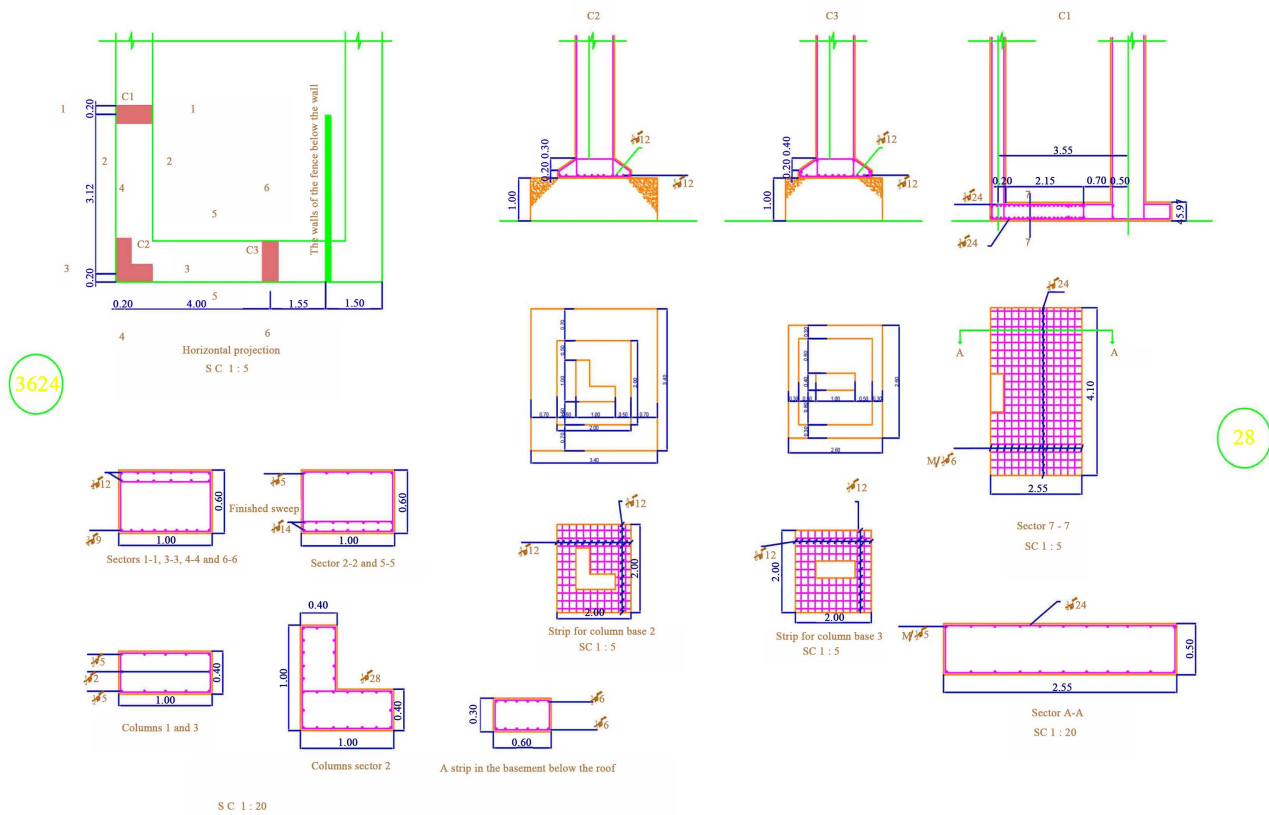
Figure 14. Foundations systems (wall footings and base isolated footings) of Al-Gawhara Palace.

The structure of the foundation consisted of continues stone cyclopean walls type of approximately 2 - 2.5 m height, beneath all the substructure walls.

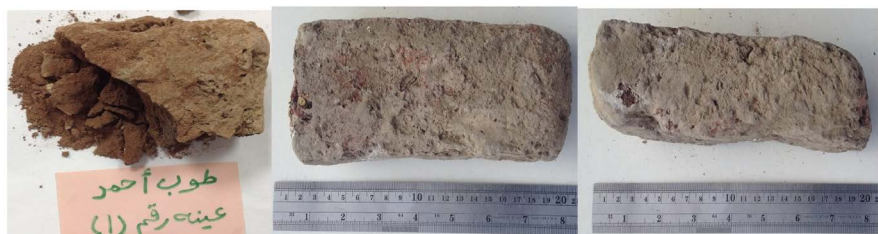
Figure 16. Some collected fired brick samples from Al-Gawhara Palace.

The study sample consists of medium-sized quartz crystals. The sample floor is composed of iron oxide and some other dark metals (Diopside) as shown by XRD and thin section analysis of the sample. There are no traces or evidence of apparent damage to the sample of the studied bricks. **Table 1** summarizes the chemical composition of the fired brick (**Figure 16** and **Figure 17**).

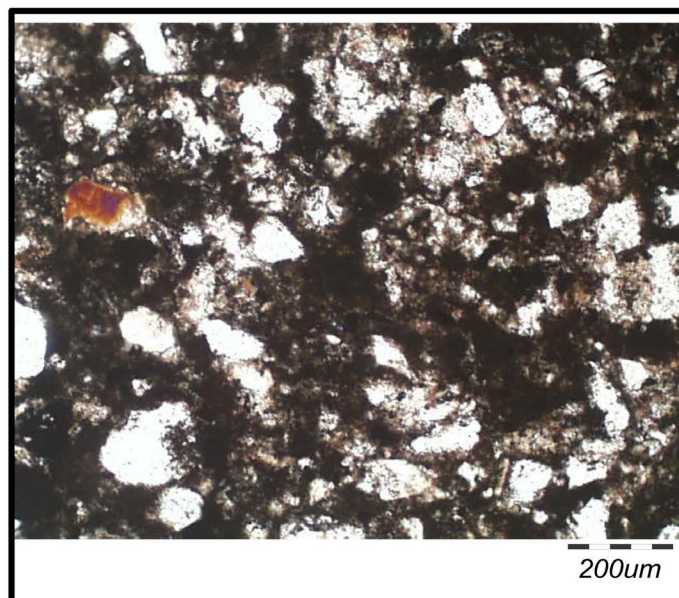
Figure 17. Thin section photomicrograph of the sample submitted by red Brick (XPL, 10).

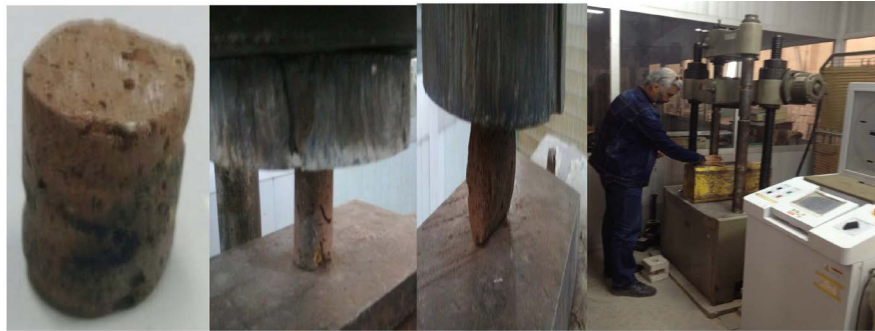
Figure 18. Some collected fired brick samples from Al-Gawhara Palace.

Tables 2-4 summarize the mechanical properties of the fired brick building material (**Figure 18**).

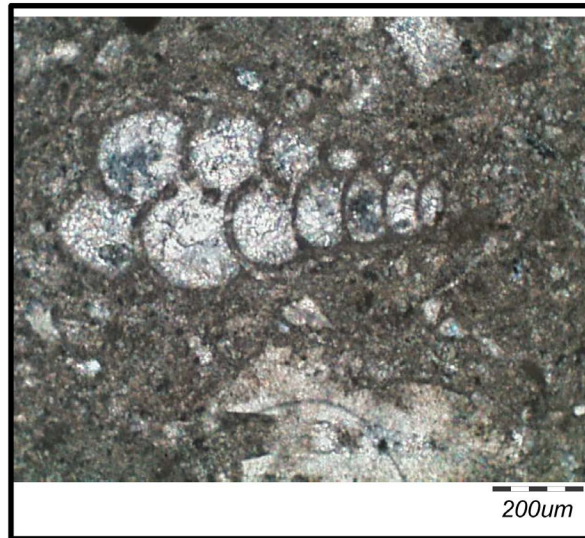
Figure 19. Thin section photomicrograph of the sample submitted by Stone (XPL, 10).

The calcareous limestone of a fossil limestone can be classified as the most fossil content of the sample from fossils of furaminefrera. There is no clear evidence under the polarized microscope that sample damage exists (**Figure 19**).

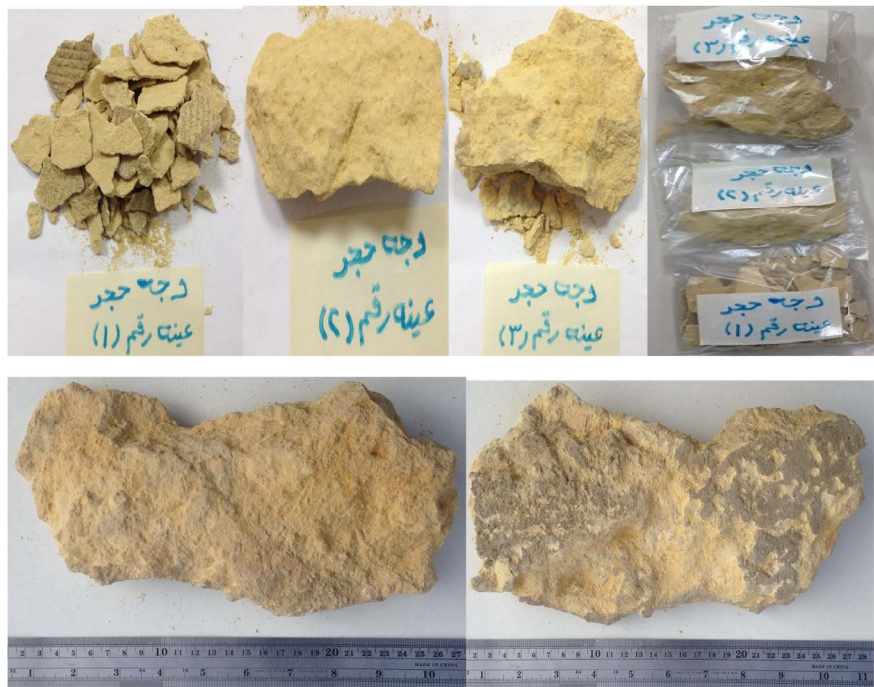
Figure 20. The collected limestone samples.

Tables 6-8 summarize the mechanical properties of the casing limestone building material (**Figure 20** and **Figure 21**).

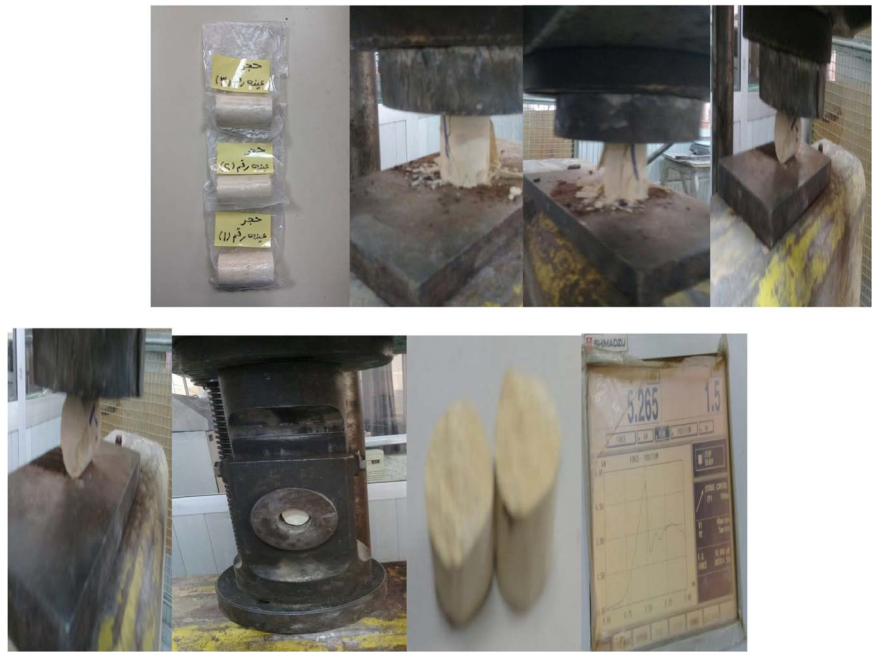
Figure 21. Mechanical testing set-up for the limestone samples.

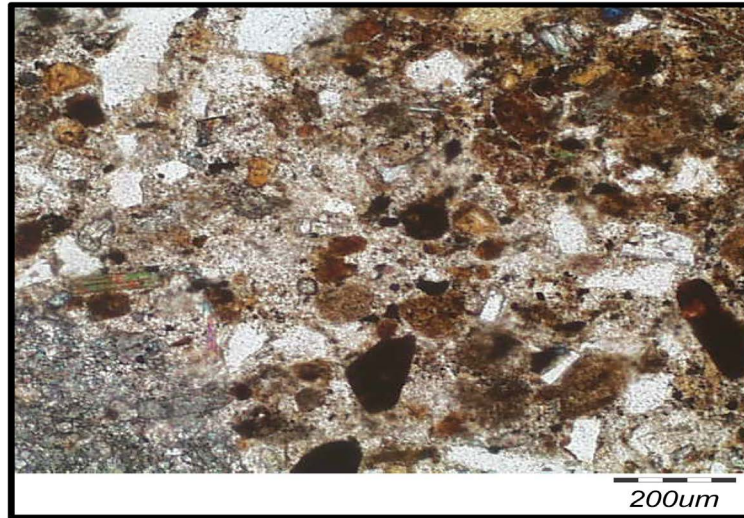
Figure 22. Thin section photomicrograph of the sample submitted by Double wall filler mortar (XPL, 10).

The sample consists of the fill mortar of medium quartz granules in addition to some iron oxides shown by the XRD and thin section analysis. There are the

feldspar crystals in the sample. Calcite is found in the lower left part of the image and is indicated by the arrow (01). Some salts and minerals appear in the sample as raw materials (Table 9, Figure 22 and Figure 23).

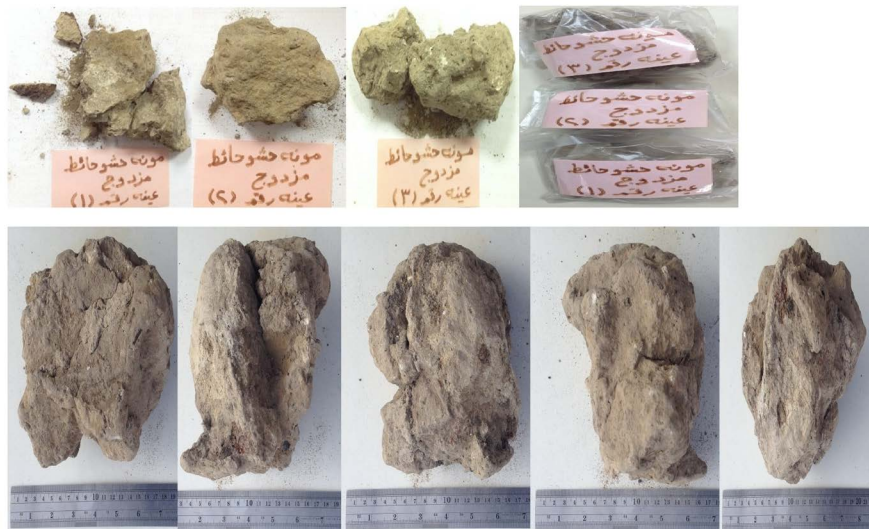
Figure 23. The collected core samples between the two external leaves.

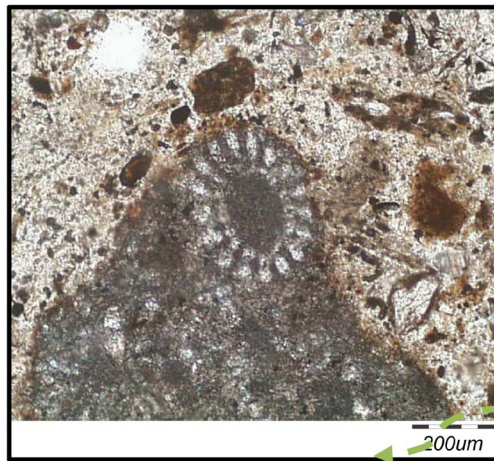
Figure 24. Thin section photomicrograph of the joining mortar samples (XPL, 10).

The study of the sample (00) of the structural mortar using the polarized microscope showed that it is composed mainly of quartz crystals (average size). The presence of granular calcite granules (sparite), represented in the excavation of the holes and some calcite, was found to be a component of the soil. Some evaporative metal traces appear in the upper part of the sample. The presence of CSH as adhesive product has been shown to bind the mortar molecules (**Table 10** and **Figure 24**).

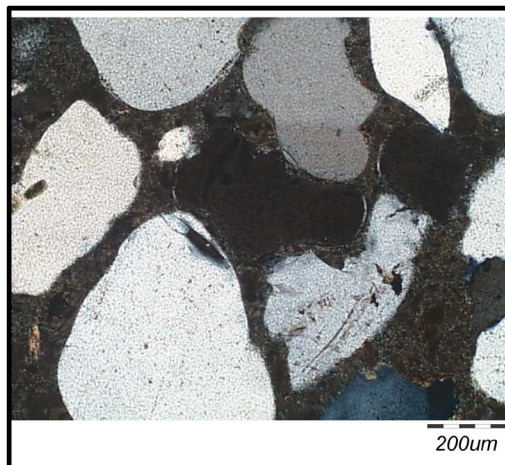
Figure 25. Thin section photomicrograph of the sample submitted by Mortar walls (XPL, 10).

The study of the sample using the polarized microscope revealed that the main component of the mortar of the studied mortar is the large quartz granules (filler) of circular shapes, representing more than 75% of the studied sample. There are some traces of certain evaporation metals (gypsum). Calcite is also found as granular flour as a solvent between quartz granules. There are some traces of the formation of fine-grained materials on the edges of quartz crystals (**Figure 25** and **Figure 26**).

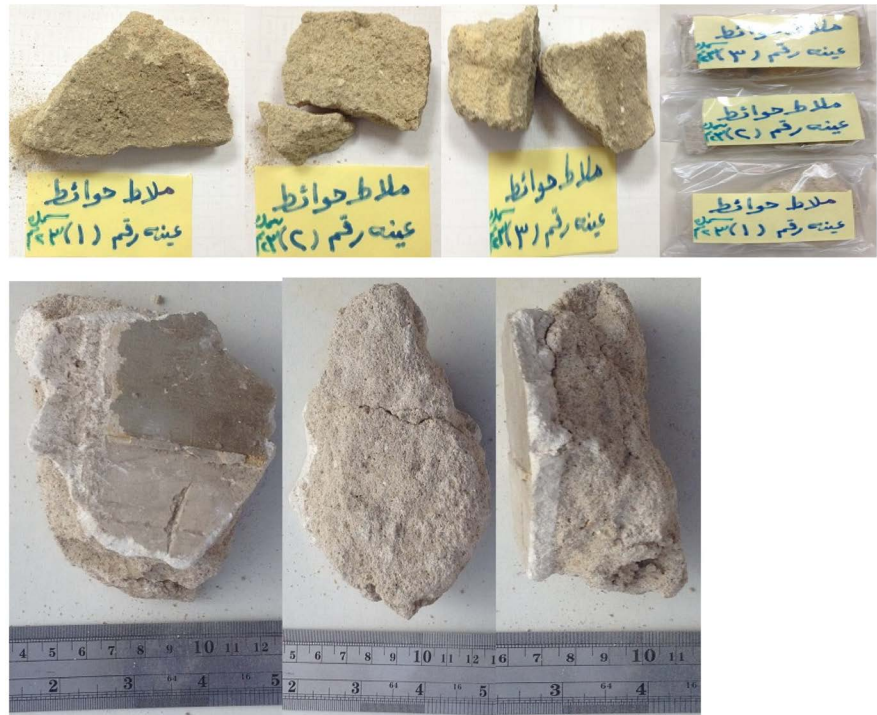
Figure 26. Some collected plaster samples.

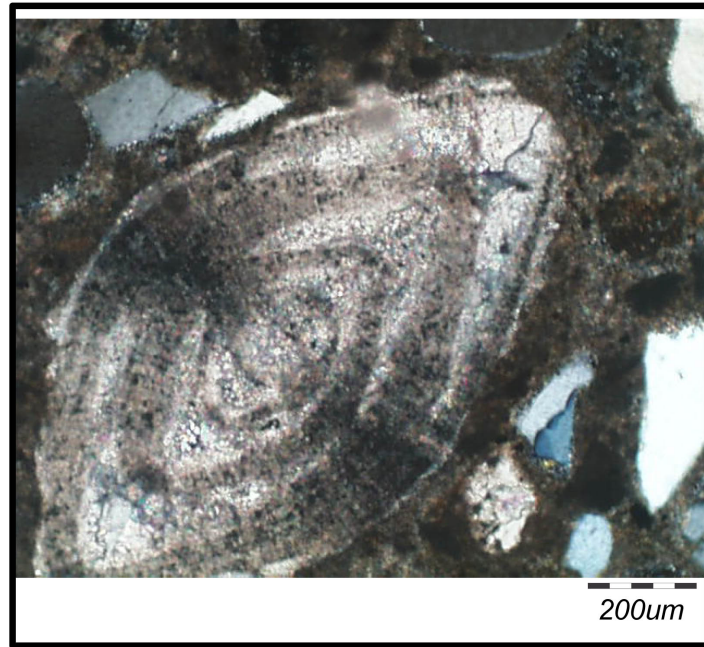
Figure 27. Thin section photomicrograph of the sample submitted by Concrete (XPL, 10).

The calcite granules are granulated with nemolite fossils, which are in turn the content of the sample (Table 11). Some of the fine cracks shown in the stock can also be depicted. This may be evidence of some sample damage (Figure 27 and Figure 28).

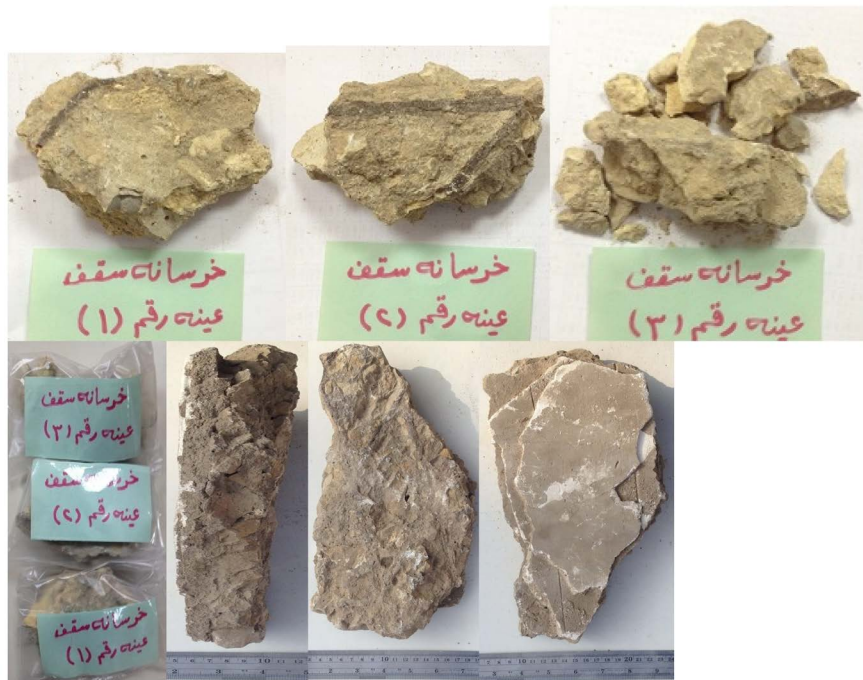
Figure 28. Collected samples from the concrete plaster samples.

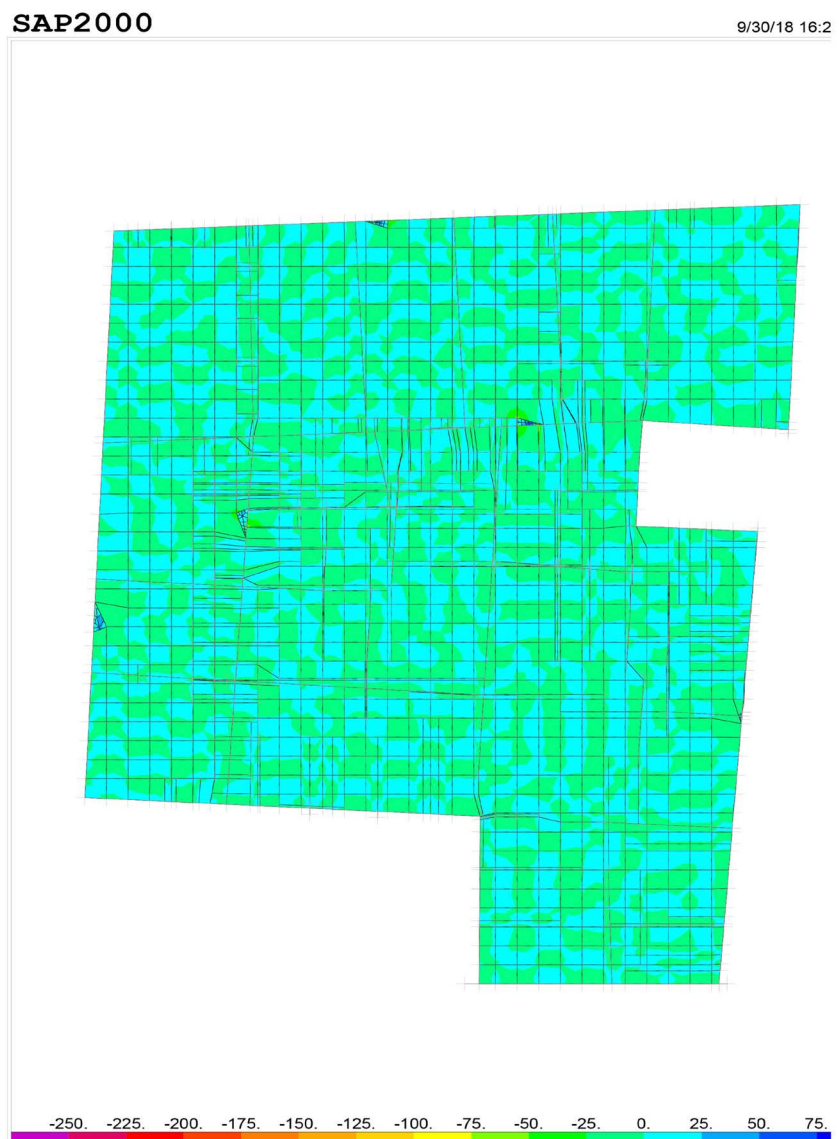
Figure 29. Structural analysis of wooden roof using SAP 2000 Program.

masonry. The done analysis with SAP 2000 had the same input features (geometry, materials, boundary conditions, loads and degrees of freedom), in order to perform a verification of the results. The numeric modeling of a real ancient structure (as the Al-Gawhara Palace) is a complex computationally demanding task, nevertheless some general recommendations were followed in order to elaborate a geometric model able to describe adequately the geometry and morphology of the real construction, representing the structural elements in the most simple form for the analysis, then a macro-model of the palace was constructed with shell elements, excluding existing damage and considering constant vertical walls (Figure 29 and Figure 30) [19] [20] [21] [22].

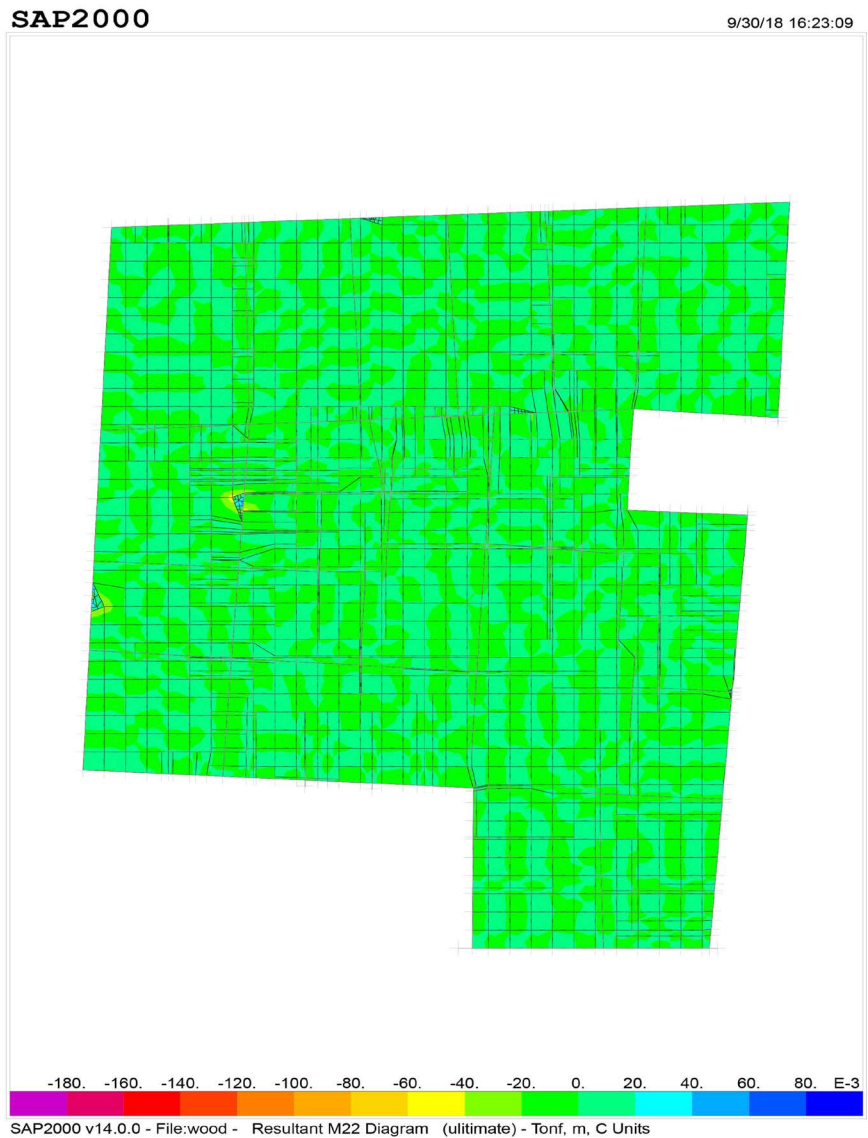
Figure 30. Structural analysis of wooden roof using SAP 2000 Program.

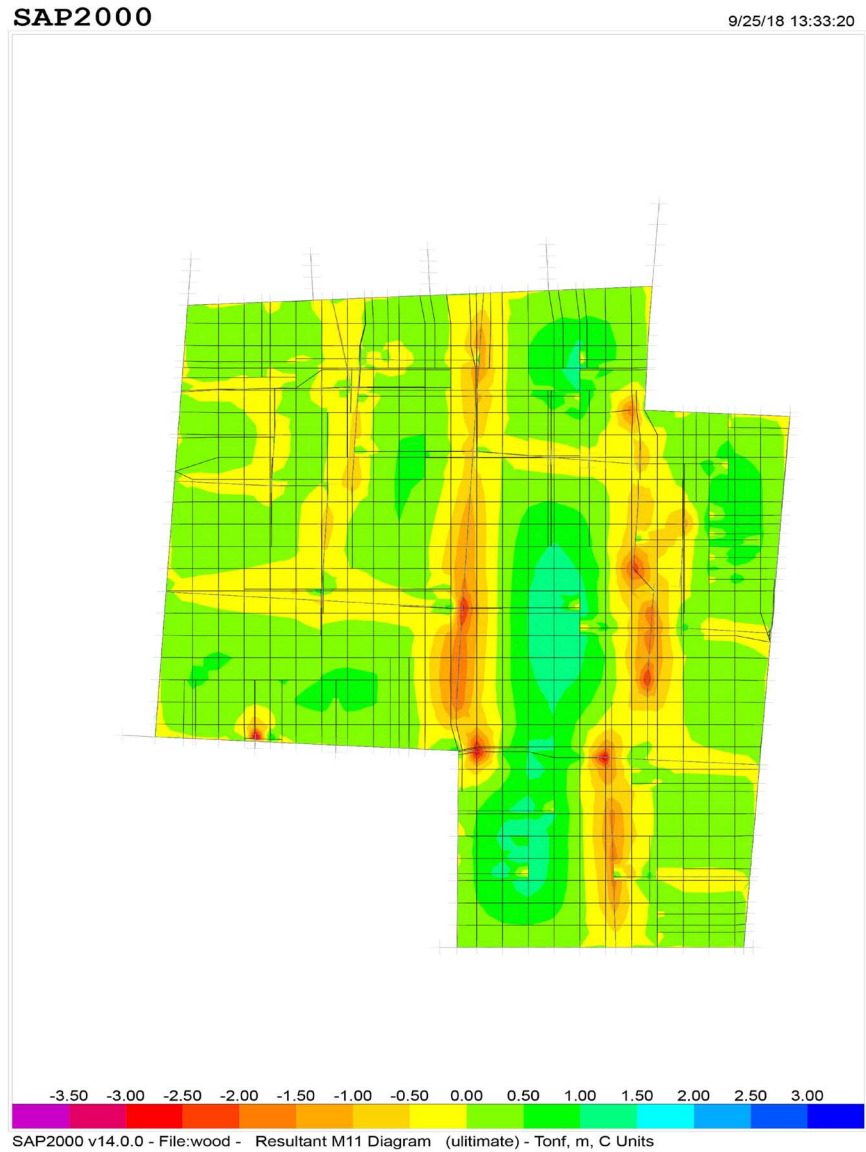
Figure 31. Stress analysis of wooden roof using SAP 2000 Program.

In other results, high values of tensional stresses (**Figure 31**) were observed in the roofing system (as were expected), mainly in the big halls, in which the stress

reaches values around the maximum allowable of 3 t/m (this explain some existing damage), and taking in account that the vaults causes horizontal forces which induce an opening in their bases against the walls in the order of 1.2 cm, this is a warning sign that walls do not have the capacity to support additional loads. Also, the results show that the maximum stress in tension, which exceeds more than twice the stress allowable, is on the rear vault, many damages were inventoried and seen in the area. Based on this there must be some element or factor increasing rigidity or stiffness, because that it support higher tensional stresses.

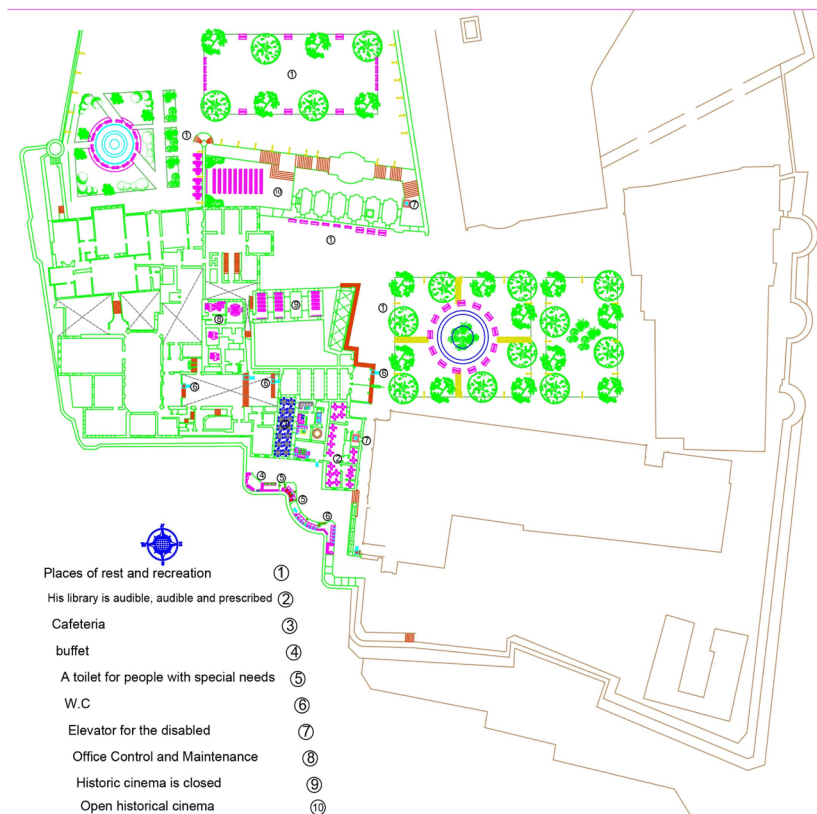
Figure 32. The proposal for the reuse of Al-Gawhara Palace.

Al-Gawhara Place has been reused many times throughout its history. The current discourse of diverse trends in preservation together with awareness for sustainable environments has led to a surge in adaptive reuse projects. The combination of new and old architecture ensures the retaining of authentic character while providing an appropriate new use and revitalizing the structure. Learning from precedents is one of the most important knowledge bases for architects. It has many layers of knowledge referring to the old building and its original use, the transformed building and its new use, and the transformation itself. The objective of this work is to propose a theoretical and practical background for a systematic process to support adaptive reuse of the palace as historic museum. A procedure for the analysis has been developed to fit the specific nature of this architecture data. **Figure 32** refers to the adaptive reuse proposal of the palace.
