Maintenance and Testing of Fume Cupboard

Abstract

2. Incident Description

3. CSS Committee Findings

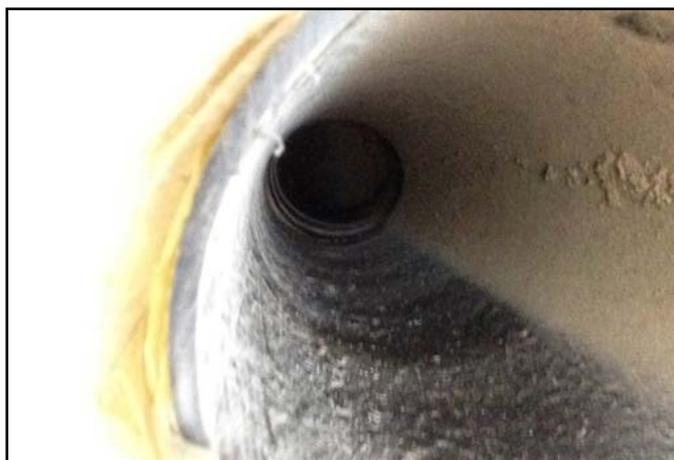
The investigation also revealed that all vertical exhaust stacks discharged exhaust at a height of less than five feet above the roof. Additionally, a white substance precipitated onto the internal surfaces of the ductwork, as shown in **Figure 1**.

Figure 1. A white substance precipitated onto the internal surface of the ductwork.

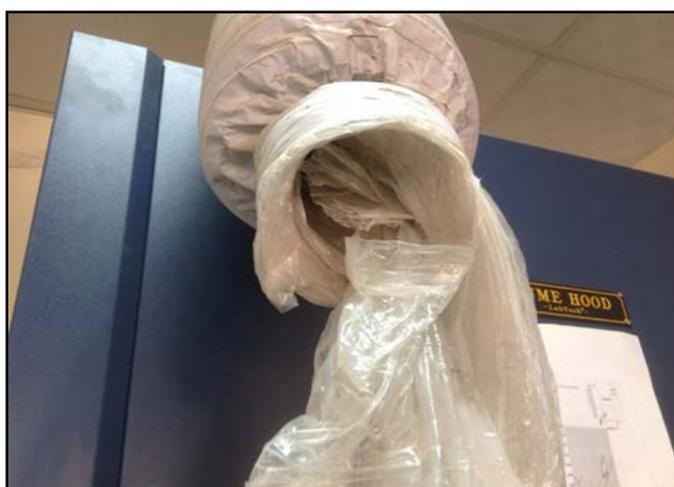
The investigation also revealed the accumulation of a plastic sheet that had been used to join the ducts (**Figure 2**). After this discovery, all plastic materials were removed, and Teflon tape, which is highly acid-resistant, is now used instead to join the ducts.

Figure 2. Plastic sheets were found inside the ducts.

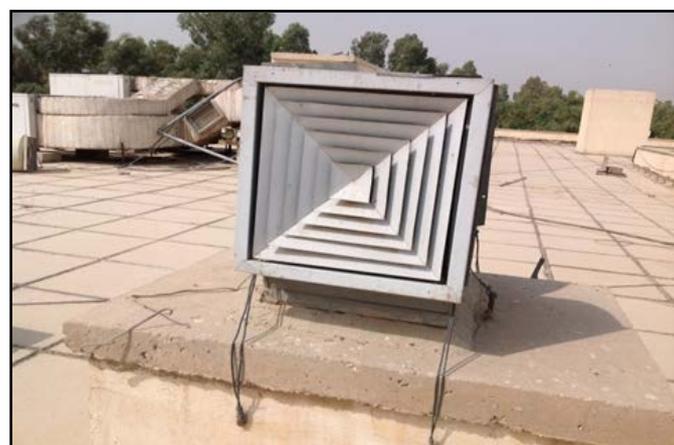
Figure 3. A discharge stack that had been fitted with a barrier.

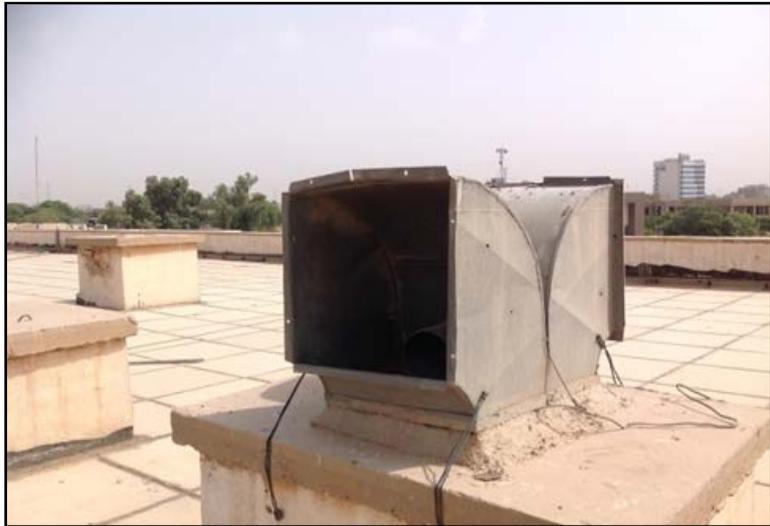
The CSS Committee's last finding was that some of the discharge stacks were not fitted with barriers (**Figures 3-5**). As a result, many dead birds were found stuck inside the ducts (**Figure 6** and **Figure 7**), leading to partially blocked ducts. Since this discovery, the dead birds have been removed (**Figure 8**) and new barriers have been supplied with the fan sets.

Figure 4. A duct which was not fitted with a barrier.

6) Fan sets and associated equipment mounted outside the building at the roof level should incorporate barriers to prevent birds or other items from getting into the ductwork.

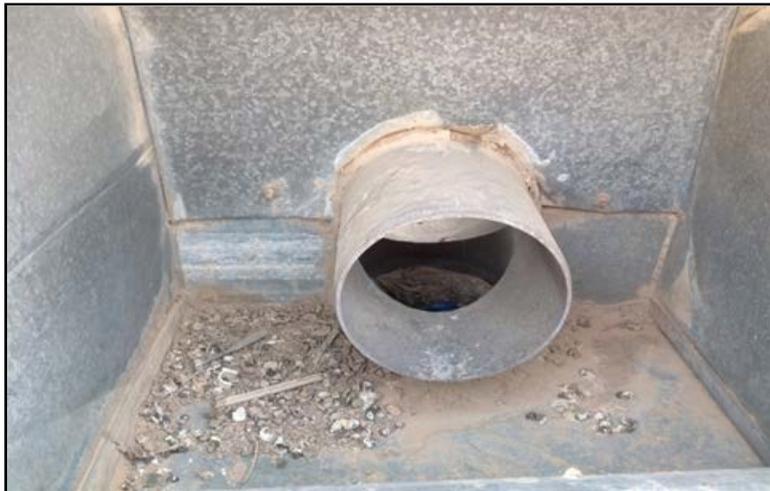
Figure 5. Another duct not fitted with a barrier.

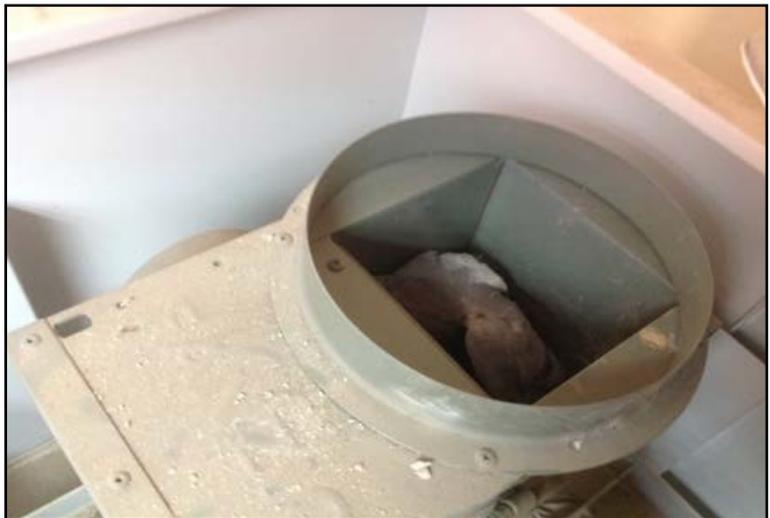
Figure 6. Dead birds were found in some of the fan casings.

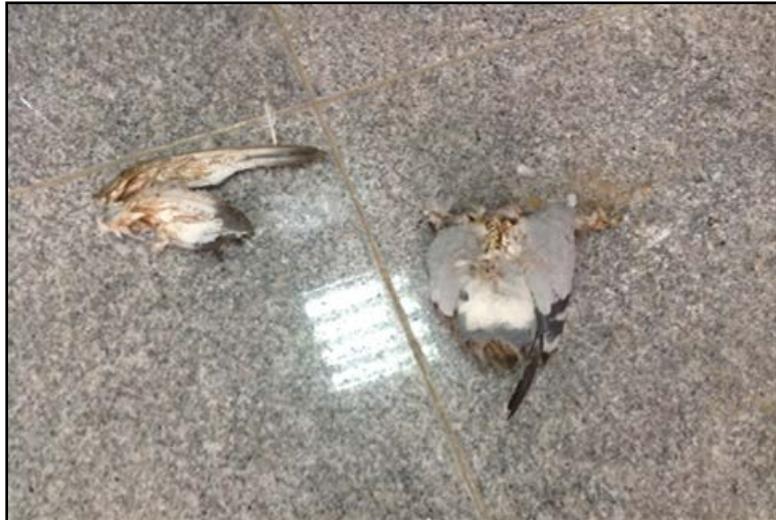
Figure 7. Dead birds found stuck inside the ducts.

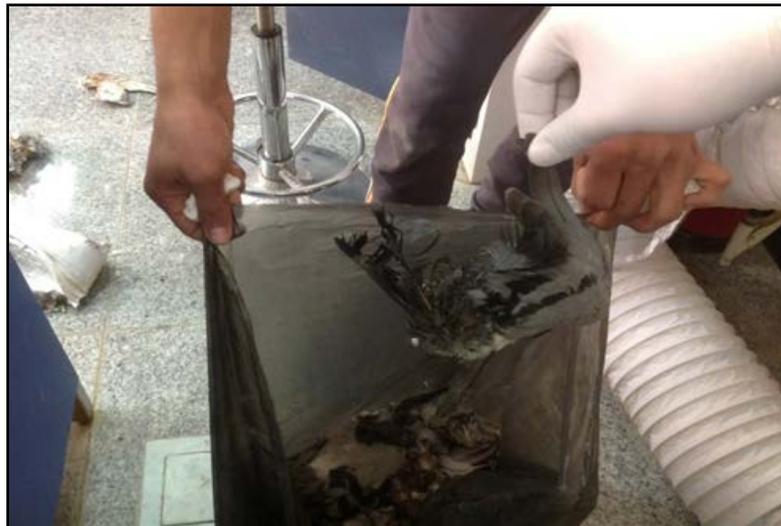
Figure 8. Cleaning dead birds out of the ducting system.

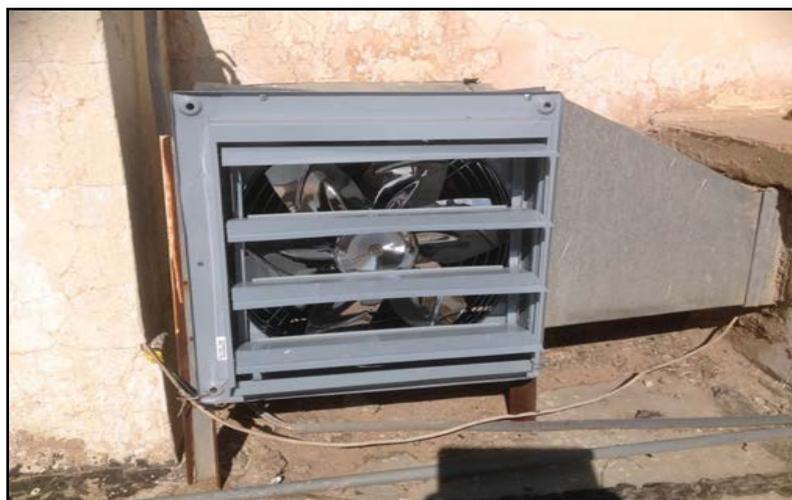
Figure 9. A set of fans have been installed at the end of the ducts.

Since the CSS Committee completed its investigation, a set of fans have been installed on the end of the ducts to increase suction efficiency. In accordance

with system specifications, the fan motor was installed outside the airstream to prevent the transmission of sparks to any potentially explosive fumes (**Figure 9**).

5) The fan motor should be situated outside the airstream to prevent the transmission of sparks to any potentially explosive fumes.
