Summary of Experience from the Long-Term Pedological Research on the Banks and Slopes of Lake Most

Petr Vráblík¹, Michal Řehoř², Pavel Schmidt², Eliška Wildová¹

How to cite this paper: Vráblík, P., Řehoř, M., Schmidt, P. and Wildová, E. (2018) Summary of Experience from the Long-Term Pedological Research on the Banks and Slopes of Lake Most. *Open Journal of Soil Science*, 8, 350-359.
<https://doi.org/10.4236/ojss.2018.812025>

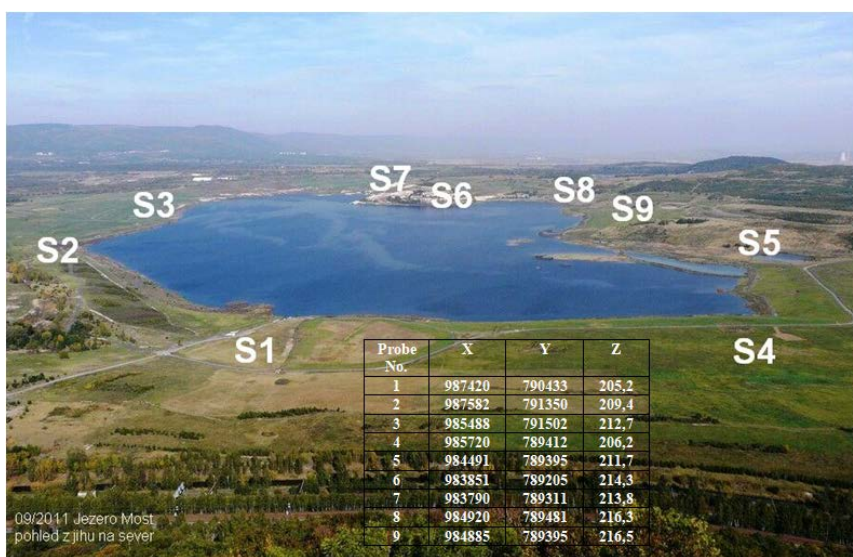
Figure 1. The situation of dug probes on the banks of Lake Most [2].

The situation of the partially filled lake with newly placed soil probes in 2011 is shown in **Figure 1** below.

S1 (X-986 620, Y-791225), S2 (X-985 490, Y-791 290), S3 (X-984 865, Y-790 805), S4 (X-986 992, Y-790 505), S5 (X-986 554, Y-789 715), S6 (X-984 915, Y-789 715), S7 (X-984 685, Y-789 725), S8 (X-984 905, Y-785 195), S9 (X-985 210, Y-789 195).
