# Rock Slope Stability Problems in Wadi Quaz-Dam Site No. 2, Jeddah-Saudi Arabia

**Ali Abdullah M. Alzahrani**

Department of Geological Engineering, King Abdullaziz University, Jeddah, Saudi Arabia  
Email: [aalzahrani7@kau.edu.sa](mailto:aalzahrani7@kau.edu.sa)

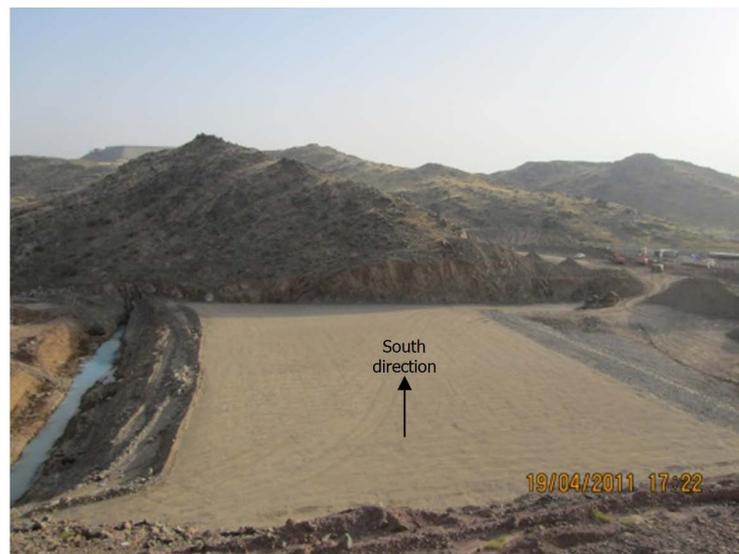
**Figure 4.** Another view of the Location on investigated Dam site (Elongated trench from south to north on the left).

The main purpose of this study is to evaluate the dam site No. 2, at Wadi Quaz, East of Jeddah by studying the physical and mechanical properties of soil and rock besides investigating the two abutments from each side of the dam whether south abutment or north abutment can be seen in **Figure 3** and **Figure 4**.

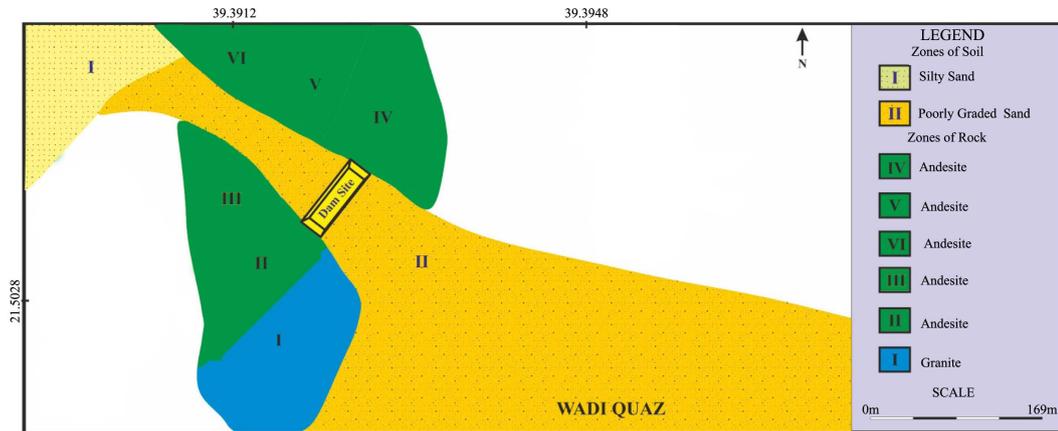
Figure 5. Geological map showing the rock types in both abutments.

The studied locations were classified into six zones as can be seen in **Figure 5**. The quality of rock masses in the study area is ranging from poor quality to good quality rock mass. Engineering classification of rock masses is necessary to recognize rock mass condition, and divide the rock mass into groups of similar characteristics for engineering purposes.

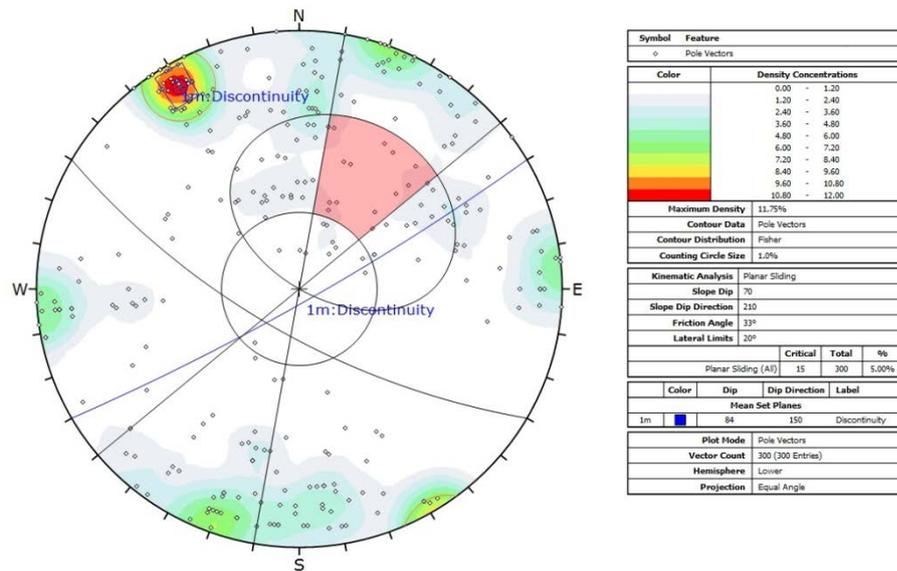
**Figure 6.** Analyze of planar sliding of North Abutment.

the investigated slopes. The results from North abutment kinematic analysis indicates that there is no potential failure mode as can be seen in Figure 6. The results from south abutment kinematic analysis indicate that there is only one potential failure mode. Planar sliding is the most likely failure mode that may occur at south abutment. Some of the discontinuities are located in red shade that shows the potential planar sliding area as can be seen in Figure 7.

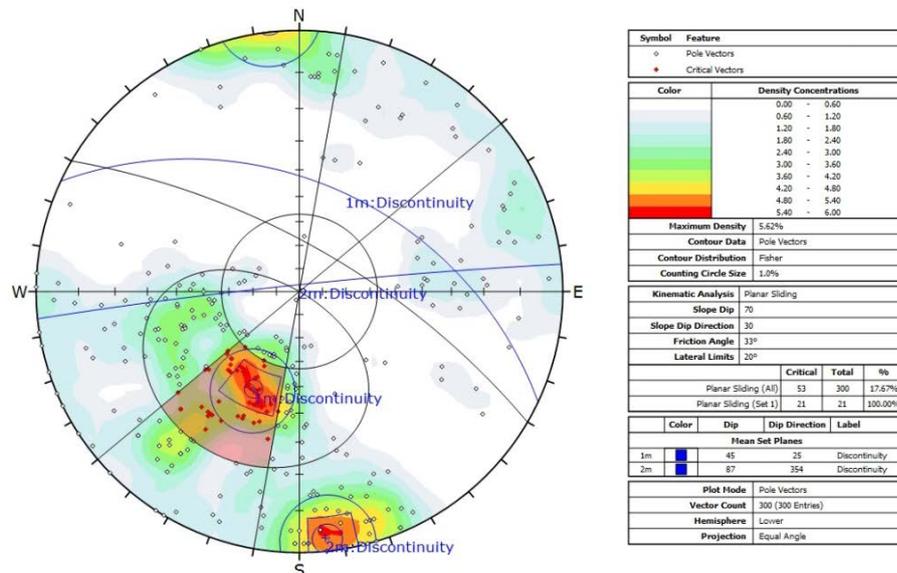
**Figure 7.** Analyze of planar sliding of South Abutment.

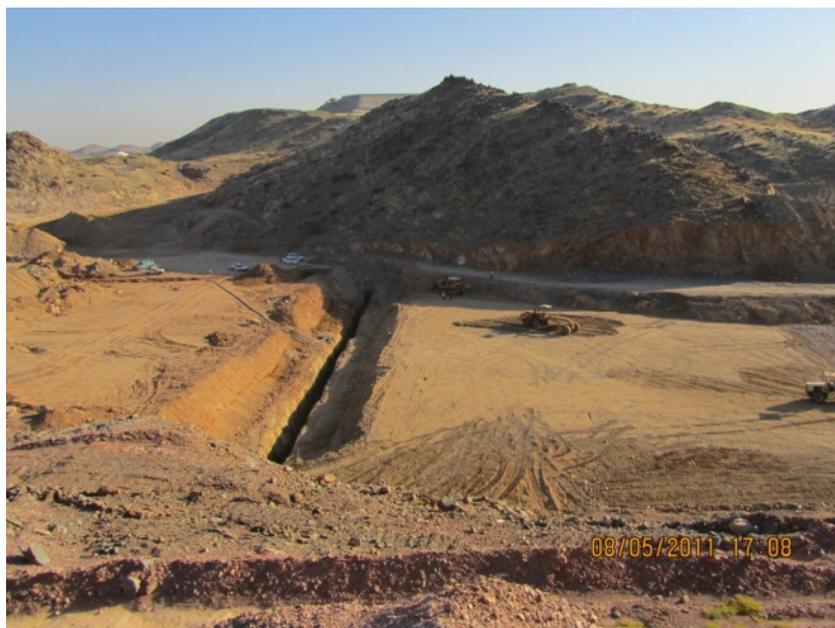
**Figure 8.** Photograph showing the elongated of trenching from North part of the study area to impede seepage of water.

The soil classification in dam site shows that the soil has permeable soil and it surely will cause an uplift force. However, it is possible to avoid the permeability problem by building cut off wall as shown in **Figure 8** and **Figure 9**.

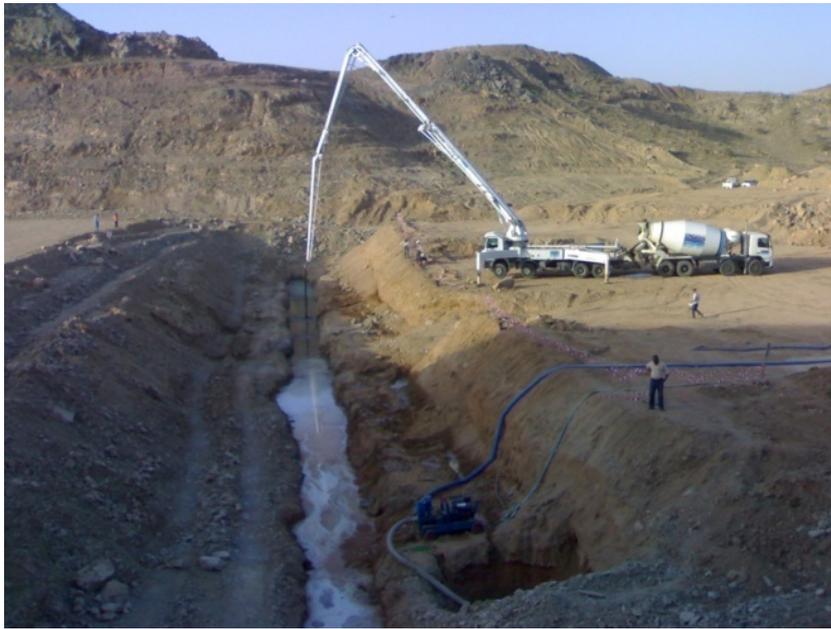
**Figure 9.** Photograph showing the grouting process at the study area to impede seepage of water (Chemical grouting by bentonite).
