# Evaluation of the Disparity Effect in the Amounts of Weathering Agents on the Archaeological Pine Wood “*Pinus sp.*”

Mahmoud Ali

Conservation Department, Faculty of Archaeology, Luxor University, Luxor, Egypt  
Email: dr.mahmoud.sayed82@gmail.com

**How to cite this paper:** Ali, M. (2021). Evaluation of the Disparity Effect in the Amounts of Weathering Agents on the Archaeological Pine Wood “*Pinus sp.*”. *Archaeological Discovery*, 9, 135-150.  
<https://doi.org/10.4236/ad.2021.92007>

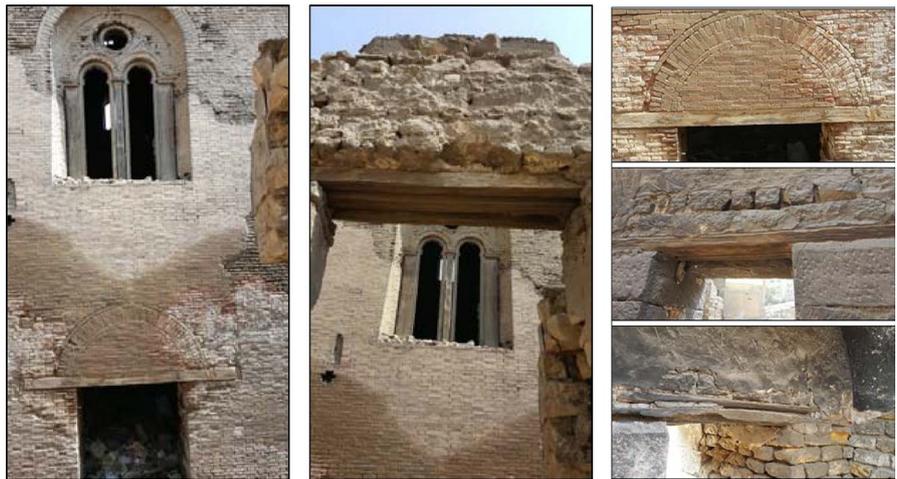
**Figure 1.** The wooden lintels at the mausoleum of Fatma Khatun.

The aim of this research is to focus on deteriorated pine wood, which was used in making some lintels at the mausoleum of Fatma Khatun (1283-1284) (AH 682-683) wife of Sultan Qalawun. This mausoleum is situated at Al-Ashraf Street, Al-Khalifa district, Cairo, Egypt. This building needs necessary restoration works, not only for the wooden elements but for the entire building sunken in the groundwater (Figure 1).

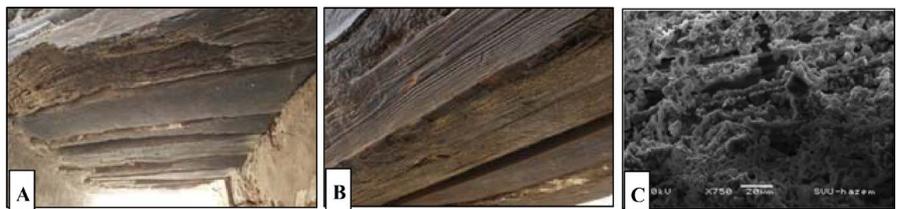
**Figure 2.** (A)-(C), shows the burn of some window lintels in the outer portico of Fatma Khatun mausoleum, (C) SEM micrograph. 20  $\mu$ m.

The wooden lintels of this mausoleum are directly exposed to the surrounding weathering factors which are: moisture, temperature, sunlight, air pollutants, and wind. Also, the factor of abandonment and neglect exacerbated the deterioration aspects of the wooden elements such as the exposure of some window lintels in the outer portico to burn (Figure 2).

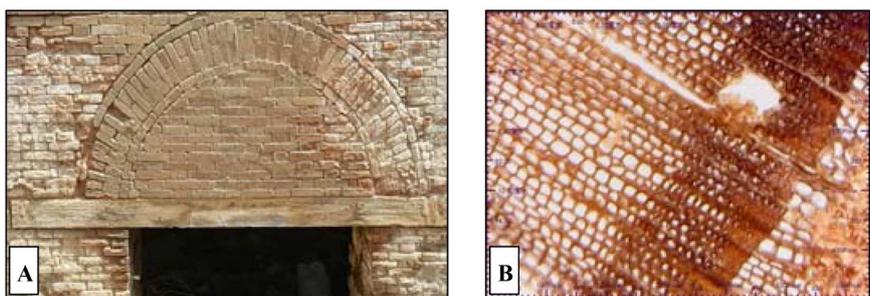
**Figure 3.** (A). The lintel of main door in the mausoleum dome chamber, (B). A cross-section of the pine wood (digital microscope).

By using the digital microscope, the examination of the wooden lintels of Fatma Khatun mausoleum, in the transverse section (TS), showed the anatomical characteristic features of the pine wood "*Pinus sp.*". It can be observed the growth rings, earlywood tracheid (with the thin-walled), latewood tracheid (with the thick-walled), the rays, and resin canals (**Figure 3(B)** & **Figure 4(B)**, **Figure 5(B)** & **Figure 5(D)**). Through the examination, it was identified another kind of wood (Hardwood) wasn't broached in this research. It was used in one of the window lintels in the entry corridor of this mausoleum.

The pine wood (*Pinus sp.*) was used in the mausoleum of Fatma Khatun to make the lintels of the main door of the mausoleum dome chamber (**Figure 3(A)**), also it was used to make the window lintels in the outer portico and in the entry corridor of this mausoleum (**Figure 4(A)**, **Figure 5(A)** & **Figure 5(C)**).

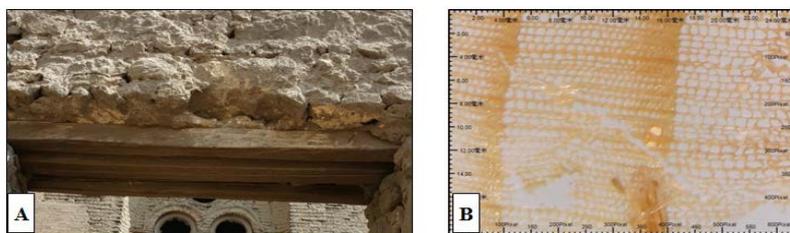
**Figure 4.** (A). The windows lintels in the outer portico and in the entry corridor of Fatma Khatun mausoleum, (B). A cross-section of the pine wood (digital microscope).

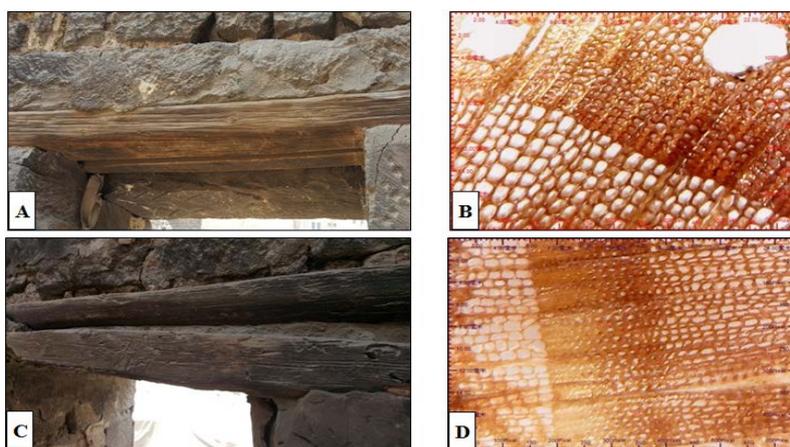
**Figure 5.** ((A) & (C)). The windows lintels in the outer portico and in the entry corridor of Fatma Khatun mausoleum, ((B) & (D)). A cross-section of the pine wood (digital microscope).

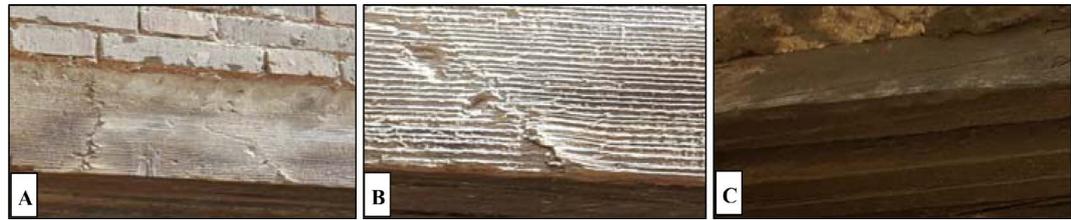
The pine wood used in these lintels is very dry and that led to the spread of large longitudinal cracks in the same direction of the wood fibers. These cracks extend to the edge of these lintels (**Figure 6(C)** & **Figure 7(B)**). On the other side, we can observe the spread of fine cracks in the cell wall layers and also that there are many separations along the longitudinal axis of the wood cells (**Figure 8**). There are also some splits and fibers breaks on the surface and an erosion of the lintel's edges. The cracks appear on the wood surface as a result of repeated exposure to the wetness by the sources of moisture and to the drying by the high temperatures and air (**Henriques & Azevedo, 2018**).

**Figure 6.** Spread of the different cracks on the pine wood surface, ((A), (B)) the lintel of the door in the mausoleum dome chamber, (C) the window lintel in the outer portico.

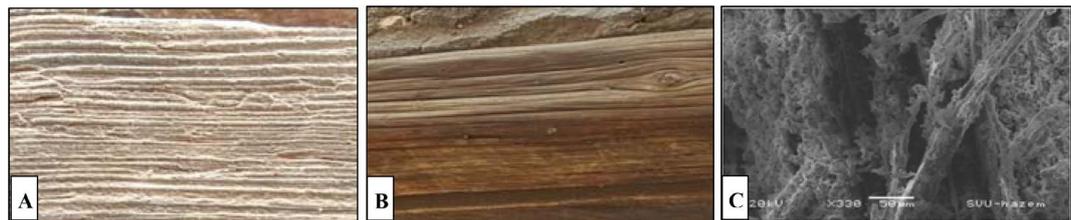
The wood surface, directly exposed to weathering, appears uneven due to the difference in erosion rates between earlywood and latewood, and also between the knots and wood tissue (**Figure 7(A)** & **Figure 7(B)**). We can observe also

**Figure 7.** ((A), (B)) The window lintels in the outer portico showing the roughness of weathered wood surface, (C) the accumulated dust particles between the wood fibers, SEM micrograph. 50 µm.

that there are color changes spread irregularly on the surface of wood such as the presence of light brown areas and other areas with a dark brown color. The archaeological wood takes this dark color when it's not exposed directly to the effect of rain (Sandberg, 1999). The dust particles are widespread in the surrounding area of this mausoleum and for this reason, the dust particles accumulated and stuck on the wood surface as a result of wetness and drying exchanges (Ali, 2019) (Figure 7(C)).

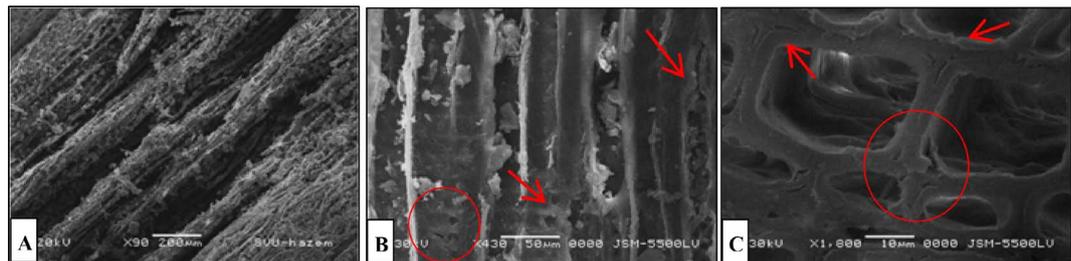
**Figure 8.** SEM micrographs of the window lintels in the outer portico. (A) a longitudinal section showing the fragile and detached wood fibers, (B) a radial section showing the longitudinal cracks and the degradation of bordered pits (C) A cross-section showing the cracks and the separation of cell walls layers. (bar: (A) 200 µm, (b) 50 µm, (c) 10 µm).

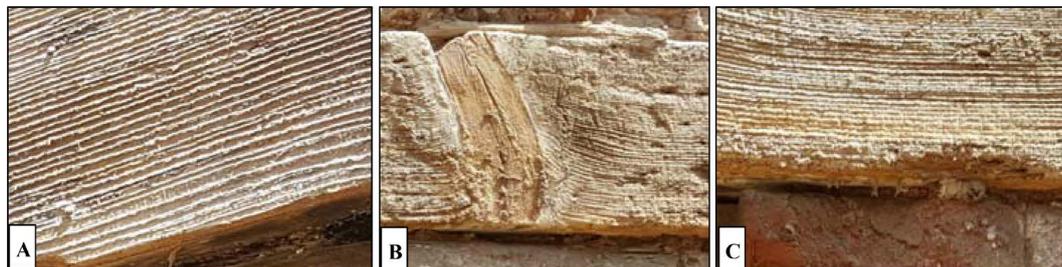
The lintel of the main door in the mausoleum dome chamber was exposed to the effect of weathering factors in the following sequence: (Moisture of “groundwater and relative humidity”, sunlight, and temperature). This arrangement was reflected in the appearance of the wood surface. The exposure of this lintel to high moisture levels, to direct sunlight and to high temperatures, especially in summer, led to the continuous exchange of wetness and dryness processes. These continuous processes were reflected in the appearance of the wood surface which appears fragile, spongy, and with incoherent fibers resulting from the breakdown of the wood components (Sandberg, 1999) (Figure 9(C) & Figure 10).

**Figure 9.** The lintel of the door in the mausoleum dome chamber (A) The roughness of weathered wood surface, (B) the wood knots affected by weathering, (C) the spongy appearance of the wood surface and the erosion of lintel edges.

One of the more visible effects of weathering on this lintel is the variation of erosion rates between earlywood and latewood. The earlywood appears as carved lines on the wood surface extending along this lintel, with variable depth (1 - 2 mm). This erosion rate depends on the density of wood, therefore the low-density earlywood was the most affected by the weathering Factors (Unger et al., 2001; Williams, 2005) (**Figure 9(A)**). On the other side, It is also observed that the knots of wood were affected by weathering factors, as there was significant erosion, some cracks, and a loss of some of its part (**Figure 9(B)**).

A remarkable erosion was noticed in the lintel edges, especially the parts adjacent to the wall. This loss in these parts can be explained as follows: the wooden lintels are in direct contact with the walls and absorb water mixed with salts and other large quantities of soluble building materials. Because of high temperature, these materials crystallize on the surface, and between the fibers and with the effect of wind, these materials fall out with some parts of the fragile wood from the surface (Figure 9(C)).

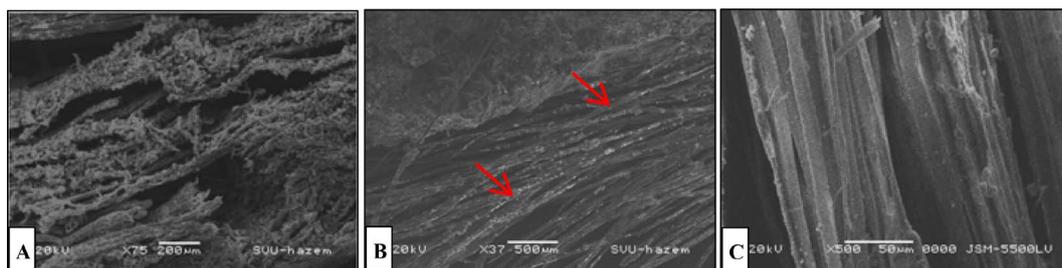
**Figure 10.** SEM micrographs of the door lintel in the mausoleum dome chamber, (A) a longitudinal section showing the fragile and detached wood fibers, (B,C) a longitudinal section showing the detached wood tracheids. (bar: (A) 200  $\mu\text{m}$ , (b) 500  $\mu\text{m}$ , (C) 50  $\mu\text{m}$ ).

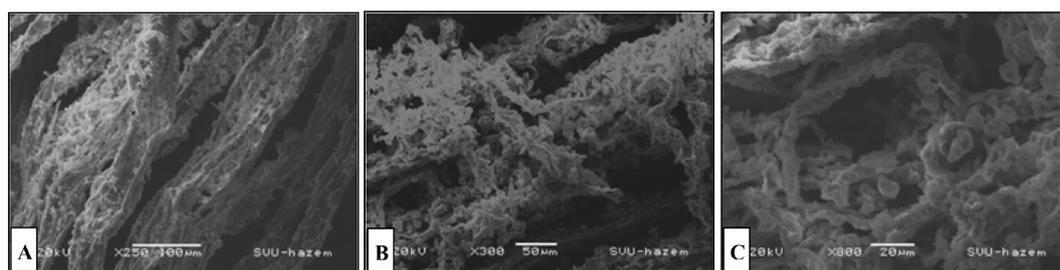
tel parts adjacent to walls tend to the white or gray, while the other parts tend to the brown. This gray layer was resulted from the exposure of this lintel to the high levels of moisture and the direct exposure to sunlight, also it may be caused by the effect of the fungus (Yildiz et al., 2018). A large amount of dirt particles accumulates on the surface of this lintel, which is one of the important agents of the archaeological wood surface deterioration (William, 1983) (Figure 11).

**Figure 11.** SEM micrographs of the door lintel in the mausoleum dome chamber, showing the detached wood fibers surrounded by dust particles. (A)-(C) longitudinal sections (bar: (A) 100µm, (B) 50 µm, (C) 20 µm).

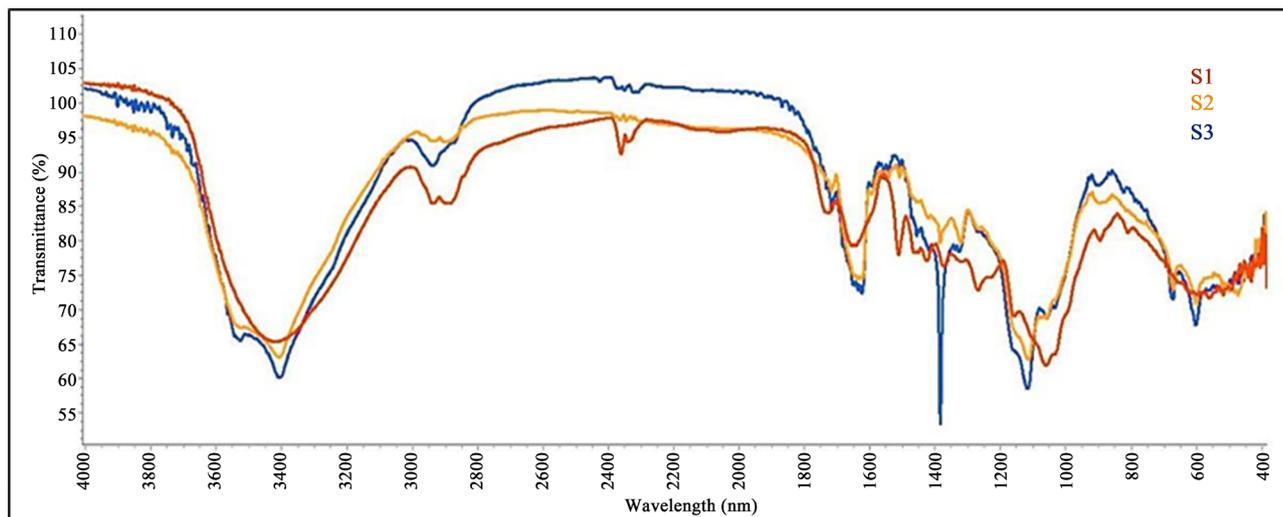
The FTIR spectra results of the pine wood samples (S1.control sample, S2 sample from the window lintel, and S3 sample from the door lintel) shown in the (Table 1) and (Figure 12). The FTIR spectra (region range between 400 - 4000  $\text{cm}^{-1}$ ) were used for the clarification of the differences between archaeological pine wood samples (weathered surface) and the control sample (unweathered sample).

By the comparison of the FTIR spectra between the archaeological pine wood samples (that were taken from the deteriorated wood surface) and the control samples (unweathered), we can understand the extent of chemical changes in the surface of this archaeological wood. This research shows a lot of changes in the bands of cellulose, hemicellulose, and lignin between the degraded wood and the control samples. It can be clarified as follows: The O-H band stretching around (3400 - 3420  $\text{cm}^{-1}$ ) shifted from 3419  $\text{cm}^{-1}$  at sample S1 (the control sample) to a lower wavenumber at 3409  $\text{cm}^{-1}$  for sample S2 and at 3408  $\text{cm}^{-1}$  for sample S3. The absorption increased in the samples S3 and S2 as a result of the increase in the degradation of these samples (El Hadidi, 2017) and the hydroxyl groups oxidation (El-Hadidi & Darwish, 2008). The wide band around 3420  $\text{cm}^{-1}$  in the archaeological wood samples were divided into two peaks (bands): for sample S2, the two peaks appear at 3409  $\text{cm}^{-1}$  and 3527  $\text{cm}^{-1}$ , for sample S3 the two

peaks appear at 3408  $\text{cm}^{-1}$  and 3527  $\text{cm}^{-1}$ . The band at 3527  $\text{cm}^{-1}$  is related to the absorbed water bound and the intramolecular H-bond in lignin (Popescu et al., 2011b). According to a previous literature, this stretching mode of H<sub>2</sub>O molecules is caused by the high level of moisture surrounding these wood lintels (El-Hadidi & Darwish, 2008).

The FTIR spectra of sample S2 shows a decrease in the absorbance at 2895  $\text{cm}^{-1}$  and 2939  $\text{cm}^{-1}$  (C-H stretching) bands, for sample S3 the band around 2890  $\text{cm}^{-1}$  is disappeared and there is a decrease in absorbance at 2895  $\text{cm}^{-1}$ . This decrease comes as a result of the degradation of cellulose and the changes in its

**Figure 12.** FTIR spectra of the control sample (S1), the window lintel in the outer portico (S2 sample), and the door lintel in the mausoleum dome chamber (S3 sample).

At the band around  $1640\text{ cm}^{-1}$  (C=O stretching), which refers to  $\text{H}_2\text{O}$  absorption, there is a remarkable increase in band intensity. This corresponds to the increase and the split in the O-H stretching band around  $3420 - 3527\text{ cm}^{-1}$ . This band comes as a result of the water absorption from the surrounding environment. The obvious multiplication of carbonyl bands in this zone is resulting from the degradation of lignin and cellulose (El-Hadidi & Darwish, 2008).

The band at  $1739\text{ cm}^{-1}$  (C=O stretch in un-conjugated ketones) concerns hemicellulose. This band disappeared in the sample S2, while the absorption intensity at sample S3 decreased obviously. The decrease in this band is caused by the deterioration of the acetyl group and hemicellulose by the effect of weathering factors (Reinprecht et al., 2018; Yildiz et al., 2018; Iruela, 2020).

The bands which concern lignin were found at  $1595\text{ cm}^{-1}$ ,  $1511\text{ cm}^{-1}$  and  $1269\text{ cm}^{-1}$ . In addition to that, the band at  $1460\text{ cm}^{-1}$  concern lignin and carbohydrates (Pandey & Pitman, 2003). All bands of lignin registered a significant decrease in absorbance. The absorption band around  $1595\text{ cm}^{-1}$  (aromatic skeletal) appears in sample S1 as a shoulder. As for the archaeological samples, a decrease in absorption intensity was observed around the band  $1595\text{ cm}^{-1}$  which appeared very weak in samples S2 and S3. According to some previous researches, the changes and the absorption decrease at this band and that may be due to the presence of water in these samples (Fors & Richards, 2010), and also to the effect of the methoxy (O-CH) groups of the guaiacyl rings (Zhang et al., 2009).

The band around  $1505 - 1511\text{ cm}^{-1}$  (aromatic skeletal) is used to assess the content of Lignin in wood samples. Comparing samples S2 and S3 with the S1 sample, there is a shift of this band and a remarkable decrease in intensity of the bands at  $1508\text{ cm}^{-1}$  for S2 and at  $1507\text{ cm}^{-1}$  for S3 which appear as very weak peaks. This decrease indicates the effect of weathering factors on the aromatic rings (Zhang et al., 2009). Previous research reported that this decrease is re-

sulting from the methoxyl groups decrease and from the loss of syringyl units of lignin (Kubovský et al., 2020). Weathering caused a decrease in the intensity of the  $1269\text{ cm}^{-1}$  band (guaiacyl ring breathing with C-O stretching) (Lionetto et al., 2012) in the archaeological samples. It was a very clear band in the control sample, but it appeared as a shoulder in the sample S2, and disappeared in the sample S3. The band at  $1460\text{ cm}^{-1}$  (asymmetric CH deformations in lignin) (Kubovský et al., 2020) in sample S2 was observed very weak, while it was absent in sample S3.

The absorption bands around  $1373\text{ cm}^{-1}$ ,  $1336\text{ cm}^{-1}$ ,  $1317\text{ cm}^{-1}$ ,  $1159\text{ cm}^{-1}$  and  $897\text{ cm}^{-1}$  refer to cellulose. The cellulose band at  $1373\text{ cm}^{-1}$  appeared in the control sample, while it appeared in the archaeological samples at  $1384\text{ cm}^{-1}$ . This band in sample S2 decreased in absorbance and appeared as a weak band. In sample S3, the band at  $1384\text{ cm}^{-1}$  increased in absorbance and appeared as a very strong band. The increase in intensity in this band refers to the depolymerization of cellulose which is intimately related to the decrease or the disappearance of the lignin band around  $1510\text{ cm}^{-1}$  (Genestar & Palou, 2006).

There was a decrease in the band intensity that was noted in the band at  $1425\text{ cm}^{-1}$  ( $\text{CH}_2$  bending cellulose, “crystallized I and amorphous cellulose”) (El Haddidi, 2017). This band shifted also to lower wavelengths in the archaeological samples: it became at  $1420\text{ cm}^{-1}$  in sample S2 and at  $1418\text{ cm}^{-1}$  in sample S3, and that indicates the extent of the cellulose damage resulting from the weathering factors

The bands at  $1335\text{ cm}^{-1}$  and at  $1316\text{ cm}^{-1}$  refer to the wood cellulose, in the control sample (S1) these bands were observed as weak bands with a shoulder at  $1318\text{ cm}^{-1}$ . In the archaeological samples (S2, S3), these bands decreased in absorption compared with the S1 sample. However, these bands can be observed as two bands in sample S3 around  $1320\text{ cm}^{-1}$  and  $1336\text{ cm}^{-1}$ , while in sample S2, only one band appeared as one peak at  $1320\text{ cm}^{-1}$ . Previous research stated that the decrease of absorption and the two similar bands in this area were a result of the increase of the content of the crystallized cellulose (Colom et al., 2003). The band at  $1235\text{ cm}^{-1}$  (C=O in xylan-lignine), disappeared in samples S2 and S3 and that comes as a result of the degradation of xylan and the lignin changes (Shi et al., 2012). The peak at  $1159\text{ cm}^{-1}$  (C-O-C asymmetric stretching vibrations in cellulose and hemicellulose) disappeared in samples S2 and S3. This means that there is a big loss in the degree of cellulose polymerization (breaking the chains of cellulose) (Darwish et al., 2013; Hamed et al., 2020).

The peak at  $897\text{ cm}^{-1}$  (C-H deformation of cellulose) (Reinprecht et al., 2018) decreased significantly in intensity. It seems like a very weak peak in the archaeological samples (S2 and S3). This decrease indicates the decrease of the amorphous cellulose (Kubovský et al., 2020). The peaks at  $806\text{ cm}^{-1}$  (the ring of benzene) decreased substantially in intensity and appeared as a very weak peak. There was a similar result in previous research which reported that the delignification from the softwood was the reason for these changes (Xing et al., 2015).
