Custom Made Fenestrated Stent Graft Collapse after Thoracic Endovascular Aortic Repair: A Case Report

Abstract

Thoracic Endovascular Aortic Repair, Collapse, Custom Made Fenestrated Stent Graft, Bird-Beak Deformity

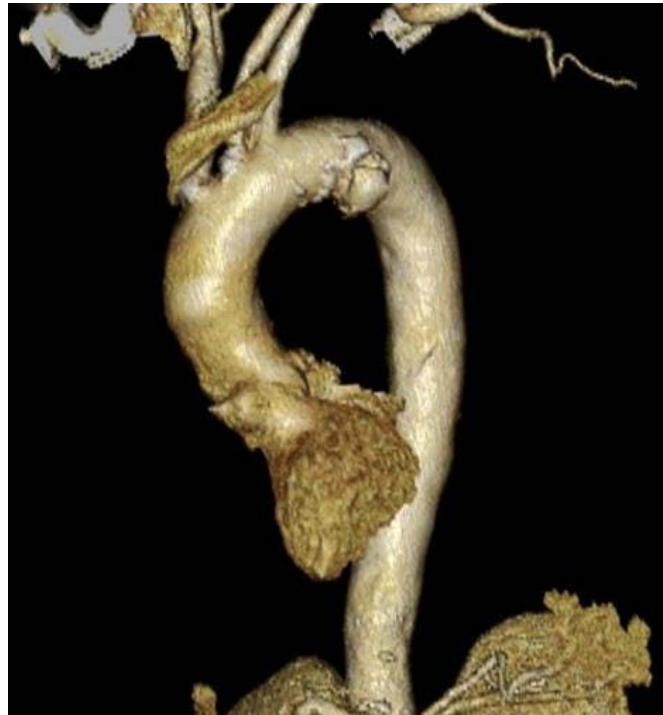
Figure 1. (a) Preoperative 3-D CT scan showing a saccular aneurysm (maximum diameter, 38 mm) in the distal aortic arch. The length of the proximal landing zone is shorter (about 5 mm). (b) The custom-made fenestrated SG with a built-in Z stent and 3 holes for the branches of the aortic arch without the use of snorkels. (c) Postoperative CT scan obtained on POD 3, showing no migration of the SG, leakage, or any other problem.

A 70-year-old Japanese woman with a history of asthma, emphysema, hypertension and obesity was admitted to our hospital, and she was diagnosed as having an asymptomatic aneurysm of the distal aortic arch. Routine chest computed tomography (CT) revealed a saccular aneurysm (maximum diameter, 38 mm) in the small curvature of the distal aortic arch, and the diameter of the aorta was about 27 mm proximally and about 28 mm distally (Figure 1(a)). We used a custom-made fenestrated SG with a built-in Z stent and 3 holes for the branches of the aortic arch (Figure 1(b)). The SG traversed the entire aortic arch.
