Analysis and Extent of Santa Fe River Flooding in North Florida Attributed to Rainfall and Wind Damage Associated with Hurricane Irma

Sergio Bernardes, Lou Manglass, Sydney T. Bacchus, Marguerite Madden

Center for Geospatial Research (CGR), Department of Geography, University of Georgia, Athens, USA

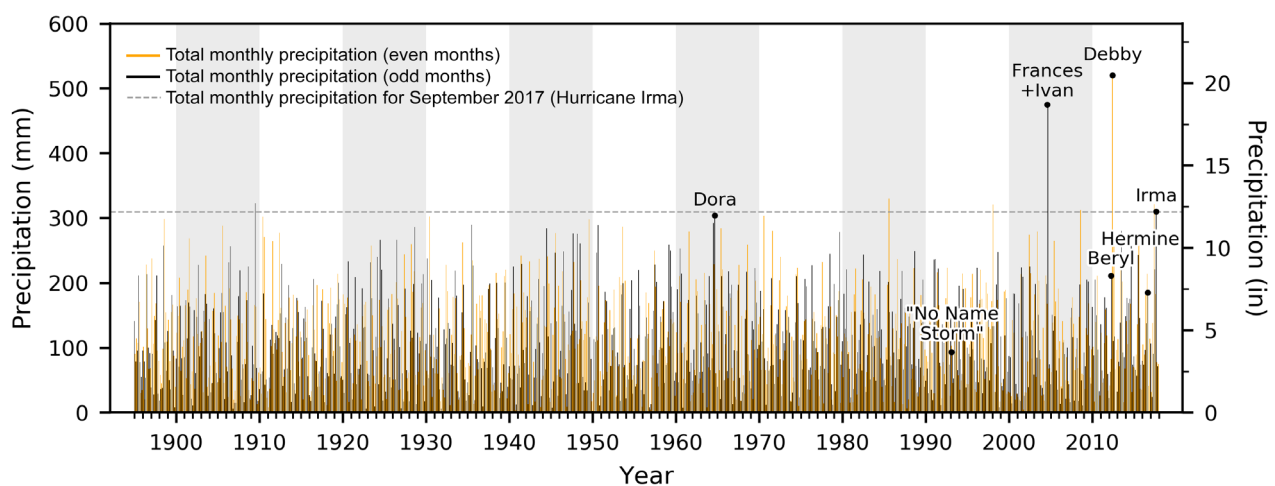
Figure 2. Total monthly precipitation for the Santa Fe River Basin (WBDHU8) from January 1895 to December 2017, with months labelled for occurrences of Hurricane Dora (1964), the “No Name Storm” (1993), Hurricanes Frances and Ivan (2004), Tropical Storms Beryl and Debby (2012), Hurricane Hermine (2016), and Hurricane Irma (2017).

Figure 2 illustrates the total monthly precipitation for the SFR Basin (WBDHU8) from January 1895 to December 2017. Total monthly precipitation for that period of record for the SFR headwaters in Bradford County is not shown because it was comparable to results for the SFR Basin in **Figure 2**. The vertical columns of alternating shading (background) in this figure separate each decade of monthly precipitation data. Alternating colors were used for even and odd months, to facilitate viewing of the data. The horizontal dashed line across the period of record is positioned at the peak total monthly precipitation for Hurricane Irma, during September 2017 (309.4 mm or 12.2 in). This horizontal line allows comparisons of total monthly precipitation for Hurricane Irma to total precipitation for preceding months dating back to January 1895. **Figure 2** shows that total monthly precipitation for Hurricane Frances and Ivan in September 2004 (474.8 mm or 18.7 in) and for Tropical Storm Debby in June 2012 (520.1

mm or 20.5 in) both exceeded total monthly precipitation for the month of Hurricane Irma (September 2017). **Figure 2** also shows four additional peaks of total monthly precipitation that exceeded total monthly precipitation for the month of Hurricane Irma, but were not described or named as flooding events by or in Bradford County. Those peaks (not labelled in **Figure 2**) occurred in August 1985 (329.6 mm or 13 in), February 1998 (320.6 mm or 12.6 in), August 2008 (312.1 mm or 12.3 in), and June 2017 (321.1 mm or 12.6 in). Following is the chronological order of storms and hurricanes, including month, year and total monthly precipitation, that have been identified by Bradford County, funding agencies, and other agencies and individuals as causing flood events in the SFR Basin and that were considered in our study: Hurricane Dora (9/64 – 304.3 mm or 12 in); “No Name Storm” (3/93 – 93.2 mm or 3.7 in); Hurricanes Frances + Ivan (9/04 – 474.8 mm or 18.7 in); Tropical Storm Beryl (5/12 – 211.3 mm or 8.3 in); Tropical Storm Debby (6/12 – 520.1 mm or 20.5 in); Hurricane Hermine (9/16 – 185.8 mm or 7.3 in); Hurricane Irma (9/17 – 309.4 mm or 12.2 in).

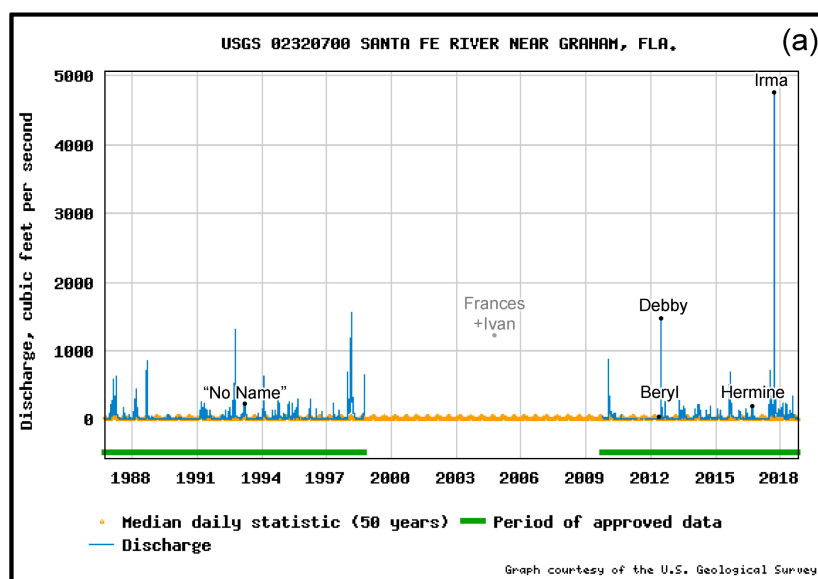
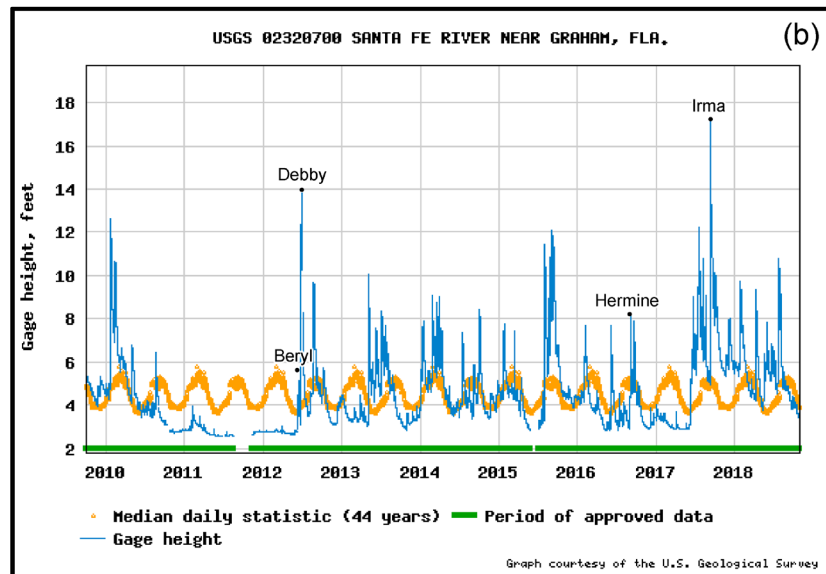
Figure 6. USGS graphs for the Santa Fe River Near Graham gage station of historical: (a) discharges from October 1, 1986 through 2018 and (b) gage heights from October 1, 2009 through 2018.

Figure 6(a) and **Figure 6(b)** provide the USGS graphs for historical stream

discharges from 1986-2018 and historical gage heights from 2009-2018, respectively, for the USGS SFR Near Graham, west of the headwaters in the Santa Fe Swamp (retrieved on February 2, 2019). There is a gap of missing USGS stream discharge data at this gage station from approximately 1998-2009. That period of missing data includes the 2004 period when the SFR experienced Hurricanes Frances and Ivan. The stream discharge data for that month was obtained from the USGS cooperating agency data set maintained by the SRWMD. For periods during which the USGS is not collecting or maintaining data from gage stations those data may be available from the local source, which in this case is collected by P. Still, Supervisor of the Bradford Soil and Water Conservation District (personal communication, P. Still, 2/19). Those data not included in the USGS graph in **Figure 6(a)**, but retrieved from the local source, show approximately 1000 cubic feet per second ($\text{ft}^3\text{sec}^{-1}$) more flow from this SFR location during Frances and Ivan in September 2004, than during the “No Name Storm” in March of 1993, which is equivalent to approximately $28.3 \text{ m}^3\text{sec}^{-1}$. There were no stream discharge records for Tropical Storms Beryl and Debby in May and June of 2012, respectively, but approximately $141.6 \text{ m}^3\text{sec}^{-1}$ ($5000 \text{ ft}^3\text{sec}^{-1}$) stream discharge was recorded during Hurricane Irma in September 2017. That record discharge occurred with precipitation significantly less than during Hurricanes Frances + Ivan and Tropical Storm Debby. Gage height from this SFR location also recorded a record of approximately 5.2 m (17 ft) for Hurricane Irma, compared to approximately 4.3 m (14 ft) for Tropical Storm Debby.

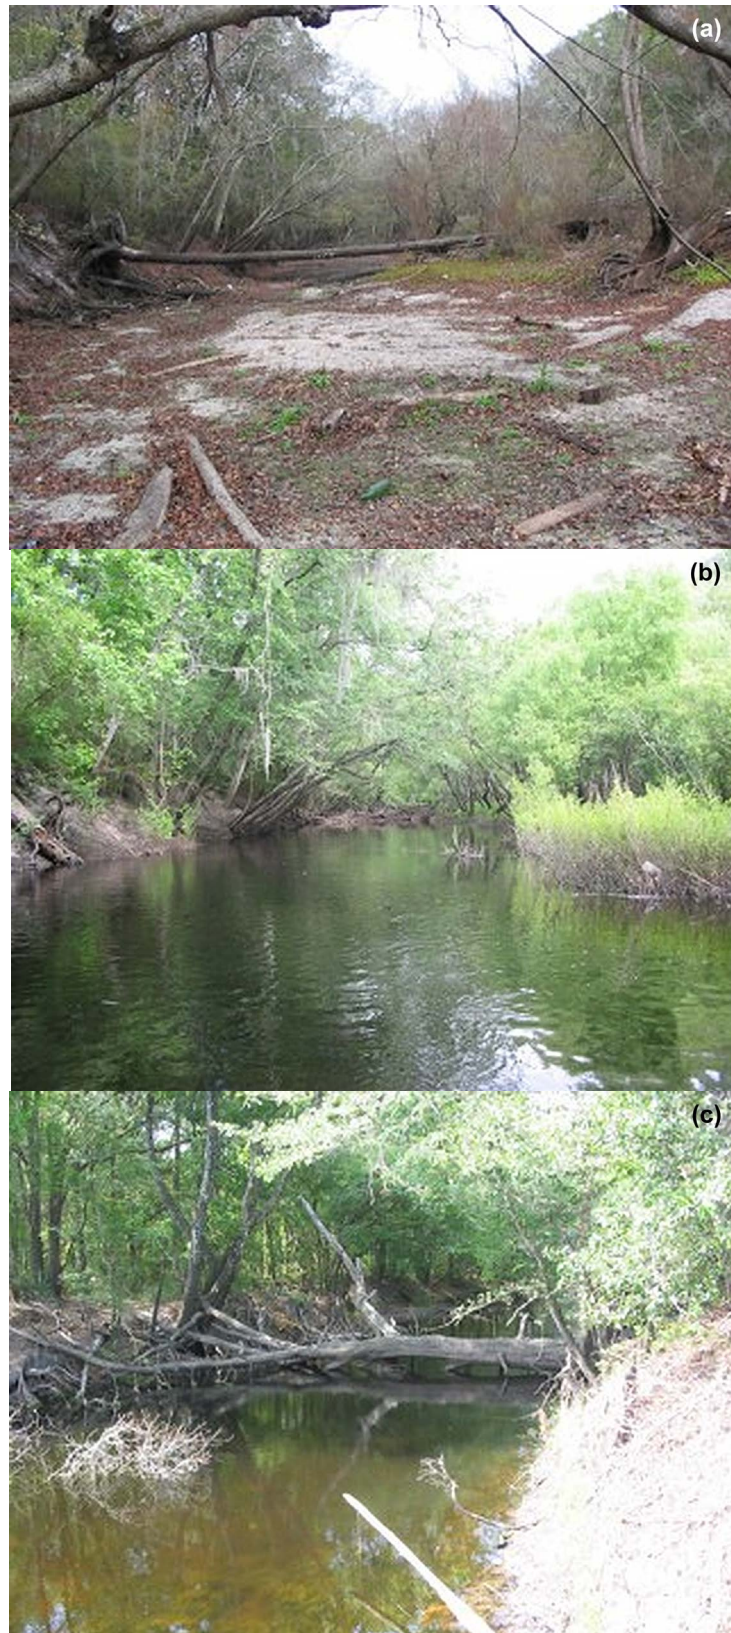
Figure 11. Historical USGS photographs of (a) Santa Fe River at Worthington Springs on December 20, 2006; (b) Santa Fe River at Worthington Springs on April 23, 2008; and (c) New River Near Lake Butler on May 30, 2007.

on December 20, 2006 and April 23, 2008 at the SFR at Worthington Springs gage station (**Figure 11(a)** and **Figure 11(b)**, respectively). The NWIS website also included historical USGS photographs of the New River Near Lake Butler gage station taken on May 30, 2007 (**Figure 11(c)**). All three of these historical photographs show multiple dead trees associated with those sections of the SFR and New River. **Figure 11(a)** and **Figure 11(c)** show dead trees that fell across the stream channel. No reports could be found of those dead trees resulting in flooding upstream of those gage stations during those periods because those trees were impeding the flow of flood waters, including during Tropical Storms

Beryl and Debby in 2012, and Hurricane Irma in 2017. The dead trees associated with the SFR and New River shown in **Figure 11** provide evidence of some other cause for tree deaths in the SFR Basin that pre-dated Hurricane Irma in 2017. Additionally, the precipitation record (**Figure 3(a)**), as well as the dry stream channel and surrounding vegetation in the USGS photograph of the SFR at Worthington Springs on December 20, 2006 (**Figure 11(a)**) suggest that lack of precipitation was not the cause of that dry stream channel.

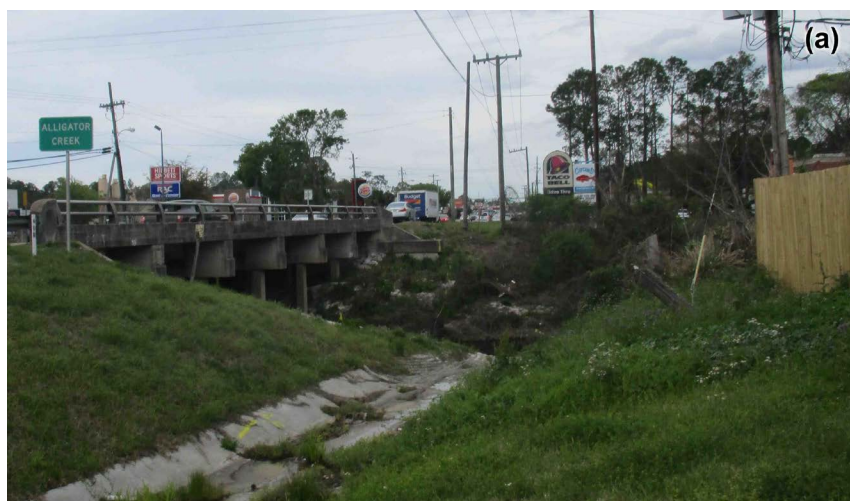
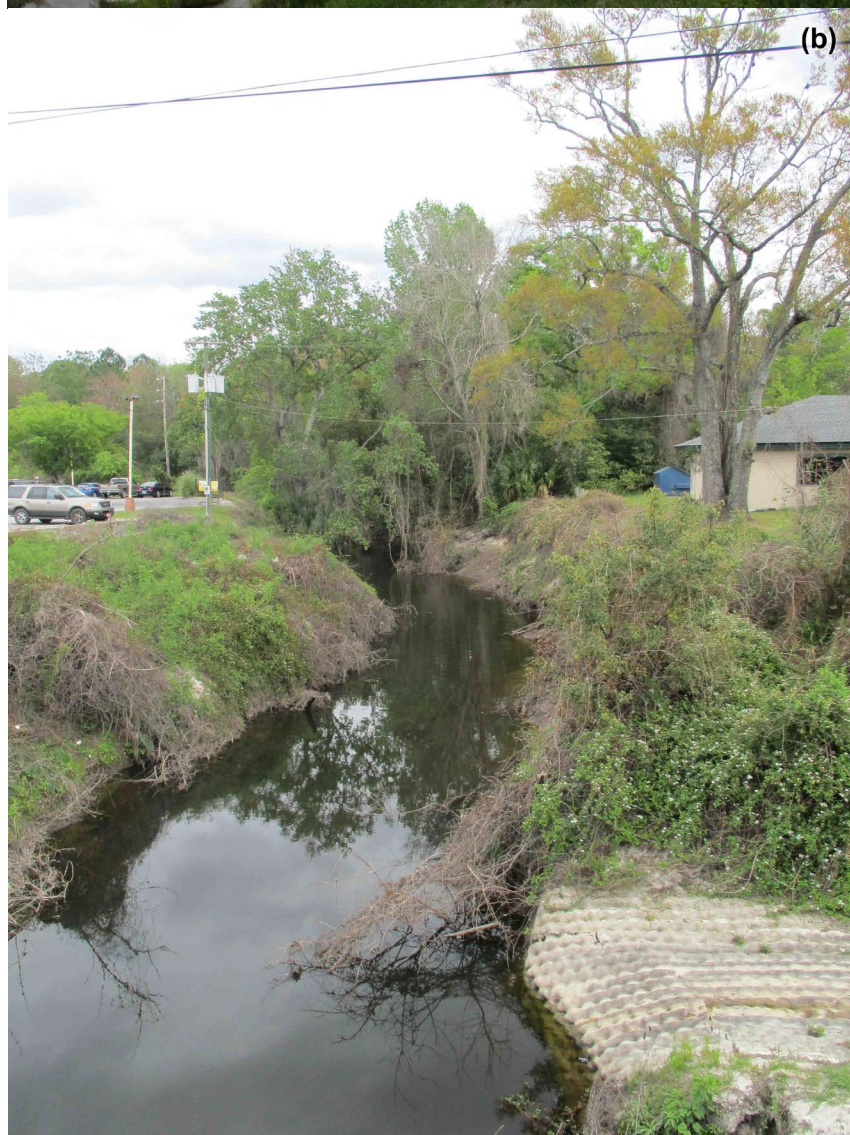
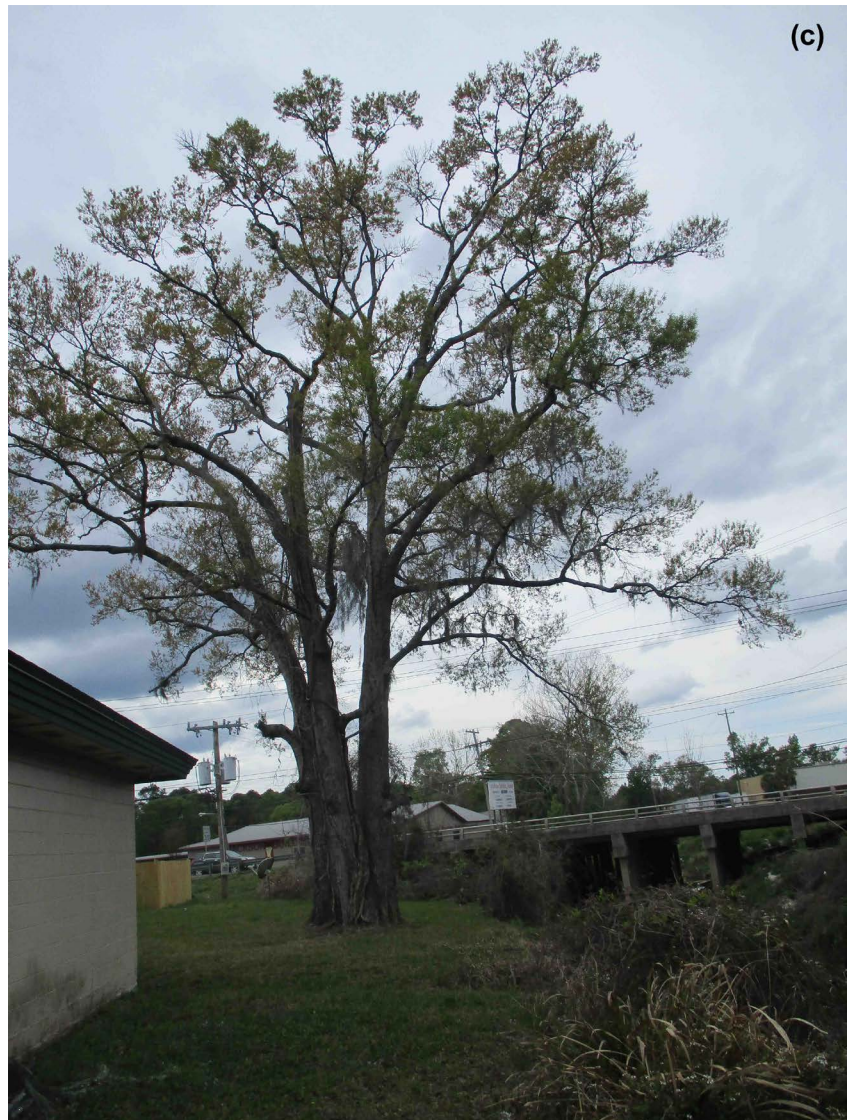
Figure 14. Photographs of the dredged channel of Alligator Creek taken in the vicinity of the Highway 301/Temple Avenue bridge in Starke, Florida on March 11, 2018, facing: (a) north; (b) east; and (c) west.

The photographs in **Figures 14(a)-(c)** illustrate the narrow, but deeply incised dredged channel of Alligator Creek in Starke, Florida. **Figure 14(a)** and **Figure 14(c)** show the bridge on the east side of Highway 301 at 900 South Walnut Street, while **Figure 14(b)** was taken from that bridge. The concrete swale shown in **Figure 14(a)** directs untreated stormwater directly from Highway 301 and surrounding paved areas into Alligator Creek. The textured end of that concrete swale at Alligator Creek is shown in **Figure 14(b)**. The Sports Utility Vehicle (SUV) shown on the left (north) side of **Figure 14(b)** provides an approximate scale suggesting that the dredged depth from the top of the Alligator Creek banks to the surface of the water exceeds 9 m (29.5 ft). That extreme depth and apparently shallow water, shown at the base of the concrete bridge in **Figure 14(a)**,

strongly suggest that the surficial aquifer has been lowered to approximately the base of that deeply dredged stream for an extensive area surrounding Alligator

Creek. Dewatering the surficial aquifer greatly decreases or completely eliminates baseflow of ground water required to maintain natural flow in the stream during periods of low rainfall.

In addition to providing information about the impacts to the surficial aquifer, **Figure 14(b)** and **Figure 14(c)** also provide information about the impacts of that hydroperiod alteration on native and invasive plants. Native wetland vegetation has been replaced by impenetrable thickets of brambles (*Rubus* sp.) on the steep banks of the dredged channel of Alligator Creek. These figures also show the premature decline in the native trees along the south bank of Alligator Creek (**Figure 14(b)**, right side and **Figure 14(c)**, left side). The photographs in **Figures 15(a)-(c)**, also taken on the south bank of Alligator Creek on March 11, 2018, show more extensive evidence of premature decline of native trees, in

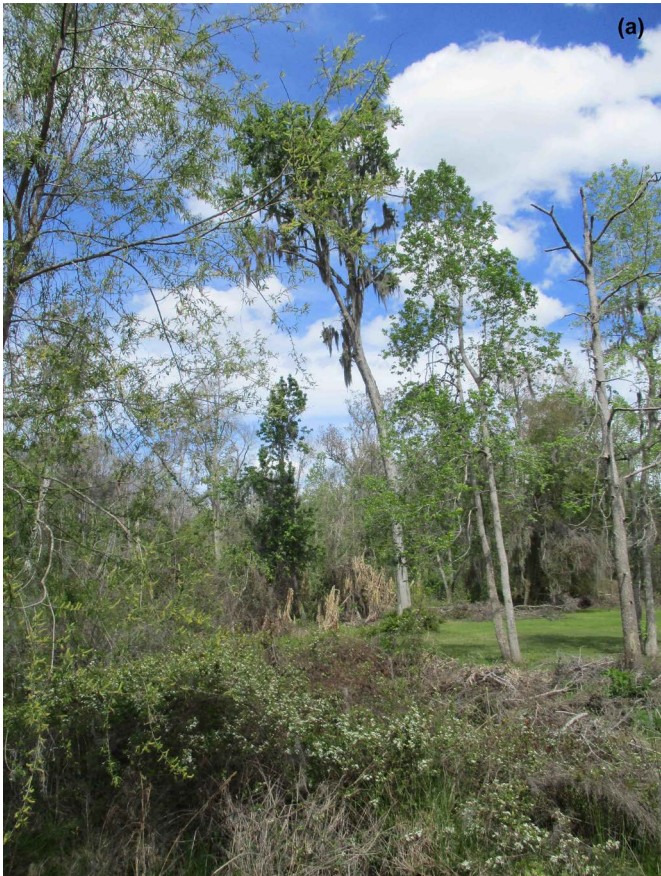
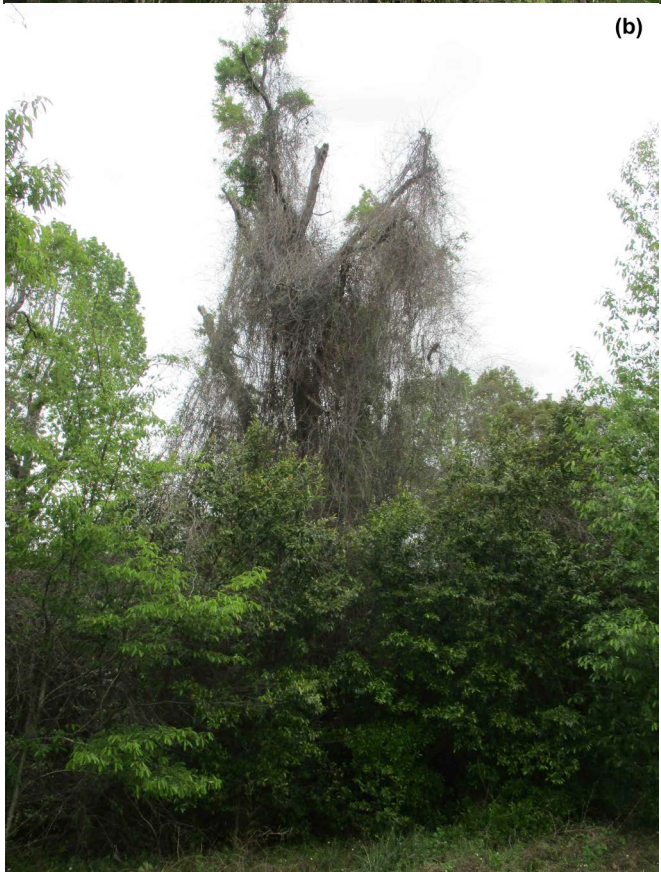
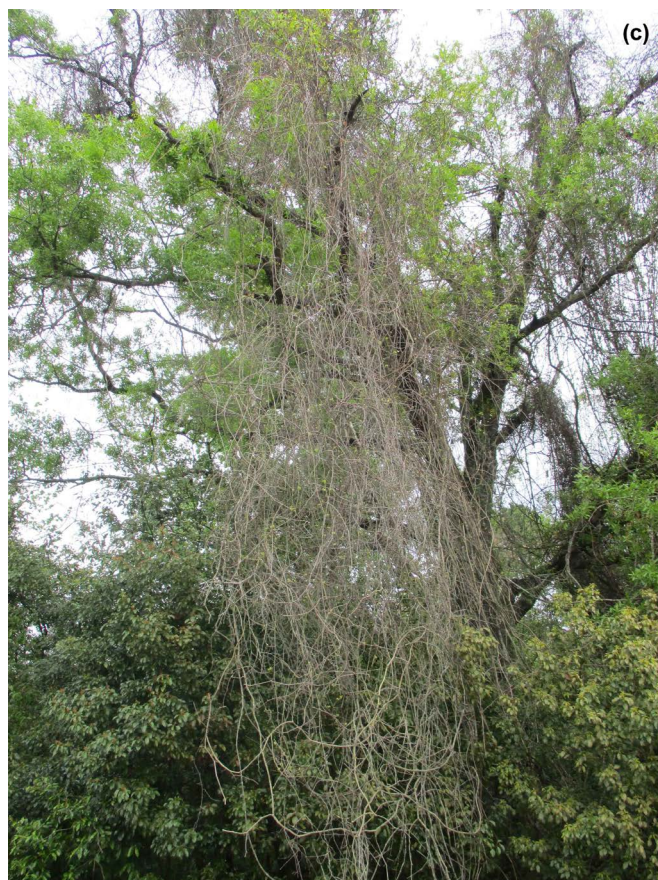
Figure 15. Photographs taken on the same date and general location of dredged channel of Alligator Creek as **Figure 14**, on the south bank, showing additional dead and prematurely declining native trees, and invasive trees, vines, and brambles.

addition to invasive trees, vines, and brambles. The extremely sparse canopy and dense Spanish moss in the canopy of native trees (**Figure 15(a)**) is a premature-decline indicator of chronic water stress from alterations of natural hydroperiods that have extended for significantly longer than the approximately six months since Hurricane Irma. The aggressive growth of woody vines that cover tree canopies (**Figure 15(b)** and **Figure 15(c)**), as well as invasive tree species, such as the thick growth of camphor trees (*Cinnamomum camphora*) shown in the lower third of **Figure 15(c)**, also are indicative of dewatered surficial aquifers from long-term alterations of natural hydroperiods. Additionally, the dead and near-dead trees shown in **Figure 15(a)** and **Figure 15(c)**, respectively, also are typical in areas of chronic water stress due to alterations of natural hydroperiods.

Altered hydroperiods by dewatering the surficial aquifer prevent native trees and other native plants associated with streams in the southeastern US from essential access to normal groundwater levels in the surficial aquifer during periods of low rainfall, including during the dry season. This type of anthropogenic alteration of natural hydroperiods commonly is caused by mining and results in the premature death and decline of both wetland and upland native trees and
