# Assessing Gravel Roads Condition to Examine Trends and Behaviors of Gravel Roads in Rural Areas in Kyela District

Paul Sango\*, Mwavuma I. Lingwanda, Gislar Kifanyi

Department of Civil Engineering, College of Engineering and Technology, Mbeya University of Science and Technology, Mbeya, Tanzania

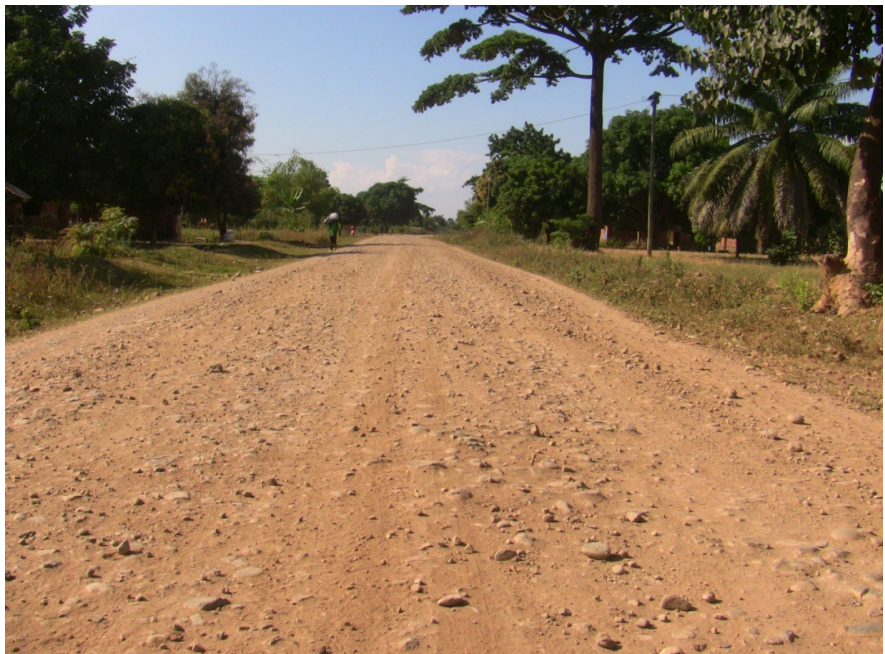
**Figure 1.** Typical gravel road; study road (2021).

The Tanzania Road Manuals defines gravel road pavements as a road design that has Annual Average Daily Traffic of less than 300 at the time of construction (TZ-MoW, 1999). Also (Hamza et al., 2018) defined gravel roads are roads that consist of natural subgrade soil, embankment, and gravel at the top. The natural subgrade soil is the existing local soil and is generally grubbed between 0.2 m to 0.4 m and well graded. The embankment is that layer constructed above the subgrade and constructed from local borrow pits. The top gravel layer is the surface layer with a height of 0.15 m to 0.25 m (Hamza et al., 2018). Types of equipment required to construct the unpaved road are motor grader, compactor, excavator, bulldozer, dump truck, water bowser, Loader, and low bed (Hamza et al., 2018). A gravel road is surfaced with a layer of gravel material that is stronger than the natural in-situ soil. It has been reported by (Walker et al., 2002); that a minimum of 1.5 to 2 inches of gravel surfacing is generally necessary to be considered a gravel road. (Pearson, 2012) found that gravel roads have a designed layer of imported material, which is typically constructed to a specified standard and width providing an all-weather surface. **Figure 1** shows a typical gravel road.

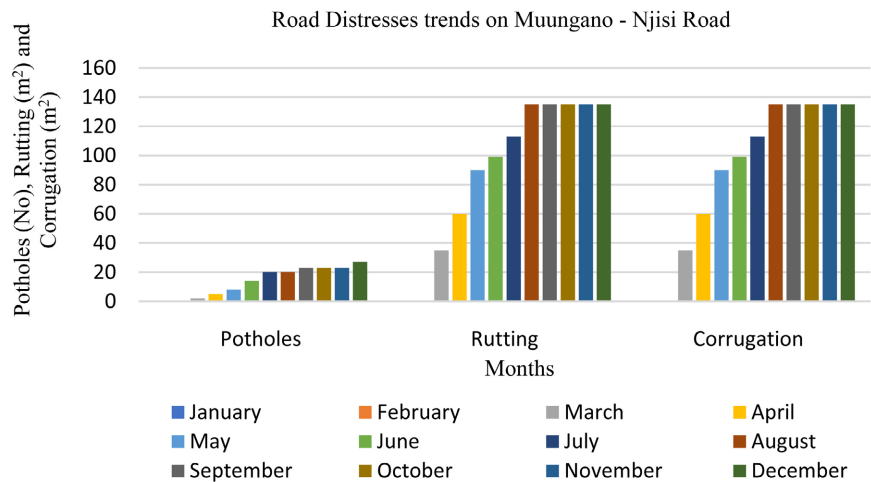
**Figure 3.** Trends of road distress on Muungano - Njisi road (2021).

The analysis of the data for road conditions was carried out based on the URCI finding each road condition distress as the parameter of analysis. As shown in **Figures 3-5** present a list of identified and assessed distress in each study road. Overall, the study road had excellent to poor distresses deteriorating the road

conditions. From **Figures 3-5**, it can be noted that from January to February Road distresses of these roads were in excellent condition followed by a slight recovery between March and May. These increases may be attributed to the decrease in soil particle size and strength of road material as compared to January and February Road material. Between June and September, another rapid decrease in road distresses is observed followed by a nearly constant value. It then falls rapidly from October and December where it again maintains a nearly constant value till December. During this period, road material is nearly constant and very poor road material.

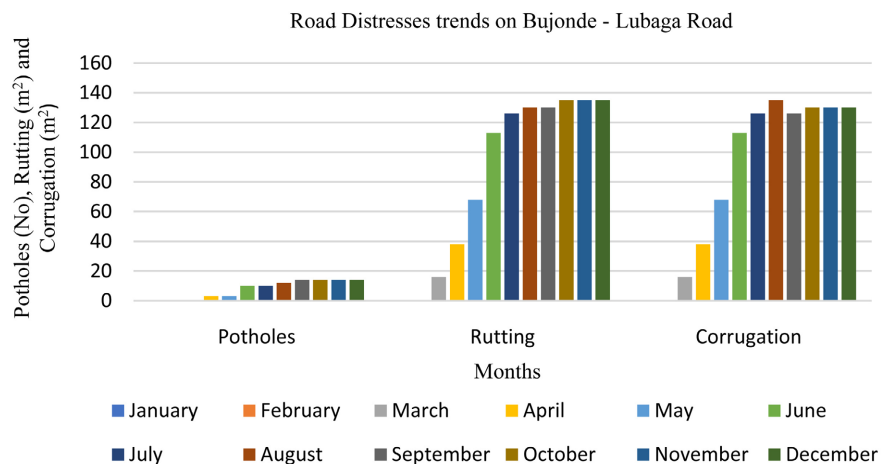
**Figure 4.** Trends of road distress on Bujonde - Lubaga road (2021).

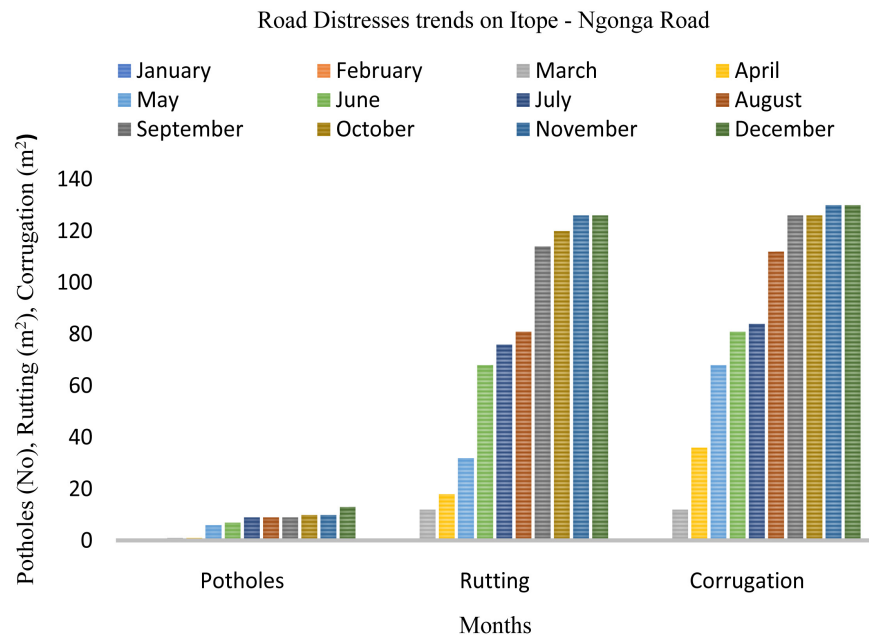
**Figure 5.** Trends of road distress on Itope - Ngonga road (2021).
