Flooding of Lake Nakuru National Park and Its Effects on the Resident Wildlife

How to cite this paper: Hongo, P.O. and Mulaku, G.C. (2021) Flooding of Lake Nakuru National Park and Its Effects on the Resident Wildlife. *Journal of Geographic Information System*, 13, 660-670.
<https://doi.org/10.4236/jgis.2021.136036>

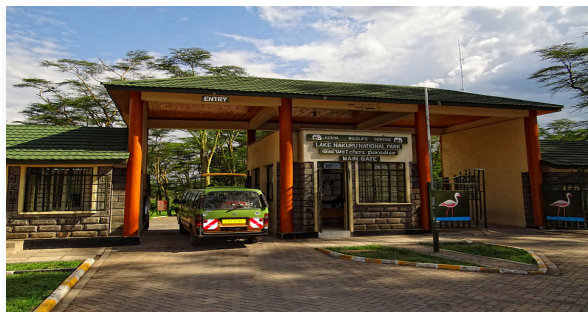
Plate 1. Lake Nakuru National Park main gate in 2009.

Since 2010 there has been continuous flooding in the park [3], with the result that important park infrastructure such as roads and buildings have been submerged; in addition, the flooding has reduced the Lake Nakuru water salinity, hence negatively affecting the growth of the blue-green algae on which the flamingos feed; furthermore the flooding has submerged some critical wildlife habitats, thus reducing wildlife rangelands, increasing wildlife crowding in the remaining habitats, and aiding in the transmission of animal diseases amongst the wildlife. This has compromised normal park operations and reduced tourist numbers to the park. **Plate 1** and **Plate 2** show the main entrance to the park before and after the floods.

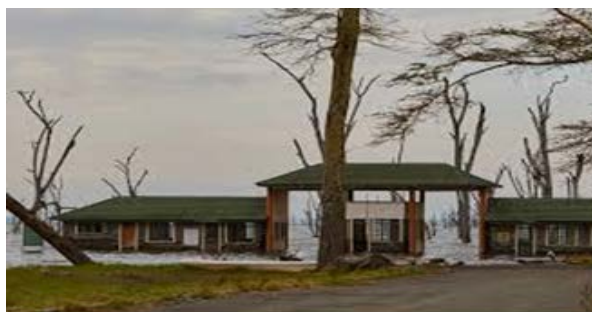
Plate 2. Flooded lake Nakuru National Park main gate in 2014.
