Corrosion Test of the Steel Plate in a WJ-8 Fastener for High Speed Rail

Zhiyong Wang¹, Zhiping Zeng², Hualiang (Harry) Teng³

How to cite this paper: Wang, Z.Y., Zeng, Z.P. and Teng, H.L. (2024) Corrosion Test of the Steel Plate in a WJ-8 Fastener for High Speed Rail. *Journal of Transportation Technologies*, 14, 16-30.

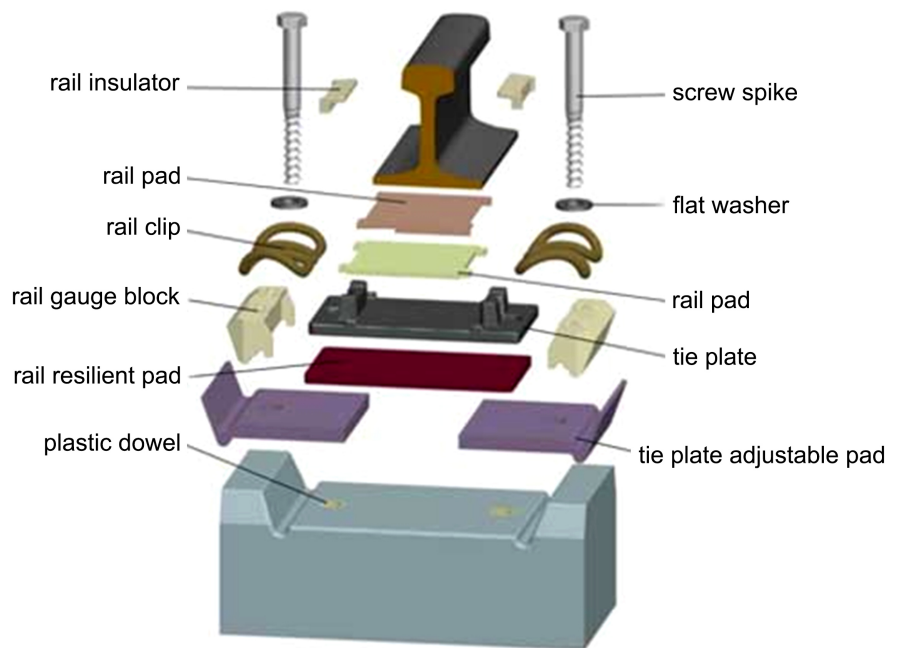
Figure 1. WJ-8 fastener used in China.

Figure 1 shows a WJ-8 fastener used in China that can be used in track on ground where the pink rubber plate under the rail absorbs most of the vibration. On bridges that are used for high speed rail, a steel plate is embedded into the rubber plate (see **Figure 2**), and it is called the composite tie plate. This steel plate has a small resistance that allows the fastener, tie, and track structure to move with the bridge structure. Thus, this fastener is known as the small resistance fastener.

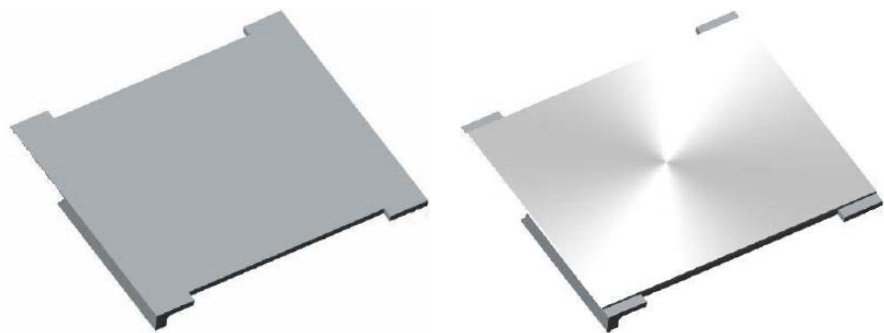
Figure 2. Rubber plate without a steel plate (left) and with a steel plate (right).

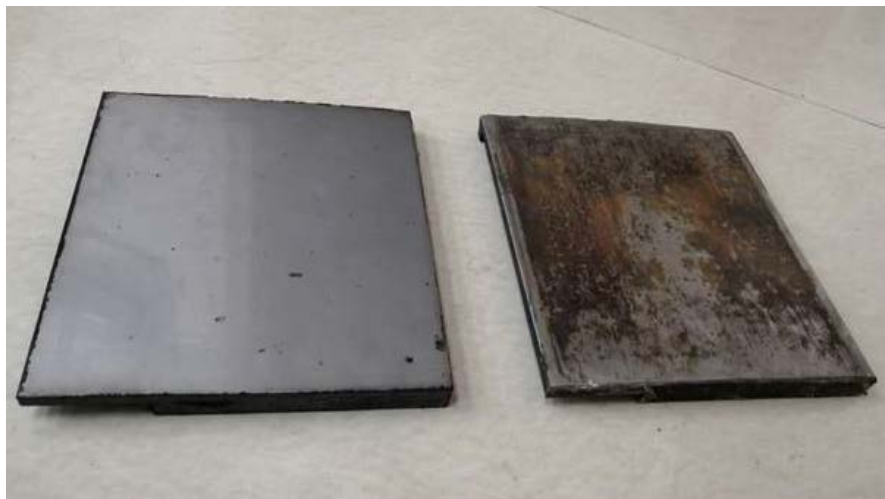
Figure 3. Steel plate without rust and with rust.

The steel plate in the composite plate is rusty because there is direct contact between the steel plate and the rail (see **Figure 3**). The rust is caused by the two materials that have different chemical properties. Zhang *et al.* [1] proposed three solutions for this issue, *i.e.*, 1) separating the two materials, 2) providing a material that can absorb the chemical interaction, or 3) developing a plate with composite materials [2]. In our study, we propose to use a zinc coating that can reduce the chemical interaction and increase the durability of the composite plate.

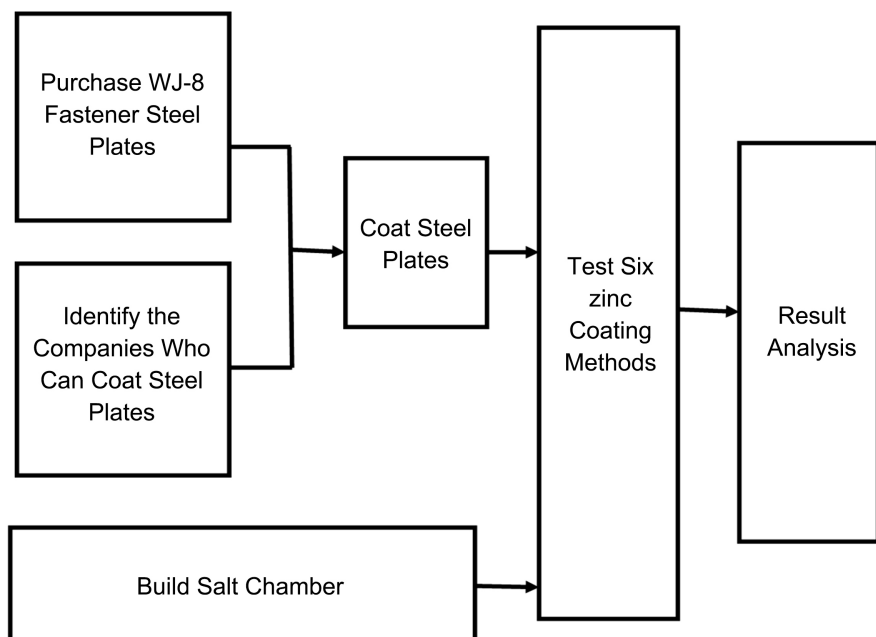
Figure 4. Methodology flow chart.

In this study, the investigation of the impact of zinc coating on steel plate corrosion started with purchasing the steel plate of WJ-8 Fastener that are popular in China. The companies in the U.S. that can coat the steel plate using different coating techniques were identified. After the identification, the purchased steel plates were shipped to these companies and they shipped the coated steel plate to UNLV for the testing. At the same time, a salt-fog chamber was built that can satisfy the need of testing multiple steel plates together. With the coated steel plates and the salt-fog chamber built, multiple steel plates were placed in the salt-fog chamber by following ASTM procedure. After the test, the steel plates were taken out of the chamber and their rusty conditions were reviewed for evaluation. The rusty conditions were analyzed based on measuring the size of rusty on the steel plates. This methodology is presented in **Figure 4**.

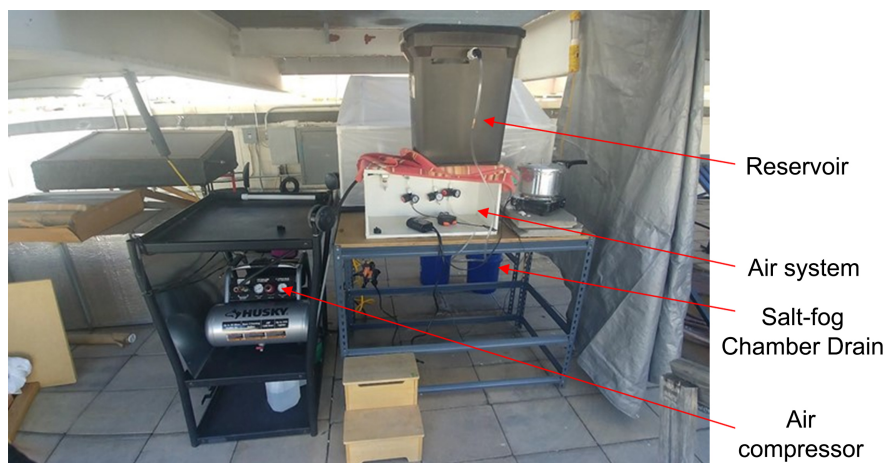
Figure 5. The salt-fog chamber.

and operated for a period of 915 hours to maximize the exposure time of the samples to the allowed time period of senior design. The resulting final constructed design is shown in **Figure 5**. The salt-fog chamber is composed of two systems, *i.e.*, a salt-water solution system and an air system. Both systems are housed on an industrial strength 4' × 5' shelving structure table.

The shelving structure provides support to hold all equipment along with external weather environments. The size of the structure allows space for the reservoir on the pedestal, which contains all small equipment and air controls, the heat source, and the environment chamber, the size of which is 3' × 4' to allow space for the sample support structures. The only exception is the air compressor, which is housed in an external rack system such that, in the case of failure during continuous operation, the rest of the system is isolated and not affected.

The solution system was constructed such that solutions flow by means of gravitation and head pressure from a high point to a low point. This allows the flow to be maintained without the use of a pump that would be corroded by the salt-water solution. The solution system is composed of a 16-gallon reservoir on an 18" high pedestal box as the high point that holds the premade 5% by weight salt-water solution. The solution flows from the reservoir and goes through an isolation ball valve at the base of the reservoir to an intermediary container. The container sits on a heat plate where the solution is heated to 100°F. The heat plate is placed on 4-inch cement tiles to isolate the heat from the rest of the support structure and to provide additional height to promote flow.

The heat plate is controlled with a temperature probe in the hot water flow pipe with the temperature controller housed in the pedestal box. The temperature controller applies an on/off signal to the heat plate to operate around the setpoint of 100°F. From the intermediary container, the solution flows to the reservoir of the spray apparatus with an isolation ball valve located at the center of the environmental chamber. The reservoir of the spray apparatus is composed of a 4" × 4" plexiglass box sealed water tight with a cap for access on each of the Cardinal faces; one face has the supply with isolation valve, the next has the

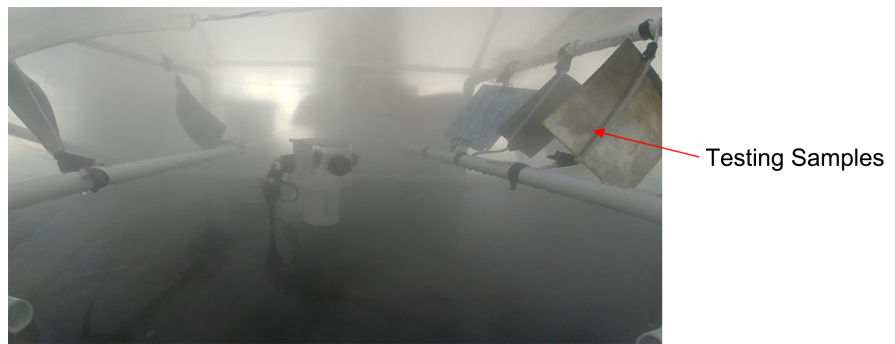
Figure 6. Salt-fog chamber.

spray nozzle, an extra for an additional spray nozzle, and the last to allow for access to the inside the box and a means to vent air from the box. Then, the solution is pulled from the spray apparatus reservoir by a venturi effect nozzle which creates a mist with compressed air that fills the environment chamber. The mist in the environment settles on the samples that are being tested, and these samples are oriented at 30° from vertical which allows the solution to interact and allows the samples run off. The samples are individually supported with tie wraps that are resistant to the solution secured to the PVC stands. The solution that interacts with the samples runs off and settles in a drain pad that makes up the bottom of the environment chamber; additional misted solution that does not interact with the samples collects into the drain pan. **Figure 6** shows the internal environment system, including the spray tower with the spray valve, samples and support structures, and drain pan with drain ports.

The solution that collects in the drain pan goes to waste through a primary or secondary drain in the pan. The primary drain is located at one corner of the pan, and the secondary drain is located near the spray tower opposite the corner of the primary drain. Both drains connect to a main drain pipe constructed of 1/4" Chlorinated Polyvinyl Chloride (CPVC) that runs to a waste bin which is emptied manually to an appropriate drain receptacle. The air system is composed of an air compressor which supplies air through a ball valve to the system at 21 psi. From the air compressor, the air runs through an air filter into a pipe header within the support pedestal. Each branch line from the header is controlled with an independent pressure regulator to ensure flow and pressure are only as required and controlled. The primary branch from the header runs through a pressure regulator within the support pedestal set at 20 psi to a spray valve mounted on the spray apparatus reservoir. The spray valve utilizes air pressure to apply a venturi effect across a nozzle pulling solution from the chamber and creates a mist. The rest of the compressed air in the header runs through a pressure regulator within the support pedestal operating at 1 psi to the solution reservoir where the compressed air runs through a pipe with puncture points allowing compressed air to bubble and provide mixing to the reservoir to ensure the salt in the solution does not separate without mechanical components which would be at risk of corrosion and contamination of the reservoir. A check

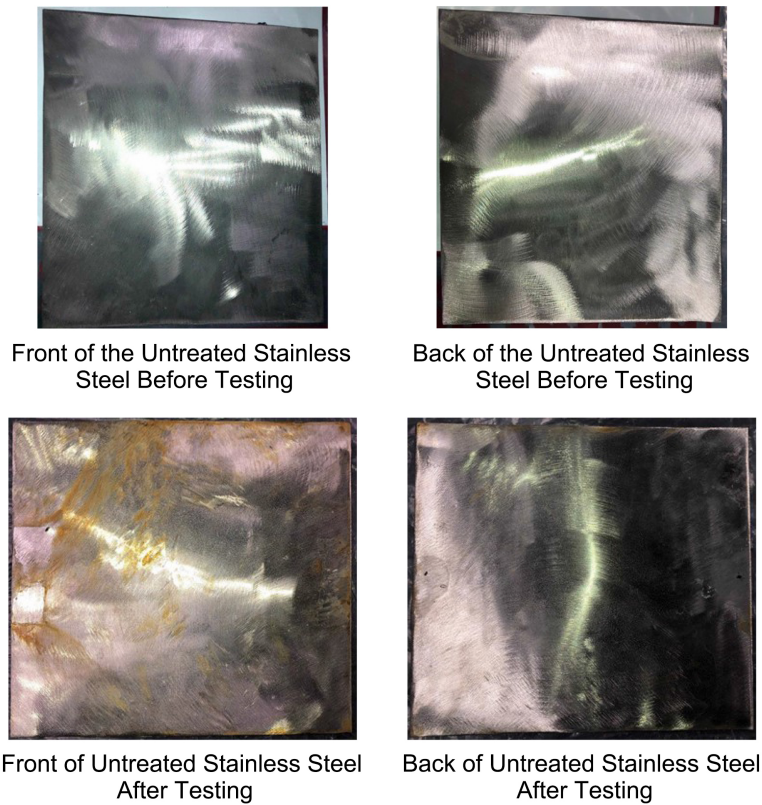
Figure 7. Front and back of untreated stainless steel plates before and after testing.

It can be seen from **Figure 7** that the standard stainless steel plate showed the most prevalent red rust corrosion. The back of the plate showed that almost 20% of the surface area was covered with rust, and, while the front fared better, there was still corrosion around the edges. **Figure 8** indicates that the ArmorGalv coated plate had red rust on about 5% of its surface area on the front and the back had red rust on about 2.5% of its surface area. **Figure 9** shows that the Greenkote coated plate with ELU Passivation performed the best with <1% of its surface area having red rust. There was no visible rust on the front, and only about 1% of the back surface area had red rust. **Figure 10** shows that the Greenkote coated plate with the phosphate layer had red rust on about 1% of its front surface area, and it had red rust on about 2% of its back surface area. **Figure 11** illustrates that the galvanized plates not only had the roughest coating layer, which would imply a higher coefficient of friction, but it also resulted in the most corrosion, which further increased the roughness of the layer. The white rust could be removed by vinegar.

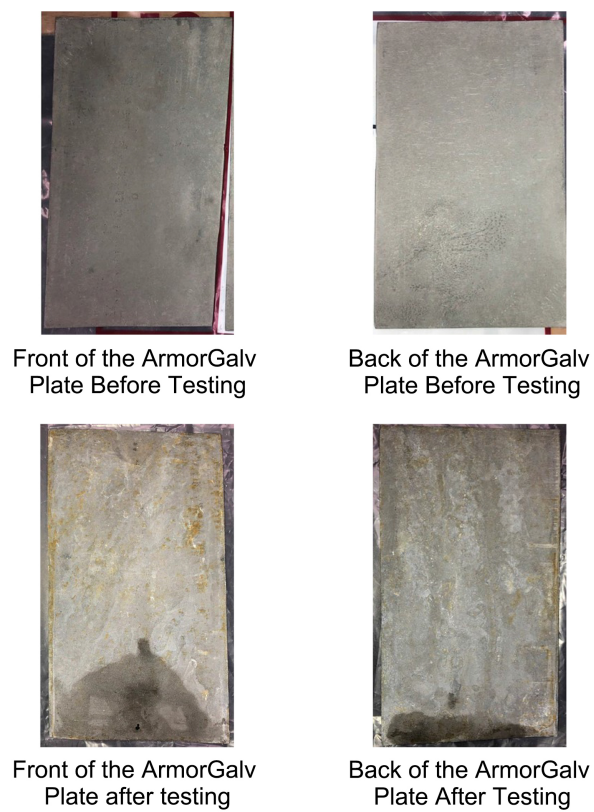
Figure 8. Front and back of the ArmorGaly treated and untreated steel plate.

with a smooth, strong finish, but it netted more surface area rust than the Greenkote with passivation. The ArmorGalv sample had more surface area with rust than the Greenkote samples. This may not be a weakness in the ArmorGalv process; rather it is more likely the result of this particular sample missing the added protection of a colored coating. The ArmorGalv formula stresses the added corrosion protection benefits of introducing transitional metal oxides into the drum both to add color and to improve the performance of the coating.

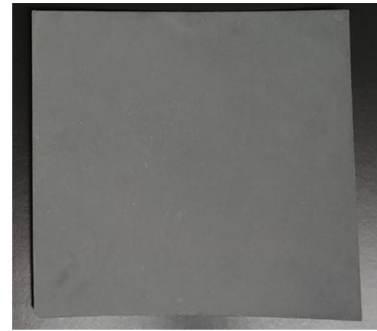
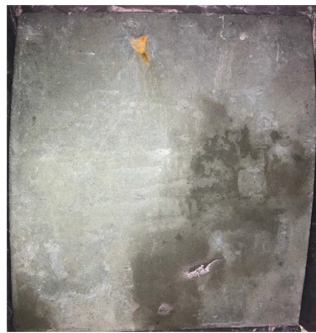
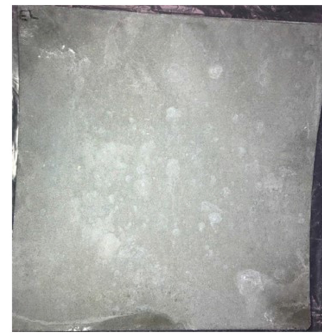
Front of the Greenkote (ELU)
Plate Before Testing

Back of the Greenkote (ELU)
Plate Before Testing

Front of the Greenkote (ELU)
Plate After Testing

Back of the Greenkote (ELU)
Plate After Testing

Figure 9. The fronts and backs of the Greenkote treated and untreated steel plates.

For railway applications, the best suited method for corrosion prevention is the Greenkote with passivation. This method provided the best overall protection against corrosion, and it has a smooth, strong finish. The galvanized option had the roughest coating layer, and it was the most reactive to the salt water solution. This makes it non-ideal for the dynamic rail environment because the increased friction of the plate could damage the supports, especially during extreme temperature situations that would cause the rail to expand or contract. Greenkote with Phosphate and ArmorGalv also provided increased corrosion prevention

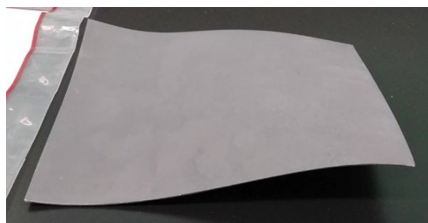
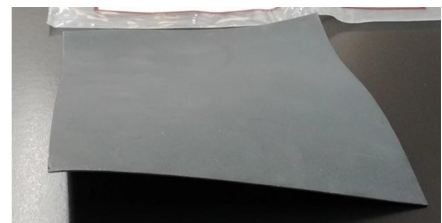
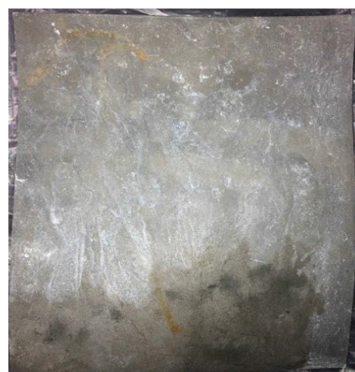
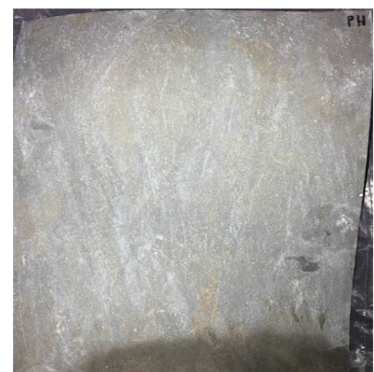
Front of Greenkote (Phosphate)
Plate Before Testing

Back of Greenkote (Phosphate)
Plate Before Testing

Front of Greenkote (Phosphate)
Plate After Testing

Back of Greenkote (Phosphate)
Plate After Testing

Figure 10. The fronts and backs of the Greenkote (phosphate) treated and untreated steel plates.

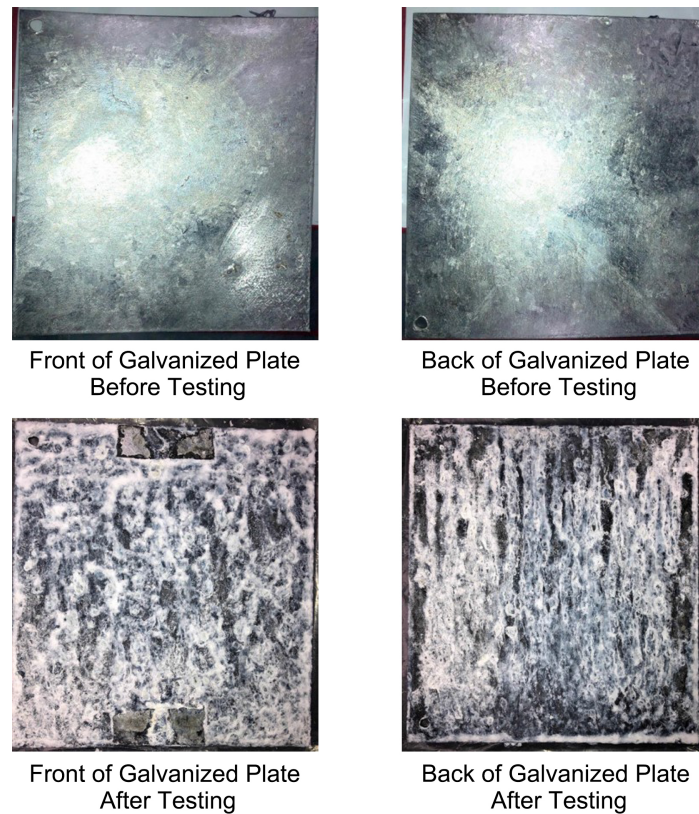
Figure 11. The front and back of the galvanized treated and untreated steel plate.
