The Environment Deterioration Impact on the Granite Rock Art Relief of Seti I in Aswan, Egypt

Ezz A. Orabi^{1,2}

¹Conservation Department, Faculty of Archeology, Aswan University, Aswan, Egypt

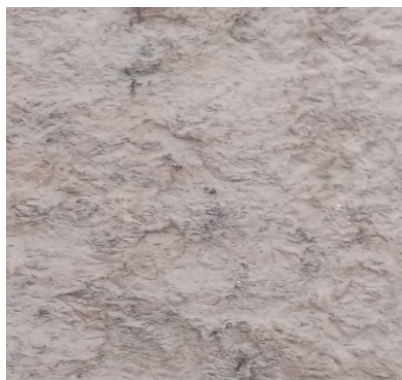
Figure 4. Corrosion, loss, gaps, and Peel off the text hieroglyphic.

- 1) The most important step, before starting the restoration and conservation work, a fence must be made surrounding the relief to protect it and prevent it from infringement.
- 2) Full registration of the relief using the modern devices and methods.
- 3) More archaeological study of the relief.
- 4) Consolidation of loose and separated parts of the relief.
- 5) The relief should be cleaned from soot and foreign things using mechanical cleaning with brushes of various sizes [33], also some wooden and metal brushes can be used to remove some hard surface plankton that are strongly adhesive to the surface, after being wetted with water mixed with ethyl alcohol [34].
- 6) Filling the cracks.

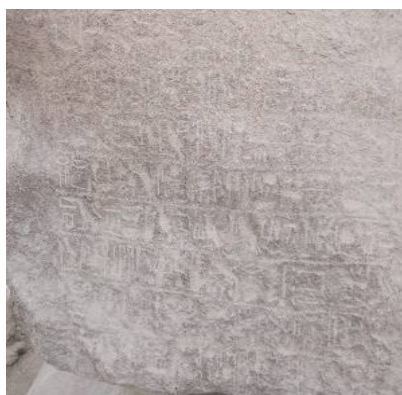
Figure 5. Corrosion, loss, gaps, and Peel off the text hieroglyphic.

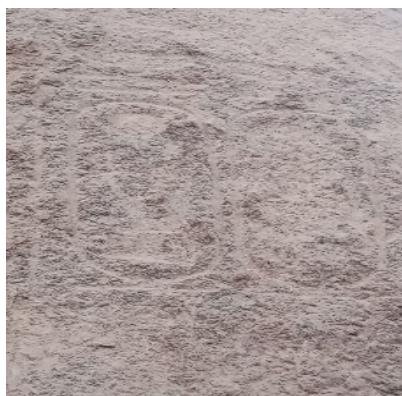
Figure 6. Name of the king suffers from Exfoliation and fragmentation.

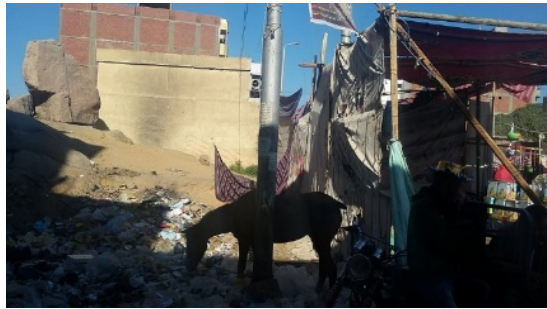
Figure 8. Animals and rubbish beside relief.

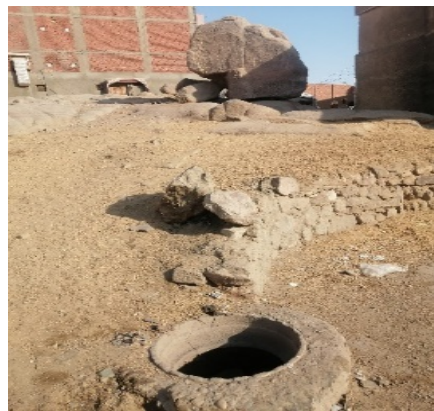
Figure 10. A sewage sinks beside relief.

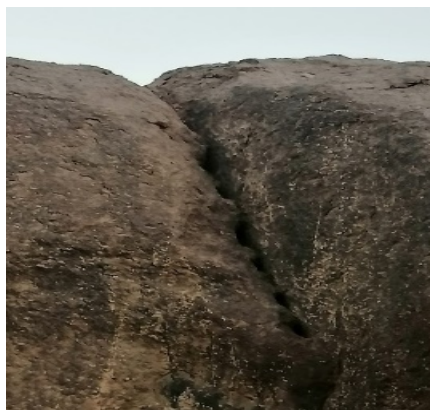
Figure 12. Calcifications covering relief.

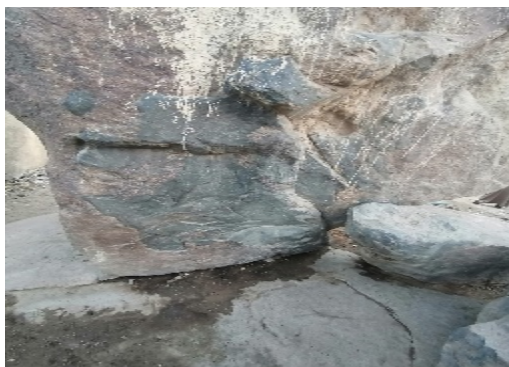
Figure 13. Waste on relief and pouring water.

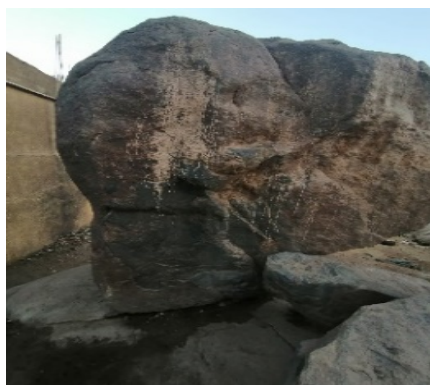
Figure 14. Effects of burning backgrounds.

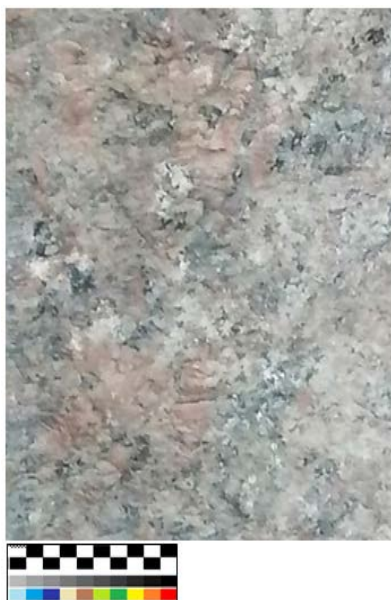
Through field Observations and investigation with the USB microscope, weakness, fragility, fragmentation and peeling of the surface layer were observed, as well as the occurrence of deep cracks (Figure 15, Figure 16).

Figure 15. Erosion and peeling of the surface layers.

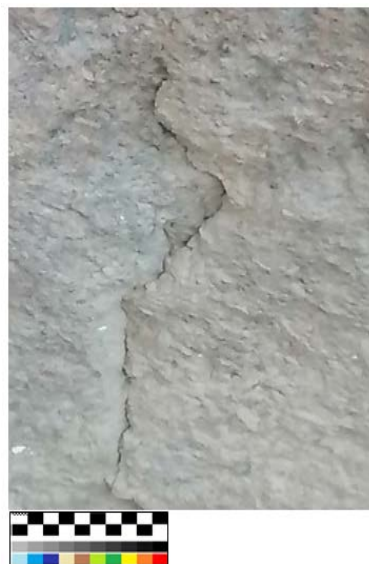
Figure 16. Weakness, fragility, fragmentation and cracks.

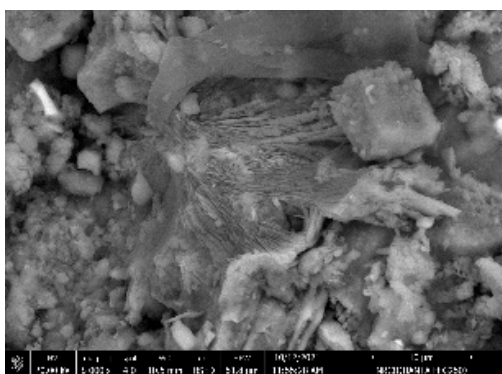
3) The third sample was examined under a scanning electron microscope: The sample suffers from cracks, separations, grains disintegration and incoherence at a magnification of 4000, as in **Figure 29**, in the magnification of 8000 shows the sample suffers from Diffusion of gaps, cracks, deformation of grains, mineral decomposition and disintegration, as in **Figure 30**.

Figure 30. Deformation and disintegration 8000×.

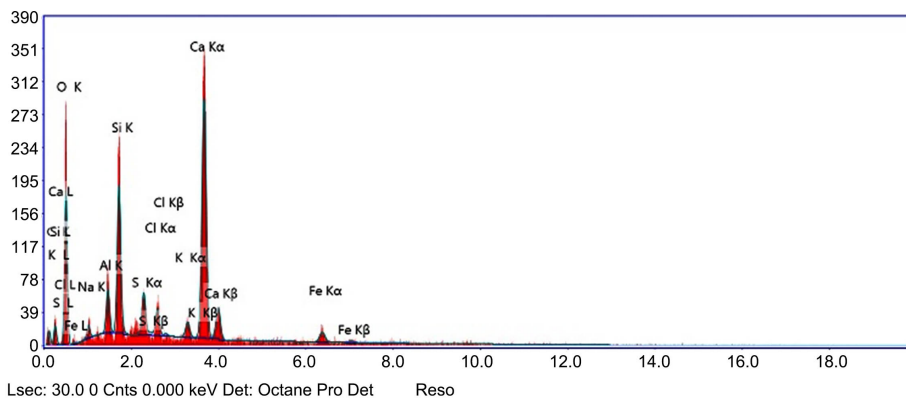
1) The first sample was analyzed by a scanning electron microscope equipped with an EDX unit, and the results of the analysis were as in **Figure 31**. It proved the presence of potassium oxide, sodium oxide, aluminum oxide, silicon dioxide, calcium oxide, iron oxide, sulfur dioxide and chlorine.

Figure 31. Potassium oxide, sodium oxide, aluminum oxide, silicon dioxide, calcium oxide, iron oxide, sulfur dioxide and chlorine.

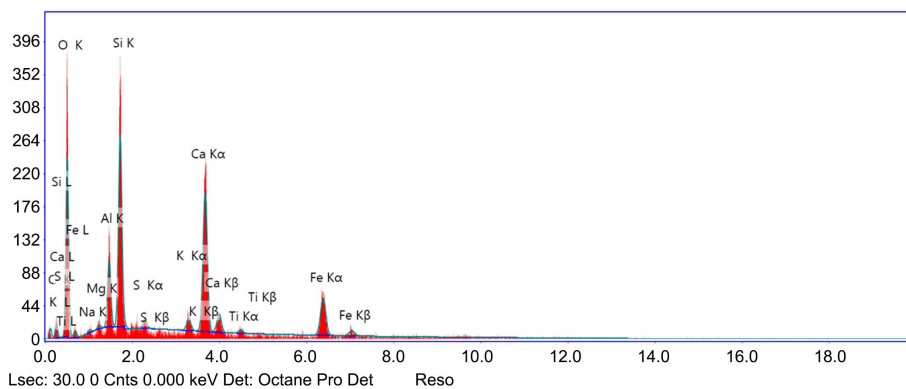
2) The second sample was analyzed by a scanning electron microscope equipped with an EDX unit, and the results of the analysis were as in **Figure 32**, it proved the presence of sodium oxide, magnesium oxide, aluminum oxide, silicon dio-

xide, potassium oxide, calcium oxide, titanium oxide, sulfur dioxide and iron oxide.

Figure 32. Sodium oxide, magnesium oxide, aluminum oxide, silicon dioxide, potassium oxide, calcium oxide, titanium oxide, sulfur dioxide and iron oxide.

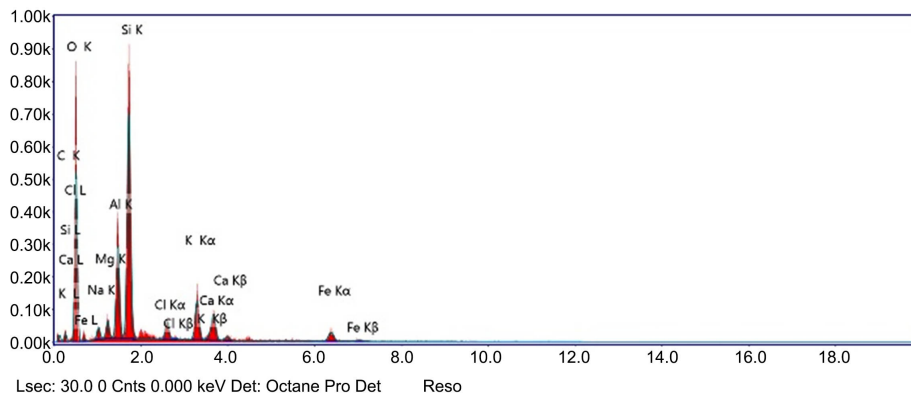
3) The third sample was analyzed by a scanning electron microscope equipped with an EDX unit, and the results of the analysis were as in **Figure 33**, it proved the presence of sodium oxide, magnesium oxide, aluminum oxide, silicon dioxide, potassium oxide, calcium oxide, chlorine and iron oxide.

Figure 33. Sodium oxide, magnesium oxide, aluminum oxide, silicon dioxide, potassium oxide, calcium oxide, chlorine and iron oxide.
