Geotechnical and Mineralogical Properties of the Recently Exposed Black Mud Deposits along the Northeastern Shore of the Dead Sea

Waed Abu Alhaj¹, Elias Salameh²

How to cite this paper: Alhaj, W.A. and Salameh, E. (2020) Geotechnical and Mineralogical Properties of the Recently Exposed Black Mud Deposits along the Northeastern Shore of the Dead Sea. *Open Journal of Geology*, 10, 943-956.

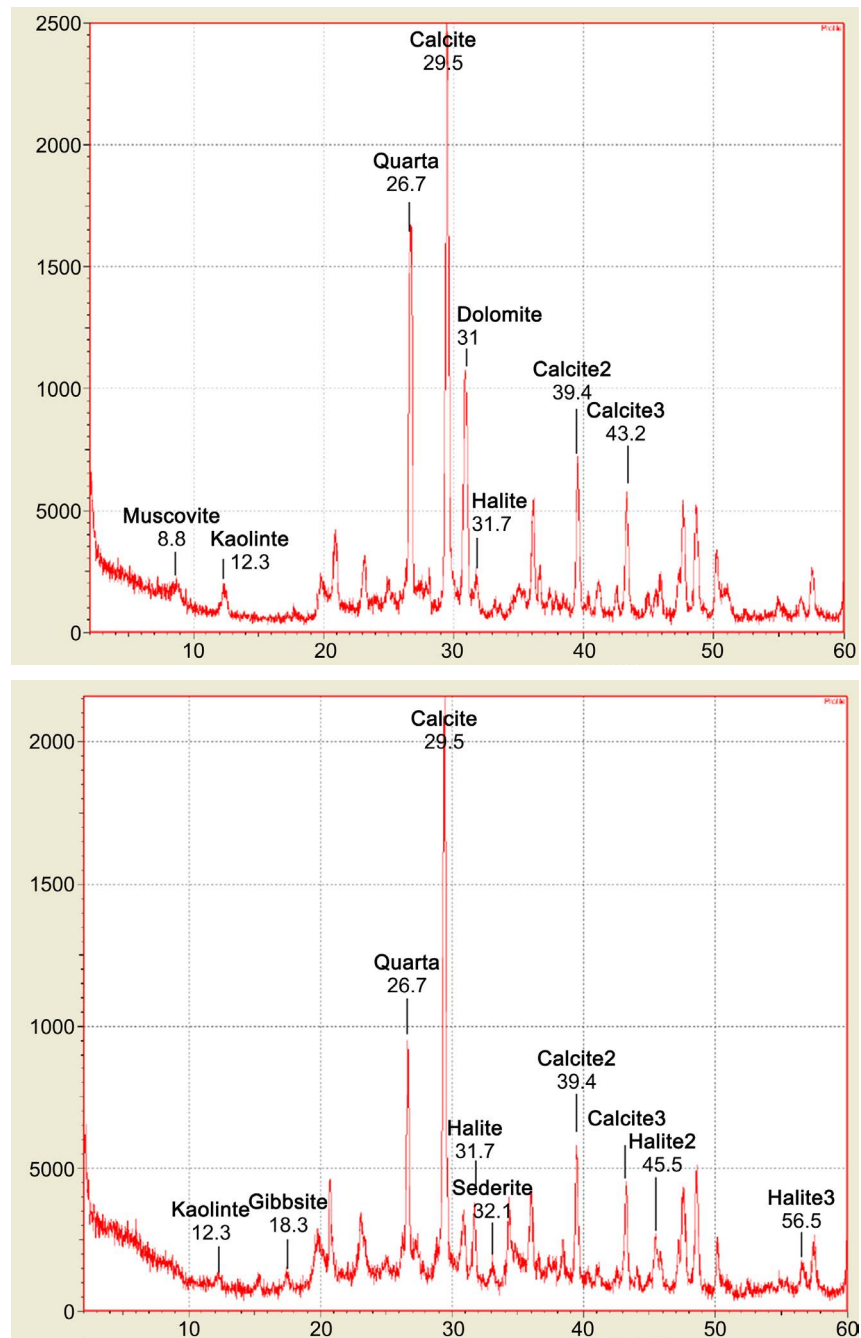
Figure 2. XRD of a black mud sample showing its mineral composition.

X-Ray Diffraction (XRD) was carried out on two samples prepared by color separation; grey and black to analyze the mineral content of the black mud. The results are presented in **Figure 2** and **Table 1**, which shows that the gray content is composed of aragonite, calcite, dolomite, gypsum, halite, halite potassium, illite, kaolinite, muscovite and quartz and does not contain anorthoclase and montmorillonite, whereas the black content is composed of aragonite, calcite, dolomite, gypsum, kaolinite, muscovite, montmorillonite and quartz and does not contain dolomite, halite, halite potassium and illite. X-Ray Diffraction (XRD) results (**Figure 2**) show that the main minerals in the samples are: Calcite, quartz, dolomite, muscovite, kaolinite, illite, smectite, halite and pyrite.

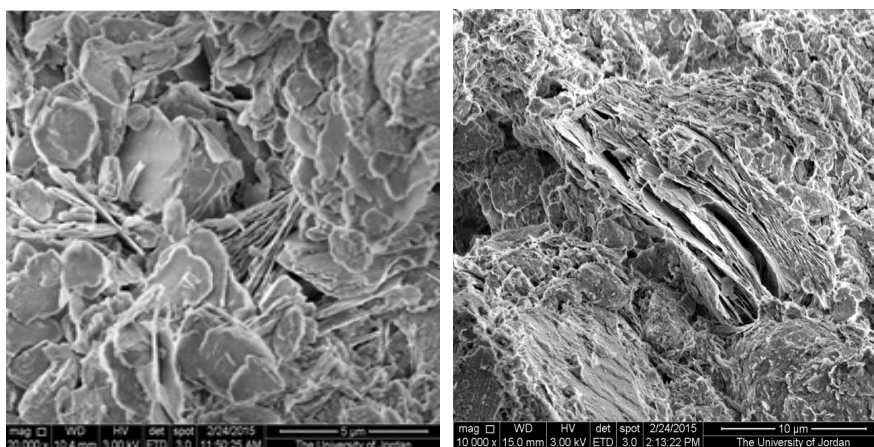
**Figure 3.** SEM image of kaolinite in the Dead Sea mud samples.

Mud samples were scanned for their contents on clay minerals and to obtain microscopic SEM images of these clays. **Figure 3** illustrates, as an example, the images of the studied mud samples showing kaolinite and the SEM analytical metal results.

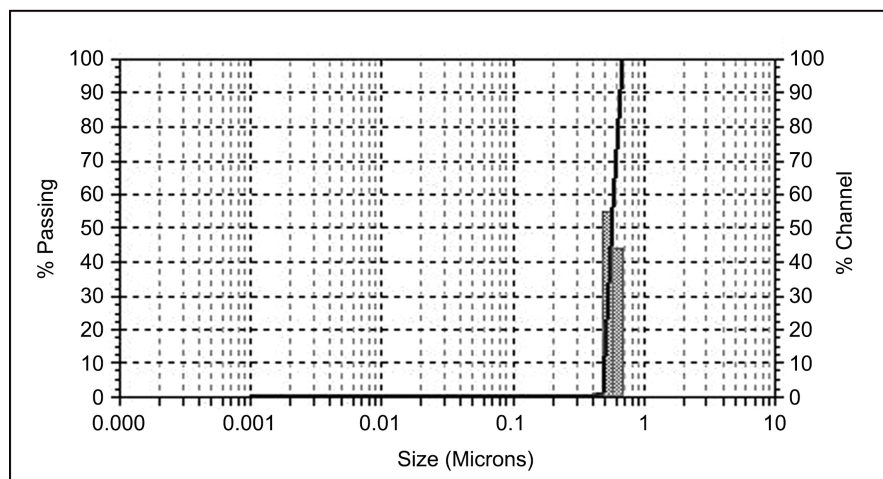
Zeta Potential	
Mobility (u/s/V/cm):	0.8100
Zeta Potential (mv):	10.3600
Charge (fC):	0.04600
Conductivity (uS/cm):	691

Figure 4. Particle size analysis test results of the Dead Sea mud samples (Table 3) from [5].

Particle size analysis tests show the following results (Figure 4):

- The Zeta Potential (MV) of the samples plotted in the range of incipient instability.
- All the samples lie in the clay range of $0.98 \mu\text{m}$ - $3.9 \mu\text{m}$ and are very well-sorted according to their standard deviation of 0.09 [11].
- According to the values of skewness (Table 3), the Dead Sea black muds are found to be near symmetrical; +0.1 to -0.1 [11].

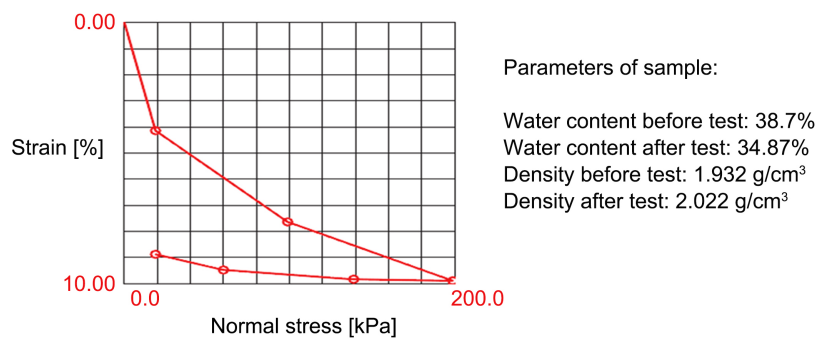
No.	Normal stress [kPa]	Normal stress change [kPa]	Strain per stage [%]	Strain cumulativ [%]	Compression modulus [MPa]
1	19	19	4.15	4.15	0.458
2	99	80	3.50	7.65	2.191
3	199	100	2.25	9.90	4.104
4	139	-59	-0.05	9.85	
5	60	-78	-0.35	9.50	
6	19	-40	-0.60	8.90

Figure 5. Stress-strain diagram for the Dead Sea mud.

The stress-strain tests show that the mud has not been exposed to pressure before and thence it has no pre-history of loading. The recovery after stress application was very minor as can be seen from the hysteresis (Figure 5).

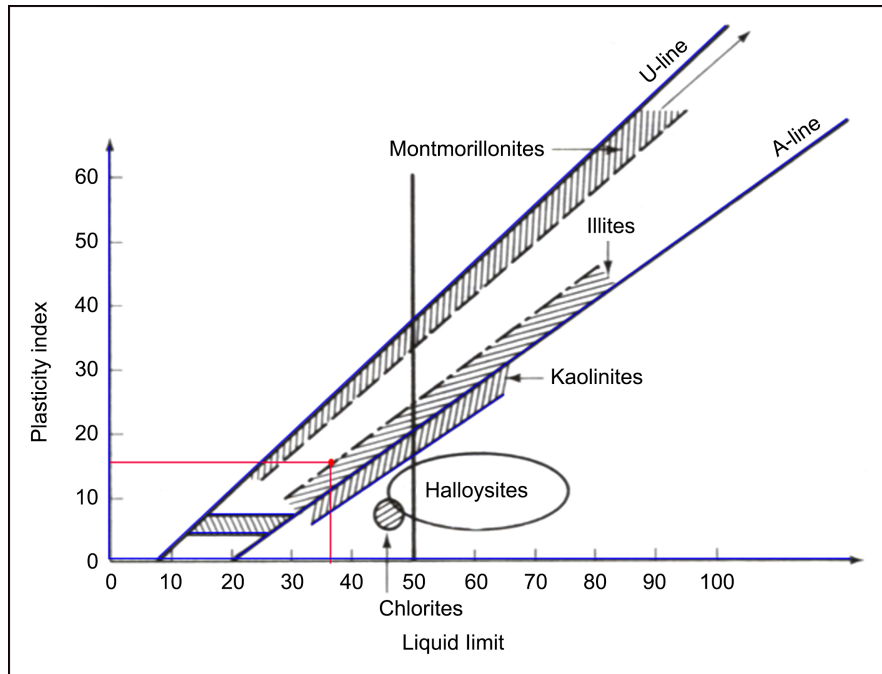
Figure 6. Liquid and Plastic Limits plotted to determine the types of clays in the samples. The Dead Sea mud plots here between A and U lines, in the illite range.

Liquid and Plastic Limit tests were carried out on the Dead Sea mud samples. The results are given in **Figure 6**, and show that the mud plots as medium plastic clay of illite composition and illite engineering properties. Also in Atterberg limits diagram DIN18122-1 [7], which correlates the Plasticity Limit (PI) with the Liquid Limit LL the mud plots as medium plastic clay TM [5].

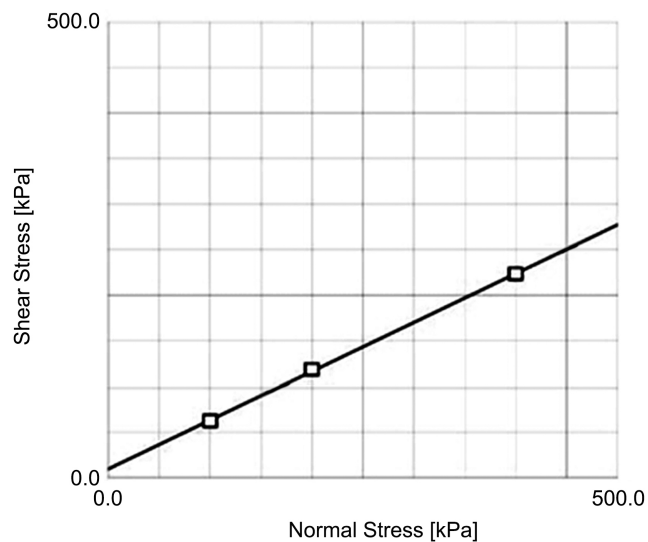
Shear Parameters

Froction Angle	28.15 [°]
Cohesion	9.33 [kN/m ²]
Corrlation	1.00

Nr.	Normal Stress [kPa]	Shear Strength [kPa]	Shear Path at Faiture [mm]
1	400.0	222.79	6.34
2	200.0	118.02	6.37
3	100.0	61.71	4.37

Figure 7. Normal stress/shear stress diagram for the Dead Sea mud samples.

Shear strength analyses were carried out on the Dead Sea samples [12] (**Figure 7**). The results give an internal friction angle of 28.15° and a low cohesion of 9.33 kN/m².

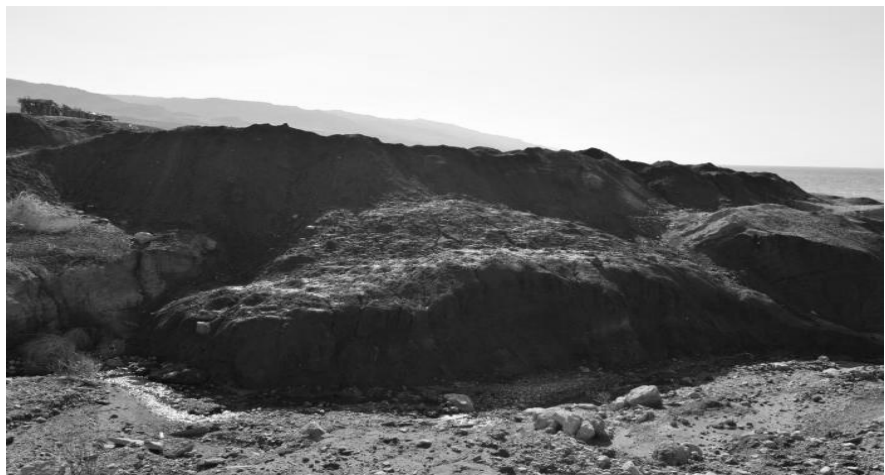
Figure 8. Front view of one of one of the landslides in the study area.

Along all wadis incised into the mud formation landslides and land collapses are very common (Figure 8 and Figure 9).

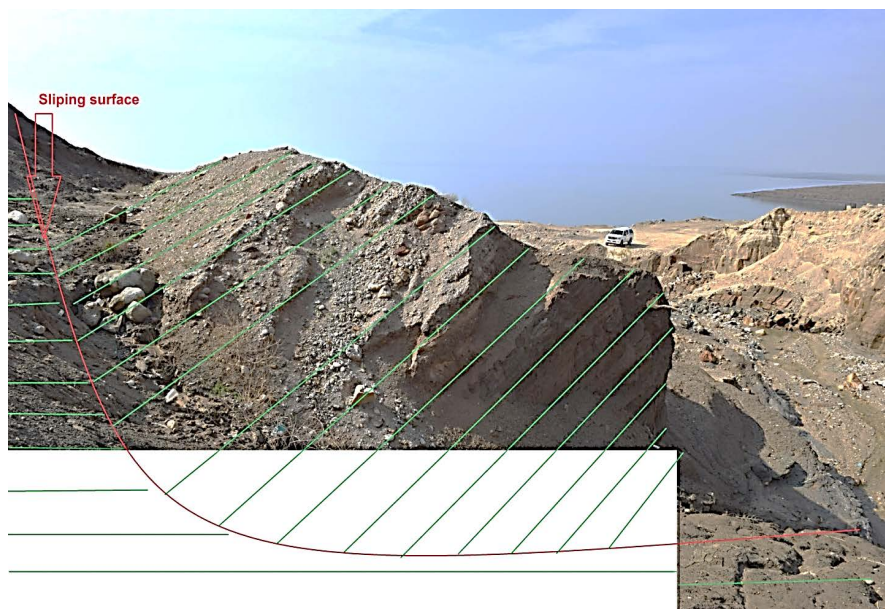
Figure 9. Side view of one of the landslides in the study area.

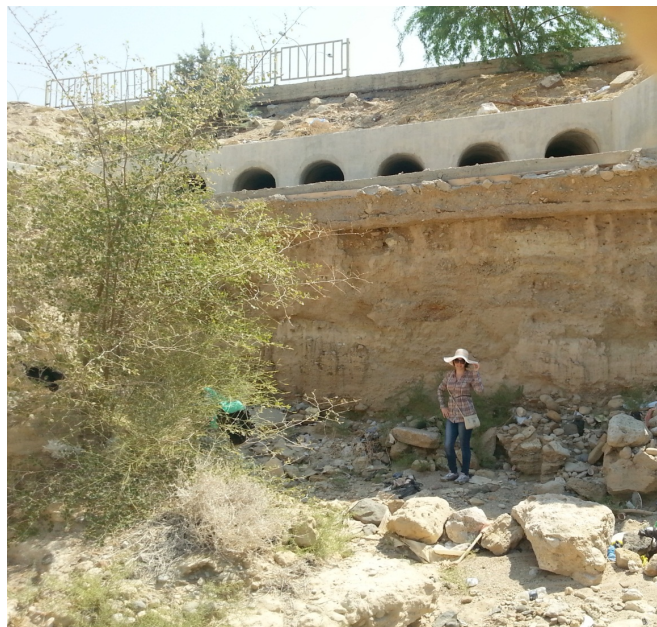
Figure 10. Head-ward erosion along one of the wadis in the study area. It has reached the main road built along the Dead Sea, which shore lies now at around 600m west of that main road. The height (thickness) of eroded materials is around 5 m and erosion has started to excavate the rocks underlying the main road.

At present the DS level drops more than one meter per year with a total drop from the 1960s until now of about 35 m. This drop has led to dramatic changes and destruction in the surrounding geomorphic system, especially in the wetland environments which has and is endangering the natural environment and the infrastructure. Severe erosion and undercutting is affecting wadi channels, roads, culverts and construction as can be seen from **Figure 10** and **Figure 11**.

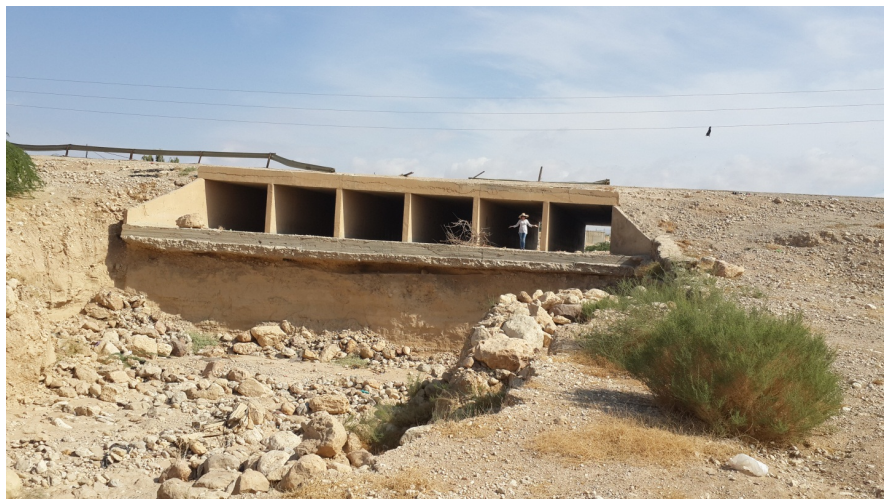
Figure 11. Severe undercutting and erosion affecting the foundation of the main Dead Sea road culvert, by now threatened to collapse.

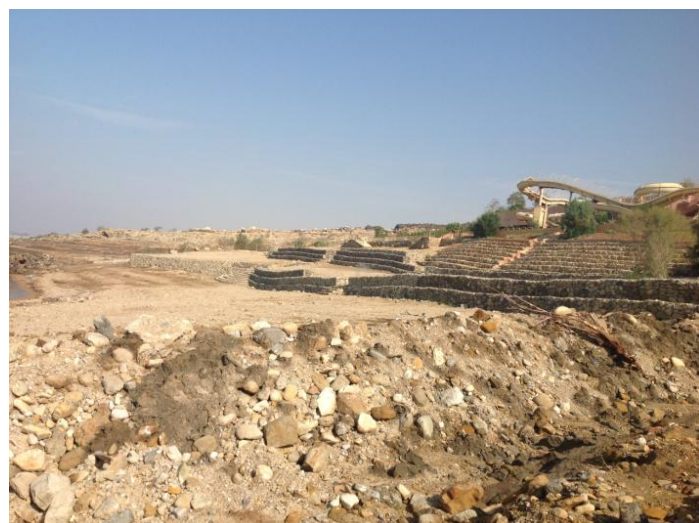
Figure 12. Gabion walls and terraces as a solution to the erosion problem in the newly formed terraces' areas which have been evacuated of Dead Sea water.

- Changing the geometry of the slope in some areas
- Providing adequate drainage
- Constructing retaining walls with proper drainage
- Construction of reinforced concrete walls
- Building of gabion walls and terraces. **Figure 12** terraces and gabions constructed by one of the hotels to alleviate the degradation processes and to stop erosion.
