Environmental Factors, Constraints and Risks of Rainwater Runoff in Commune II of Maradi (Republic of Niger)

How to cite this paper: Babaye, M.S.A., Hantchi, K.D., Issaka, A.M., Manzo, O.L., Labo, Y.S., Sannoussi, C.L. and Konaté, M. (2023) Environmental Factors, Constraints and Risks of Rainwater Runoff in Commune II of Maradi (Republic of Niger). *Open Journal of Modern Hydrology*, 13, 211-228.

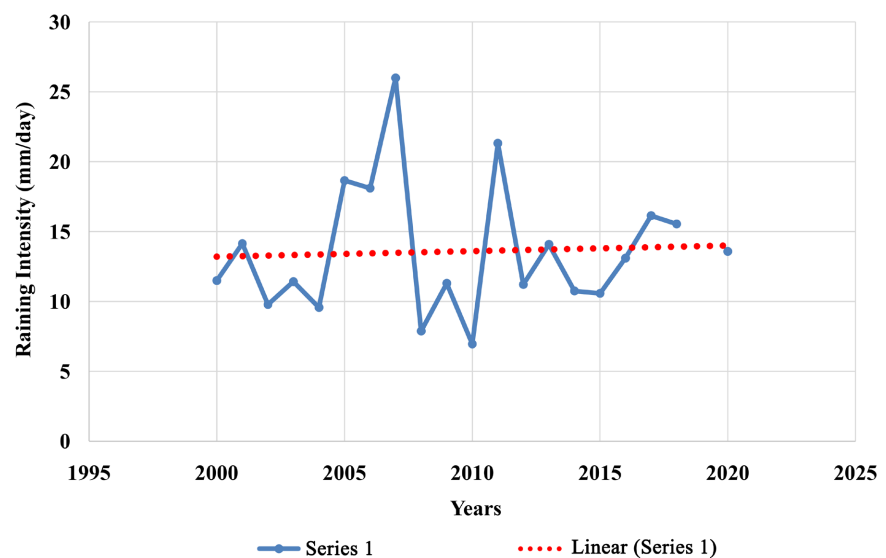
Figure 4. Interannual evolution (series in blue) of rainfall intensity (annual cumulative rainfall/number of rainy days per year) in the city of Maradi (2000-2020). The line in red is the linear regression line of the series in blue.

Figure 4 illustrates the evolution of the intensity rate of annual rainfall from 2000 to 2020. It appears that some years have low rainfall accumulations with a large number of rainy days, while other years record high annual accumulations with a reduced number of rainy days. However, most years of this rainfall series (dotted red line, **Figure 4**) show a real positive evolution in the intensity of rainfall in the city of Maradi.

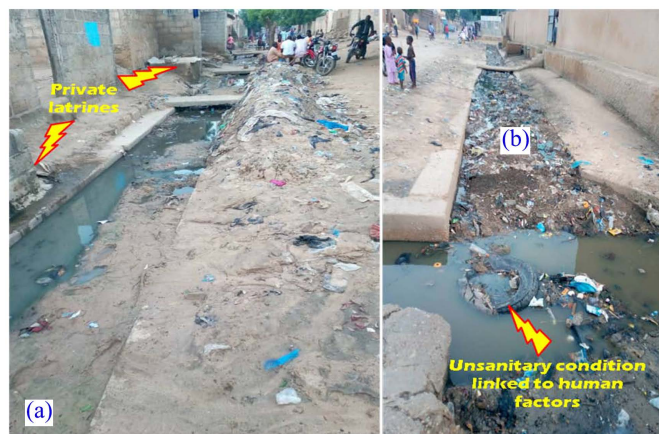
Figure 5. Status of rainwater harvesting facilities in the municipality II, according to the reality of the ground. (a) Old gutter connected to private latrines. (b) Old gutter considered as a receptacle for all types of waste.

From field work (Figure 5), it appears that runoff water carries all kinds of domestic waste and sand that it encounters on its way and brings it into the drainage channels. These domestic wastes and other materials fill the gutters and block the flow of water. Once blocked, all these waters will run down the streets in search of an outlet. Although this issue may seem of little importance to decision-makers, it is nevertheless what ensures the effectiveness of the rainwater drainage system in Commune II of the city of Maradi. Developments in urban areas have effects on stormwater runoff. Tarred roads and cobblestones do not let water infiltrate. This impermeability therefore allows runoff or stagnation in the event of rain. In addition to the fact that the flooding of the roads is linked to the total impermeability of these, the reality on the ground shows that these roads are not connected to a rainwater drainage network. This results in establishing a very difficult traffic system in the city (Figure 10).

And, due to a chronic lack of upkeep and maintenance, these drainage works are and remain in very poor condition. Consequently, this insufficient network is filled by various solid and liquid wastes of anthropogenic origin (Figure 5), and by the natural development of flora and plant species (Figure 7). A cleaning takes place every year before and after the rainy season, but the combined effect of the wind and the runoff ends up bringing back this waste. This health problem, due to political laxity and various anthropogenic actions, is related by the research results of Laminou Manzo *et al.* [4] and Saadou [5] like those of Saidou and Aminou [28], who pointed out that these networks are the preferred places for the discharge of domestic and industrial wastewater, garbage dumps and faecal sludge, and sometimes even defecation [6]. The same observation was made by Amadou Malam *et al.* [29] who point out that the inhabitants of the city of Zinder transform the gutters and the lowlands into false septic tanks, wild dumps and sewage outfalls. Floods are therefore linked to natural causes (flow of the river which can come out of its bed) and to direct anthropogenic causes. These anthropogenic causes correspond in particular to the impermeability of urban development (tar, cobblestones, laterites), and to the compaction of soils which accentuates runoff. This increase in runoff is the direct consequence of the degradation not only of urban infrastructure and soil, but of the resurgence of waste and the clogging of sandy deposits [3] [14] [30].

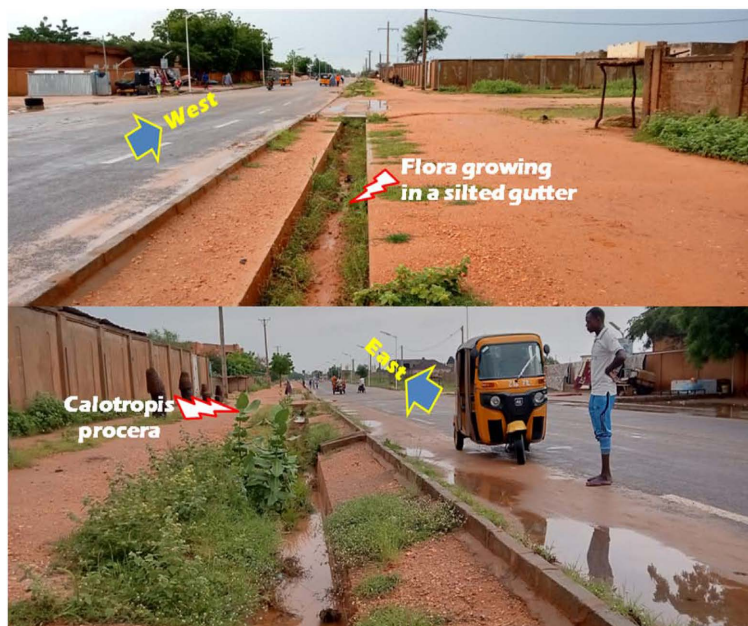
Figure 7. New gutter in the Ali Dan Sofo District subject to silting and the establishment of diverse flora and vegetation during the rainy season. Source: field August 2023.

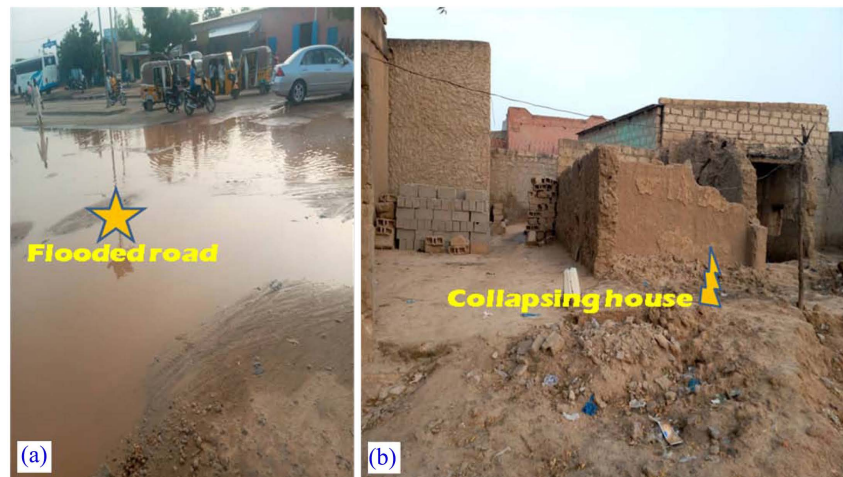
Figure 8. Views of a flooded road (a) and a collapsing habitat (b).

Urban runoff causes flooding. These floods, which are sometimes significant, are the immediate consequence (Figure 8) of roads that are submerged and/or clogged with rainwater (60% of respondents) and the collapse of habitats (73.07% of respondents). Figure 9 shows that road degradation and soil erosion expose crumbling headlands to land clearing, frequent landslides and settlements, as well as damaged roads and canals.

Table 2 summarizes the rate of mention of the various reasons and causes of collapses (**Figure 8(b)**) in Commune II. For 78.83% of respondents, these collapses are due to the intensity of the rain (rainwater runoff) and the lack of adequate planning. Among the other types of causes of collapses, the investigation shows two causal factors, namely: the typology of the soil and the nature of the construction materials (cement or mud). Thus, 69.23% of respondents confirm that the constructions are made of mud or mudbank (**Table 2**), just as field observations have shown that the collapsed houses are made of mud (**Figure 8(b)**). Similarly, clay soils are dominant in the study site with 50% as a percentage, then sandy soils with 48.08% and finally sandy-clayey soils with 1.92% (**Table 2**). Clay is not permeable, it is a type of soil that stores water. This stored water makes the clay sensitive and therefore exposed to the risk of movement. Clay swells on contact with water and disperses easily. And, it is this dispersion that makes the clay fragile.

With an exploitable area of 2775.5 ha spread over approximately 12 km, the Goulbi valley has significant potential for irrigable land for the municipalities of Maradi (**Figure 2**). However, during the second decade of July and the first of August, it is normal that the heavy rainfall recorded in the sub-region caused the overflow of the Goulbi. Rainfed crops, which represent 80% of the total usable area in rainy season, were thus carried over damaged by such an overflow of the Goulbi. In fact, the Goulbi valley is not only used for the practice of rainfed crops, but market gardeners have opted for the intensification of both irrigated crops and arboriculture. According to the Rural Engineering of the city of Maradi, since the repetitive floods of 2018, market gardeners have encountered enormous difficulties, in particular the total loss of agricultural inputs and the lack or defect of irrigation means. Thus, 100 market garden wells, 150 agricultural boreholes and 100 motor pump units were damaged. On the other hand, it is losses of various infrastructures which are observed within the Commune II of Maradi. The Regional Directorate of Rural Engineering (DRGR) recorded the following results: an area of 480 ha flooded in Commune II, while 42 houses in this area collapsed (**Figure 8(b)**). During these floods, *circa* 1412 people were affected.

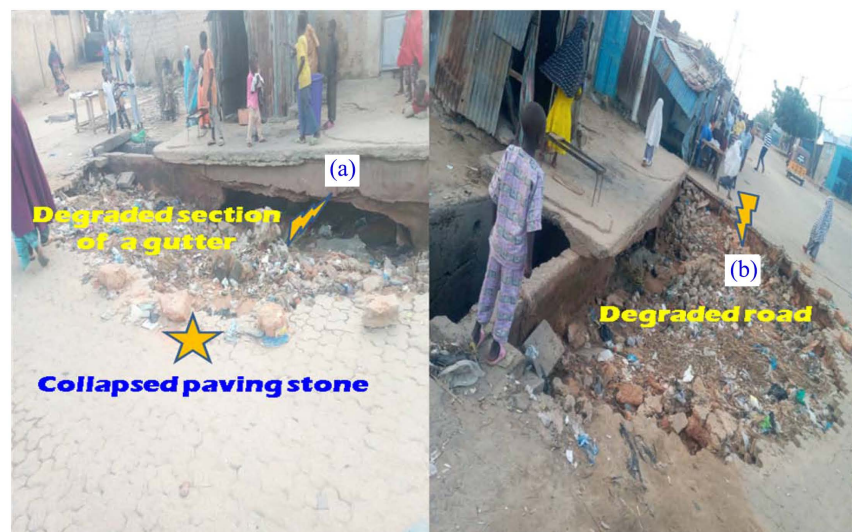
Figure 9. Views of a damaged canal (a) and a degraded road (b).

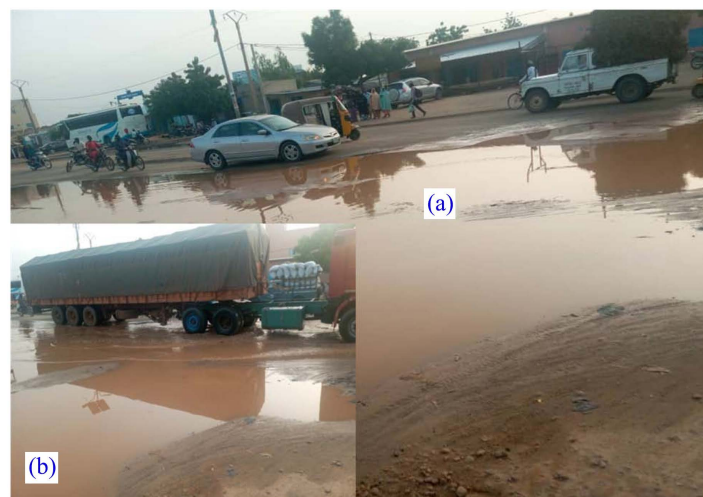
Figure 10. Illustration of a cases of difficult circulation ((a): of people and of cars; (b): heavy vehicle) after water stagnation following a rain event in the Municipality II.
