Why Does the Repaired Len Small Levee, Alexander County, Illinois, US Continue to Breach during Major Flooding Events?

Kenneth R. Olson¹, David R. Speidel²

How to cite this paper: Olson, K.R. and Speidel, D.R. (2020) Why Does the Repaired Len Small Levee, Alexander County, Illinois, US Continue to Breach during Major Flooding Events? *Open Journal of Soil Science*, 10, 16-43.

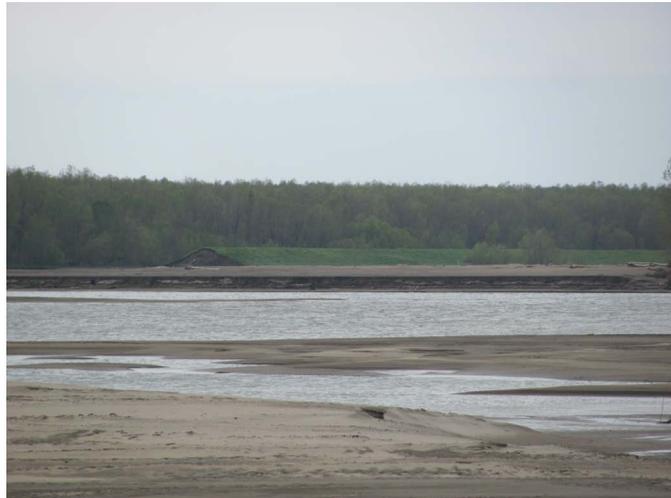
Figure 6. Len Small levee breach after the 2016 flood which was not repaired.

In 2019 the flooding resulted in 6 empty runaway barges (**Figure 10**) passing through the Len Small breach (**Figure 6**) and knocking down power lines, crossing a road and coming to rest on an irrigation system in a farmer's field. As noted in Olson and Morton [6] the Mississippi River is cutting 5.8 km channel across Dogtooth Bend and trying to cut off 24 km of the current Mississippi River navigation channel (between mile marker 33 and 15) (**Figure 3**). To date the barge company has been only able to remove 4 of the barges from the farmer fields. The other two still remained (**Figure 10**) in September of 2019. Previous testimony at the Mississippi River Commission public hearings by Drs. Olson and Morton and by Jeff Denny, the Alexander County highway engineer, and 3 year lobbying efforts by the Farm Bureau have failed to get the 2016 Len Small levee breach repaired as more and more Dogtooth Bend farmers are going out of business. However, the runaway barges which traveled through the rock pile, notch dike and Len Small breach indicate that the Mississippi River navigation channel has now been compromised.

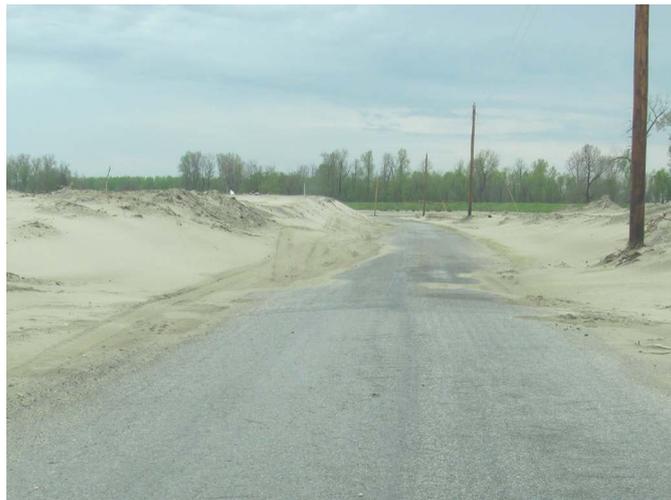
Figure 7. Sand dunes and roadway as a result of the 2016 flood which required graders to push back the sand overlying the road.

The receding floodwaters of the Mississippi River in January, 2016 left behind barren sand dunes (**Figure 7**) on southern Illinois farmland reminiscent of the windswept dunes of the movie *Lawrence of Arabia*. Large sand deposits up to 1.2 m deep (**Figure 7**) covered nearly 800 ha of farmland near Miller City, Illinois in the Dogtooth Bend peninsula [8]. Rainfall almost three times above average in November and December, 2015 over Missouri (Francois Mountains) set in motion record flooding. The Cape Girardeau river gauge exceeded the 1993 record at 14.9 m and led to the breaching of both the Commerce and the Len Small levee on January 2, 2016. The Thebes river gage also set a record; making these two main stem Mississippi River gages the only new flood records in 2016. Runoff water from the Ozark uplands (**Figure 4**) rapidly drained into the Headwaters diversion south of Cape Girardeau to confluence with the near-record Mississippi floodwaters flowing south of St. Louis. Constrained at the Thebes gap, the height of the Mississippi River rose as it pushed against the bedrock controlled banks (**Figure 2**). However, once past the gap, the river released its energy against the earthen levees of the Len Small, breaching and cutting deep crater lakes and gully fields on the farmland the levee was designed to protect. After the river breached the levee at mile marker 34, the fast-moving water scoured the landscape and then followed an old meander channel across the narrow neck of Dogtooth Bend peninsula and reconnected with the Mississippi River at mile marker 15 (**Figure 3**).

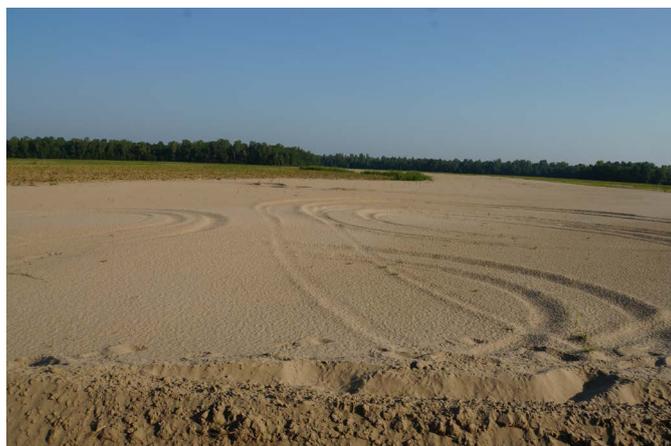
Figure 8. The flood of 2016 covered fields with sand which made cultivation impossible.

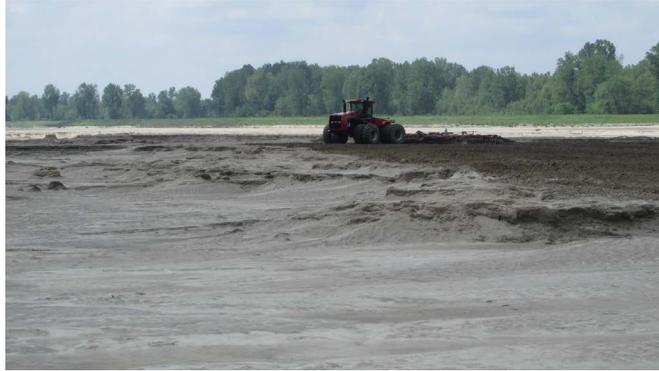
Figure 9. Tilling around gullies in an attempt to farm the land which proved to be impossible with no crop yields after 2016.

Missouri land owners built levees which by 1915 re-routed the Ozark Plateau floodwaters into the Mississippi River just north of the Thebes Gap. In 1943 the Illinois farmers in Alexander County built the Len Small district levee (Figure 2) to protect their farmland and farmsteads from floodwaters. In the 1960s the levee was extended. The Len Small breached in 1993 and was repaired. The Len Small levee failed in 2011 and was restored. When the levee failed again in 2016 (Figure 6) it was not fixed due in part the extent of the land and levee damage, and the estimated total cost was \$16 million with a local required match of \$3 million. Since 2016 the Dogtooth agriculture land flooded every year with tens of hectares of land eroded and hundreds of hectares land and ditches and roads covered with thick sand deposits (Figure 7 and Figure 8). The floods of 2017, 2018 and 2019 all entered and covered most of Dogtooth Bend and continued to make agriculture production (Figure 9) on Dogtooth Bend difficult or impossible.

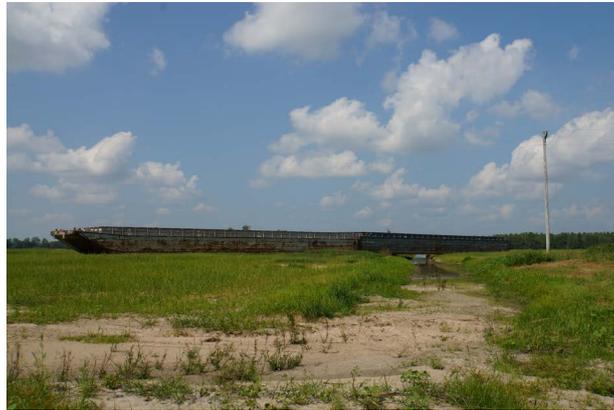
Figure 10. Runaway barges that passed through the Len Small breach during June-July 2019 flood. Picture taken by Lois Wright Morton.

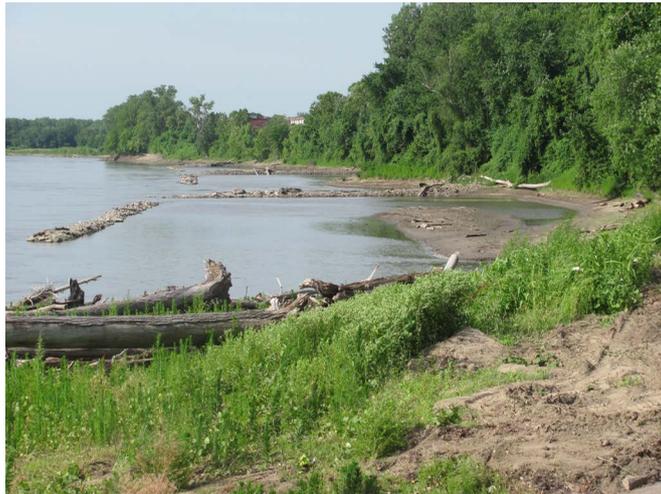
Figure 11. Wing dikes, river training structure, used to protect the river bank from erosion and to maintain the navigation channel. Picture taken by Lois Wright Morton.

The Mississippi River basin is controlled and regulated by the river engineering structures including earthen levees [1], locks and dams [7] and wing dikes (Figure 11) step up dikes (Figure 12) on the main stem, notched dikes [8] and

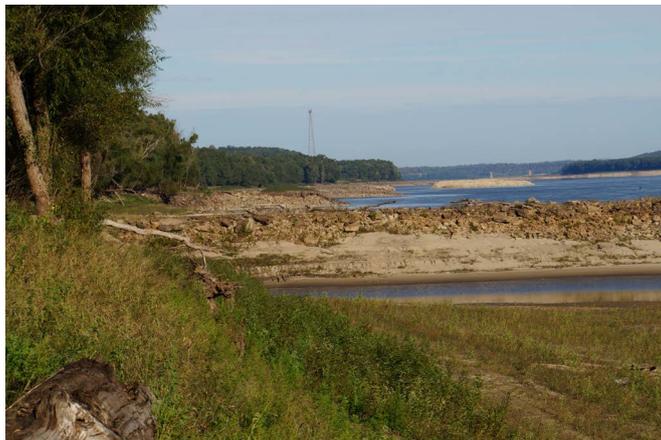
Figure 12. Step up dikes on Mississippi River to prevent sediment from accumulation along the shoreline. Picture taken by Lois Wright Morton.

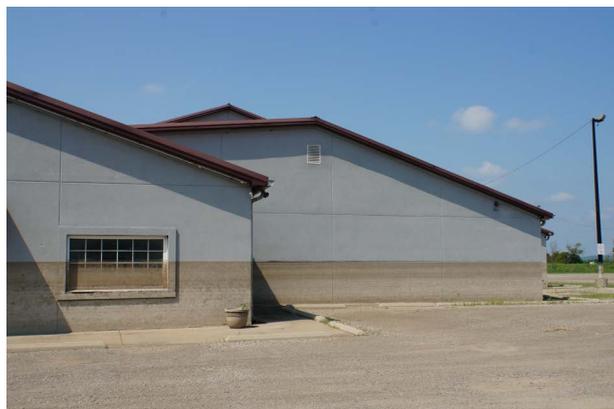
Figure 13. The 2019 high water mark on building. Picture taken by Lois Wright Morton.

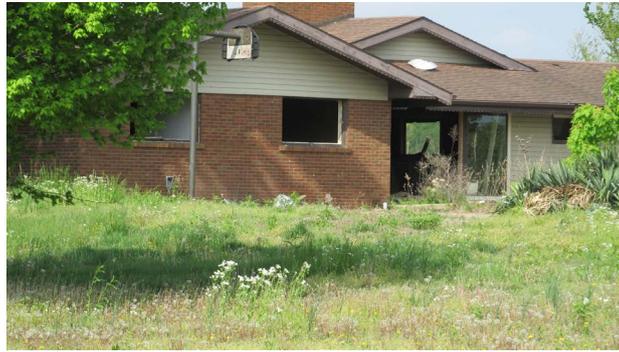
Figure 14. Flood damaged home purchased by FEMA along the 1993 channel. Picture taken by Lois Wright Morton.

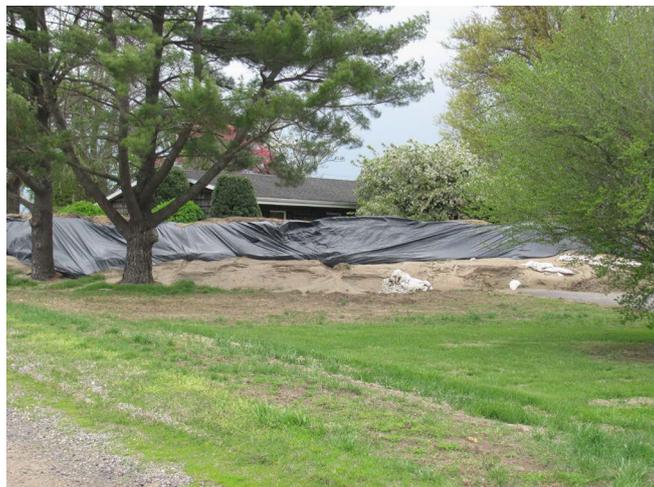
Figure 16. Berm or levee around home. Picture taken by Lois Wright Morton.

The increase in Mississippi River peak flow as a result of LRDD diversion placed additional river pressure on levees and led to increased flooding, especially during the floods of 1927, 1937, 2011, 2016 and 2019. The Kentucky, Illinois and Missouri farmers' and landowners' response to the additional volume and height of the Mississippi River from the diversion channel valley, and the prevention of the Mississippi River floodwaters from flowing into the ancient Mississippi River valley and Big Swamp, was to build floodwalls, levees and berms around farmsteads (**Figure 16**) [1].

The 1993 and 2011 levee breaches resulted in the flooding of 6800 to 14,000 ha with an unknown number of buildings damaged and removed after the 1993 flood and 169 structures damaged during the 2011 flood [8]. The Federal Emergency Management Agency awarded the State of Illinois an US\$8.7 million grant that required a state match to purchase these structures beginning in April of 2015, but only a few homes were purchased before July 1, 2015. After the Illinois legislature failed to pass a state budget in July of 2015, the state matching funds were not available and the program could not be fully implemented before the 2016 flood. In 2018 an Illinois State Budget passed and the purchase of structures resumed. By not repairing the 2016 Len Small breach, Dogtooth Bend has become the defacto floodwater storage area. In the early 1990s there were 100 homes on Dogtooth Bend. After the 2011 flood FEMA began purchasing many of the remaining homes (Figure 14). Today there are only a few and most with berms around the homes or farmsteads (Figure 16).

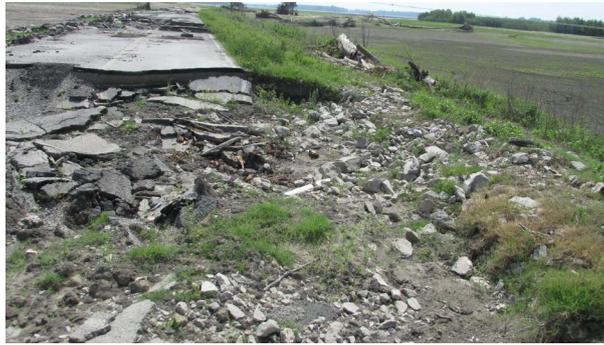
Figure 17. Extensive road damages caused by the 2019 flood. The road is located between Miller City and Olive Branch and just south of entrance to Horseshoe Lake.

berms were removed from a 1 km section of pavement and the road bed was washed out with pavement broken and in some places had 1 meter deep drop offs in the road and on the edges (Figure 17). The entire road base will need to be reconstructed before re-paving. Considerable amount of trees and drift wood accumulated on the road and was piled up and/or was burned. Other sections of the road had berms removed by the flowing water and had 1 m or more drop offs which required vehicle drivers to avoid pulling onto the former berms (Figure 17). The road had to be closed after the floodwater receded and was not opened during the rest of 2019. The Alexander County highway and road reconstruction and repairs will cost millions of dollars and will probably be the focus of future litigation.
